Ground handling occurrence involving Airbus A330, 9M-MTB

Melbourne Airport, Victoria | 31 March 2016

ATSB Transport Safety Report
Aviation Occurrence Investigation
AO-2016-028
Final – 13 September 2016

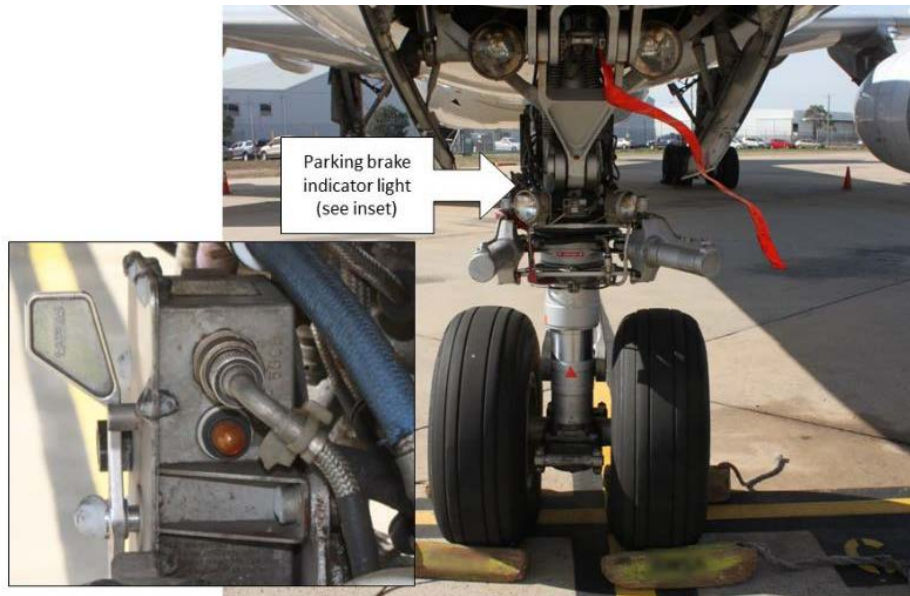
- nose landing gear chocks were installed
- park brake indicator light on the nose landing gear had been on when it was recently checked by the AME, consistent with the brake being engaged (Figure 1).

Figure 1: Nose landing gear showing the aircraft's park brake indicator light (note the wheel chocks in place)

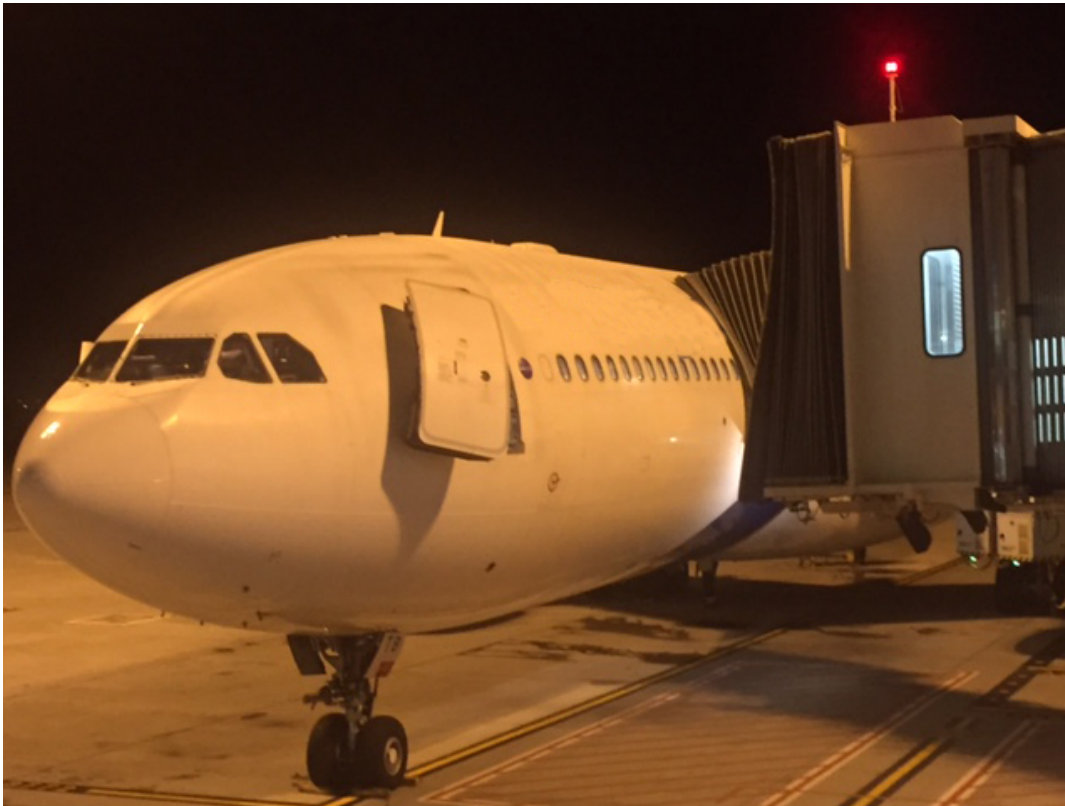
The aircraft's forward-left door was dislocated by the contact with the aerobridge (Figure 2). The door, hinges, and aerobridge were damaged and there was slight indentation of the fuselage skin forward of the door. There was no major structural damage. There were no injuries.

Figure 2: The aircraft’s forward fuselage showing the dislocated forward-left door. The slight indentation in the fuselage skin forward of the door is not visible. The aerobridge is shown retracted from its position when struck by the aircraft

On 27 May 2016, Malaysia Airlines Berhad reported that it was planning to amend its procedures so that flight crews advise ground crews whenever the park brake is about to be released. As an interim measure before the amendment could be approved, the operator sent A330 flight crews a reminder to communicate with ground crews before releasing the park brake to verify that chocks are in place.

On 5 August 2016, Menzies Aviation (the tractor operator) developed a written local operating procedure to incorporate local differences in work practices and improve coordination between work crews.

- The engineering team that day received retraining in pre-departure and pushback operations. This included familiarisation with documented procedures, practical assessment and a requirement to perform a team safety brief on lessons learned.
- AMSA began introducing standard aircraft arrival, turnaround and departure procedures to all ports. This will ensure that practices are standardised and that they are over and above client's requirements.
- AMSA commenced periodic operational safety inspections at all ports. These inspections include assessments of the standard procedures to identify opportunities for improvement.
