AIRCRAFT ACCIDENT REPORT 1/2015

**Report on the accident to
Airbus A319-131, G-EUOE
London Heathrow Airport
24 May 2013**

Air Accidents Investigation Branch

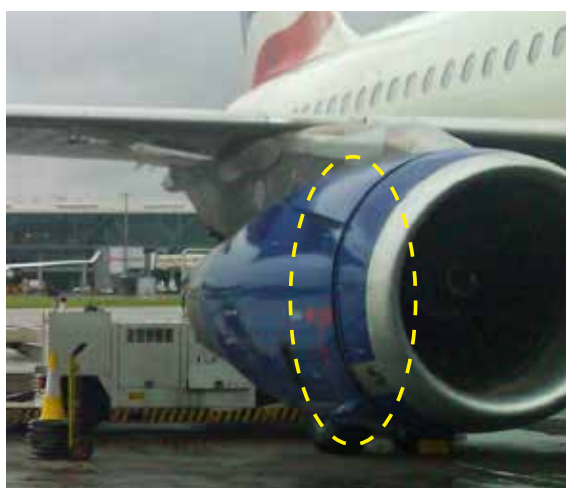
Figure 1

While the aircraft was being prepared for flight, a member of the operator's staff happened to take a sequence of photographs of the ground handling activities for the purpose of a ground handling training video. The photographs had inadvertently captured evidence that the fan cowl doors on both engines were in the unlatched condition. On the right engine this is indicated by the gap between the outboard fan cowl door and the nose cowl (Figure 1) and on the left engine by two latches protruding visibly below the cowl doors (Figure 2).

G-EUOE right engine, outboard fan cowl door, showing gap with nose cowl (circled)

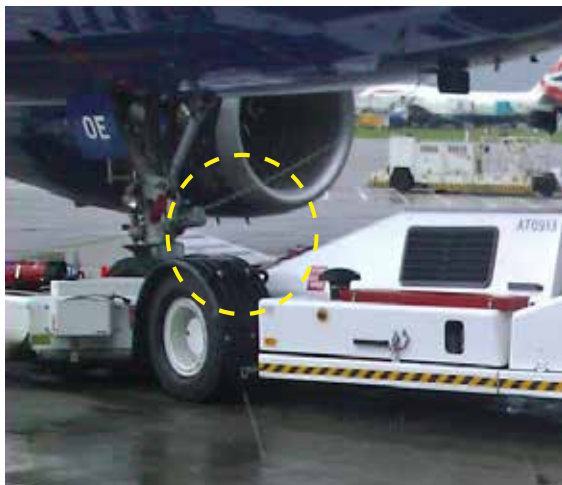
Figure 2

G-EUOE left engine fan cowl door latches visible in unlatched condition (circled)

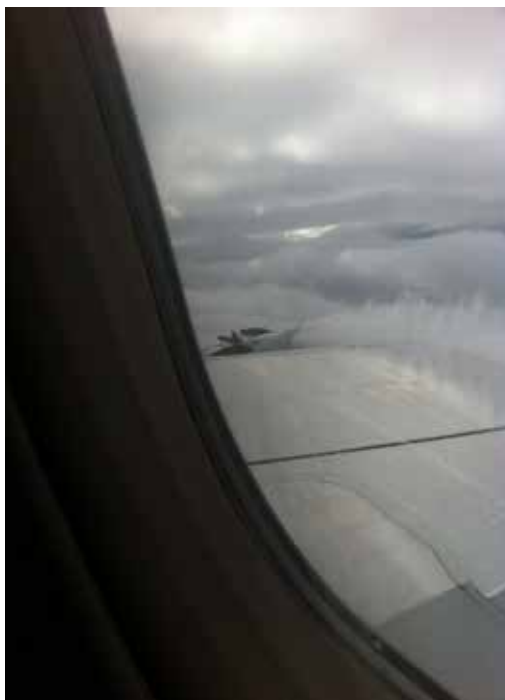
Figure 3

A number of passengers saw fuel leaking from the right engine. One passenger highlighted the leaking fluid to a member of the cabin crew, stating that it appeared to be fuel, but was told that it was not. Photographs taken by passengers show a significant fluid leak from the right engine (Figure 3).

Photograph taken by a passenger showing right engine fuel leak

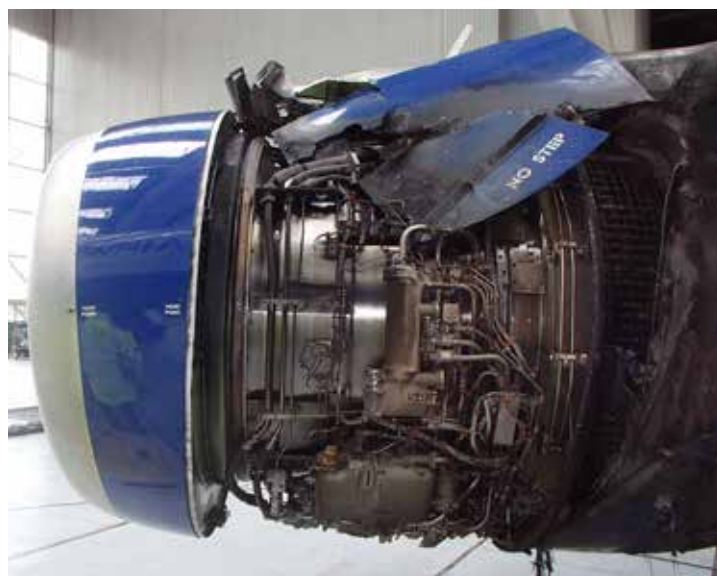
Figure 4

The inboard and outboard fan cowl doors from both engines had detached, close to the pylon attachment hinges. Whilst three of the four fan cowl doors had separated by delamination of the fan cowl's composite structure, the forward section of the right inboard door, together with the inboard nacelle aerodynamic strake, had remained attached to the aircraft (Figure 4). The majority of the detached remnants of the doors were recovered from Runway 27L.

Attached remnants of right engine inboard fan cowl door

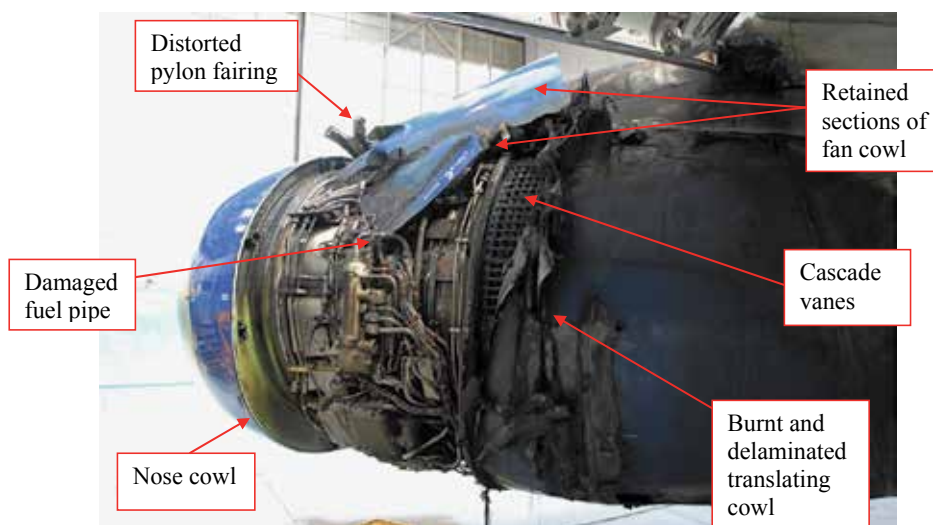
Figure 5

View of inboard side of the right (No 2) engine

Two large sections of the inboard fan cowl door remained attached to the right engine (Figure 5). The large section was attached to the hinge line along the top of the engine; the smaller section, incorporating the aerodynamic strake, was trapped behind a large diameter fuel pipe mounted on the fan case. Both attached sections showed extensive burning along their leading and lower edges. The fuel cooled oil cooler (FCOC) supply and return fuel pipes, behind

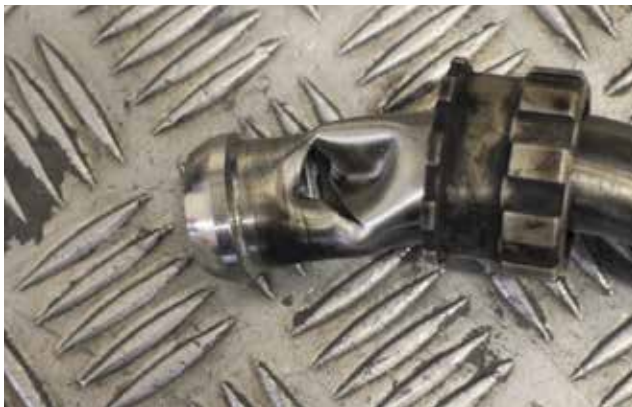
Figure 6

which the smaller section of fan cowl door was trapped, were also distorted. When the section of fan cowl was removed, puncture damage from the cowl was visible on the rear of the fuel metering unit (FMU) spill return pipe (Figure 6).

Damaged FMU spill return pipe after removal from the engine

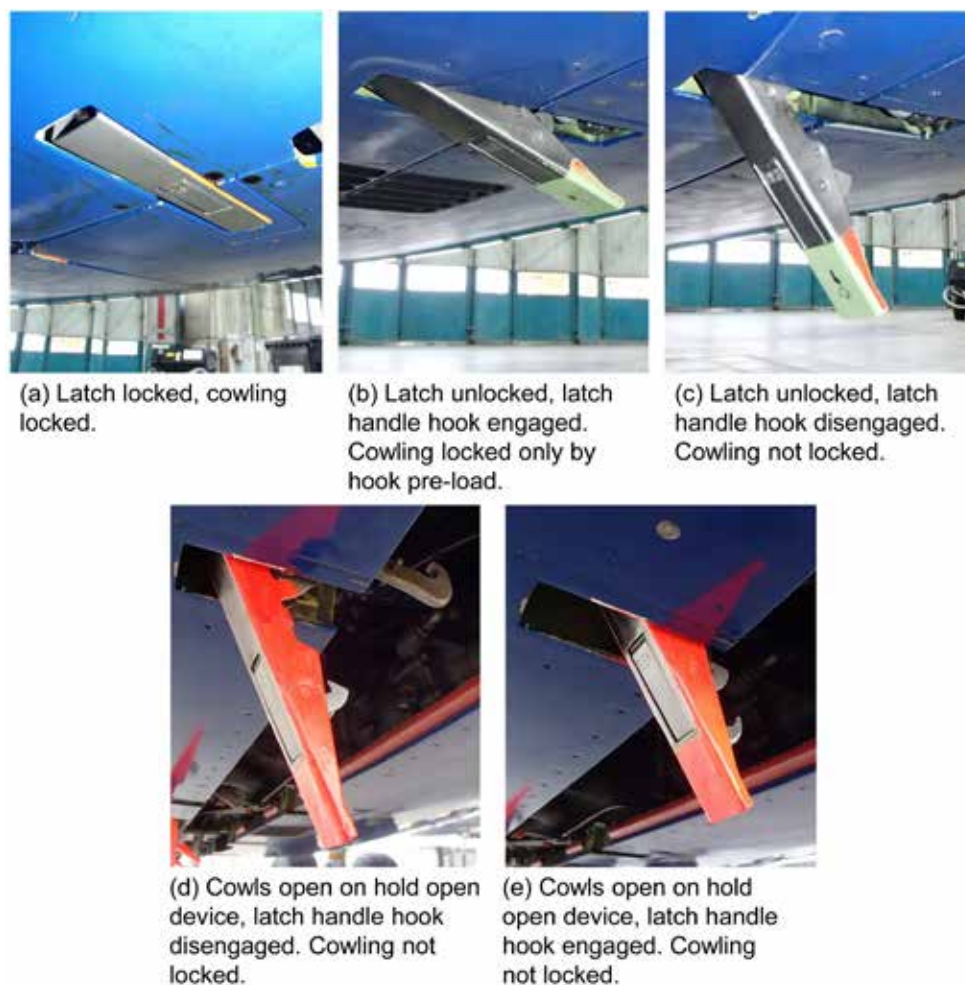
Figure 7

From discussions with maintenance personnel during the course of the investigation it was determined that it was common practice to leave the latches in this condition when the fan cowls were open, as the fully free condition (depicted in Figure 7(d)), in their opinion, presented a personal injury risk. Seven of the eight latches from G-EUOE, which were recovered with the fan cowl debris from the departure runway, were found in this condition.

Possible configurations of the fan cowl door latches

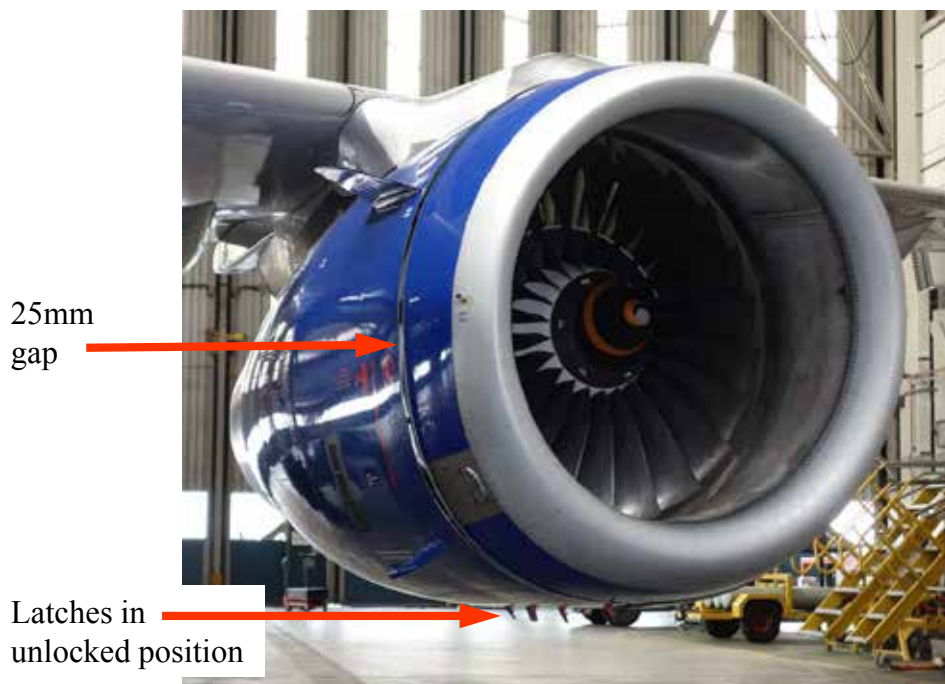
Figure 8

To make it more obvious that fan cowl doors are unlatched, the nacelle is equipped with a hold-open device that is bolted to the fixed nose cowl. The device consists of a spring-loaded blocker bar assembly which, when depressed upwards against a spring by maintenance personnel using a screwdriver, allows the fan cowls to be raised from their closed position. Once the fan cowls are raised, the screwdriver is withdrawn from the device and the blocker bar lowers into the 'hold open' position by spring force. In this condition the device prevents the fan cowls from closing flush with the nacelle, due to gravity, and the fan cowl doors stand about 25 mm proud of the nacelle to provide a visual cue that the doors are not latched (Figure 8).

Fan cowl doors on the hold-open device; latches in unlocked position as shown in Figure 7(e)

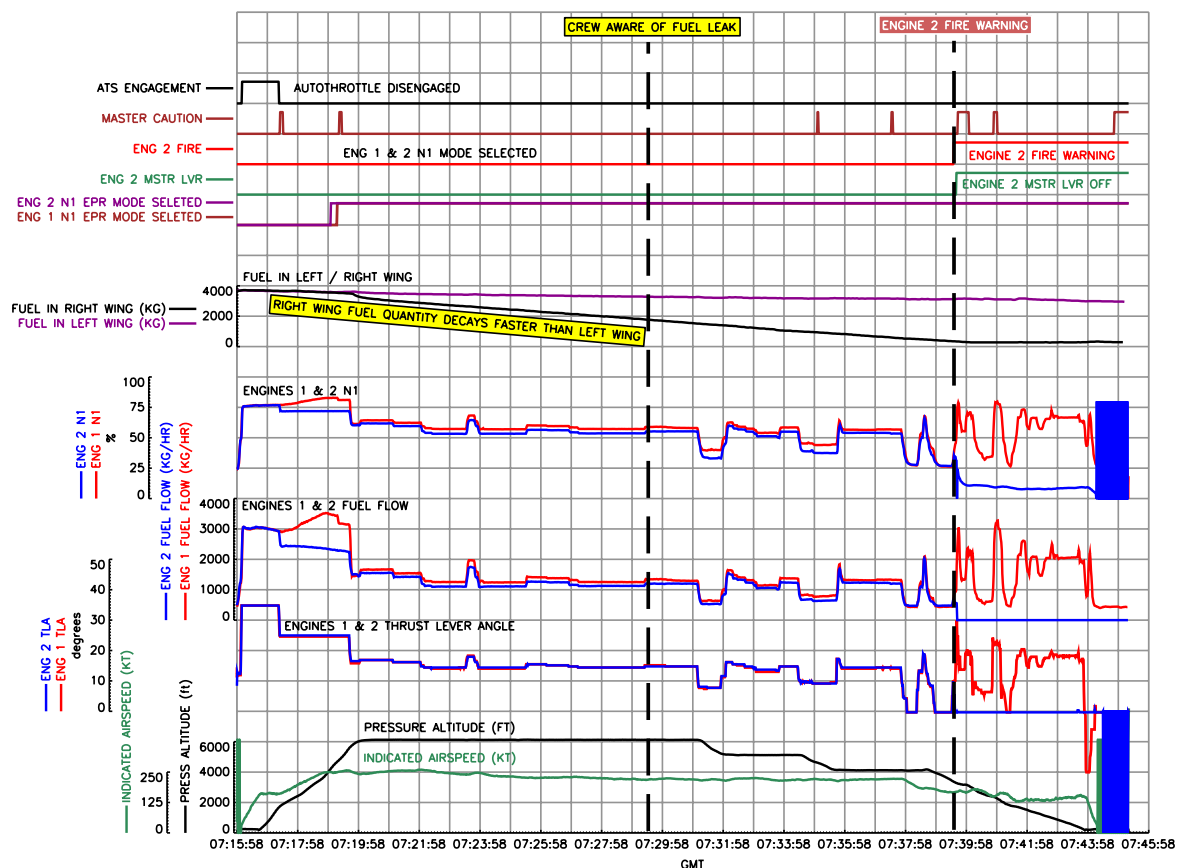
Figure 16

The total fuel consumption, calculated by integrating fuel flow rate over time, revealed that both engines had used approximately the same quantity of fuel and the aircraft manufacturer confirmed that the consumption rate of fuel for both engines was as expected. Calculations suggest that a total of 2,887 kg of fuel had leaked from the right engine.

G-EUOE engine and fuel usage data

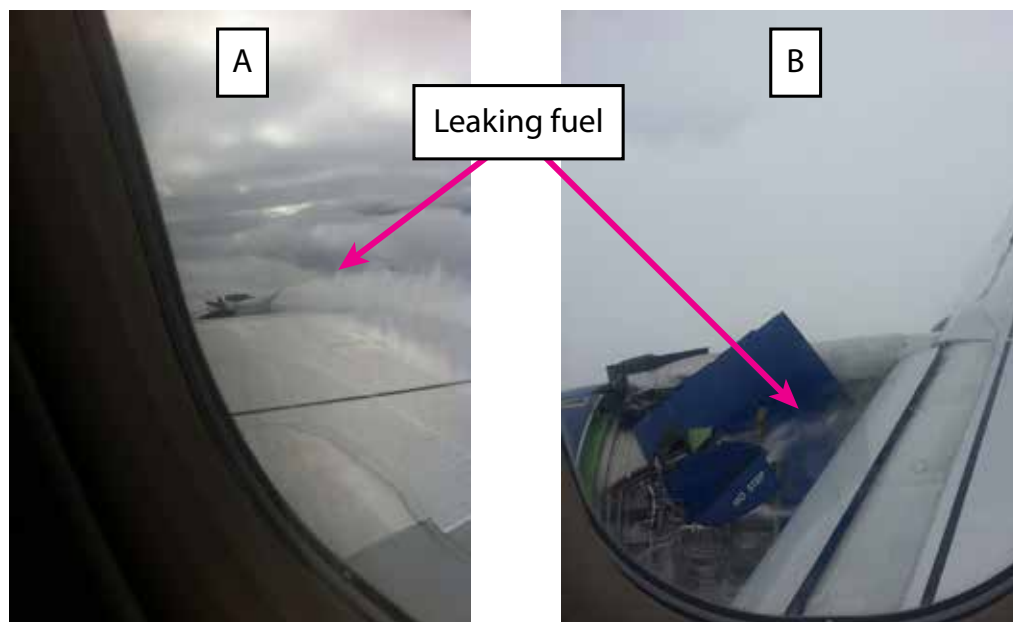
The aircraft rotated at 07:16:39 hrs and it is at approximately this point that fan cowl door sections from both engines were observed to have departed the aircraft. Within three seconds, the engine control system on the right engine identified a fault with the P2/T2 probe heat system. At 07:17 hrs a Yellow hydraulic system reservoir low level warning occurred indicating a leak of hydraulic fluid. At 07:19:21 hrs a Yellow hydraulic system low pressure warning was triggered. Variations in the right wing fuel tank quantity versus engine fuel flow provided the first evidence, 90 seconds after rotation, that fuel was leaking from the right engine, although the crew would not have been aware of this. Evidence from passenger witness reports confirmed that as the flight continued there was a significant fuel leak from the engine, though no reports of a fire at this stage. Picture A in Figure 18 was taken at 07:23:14 hrs. Picture B was taken at 07:39:14 hrs. The recorded data shows that the leak rate was effectively the same in both pictures, but the deployment of the leading edge slats by the time the second photograph was taken had significantly changed the airflow and thus the dispersal of the fuel as it left the engine.

Passenger photographs showing the fuel leak

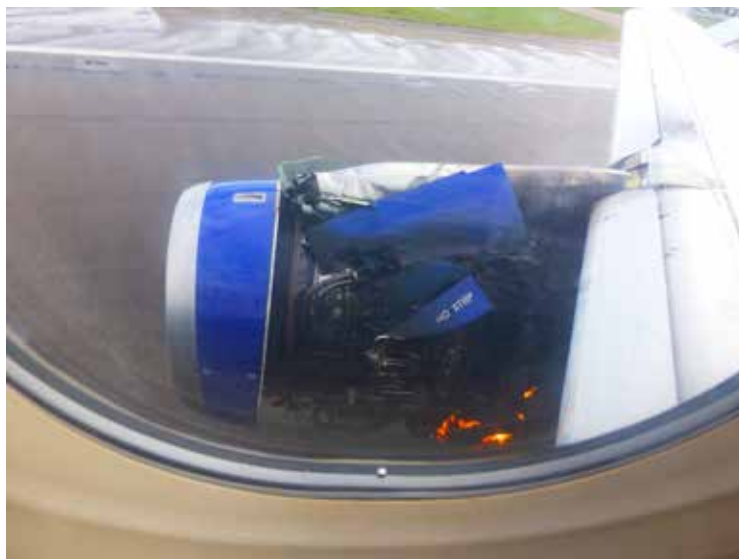
Figure 19

A photograph, taken by a passenger during the landing roll (Figure 19), shows that a fire continued to burn in the lower section of the engine until the end of the flight. Video evidence and witness statements from the attending airfield operations staff and firefighters who attended the aircraft, describe the fire intensifying again once the aircraft came to a stop on the runway. However, it was quickly extinguished by the AFRS and London Fire Brigade (LFB) assets, who had attended as part of the pre-determined response to the ATC declaration of 'Aircraft Accident Imminent'.

Engine fire during landing roll

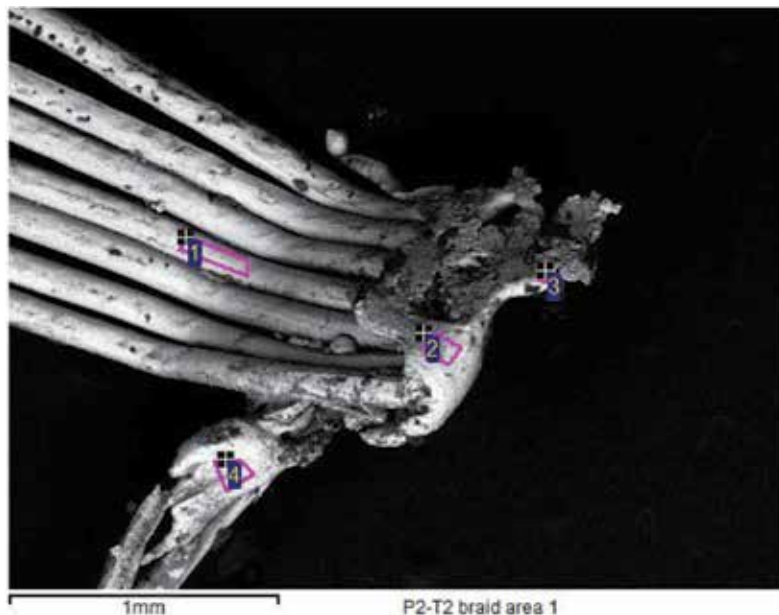
Figure 21

Of these looms, only the P2/T2 loom exhibited evidence of arcing. The temperatures associated with an electrical arc can reach several thousand degrees centigrade and it therefore provides a ready ignition source. The P2/T2 wiring loom contains the probe heater supply, which is 115 V AC. Mechanical damage was identified on the loom 90 mm from the connector. This damage exhibited evidence of arcing. Energy Dispersive X-ray (EDX) analysis of the copper wiring core, using a Scanning Electron Microscope (SEM), identified that it was contaminated at points 2, 3 and 4 (Figure 21) by traces of a stainless steel material, indicating that arcing had occurred between the cable and a component made from this material. The melting point of stainless steel is approximately 1,500°C, depending on the grade of steel.

SEM image of the P2/T2 wiring loom

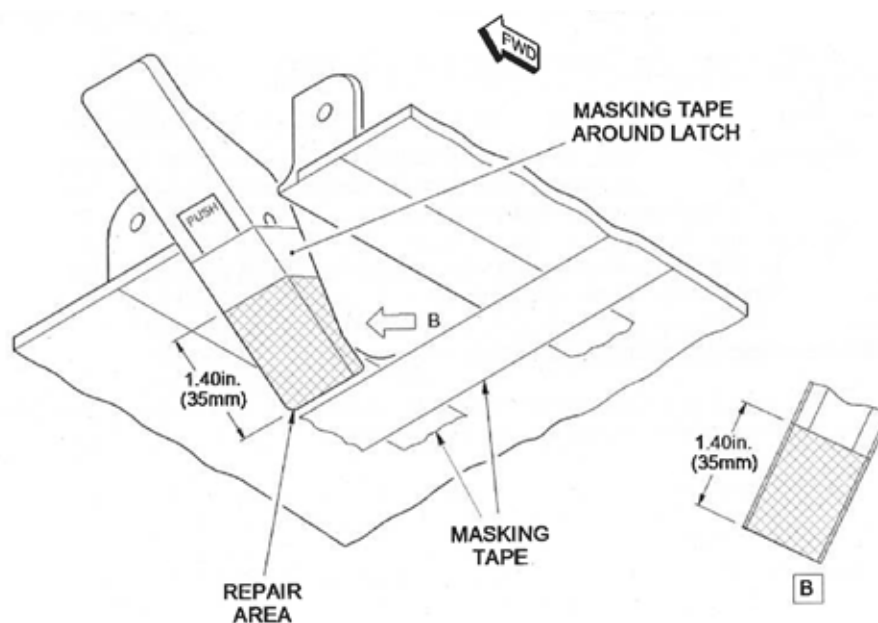
Figure 27

The Structural Repair Manual 54-20-00 for the fan cowl doors contained 'Repair Number 033 – Fan cowl door latch handles paint repair', last revised in February 2012. The repair instructions described the materials and processes to be used when repairing damaged high visibility paint on the latches, and included the following diagram of which area of the latches to repaint (Figure 27):

Latch painted area as defined by Structural Repair Manual 54-20-00, Repair Number 033

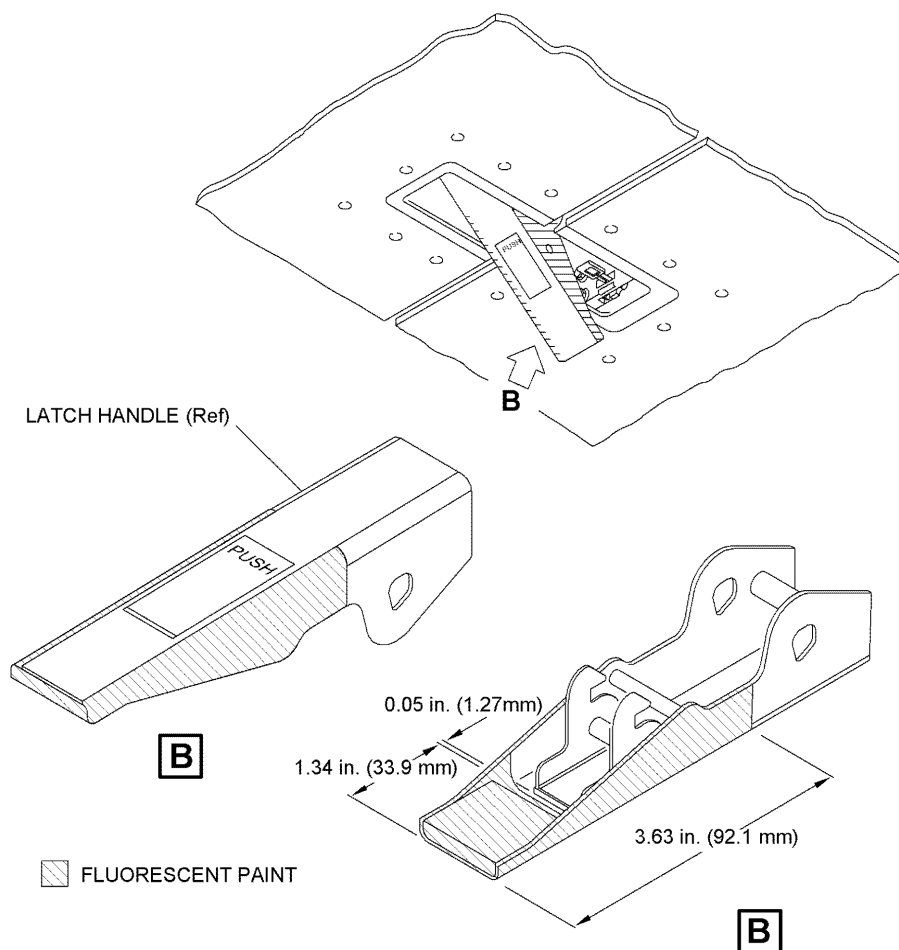
Figure 28

The area of the latch to repaint identified above was different from the painted area as defined in the engine manufacturer's August 2008 Revision 1 of Service Bulletin SB V2500-NAC-71-0227, which included the following diagram (Figure 28):

Latch painted area as defined by SB V2500-NAC-71-0227 Revision 1
