# **BULLETIN**

**Serious incident**

**30-5-2019**

**DE HAVILLAND CANADA DHC-8-202**

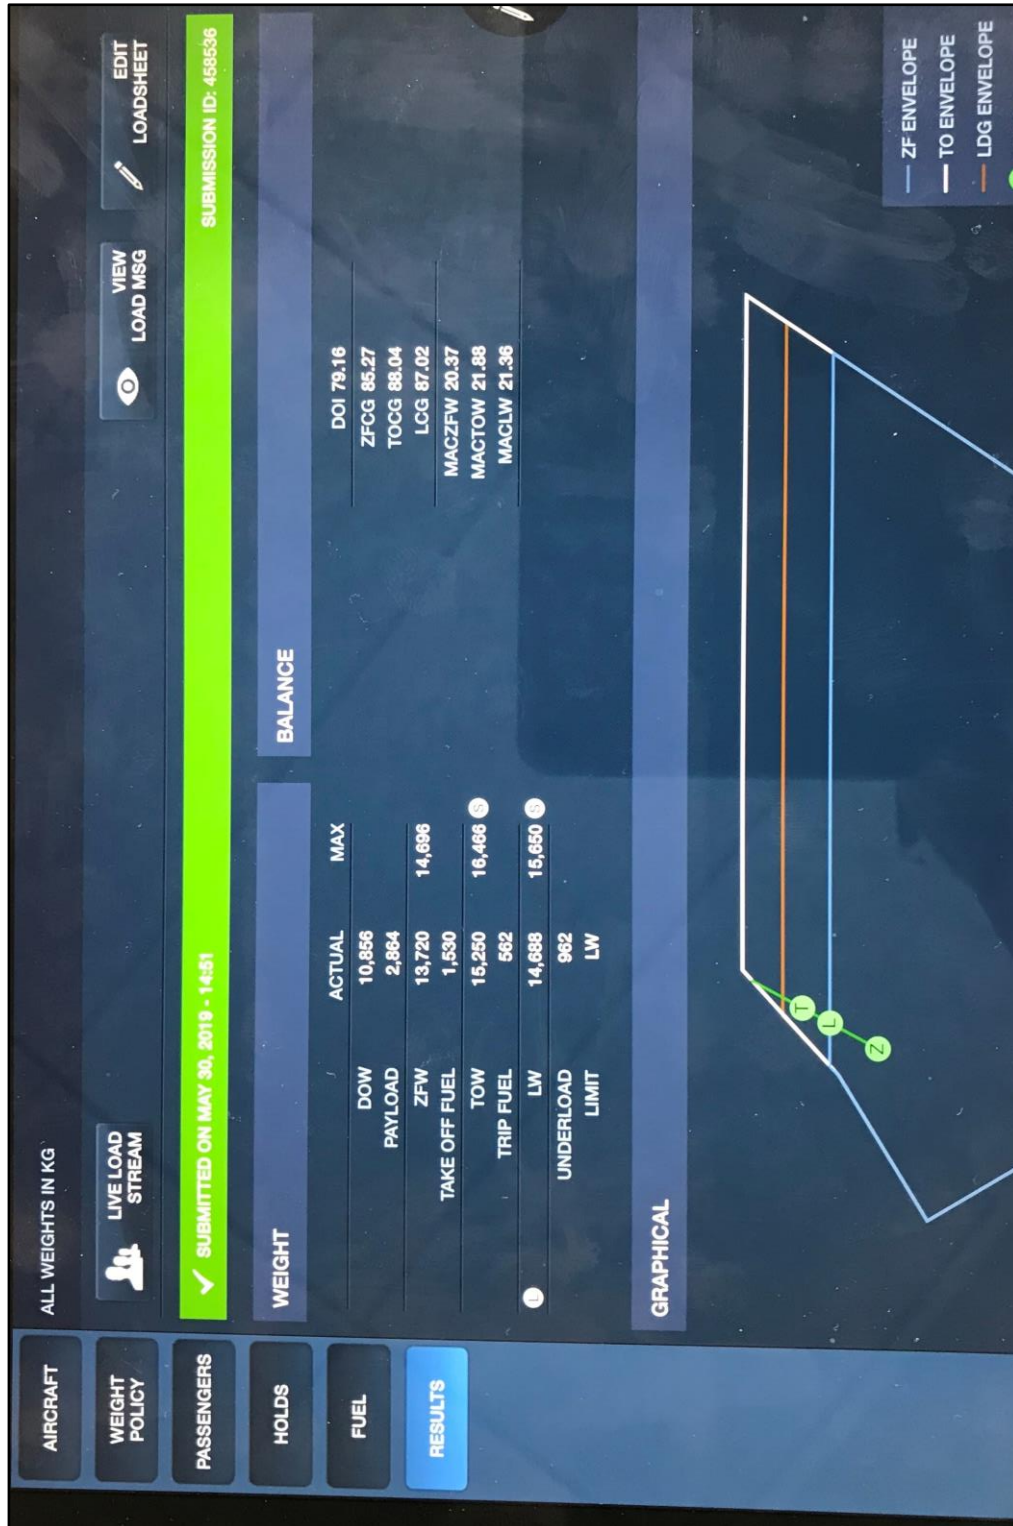
APPENDIX 2

The flight crew electronic presented mass and balance results - [see appendix 2](#).

The Dry Operating Weight (DOW) included 64 kg of catering.

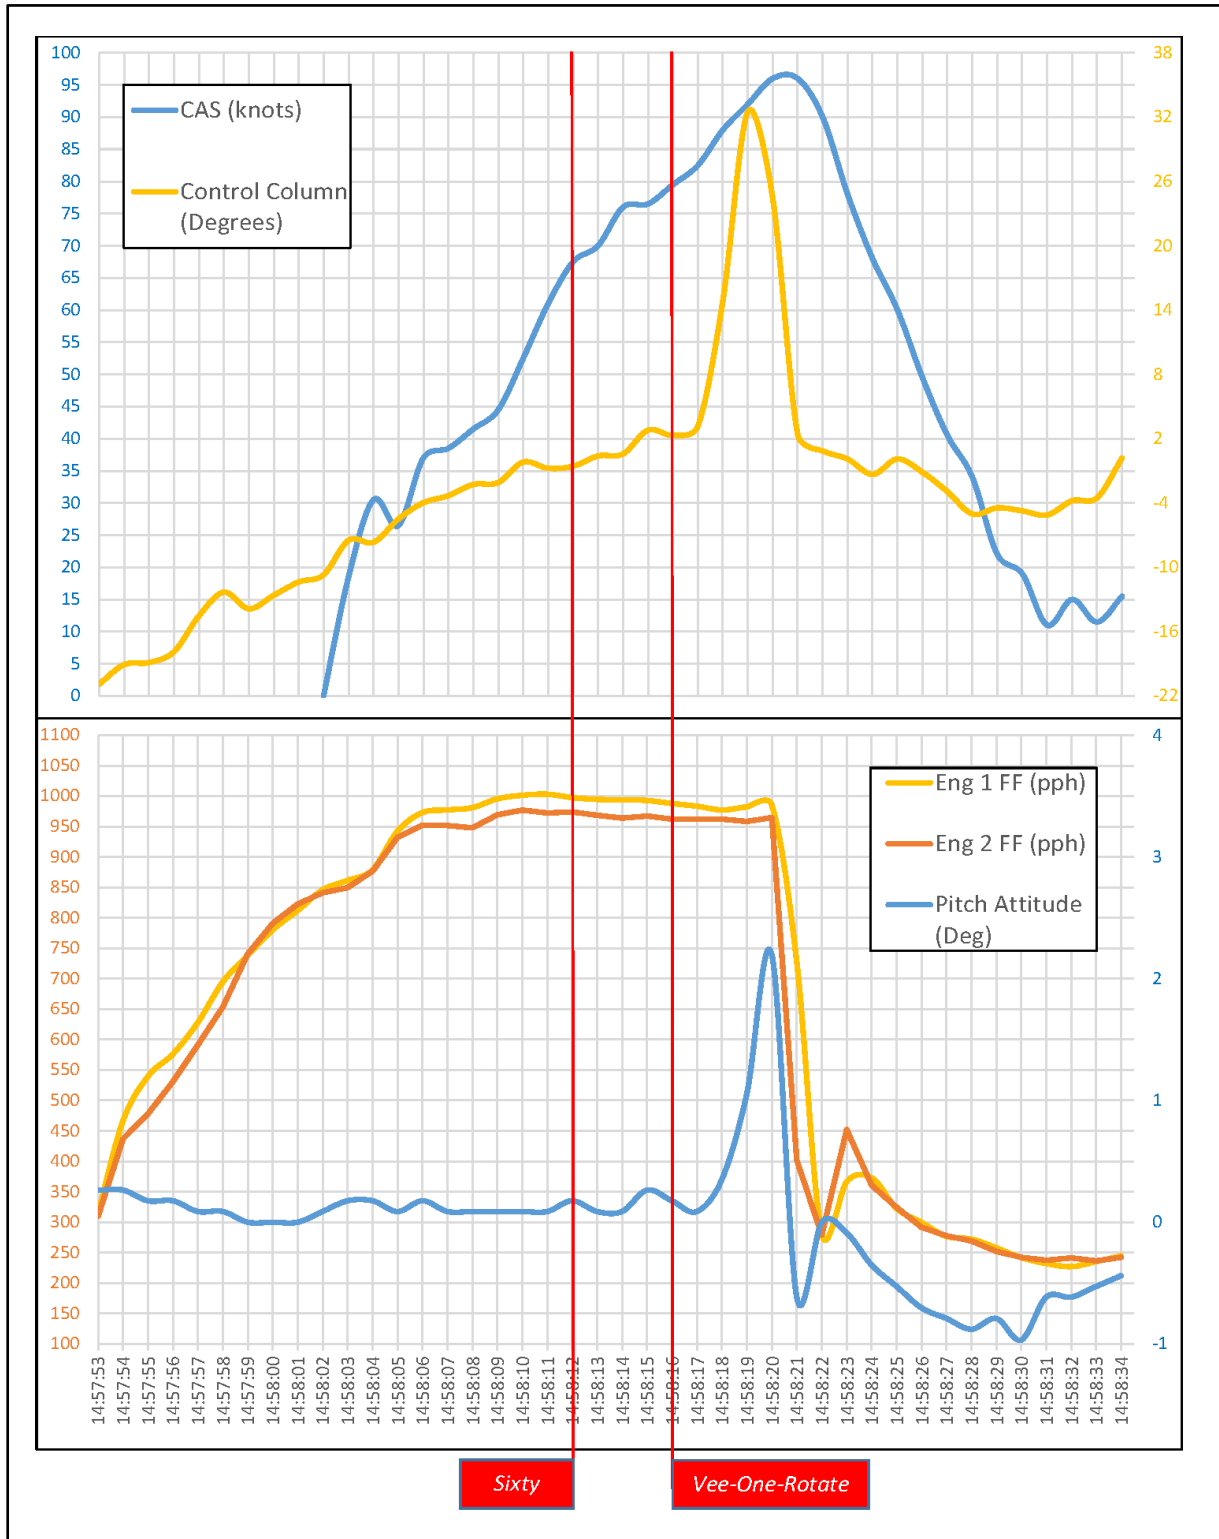
## APPENDIX 7

With the addition of the CVR *Sixty* and *Vee-One-Rotate* callouts, the AIB generated a QAR data plot - [see appendix 7](#).

Note. The elevator position attained was sufficient to rotate an aircraft loaded within the operational CG envelope (elevator position not presented in this plot).

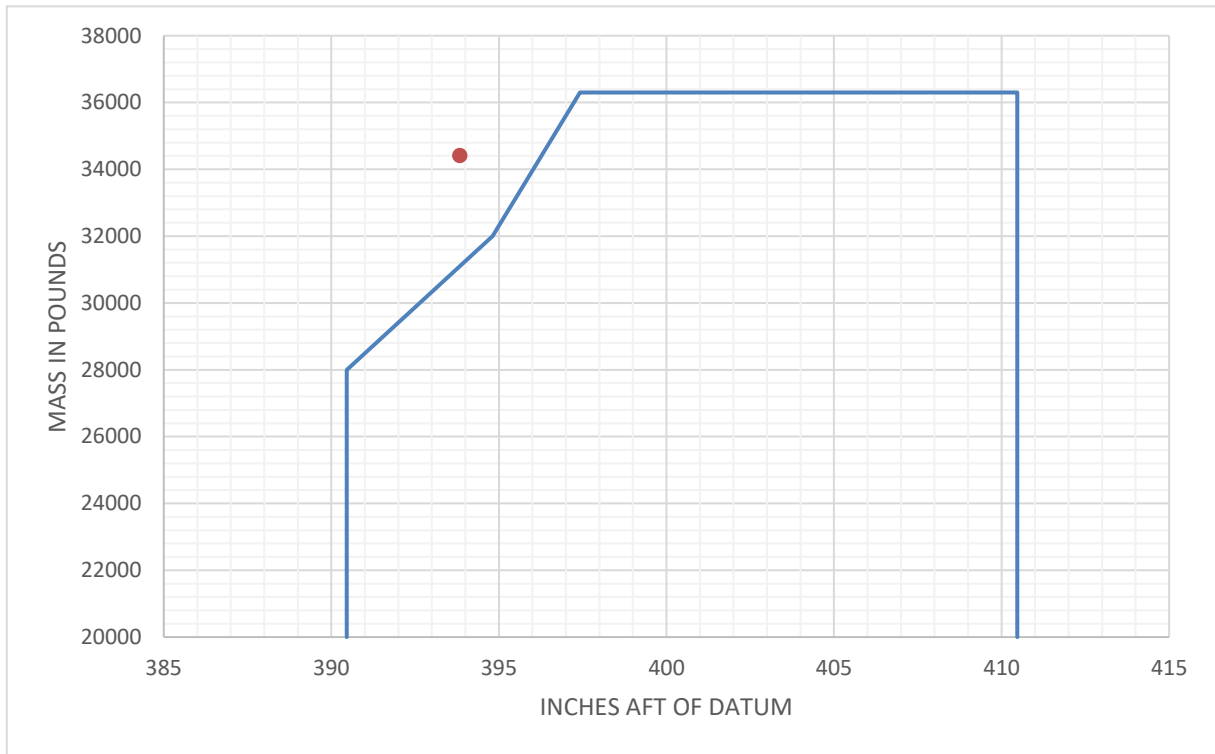
Mass and balance diagram

To the AIB, actual masses above standard masses resulted in the CG being forward of and outside aircraft operational CG limitations and was the root cause to reduced aircraft rotation ability.
