# Aircraft loading event involving Boeing 737, ZK-TLK

Sydney Airport, New South Wales, 17 December 2016

**ATSB Transport Safety Report**  
Aviation Occurrence Investigation  
AO-2017-002  
Final – 27 April 2017

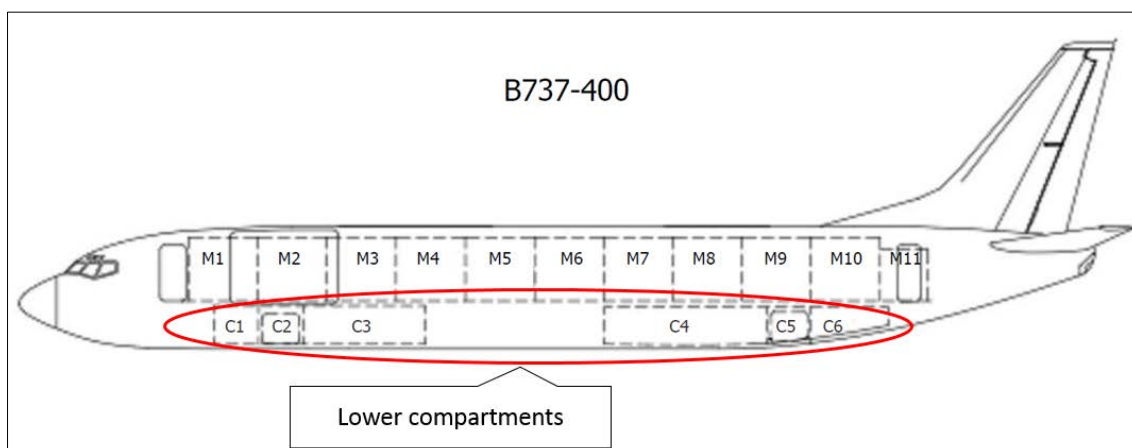
**Figure 1: Boeing 737-476SF lower compartments**

On the evening of the incident, two 737 freighter aircraft, operated by the same freight company, with the same paint scheme, were conducting freight flights into and out of Sydney Airport. The loading supervisor received loading instructions for the two aircraft shortly after they<sup>1</sup> started their shift at 1600 Eastern Daylight-savings Time (EDT). The loading instructions included changes to the scheduled lower compartment loads for the two 737 freighter aircraft, TLK and ZK-JTQ (JTQ) (Figure 1).
