**FRICTION CHARACTERISTICS  
OF HELIDECKS ON OFFSHORE  
FIXED-MANNED INSTALLATIONS**

I Beaty, Cranfield University

REPORT PREPARED BY COLLEGE OF AERONAUTICS  
FLIGHT SYSTEMS AND MEASUREMENT LABORATORIES,  
AIRCRAFT GROUND OPERATIONS GROUP  
AND PUBLISHED BY  
**CIVIL AVIATION AUTHORITY, LONDON, MARCH 1998**

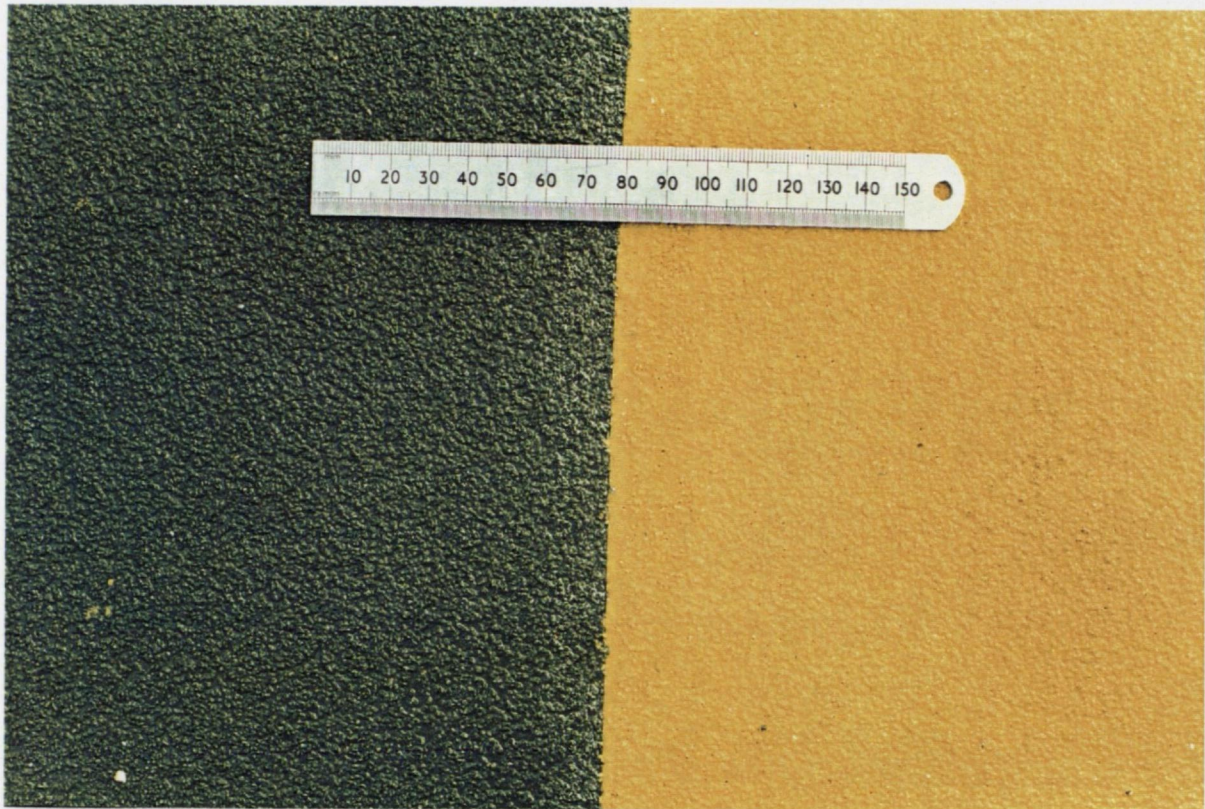
Figure 3 Sealcoat Green and Safeflor Yellow Finishes

2.3.2 The experimental epoxy surfaces were manufactured and laid by Safeway Traffic Products Ltd. The overall surface finish on the helideck was 'Sealcoat Green' (Figure 2) whilst the markings were also of the same epoxy finish, but with an added pigment to give 'Safeflor Yellow' (Figure 3) on the aiming circle and 'Safeflor White' on the 'H' and the platform name. The yellow and white pigmented areas contain retro-reflective materials for improved visibility at night.

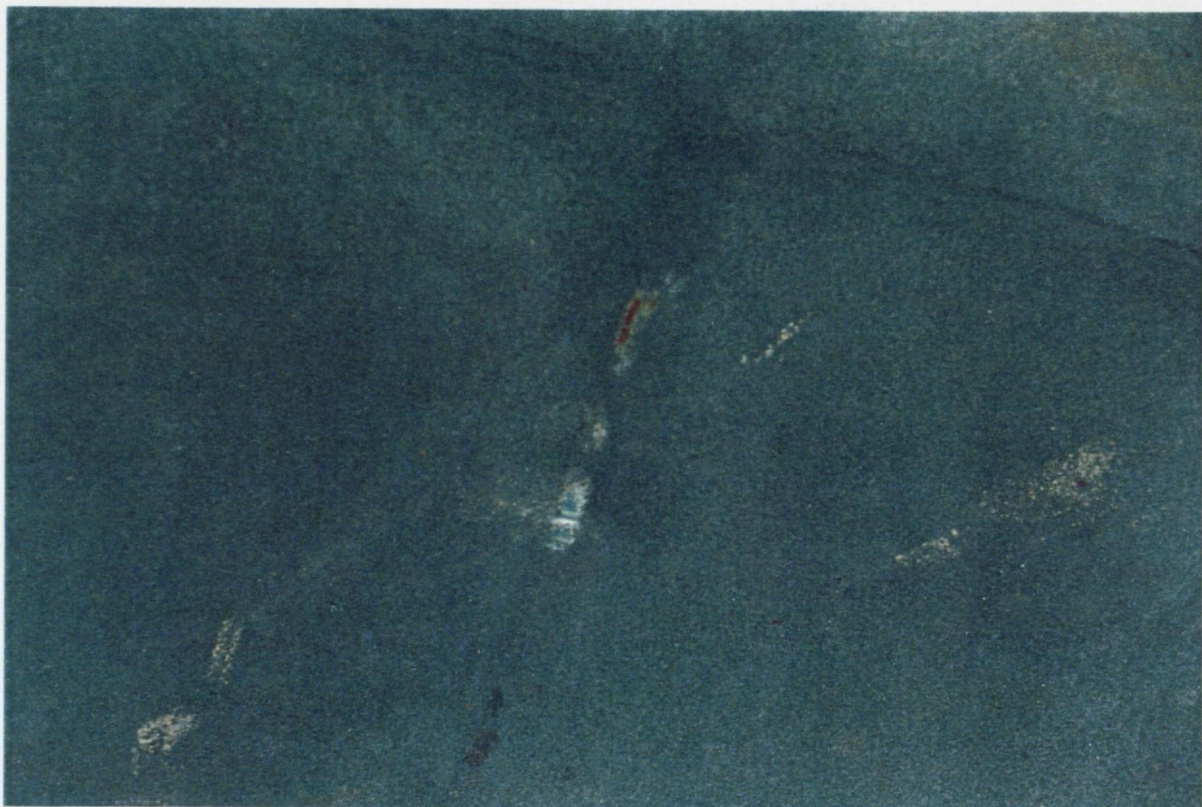
Figure 4 Damage to Weld Seam by Helicopter Skids

2.3.3 Since the installation of the new surface some damage has been caused by helicopters fitted with skid-type undercarriages (Figure 4). The damage consisted of worn patches on the tops of the deck weld seams which had permitted corrosion to occur, together with areas where the friction material had been badly scuffed. This was caused by high pressure contact with the skids of the in-field shuttle helicopter, which sits on the helideck with the engine running and rotor blades turning for considerable periods of time while personnel and freight are being loaded and unloaded. The resulting vibration had worn the surface coating in scattered areas (all within the aiming circle).

- 2.8.4 There is more variability inside than outside the aiming circle which can be attributed to two factors; a) contamination from fuel and oil spillage which, although cleaned off regularly, still marks the surface; b) surface damage caused by helicopters with skids. The contamination can be kept under control by regular cleaning. The latter problem will soon be eliminated with the withdrawal of skid-fitted helicopters from North Sea operations.

- 2.9.3 The surface has stood up well to the regular impact of the skid fitted inter-platform shuttle helicopters. Scuff marks have been repaired by the resident helideck team.

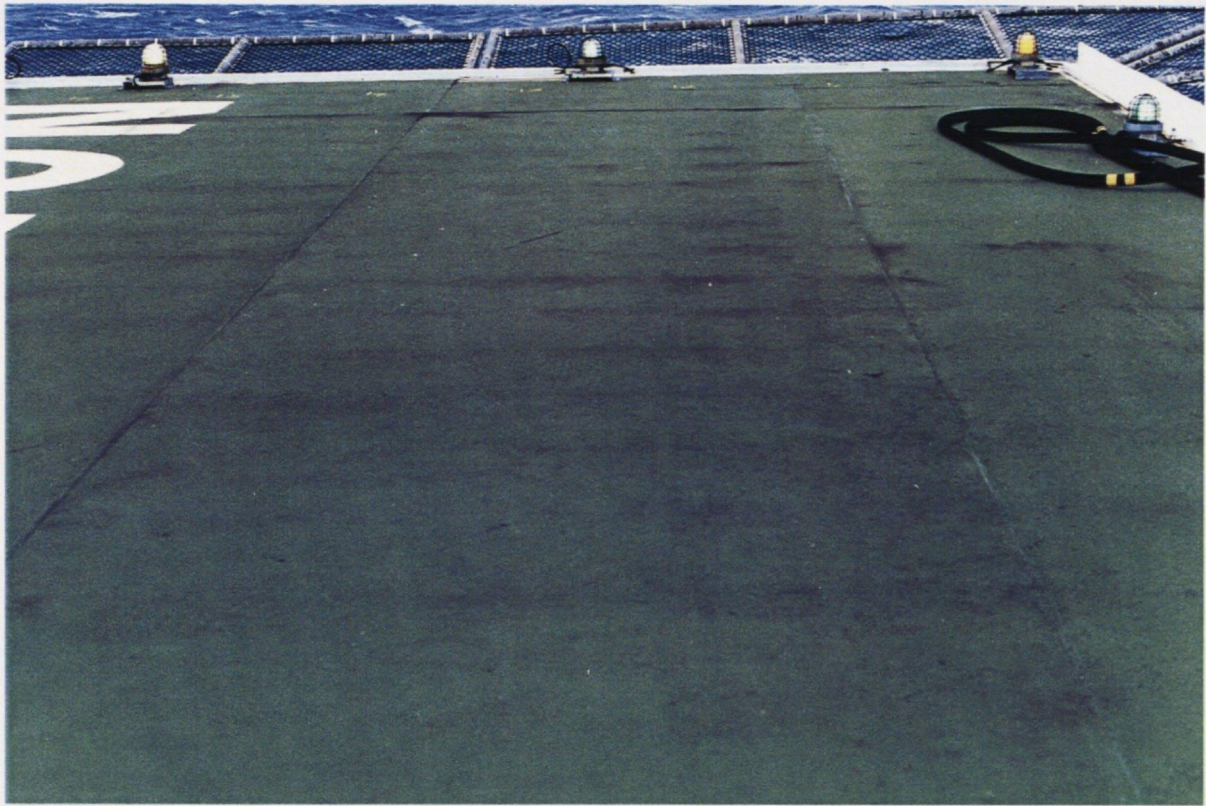
Figure 5 Pollution Deposits

2.3.4 In the early stages some dark staining of the deck occurred in the north-west corner (Figure 5) which was thought to be caused by pollution.

- 2.9.4 Initial dark staining of the deck, thought to be caused by pollution, has worn off and not reappeared. A white bloom, thought to be caused by moisture ingress during the initial installation, was overlaid and successfully eliminated with a thin layer of polyurethane resin.

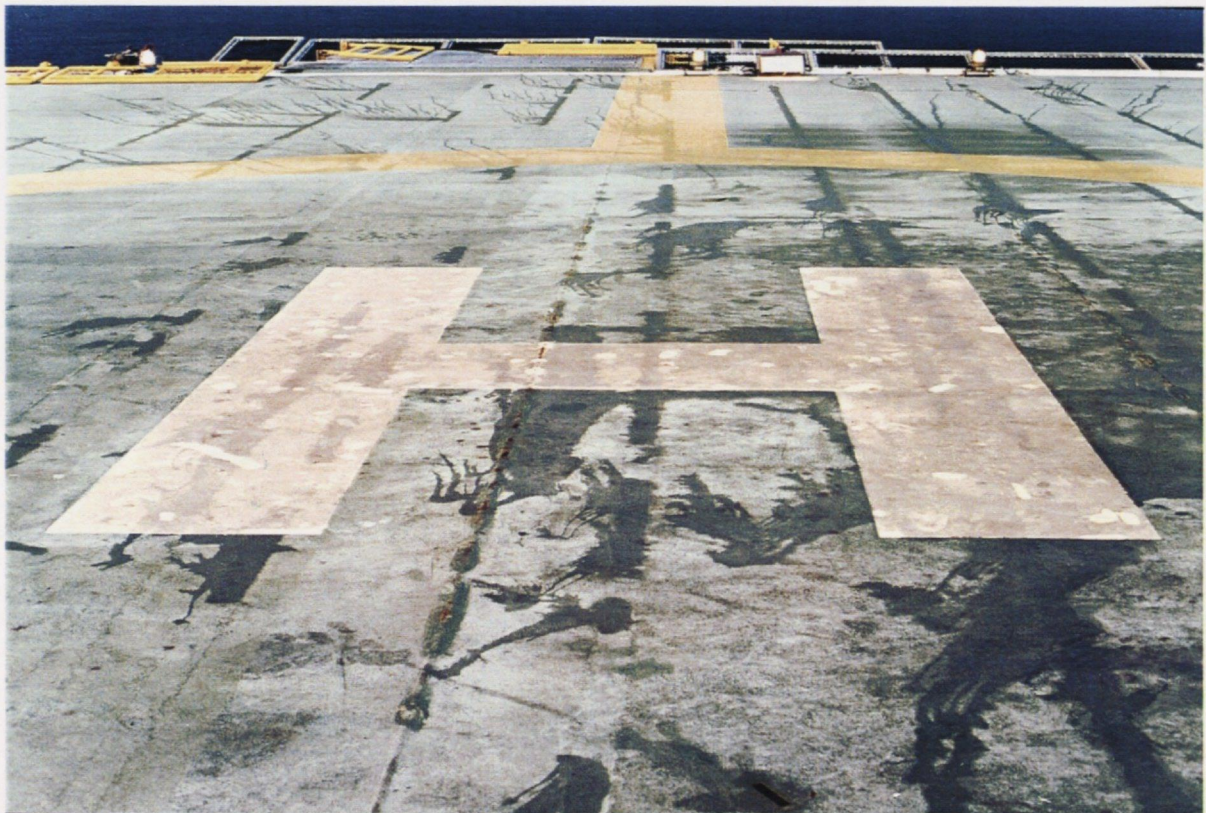
Figure 6 White Bloom

2.3.5 In the later stages the surface material attained a white 'bloom' (Figure 6) which was believed to be caused by the adverse weather conditions during the installation. In the summer of 1994 the deck was overlaid with a thin layer of polyurethane resin which succeeded in restoring the original green colour of the surface at the cost of a short-term slight reduction in the friction value, (Figure 7).

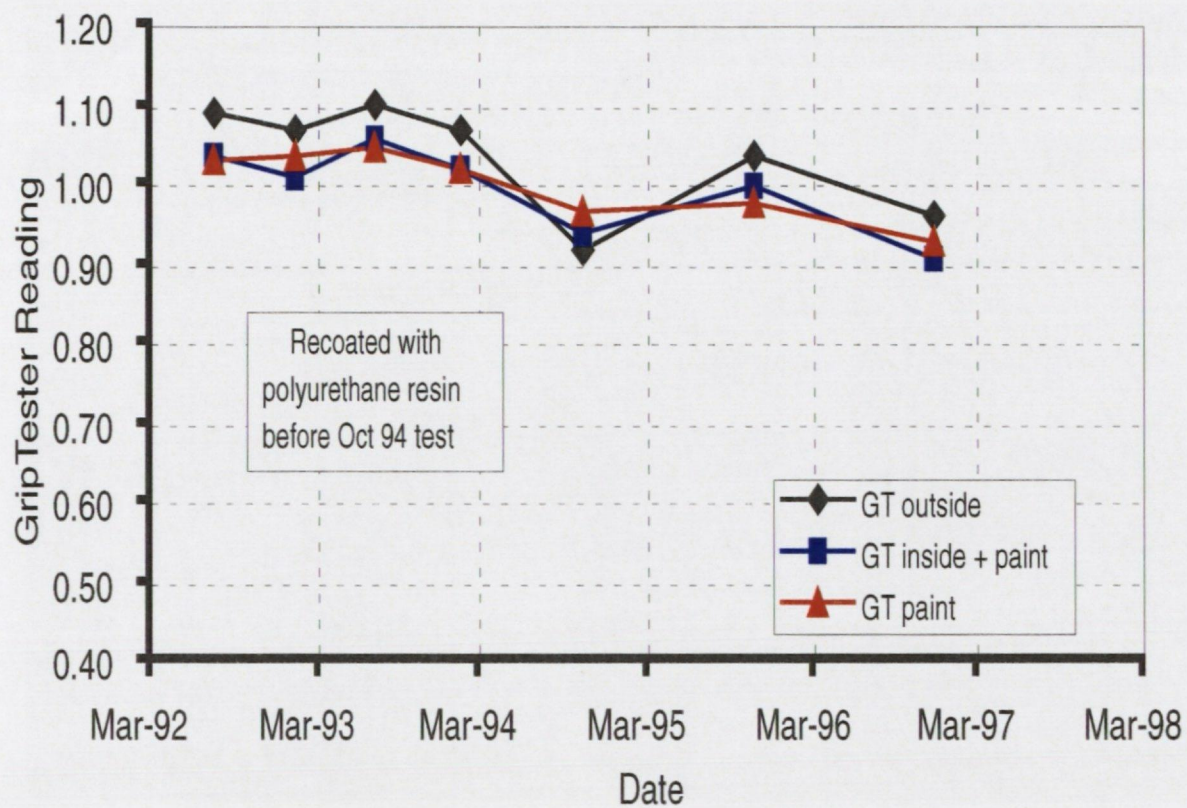
Figure 7 North Cormorant Friction History

- 2.8.2 Table 2 is a summary of the friction values since the beginning of the project.
- 2.8.3 The friction values on this helideck have remained high throughout its life to date, but the overall trend in friction readings is downward (Figure 7). Extended trendlines in Figure 8 will cross the 0.7 $\mu$  level at the end of 2005. It should be noted that the test in October 1994 was the only one performed on a wet deck.
