13 November 2013
FOIA reference: F0001702

AIRPROX REPORT No 2012153

AIRPROX REPORT No 2012172

AIRPROX REPORT No 2013048

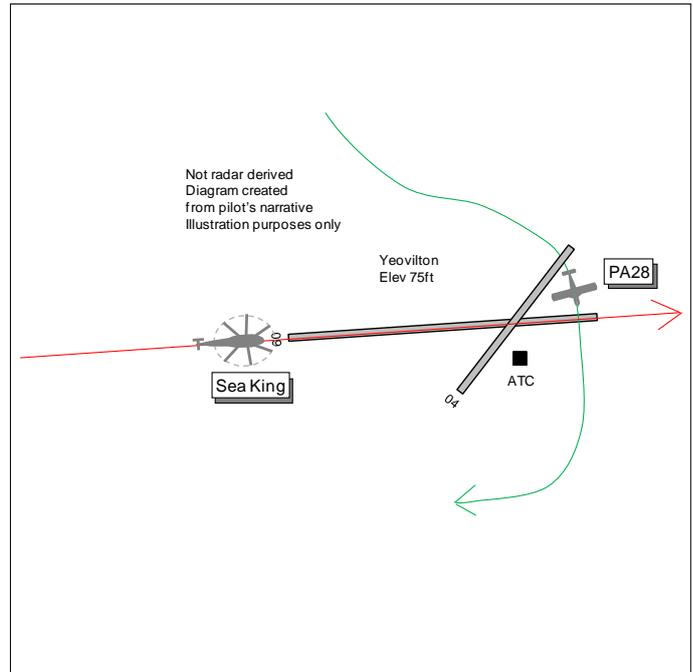
Position: 5101N 00238W (O/H RW09
Yeovilton - elev 75ft)

100ft V/400m H 1200ft V/1350m H

The initial factor which started the evolution to the Airprox was the disconnect between the YAvOs and the YFC FOB. The PA28 pilot was expecting to carry out an O/H join iaw YFC FOB; however, this procedure was not permitted in the YAvOs. Nevertheless, this request by the PA28 pilot, instead of being refused by the APP, was approved. The APP then did not apply positive control to the PA28 flight by issuing instructions to ensure both ac were deconflicted. This resulted in the PA28 flying into conflict with the Sea King on a go-around, which was the cause of the Airprox.

Cause: The Yeovilton APP allowed the PA28 flight to carry out an O/H join, contrary to YAvOs, and fly into conflict with the Sea King on a go-around from PAR.

Degree of Risk: C.

Five recommendations were made: -

1) Alignment of YAvOs and YFC FOB. The PA28 pilot requested a procedure not authorised by YAvOs while the aerodrome was open for normal operational flying, during a period of night flying. This alignment is to ensure that procedures in YAvOs are not overruled by the lower level orders on the YFC FOB. Although this relates specifically to methods of rejoining the aerodrome whilst open for normal operations and ATC is manned, in order to ensure thoroughness all orders should be reviewed with YAvOs being the primary document. – Action completed 3/12/2012. The YAvOs and YFC have been aligned.

2) Recognition of unusual situation during low arousal. The progression of events from the approval of the PA28 pilot's request for an O/H join, to the point where the PA28 crossed the path of the overshooting helicopter, resulted from lack of SA by the ADC. Although visual with the PA28, clearly no contact had been established and this should have been questioned in a more robust manner as the situation developed. All controllers should be rebriefed on taking appropriate actions in the event of recognising an unusual circumstance that could lead to an unsafe situation developing, particularly during periods of low arousal such as during night flying. Action completed 10/12/2012. The results of the originating report have been highlighted to all ATC staff through formal training briefs (conducted 3 x weekly) and informally through Watch Leaders. Other ATC Incident reports have been promulgated for wider awareness and this has included populating the ATC crewroom with Accident/UKAB reports.

3). Competency of controller requires to be assured. APP did not impose a robust method of recovery for the PA28 in order to ensure separation from the Sea King conducting an IFR approach. The APP requires a period of retraining before acting in a solo capacity as APP/Director.

4). Review mixed operations of YFC and Station based ac during night flying. The PA28 pilot requested a procedure not authorised by YAvOs while the aerodrome was open for normal operational flying, during a period of night flying. Action completed 3/12/2012. Occurrence Review Group accepted that continued mixed operation could continue.

5). Review YAvOs 0211 – Fixed-wing recoveries. The progression of events from the approval of the PA28 pilot's initial request for an O/H join, to the point where the PA28 crossed the path of the overshooting helicopter, resulted in lack of SA by the ADC. Although visual with the PA28, clearly no contact had been established and this should have been questioned in a more robust manner as the situation developed. Fixed-wing recoveries are to be reviewed and re-written clearly defining that O/H joins are not permitted when Yeovilton is open or at night. The fixed-wing community operating at Yeovilton are to be involved in the review. Action part completed 30/01/2013. Amendment written, awaiting incorporation into YAvOs.

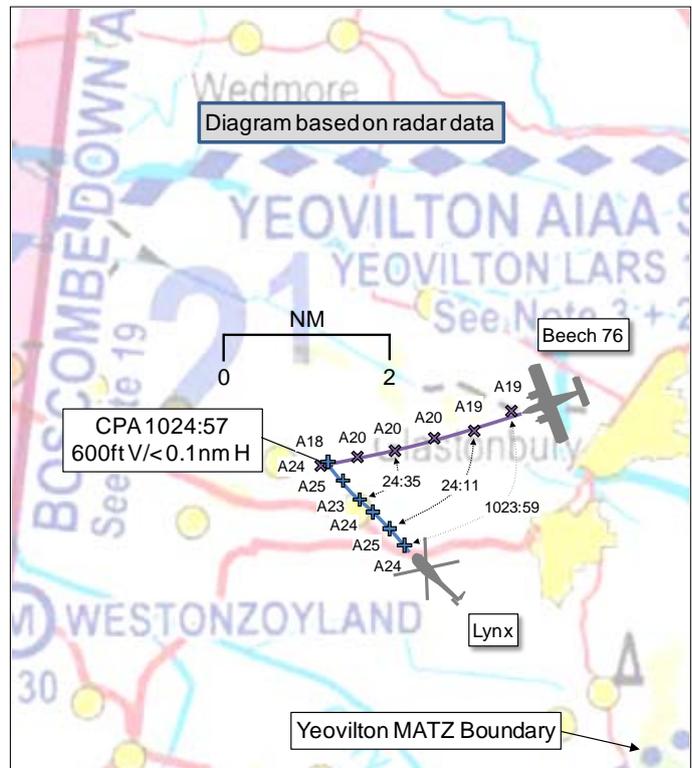
Position: 5108N 00249W
(RNAS Yeovilton 320°/10nm)

100ft V/0ft H 100m V
500-1000m H

600ft V/<0.1nm H

It was apparent from the radar recording that the 2 ac were separated by some 600ft at the CPA. Nevertheless, the Lynx pilot was sufficiently concerned to file an Airprox. The Board opined that the Lynx pilot's concern was due to his late sighting and consequent surprise at the proximity of the Beech 76 and that the Beech 76 instructor had taken effective and timely action to avoid a collision.

Cause: Late sighting by the Lynx pilot.

Degree of Risk: C.

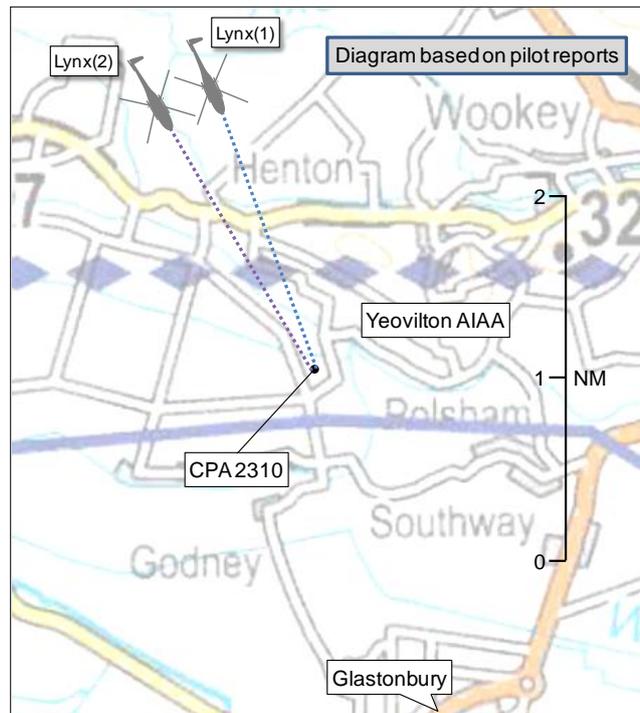
Position: 5111N 00244W
(11.5nm NNW Yeovilton)

20ft V/50ft H NK

The Board agreed that the cause of the Airprox was a late sighting, and non-sighting, by the Lynx pilots; lack of an effective deconfliction plan was a contributory factor. Members also opined that in this case the safety margins were reduced so far below normal that the situation had only just stopped short of actual collision. The Board agreed that the safety barriers pertinent to this Airprox were 'aircrew rules and procedures', 'visual sighting', 'aircrew action' and 'SA gained from RT'. It was concluded that the barriers were minimally effective, so the Airprox was allocated a score of 20 on the Event Risk Classification Matrix.

Cause: A late sighting and non-sighting by the Lynx pilots.

Contributory Factor(s): Ineffective deconfliction plan.

Degree of Risk: A.

Equipment Improvements: The ORG agreed that the most effective way to improve lookout in the low-level NVG environment is to make system improvements. Wider field of view NVGs would naturally contribute to improved aircrew peripheral vision. Whilst this requires an equipment upgrade, such systems are available today and arguably would have enabled the crews, in this case, to have seen each other at a much earlier stage.

Collision Avoidance or Traffic Warning Systems are widely used on both civilian and military ac types, and are considered an effective tool in directing aircrew lookout to sources of potential danger. Whilst they may have limitations in the low level environment, it is likely that this Airprox would not have occurred had such a system been installed in the Lynx Mk8.

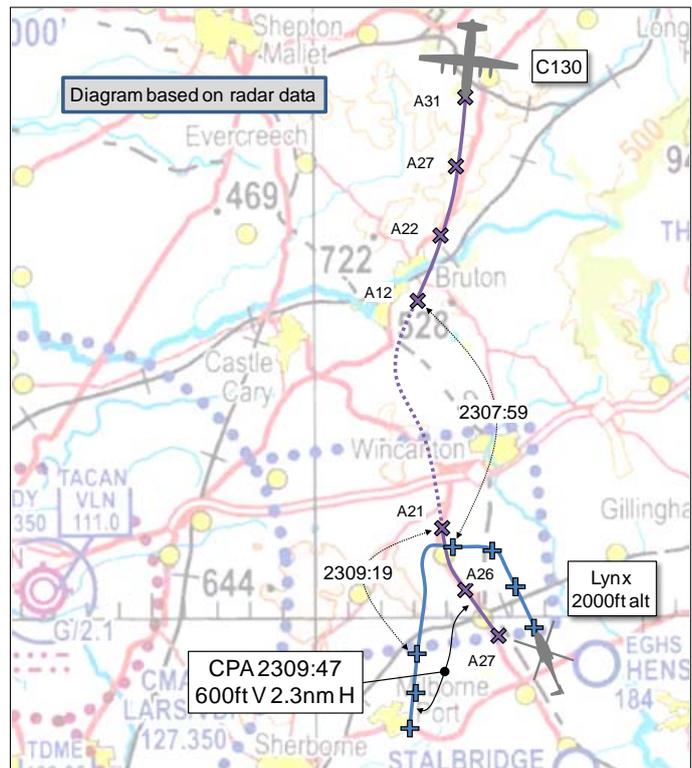
600ft V/2.3nm H

The Board then considered deconfliction action carried out on the night. It was agreed that neither crew was best served by the failure to achieve meaningful deconfliction before flight but the Board felt that on this occasion the onus of responsibility fell to the C130 crew. Some Members opined that routeing under the E stub of the RNAS Yeovilton MATZ amounted to poor planning, albeit understandable given the C130 crew's mistaken belief that Yeovilton was shut, and that they would have been better advised to attempt RT contact with Yeovilton as they neared the MATZ in marginal Wx conditions. In the event it was the C130 crew's climb into the Yeovilton MATZ stub without clearance that caused the Airprox.

Cause: The C130 crew penetrated the Yeovilton MATZ without clearance.
