# SAFETY FOCUS

2013/02

## “TOES OFF BRAKES” INADVERTENT APPLICATION OF BRAKES DURING TAKE-OFF ROLL

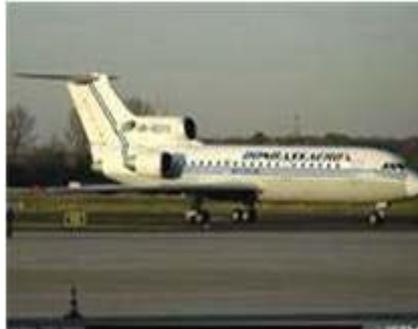
In the first event a Yakovlev 42 was destroyed in September 2011 when it crashed about 1 km from the end of the runway at Yaroslavl Airport in Russia, killing 44 of the 45 on board. Take-off was initiated at nominal engine thrust and at a speed of 185 km/h the nose wheel lifted off the runway but the pitch angle did not increase; shortly afterwards the Indicated Air Speed (IAS) momentarily decreased. The crew used additional elevator and trimmed the stabiliser nose up but the aircraft still did not become airborne. It travelled past the end of the runway onto the grass, finally lifting off about 400 m past the threshold. The aircraft struck a localiser antenna and rapidly attained a 20 degrees nose-up attitude reaching a height of 5-6 metres. The aircraft then rolled left, struck the ground and broke up.

The report concluded that the Captain had over 1,300 hours on the Yakovlev 42 aircraft. However, he flew the smaller Yakovlev 40 aircraft on which he had more experience; the same applied to the Co-pilot. Both aircraft have a different method of braking and the investigation concluded that the Captain or Co-pilot probably held his feet on the brake pedals during take-off roll in a similar manner that he had used on the Yakovlev 40. Thus, in the accident, he inadvertently activated the brakes while pulling the controls to lift the nose for take-off.

According to the Chief of the Investigative Commission: "the immediate cause of the Yak-42 plane crash was the flight crew's erroneous actions, namely the pilot stepping on the brake pedals before raising the nose wheel because of the wrong position of the feet on the brake platforms during take-off".

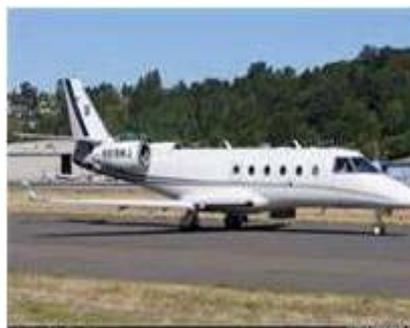
The second event happened in February 2011 at RAF Northolt, London, and involved a German registered Gulfstream G150. A take-off was attempted from Runway 25. When the Commander pulled the control column back to rotate at  $V_R$ , and subsequently fully back, the aircraft only pitched up to  $1^\circ$ . The take-off was rejected just before  $V_2$ , full braking was applied and the aircraft came to a stop at the end of the paved surface. A fire broke out around the left main wheels which was suppressed quickly by the Rescue and Fire Fighting Service. The flight data showed that the aircraft's acceleration during the take-off roll was below normal but the investigation did not reveal any technical fault with the aircraft. The most likely explanation for the lack of acceleration and rotation was that the brakes were being applied during the take-off, probably as a result of inadvertent braking application by the Commander, which caused a reduction in acceleration and a nose-down pitching moment sufficient to prevent the aircraft from rotating. However, it could not be ruled out that another factor had caused partial brake operation. As a result the aircraft suffered fire damage to the left brakes and tyres, and the left and right brakes seized.

Tests showed that a pedal angle of only  $2^\circ$  was required to produce a brake pressure of 2,620 kPa (380 psi), which resulted in a 6.3 mm deflection of the upper part of the pedal. Thus, the pedals need only a relatively small deflection to produce the amount of brake pressure required to cause the reduced acceleration and prevent rotation. The manufacturer's test pilots noted that, during taxi, by resting the feet on the pedals some brake pressure could be applied, which was almost imperceptible but could be recognised by the reduction in expected taxi speed.

It is interesting to note that neither pilot noticed the lack of normal acceleration of the aircraft, even though the acceleration had reduced to nearly zero at one point. A particular aircraft's performance will be different for every take-off and this demonstrates that pilots are not always able to judge how the take-off is progressing.

As the most likely remaining explanation for the lack of acceleration and rotation in both of the events was that pressure was inadvertently applied to the brakes pedals by one of the pilots, it is felt that operators and pilots should be made aware of these incidents. They should make careful note of where they rest their feet during the take-off roll, especially if the aircraft uses differential braking for ground manoeuvring.

- Holding the toes clear of the upper part of the pedals while placing the heels on the rudder bar allows the possibility that some pressure could be applied to the brake pedal without the pilot being conscious of it;

- Brake pedals need only a relatively small deflection to produce the amount of brake pressure required to cause a reduced acceleration and prevent rotation;

- The correct steering and braking techniques for each different aircraft type for ground manoeuvring and the take-off roll must be studied and practised by pilots;

- Pilots' toes should not be able to touch the brake pedals during the take-off roll; and
- A particular aircraft's performance will be different for every take-off and this demonstrates that pilots are not always able to judge how the take-off is progressing – so crew should attempt to gain some appreciation of their aircraft's acceleration at differing weights.
