Civil Aviation
Authority

FLIGHT TEST NEWSLETTER

Issue 1

July 2012

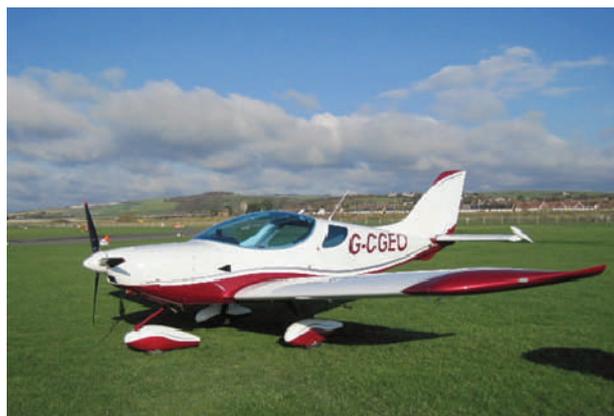
In the case of the Sportcruiser, many of which are fitted with ground-adjustable fixed-pitch propeller, the check flights on the first three aircraft due for Permit renewal revealed that the measured climb performance was well below the scheduled data in the Pilot's Operating Handbook (POH) (135 to 184 ft/min below at the tested altitudes).

Subsequent investigations revealed that the aircraft performance had been determined and scheduled with a fine pitch setting, but that the aircraft were delivered with a coarse pitch setting. As a result, the take-off and climb performance on these aircraft was well below that scheduled.

There was no performance data in the POH to accommodate a coarse propeller pitch setting, so the performance in the POH was therefore invalid. This meant that a number of aircraft were effectively grounded until a solution could be found. To get the aircraft back in the air, CAA, at no cost to the owners, undertook a flight test to determine a performance factor that could be used as an interim measure to ensure the safe operation of these aircraft until the manufacturer data was made available.

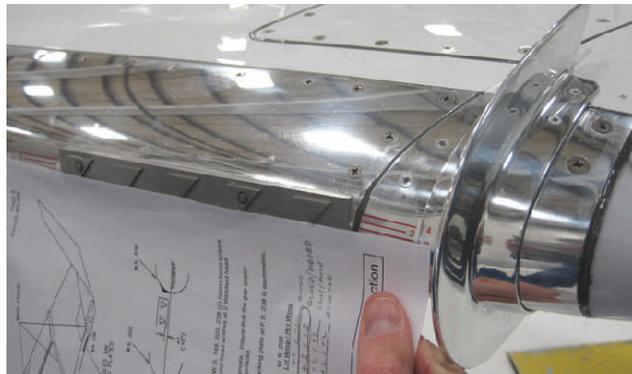
The most significant finding was that the stall handling characteristics were unacceptable - the wing drop associated with the stall being in excess of 60° - it should have been less than 20°.

The manufacturer subsequently conducted its own stall evaluation flight on the aircraft and also deemed the stall characteristics unacceptable. They noticed excessive use of sealant on the wing and winglet leading edge seams, which was removed from the upper leading edge surface and the stall fence joints.

All the excessive sealant was removed from the lower surface of the wing leading edge and winglets. Additionally, the position of the stall strips was adjusted. On the second flight the characteristics were then found to be acceptable; the roll was within the tolerance of $\pm 20^\circ$, and the stall speeds within ± 3 knots of the scheduled values.

Although we all know that a stall will always be inadvertent, it does happen. The condition of wing leading edges and the correct alignment of stall strips on many aircraft is paramount to ensuring safe stall handling. Proper adherence to Maintenance Manuals, Repair Manuals etc. will lessen the risk. If in doubt, speak to the manufacturer.

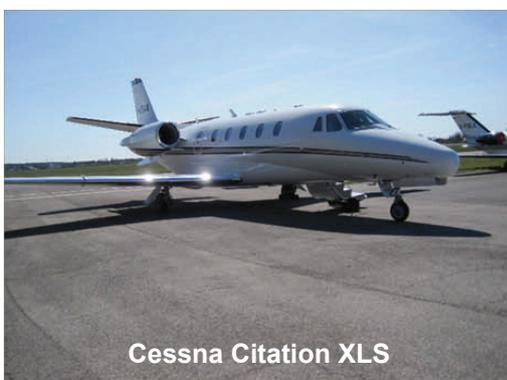
Cessna Citation XLS

A check flight on a used imported Citation XL aircraft had to be abandoned before take-off when the check of the take-off configuration warning system did not work as expected. A modification to install a Flight Data Recorder had just been completed. This had disturbed the flap position sensing which resulted in false flap position indications to the take-off configuration warning system. There was a risk that crews would not be alerted to genuine take-off configuration errors.

Whenever modifications are installed which disturb flying controls, proper ground testing of the affected systems must be carried out.
