Our ref: 9/97/CtAw/163

29 October 2001

LETTER TO OWNERS/OPERATORS NO 2276 JET PROVOST ALL AIRCRAFT MARKS HYDRAULIC BRAKE PIPE FAILURE

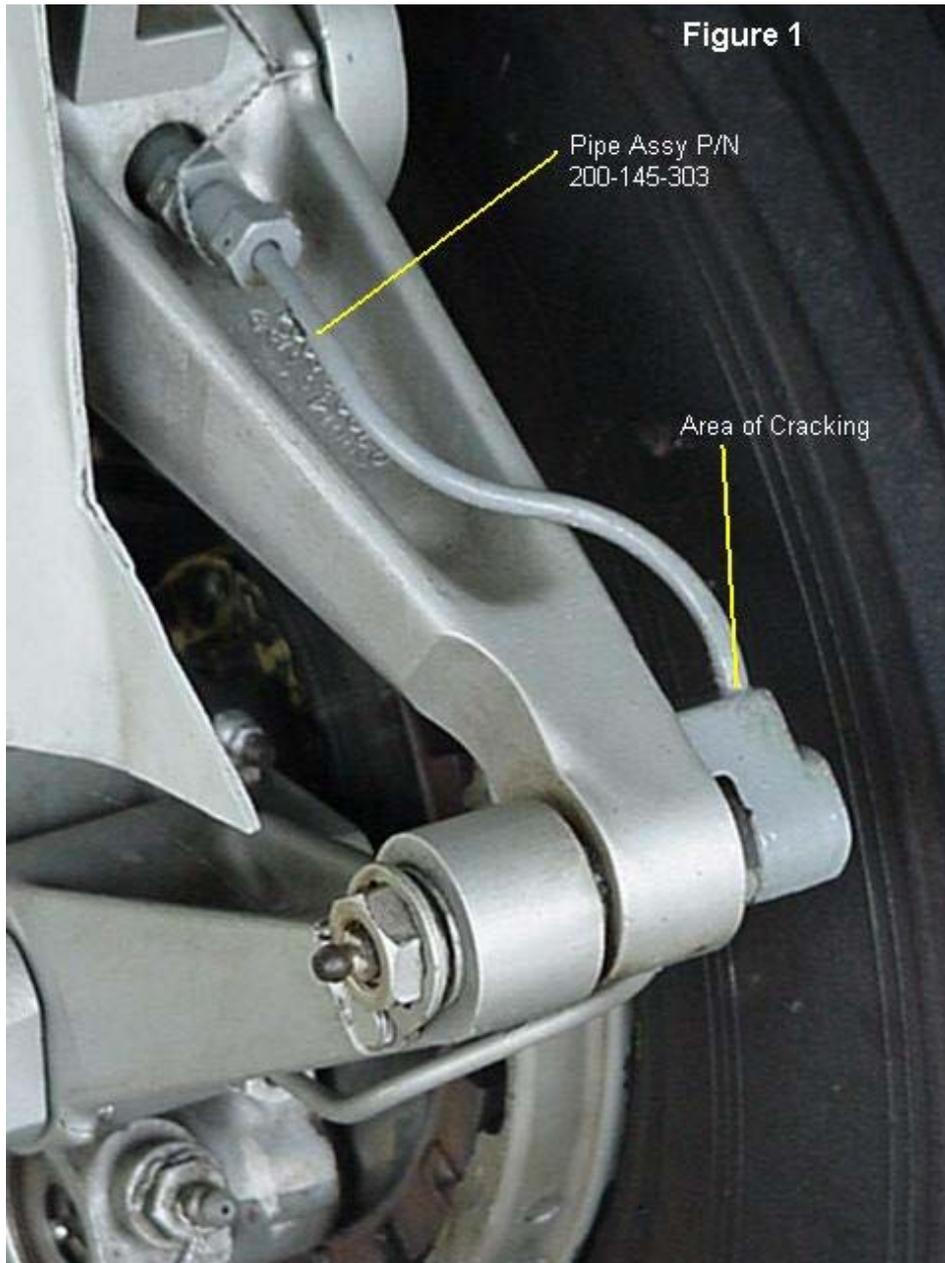
Figure 1

A Jet Provost aircraft experienced a failure of the wheel brake system during landing causing the aircraft to over run the runway. Subsequent investigation revealed that a rigid brake pipe located on the right hand main undercarriage leg had cracked, causing a loss of wheel brake hydraulic fluid and consequent failure of the wheel brake system.

The failed pipe assembly part number 200-145-303 is fitted between the main undercarriage upper torque link, and the upper to lower torque link pivot pin. The pipe had failed at the brazed joint where it enters the swivel fitting.

In this particular case the crack is suspected as being caused during maintenance of the main undercarriage leg. This involved removal of the upper and lower torque links. The mode of failure indicates that when viewed from the front, either the upper end of the pipe was disconnected from the upper torque link and then bent from right to left, or the upper end of the pipe assembly was still connected when an attempt was made to remove the torque links pivot pin. The maintenance instructions are not comprehensive in that they do not specifically address removal of the pipe assembly part number 200-145-303.

No other reports of cracking have been received and the CAA does not propose to issue any mandatory action. It is however recommended that at the next opportunity and with the aid of a X10 magnifying glass, a one time visual inspection be carried out to detect cracking around the brazed joint of the pipe to swivel fitting of wheel brake pipe assemblies part number 200-145-303 [Figure 1 see over]. The discovery of cracking should be reported to Mr John Nicholas at the CAA Stansted Regional Office telephone no 01279 466747, fax no 01293 466757. It is also recommended that maintenance organisations re-establish the need for maintenance personnel to observe best maintenance practice and to seek guidance in the absence of specific maintenance instructions.
