Safety Regulation Group
Applications and Certification Section

27 April 2005

Our Ref 9/97/CtAw/171

LETTER TO OWNERS/OPERATORS NO 2785
PIPER PA-34-200T
PROPOSED WING SPAR INSPECTION

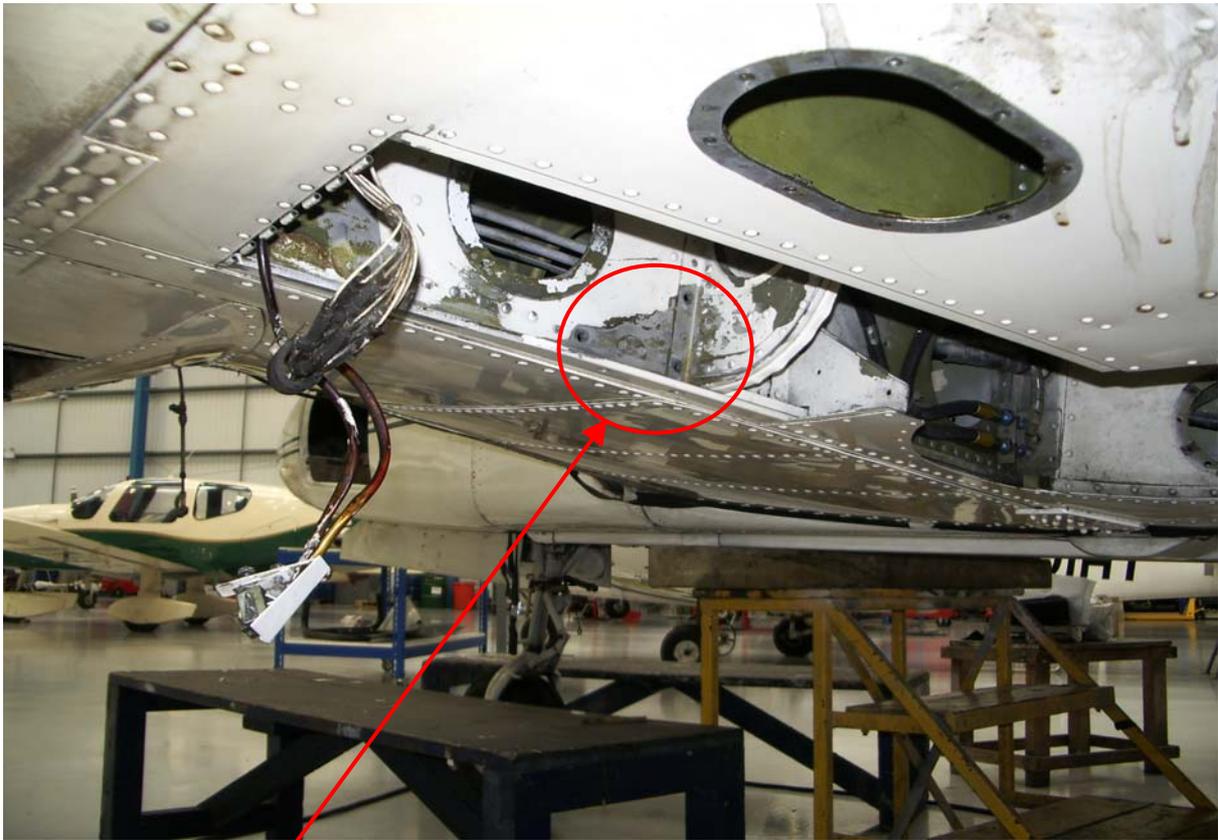
Picture 1

View on left wing main spar main landing gear truss attachment point.

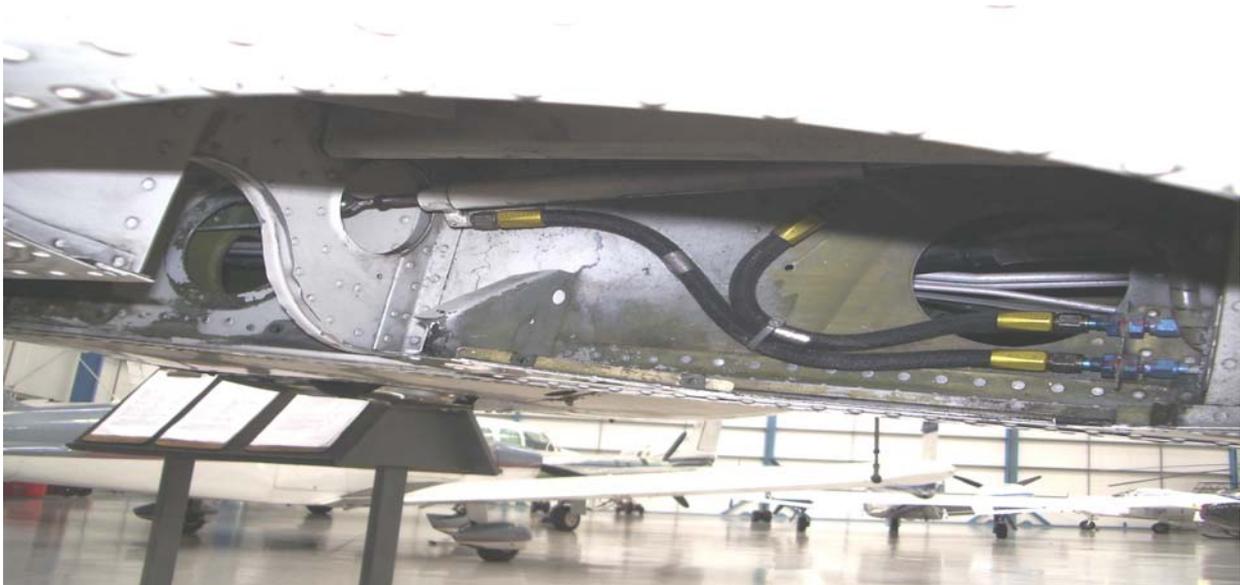
Picture 2

View showing holes in main spar either side of wing station 49.25. Inspection of the forward face of the spar at the landing gear truss attachment point can be performed through these holes.

- i Support the aircraft on jacks.
- ii From inside the wheel well remove the access covers from the main spar web lightening holes either side of wing station 49.25".

- v Working inside the forward wing section with the aid of a torch and mirror or boroscope if available, visually inspect the area adjacent to the vacated mounting holes in the main spar web and lower forward angle for cracks.

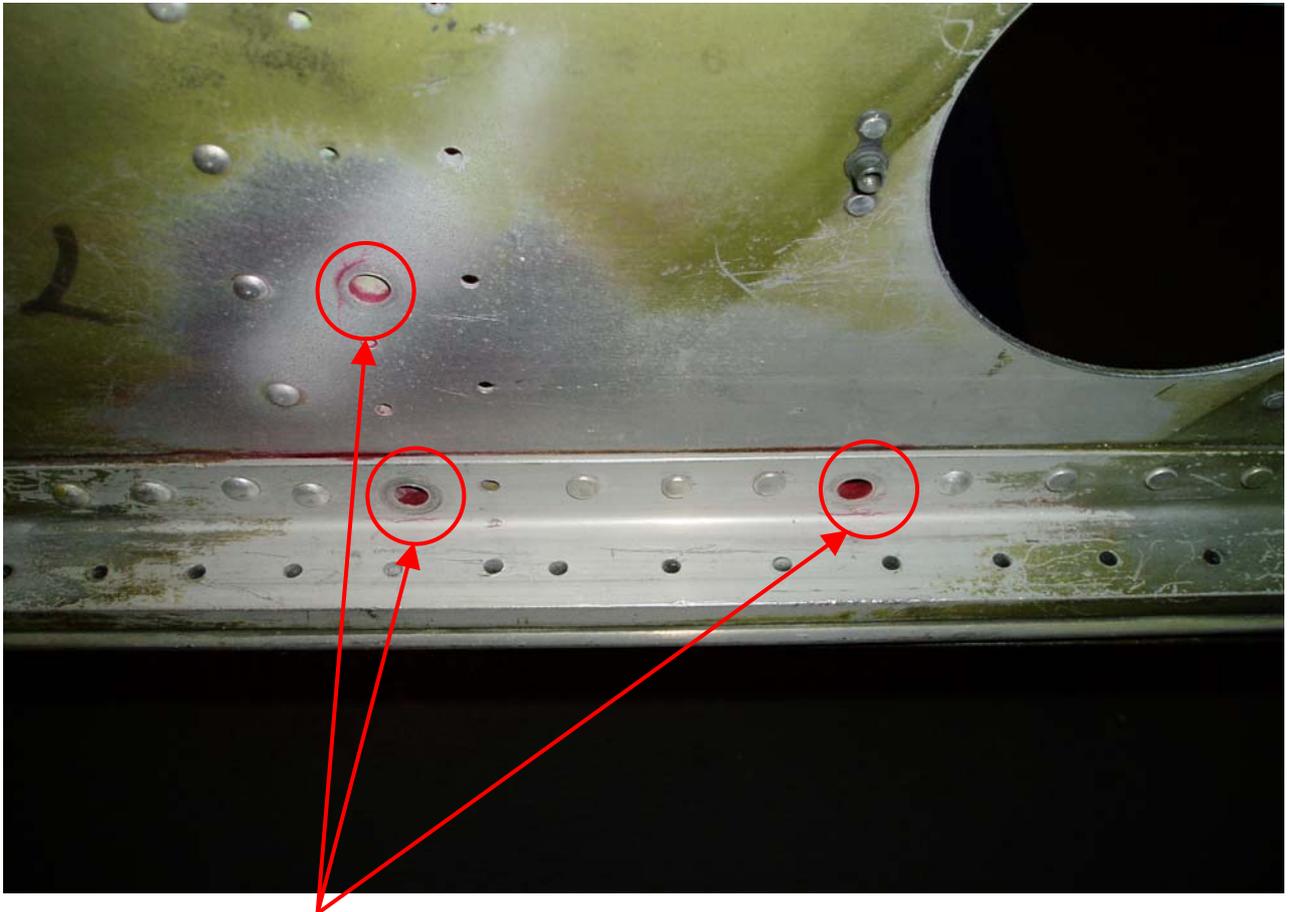
Picture 3

The UK-CAA has received a report of cracks being found in the main spar on a high proportion of Piper PA-34-200T Seneca II aircraft being flown by one operator. Damage is located at the wing spar attachment point of the bracket assembly – main gear truss on both wings, (Piper Aircraft PA-34-200T Seneca Parts Catalogue item 11 on pages 1A12 and 1A14). The photographs on page 2 and 3 show the location and typical orientation of cracking described above.

Damage detected so far would seem to be restricted to aircraft that have flown at least 7,000 hours. It has previously been found that the following inspection procedure applied to both main wing spars in the region of the bracket assembly – main gear truss (Main U/C side stay bracket) attachment points should identify any existing damage and should be carried out to standards set out in the manufactures maintenance manual: -

View of forward face of main spar at wing station 49.25 showing typical crack locations.

The TCH advises that any damage revealed by this inspection should be repaired prior to further flight.
