Safety Regulation Group

31 October 2005

Our Ref 9/97/CtAw/30

LETTER TO OWNERS/OPERATORS NO 2846 BEECH BONANZA H35 CRACKING OF FORWARD SPAR LOWER BOOM FITTING ON THE WING

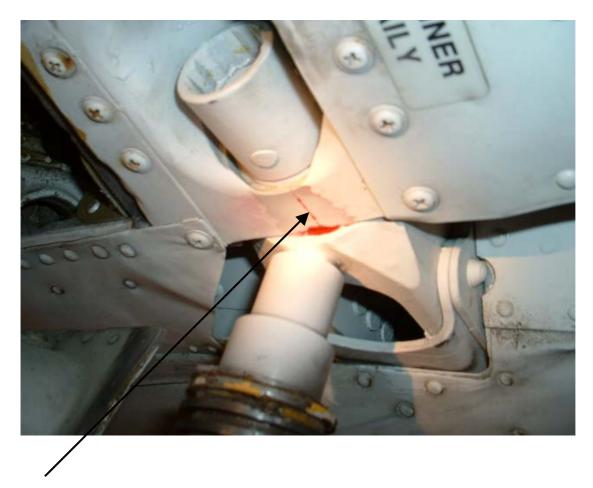
The UK Civil Aviation Authority has been informed by a UK maintenance organisation of a crack in the forward spar lower boom fitting on the wing. The location can be seen on the photograph on page 2. The crack extends the length of the fitting in this area and is about one third of the thickness of the fitting. The manufacturer of the aircraft has been informed and they have stated that this is the first reported finding of such a crack on the type.

On disassembly of the wing attachment, it was discovered that the radius washer beneath the nut had been installed in the reverse orientation. Witness marks remain on the fitting and these are close to the crack location. Detailed metallurgical examination of the fitting will be needed to determine the cause of the cracking.

Crack

View looking up on the forward spar lower boom fitting on the wing. The crack being identified by the dye penetrant witness marking.

The cracking as discovered on this aircraft has not identified an immediate risk to flight safety. At present there is a concern as confirmation of the cause of the cracking is still awaited and there are other aircraft in the UK fleet at significantly higher cycles than the subject aircraft. For the moment however, the CAA is not proposing or requesting (from others) the issuance of an airworthiness directive. However due the criticality of this joint to the structural integrity of the aircraft, the CAA has determined it to be prudent to issue this LTO and to request that owner/operators of this type of aircraft arrange for this area to be inspected at the earliest convenient opportunity.

Owners/operators should report any inspection findings to the manufacturer Raytheon and to the CAA through the Mandatory Occurrence Reporting scheme.
