EMERGENCY MANDATORY PERMIT DIRECTIVE

MPD: 2009-004 VPM GYROPLANES

Subject:	Airframe Structure Inspection
Applicability:	VPM M14 and VPM M16 Tandem Trainer Gyroplanes.
Reason:	During a routine inspection of a VPM M16 Tandem Trainer Gyroplane cracks were discovered in the tubular steel airframe. Cracks, thus far encountered, have been found in and around the welds connecting the mast and the engine mount and the mast to seat assembly.
Compliance:	<p>Before further flight, and each 50 flying hours after the effective date of this MPD, an approved LAA inspector must inspect the airframe. The purpose of this inspection is to detect any cracks in the tubular steel structure of the airframe. To facilitate this inspection both the seat/fuel tank must be removed and the airframe thoroughly cleaned. The airframe must be inspected carefully and systematically using a bright light, paying particular attention to welds and the area around the welds connecting the mast and the engine mount and the mast to seat assembly, see drawings and photograph overleaf.</p> <p>The airframe of this aircraft is painted and therefore any cracking, flaking or staining of the paint must be thoroughly investigat

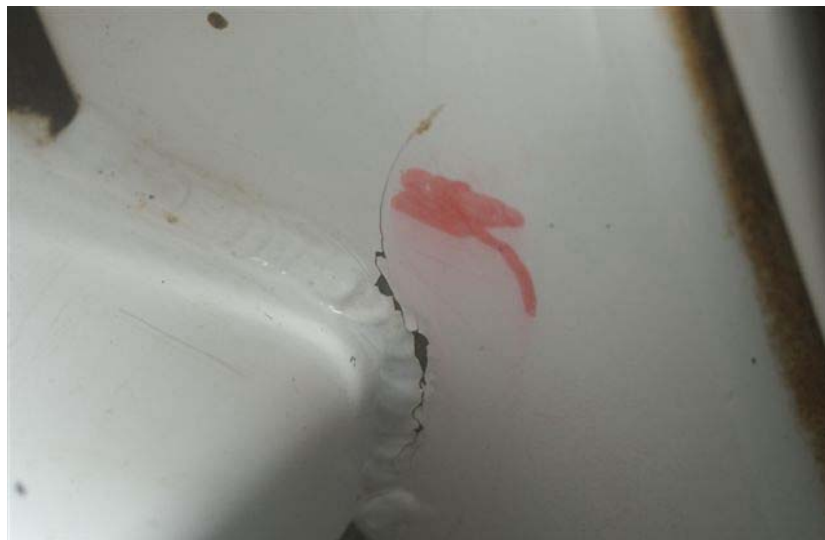
Figure 2. An example of a crack emanating from a welded connection. (Photo. R. Savage)
