MPD No: 2010-004

MANDATORY PERMIT DIRECTIVE

MPD: 2010-004 ROLLS-ROYCE

Subject: Rocker Arm Inspection

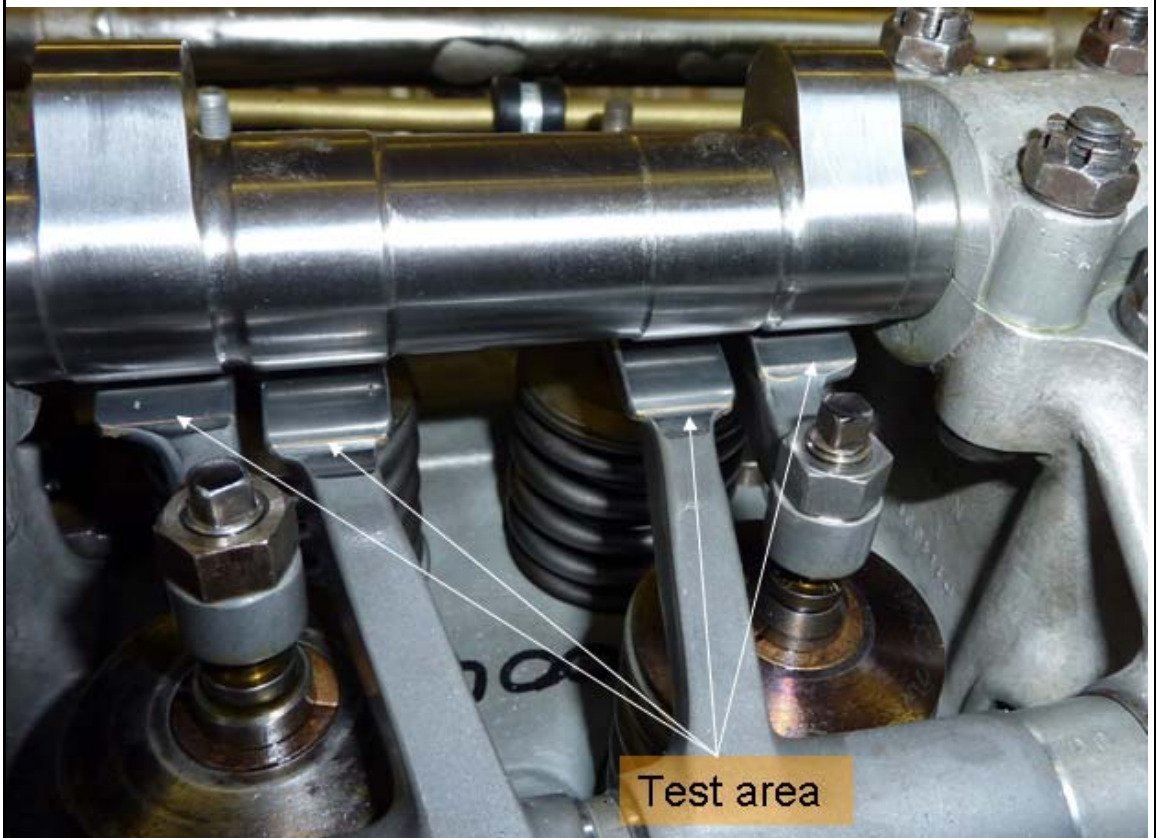
Figure 1.

- a) Inspect each modified rocker arm fitted for detachment of the carbide pad. Remove from service any rocker arm, which exhibits a released pad along with the associated pad. Replace with a serviceable arm. If any pad cannot be located on the cylinder block carry out further in-depth inspection to locate the pad, if necessary by removing the engine. Rectify any damage caused by the released pad prior to engine release back to service.
- b) For the remaining modified rocker arms, inspect the region of the brazed joint between the carbide pad and the rocker arm as shown in figure 1 using a x10 glass or if preferred a stylus of maximum radius 0.005". Inspect for evidence of movement of the pad on the arm, which is revealed by a line indication or step on the arm.

In cases where movement is observed, carry out a comparison with a feeler gauge to measure the size of step. Any arm, which exhibits a step estimated at 0.005" or less may continue in service in accordance with paragraph (d). Any arm, which exhibits a step in excess of 0.005" but less than 0.015" is to be re-inspected at intervals in accordance with paragraph (c). Any arm, which exhibits a step of 0.015" or more, is to be removed from service.

- c) Re-inspect those rocker arms, which exhibit a step in excess of 0.005" but less than 0.015" at intervals not to exceed 15 flight hours or annually, whichever limit is reached first. At each re-inspection, reject any arm, which exhibits a step of 0.015" or more.
- d) Re-inspect rocker arms declared fully serviceable at 25-flight hour intervals or annually, whichever limit is reached first, in accordance with the previously defined maintenance regime for these arms.
