www.caa.co.uk/gasil

Issue no 1 of 2010

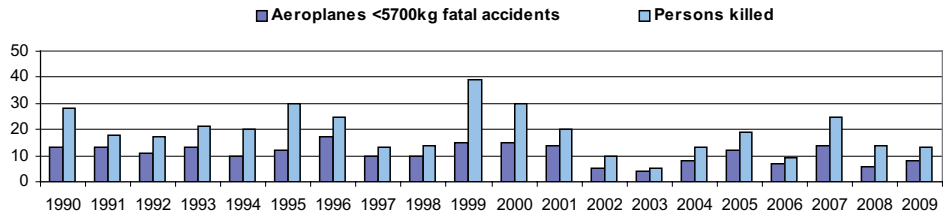
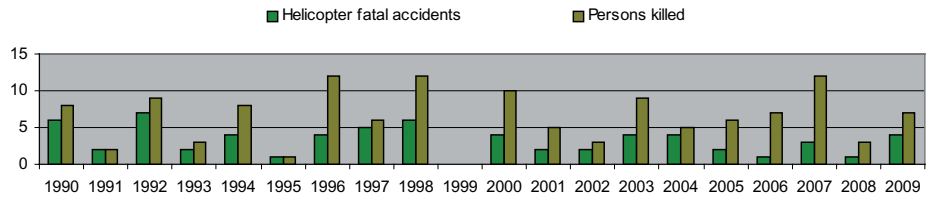
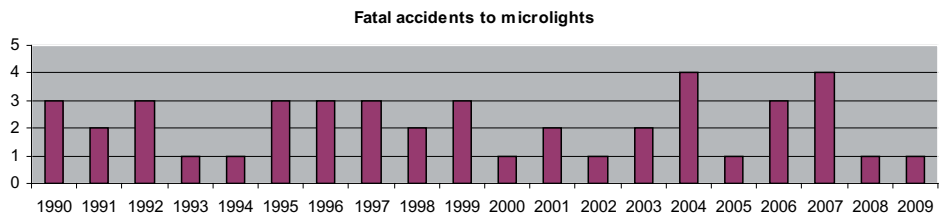
There were 8 reported fatal accidents, involving 13 fatalities, to UK registered civilian operated light aeroplanes during the year, including one to a microlight with 2 fatalities. 4 fatal accidents were reported to UK registered light helicopters, involving 7 fatalities. There were 3 glider fatal accidents, and 2 (including one which is unlikely to be recorded as an aircraft accident) involving gyroplanes. In addition, there were 2 mid-air collisions involving military operated civilian registered light aeroplanes, in which 6 persons were killed, and another collision, this time between 2 paragliders, resulted in a further 2 deaths.

The list below includes military operated and non-UK registered aircraft (2 accidents with 3 fatalities) for completeness, although the graphs do not. Since few of the investigations have been completed, it would be inappropriate to draw too many conclusions from the information. However, while poor weather continues to feature in the initial reports, losing control at low altitude appears the most common type of accident. Attempting to turn back after take-off following an engine problem has again been shown to be dangerous, and we are reminded that care is required when manoeuvring to avoid a possible collision. Maintaining the correct airspeed for the conditions and phase of flight is vital!
