www.caa.co.uk/gasil

Issue no 7 of 2009

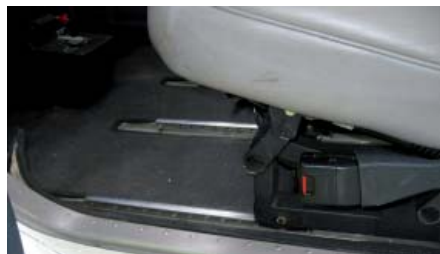
The most obvious possible problem occurs when the seat locking pins have failed to correctly lock in their locating holes. Hopefully, a positive check of the seat movement before take-off (without exerting too much pressure on the rudder pedals - their mountings have been known to break) would confirm that the location is correct.

However, it has been found that flexing during flight can expand even apparently hairline cracks in the rails to such an extent that the pins may slip out of the holes. Only conscientious maintenance inspection can detect damage to the rails before the cracks grow to a dangerous extent.
