**Final Investigation Report on Ground Fatal Accident to
Air India Ltd. Airbus A-319 aircraft VT-SCQ at Mumbai
on 16.12.2015**

COMMITTEE OF INQUIRY VT-SCQ

FINAL INVESTIGATION REPORT ON GROUND FATAL ACCIDENT
TO AIR INDIA LTD. AIRBUS A-319 AIRCRAFT
VT-SCQ AT MUMBAI ON 16.12.2015

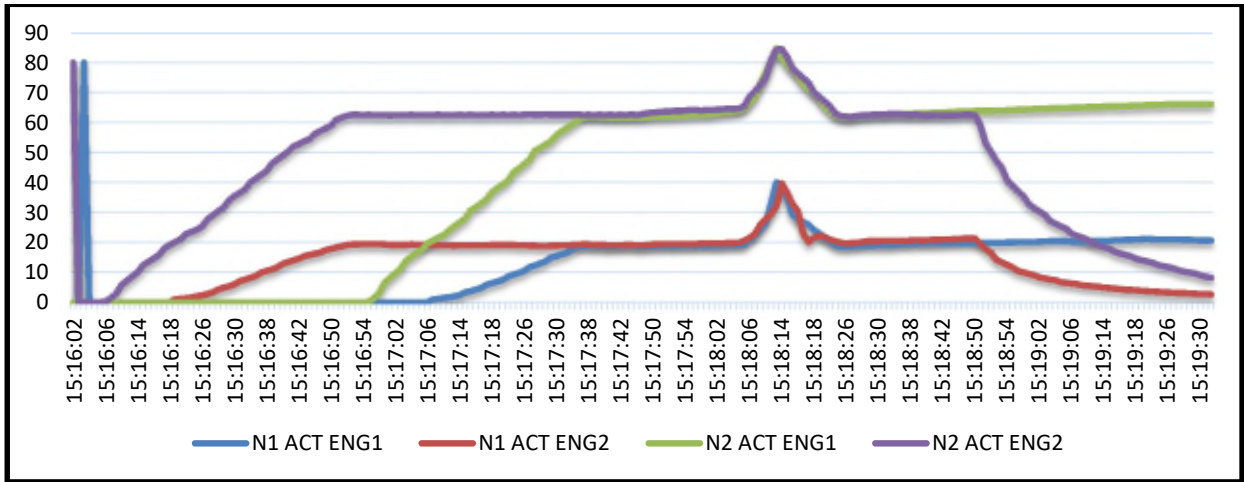
Graph between N1, N2 of Engine 1 & Engine 2

- At the time of accident No # 1 engine N2 was 81.69% & N1 was 39.13% and No # 2 engine N2 was 84.56% and N1 was 39.69%.
- At 15:18:38 UTC parking brake is set (applied). Aircraft heading is 206. Both engines are running.

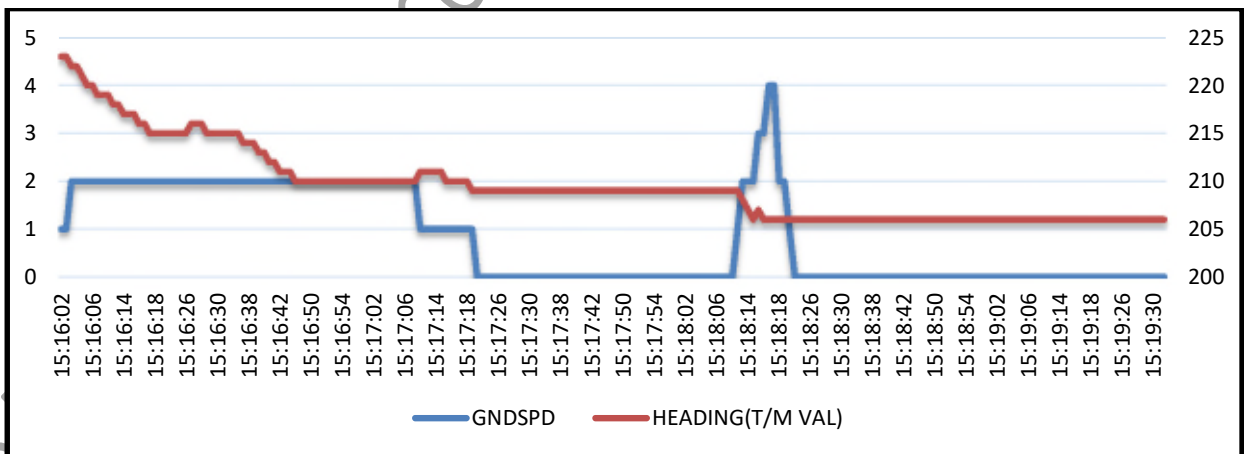
Graph between Heading & Ground Speed

- At 15:17:34 UTC both engines reach stabilized rpm.
- At 15:18:06 UTC parking brake is released.
- Aircraft ground speed is observed to be increasing and maximum ground speed recorded is 4 knots.

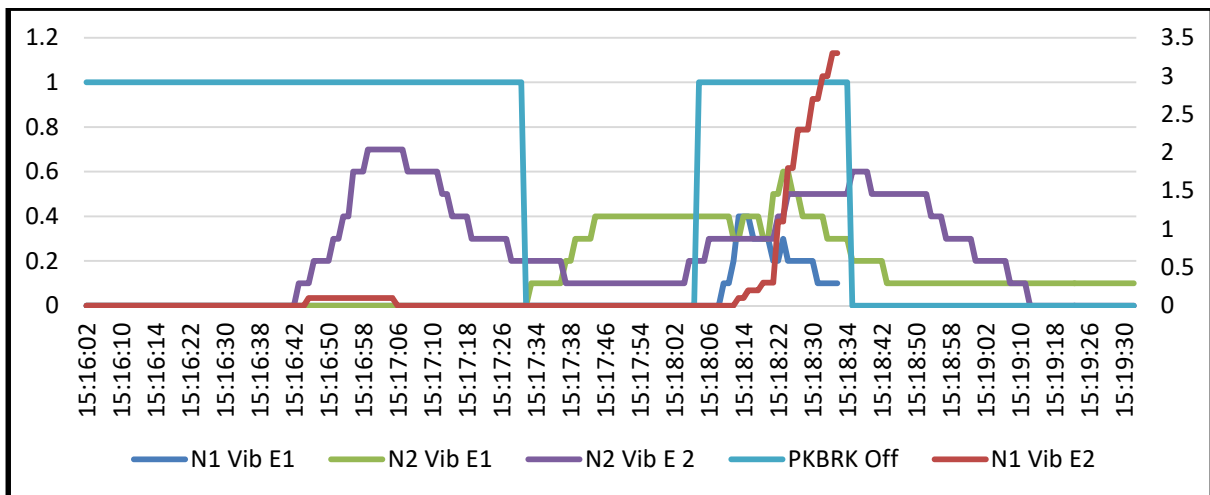
Graph between Engine Vibration & parking brake

- At 15:18:22 UTC probable time of accident as # 2 engine N1 vibration observed to be increasing from 0.3 to a maximum value of 3.6 which is recorded at UTC 15:18:46.
