AIR TRANSPORTATION SAFETY INVESTIGATION REPORT A17C0146

LOSS OF CONTROL AND COLLISION WITH TERRAIN

West Wind Aviation L.P.
Avions de Transport Régional ATR 42-320, C-GWEA
Fond-du-Lac, Saskatchewan
13 December 2017

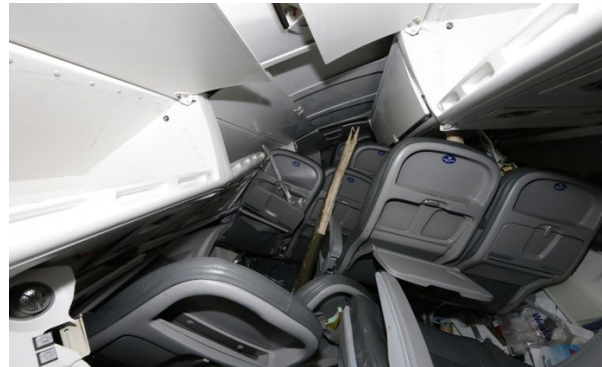
The reduced survivable space between the floor above the main landing gear and the collapsed upper fuselage caused crushing injuries, such as major head, body, and leg trauma, to passengers in the middle-forward left section of the aircraft. Of the 3 passengers in this area, 2 experienced, serious life-changing injuries, and 1 passenger subsequently died.

Figure S3. Image of the displaced cabin seats
(Source: TSB)
