**INCIDENT**

<b>Aircraft Type and Registration:</b>	Boeing 767-383, G-VKNI	
<b>No &amp; Type of Engines:</b>	2 Pratt & Whitney PW4060 turbofan engines	
<b>Year of Manufacture:</b>	1989	
<b>Date &amp; Time (UTC):</b>	28 September 2006 at 1854 hrs	
<b>Location:</b>	Royal Air Force Brize Norton, Oxfordshire	
<b>Type of Flight:</b>	Public Transport	
<b>Persons on Board:</b>	Crew - 12	Passengers - 136
<b>Injuries:</b>	Crew - None	Passengers - None
<b>Nature of Damage:</b>	Abrasion damage to tailskid	
<b>Commander's Licence:</b>	Airline Transport Pilot's Licence	
<b>Commander's Age:</b>	42 years	
<b>Commander's Flying Experience:</b>	8,700 hours (of which 2,300 were on type) Last 90 days - 210 hours Last 28 days - 70 hours	
<b>Information Source:</b>	Aircraft Accident Report Form submitted by the commander, operator's reports, and flight data analysis by Boeing

**Synopsis**

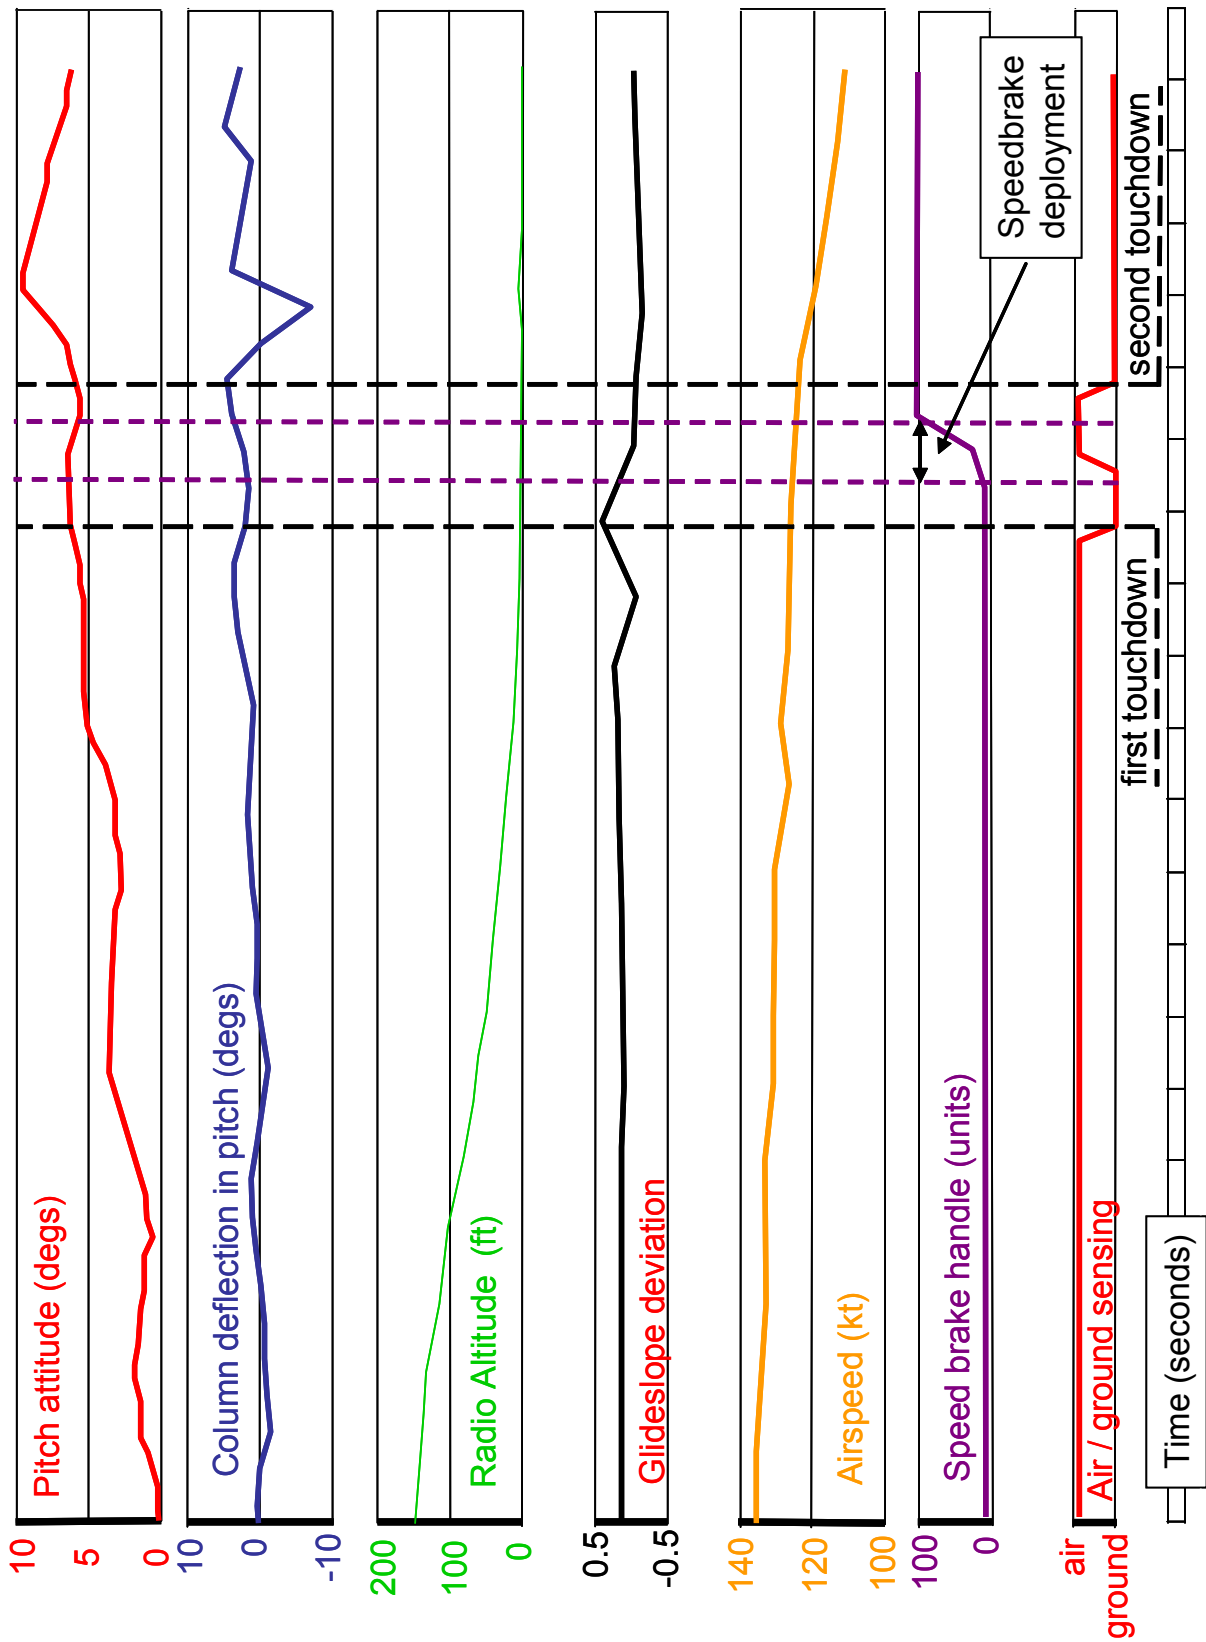
Figure 1  
Relevant flight data (simplified)

Boeing's Air Safety Investigation Department conducted an analysis of the Flight Data Recorder (FDR) data for both the takeoff and landing events. However, several parameters were not valid during the period of the takeoff and initial climb. These parameters included the EPR and speeds for both engines, both elevator positions, and the stabilizer position. The stabilizer position remained invalid throughout the flight, while the elevator and engine data returned to normal after the initial climb period. The nature of the data anomalies suggested a maintenance issue existed, which the aircraft operator has been made aware of. The airspeed, groundspeed and vane angle data confirmed that the atmospheric conditions were relatively calm during the landing event. A simplified presentation of the relevant flight data is at Figure 1.

At touchdown, the main gear untilted (producing an 'on ground' signal) then tilted again, suggesting that the aircraft unloaded or 'skipped' before touching down again with a maximum recorded vertical acceleration of 1.55 g. An incremental 9° nose-up elevator command commenced with speed brake deployment, shortly before the main gear tilted again. There was a significant pitch-up after the second touchdown, which led to the pitch attitude increasing from the touchdown attitude of 6.4° to 9.5° in

1.5 seconds. The flight crew responded to this pitch-up with an incremental nose-down elevator input of 26° (from 16° nose up to 10° nose down).
