Runway overrun Onur Air

Runway overrun after rejected take-off of the Onur Air MD-88, registration TC-ONP, at Groningen Airport Eelde on 17 June 2003

The Hague, 6 April 2006 (investigation number 2003071)

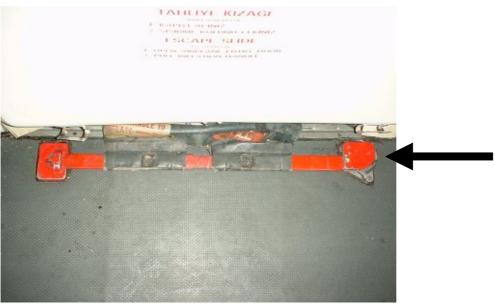
Slide bar right forward door

During the investigation it was noted that two different systems that hold the slide bar were used for the left and right forward aircraft doors. (See pictures below)

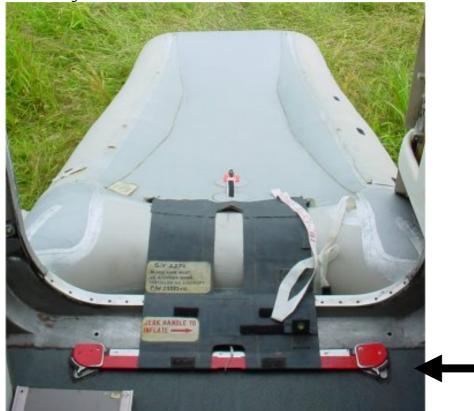
Slide bar left forward door

The left forward aircraft door was used during the evacuation. This door was fitted with an escape slide. The purser stated that she opened the door and activated the slide by pulling the inflation cord. The right forward aircraft door was not used during the evacuation. When a cabin crew member opened this door the slide fell out off its container and the package dropped on the ground next to the aircraft.

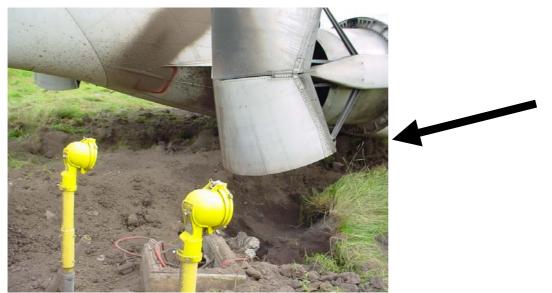
At the day of the accident the soil in the overrun area was not strong enough to support the aircraft. During the overrun the main landing gear sank in the soft soil and damaged several of the approach light system embedded concrete structures and their contents. The centre and wing fuel tanks and engines did not encounter the concrete construction.

• It is recommended to the Minister of Transport, Public Works and Water Management to investigate to which extent the requirements concerning the underground infrastructure in the direct vicinity of start and landing runways has to be stepped up to prevent serious damage to aircraft that overrun the runway.

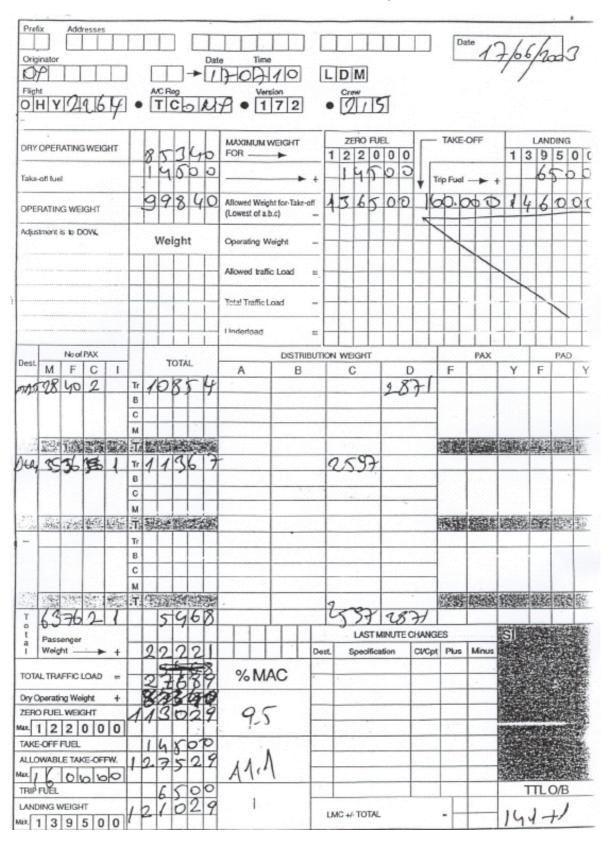
Appendix K Load and Trim Sheet made by the crew

An outdated dry operating weight index (DOI) document was used. The valid document was not found onboard the aircraft. On request, Onur Air forwarded the missing document that revealed a more forward TO-CG of the empty¹⁰ aircraft. Take note of Appendix C part A for DOI background information.

- It is recommended to the Civil Aviation Authority, the Netherlands (IVW) to check in which way the risks of an incorrect load can be decreased in the short term by, among others, verifying how this aspect can be given more attention during inspections.
- It is recommended to the Civil Aviation Authority, the Netherlands (IVW) to develop certification requirements for aircraft from the civil aviation category, to provide weight and centre of gravity measurements to the crew of new aircraft and to investigate the possibility to provide these data with existing aircraft.
