Air Accident Investigation Sector

- Final Report -

AAIS Case N°: AIFN/0003/2014

Ground Vehicle Collision with a Parked Aircraft

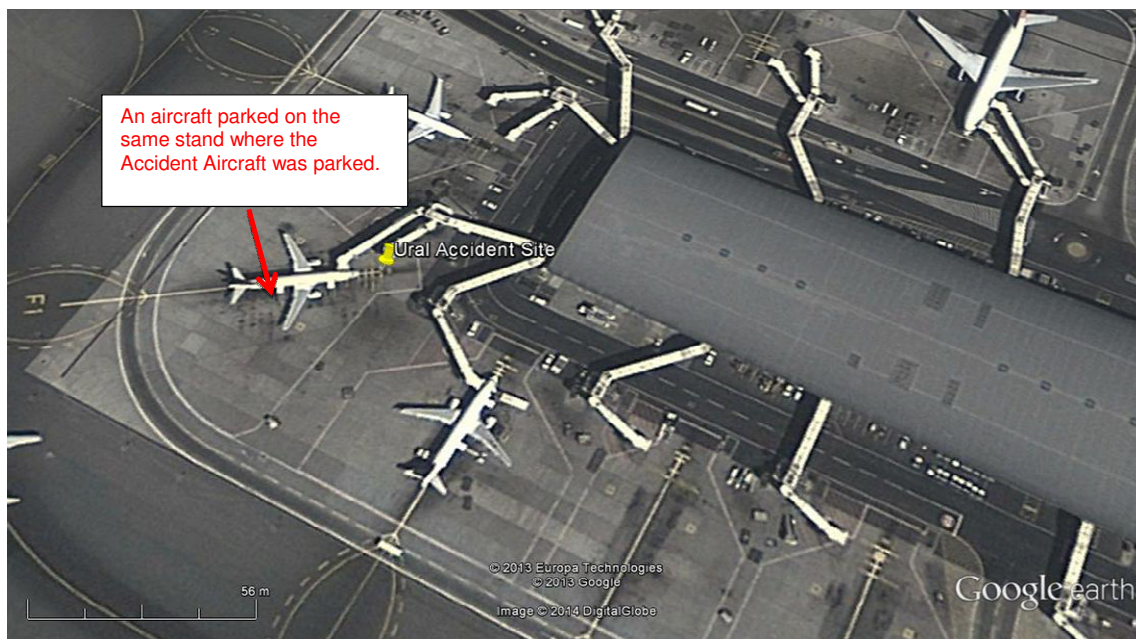
Figure 1. Position of the Aircraft at the Airport

The force of the impact caused the Aircraft to move to the right through approximately 30 degrees from its original heading. This equated to a distance of four meters to the right of the parking bay centreline.
