CAA PAPER 96005

## HELICOPTER CRASHWORTHINESS

- Study I**    **A Review of UK Military and  
World Civil Helicopter Water Impacts  
over the period 1971–1992**
- Study II**   **An Analysis of the Response of  
Helicopter Structures to Water Impact**

**REPORT PREPARED BY WESTLAND HELICOPTERS LTD, YEOVIL, SOMERSET  
AND PUBLISHED BY  
CIVIL AVIATION AUTHORITY, LONDON, JULY 1996**

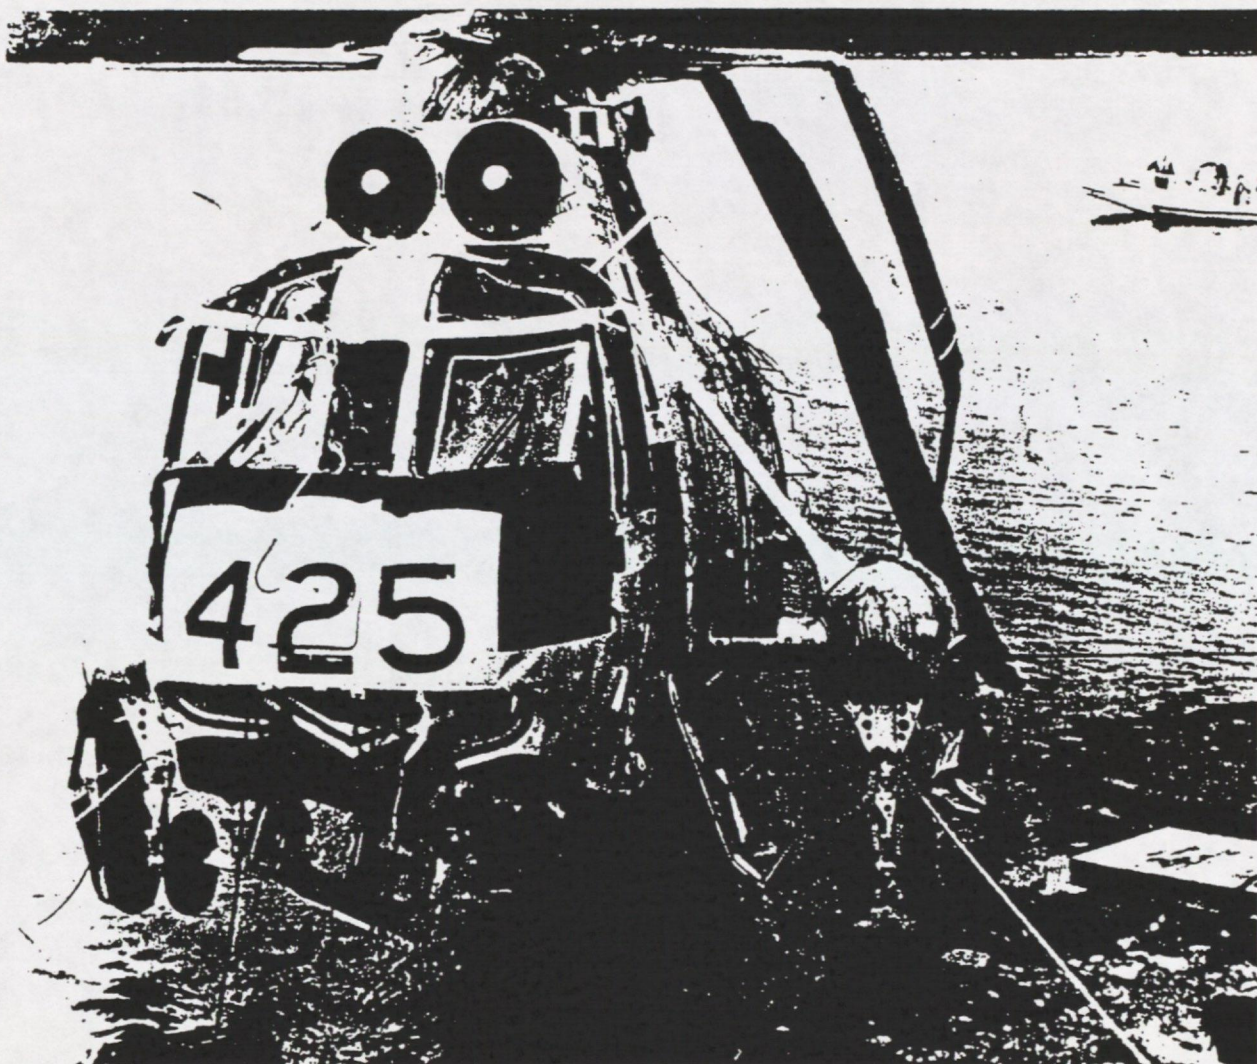
**Figure 1**     Damage to Canadian S61 following impact with water  
(from Brooks Ref. 10)

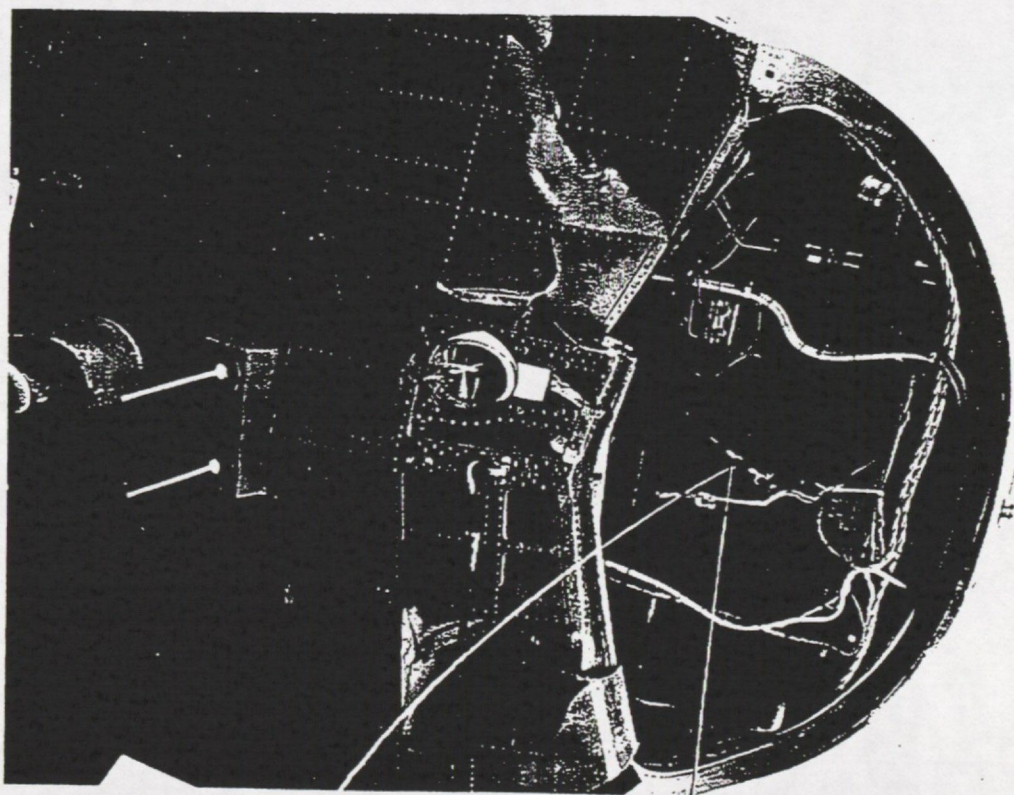
Figure 8 Damage to lower fuselage of a Sea King helicopter showing loss of electronics bay door

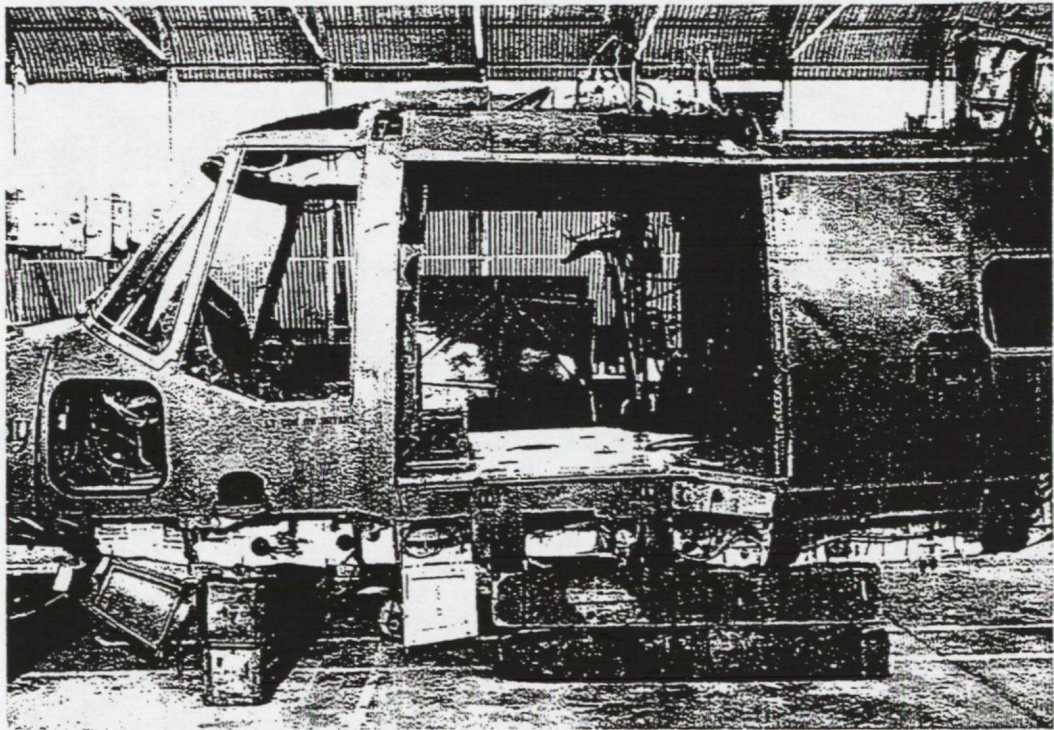
Figure 9    Damage to main cabin of a Navy Lynx helicopter following a vertical descent with limited control

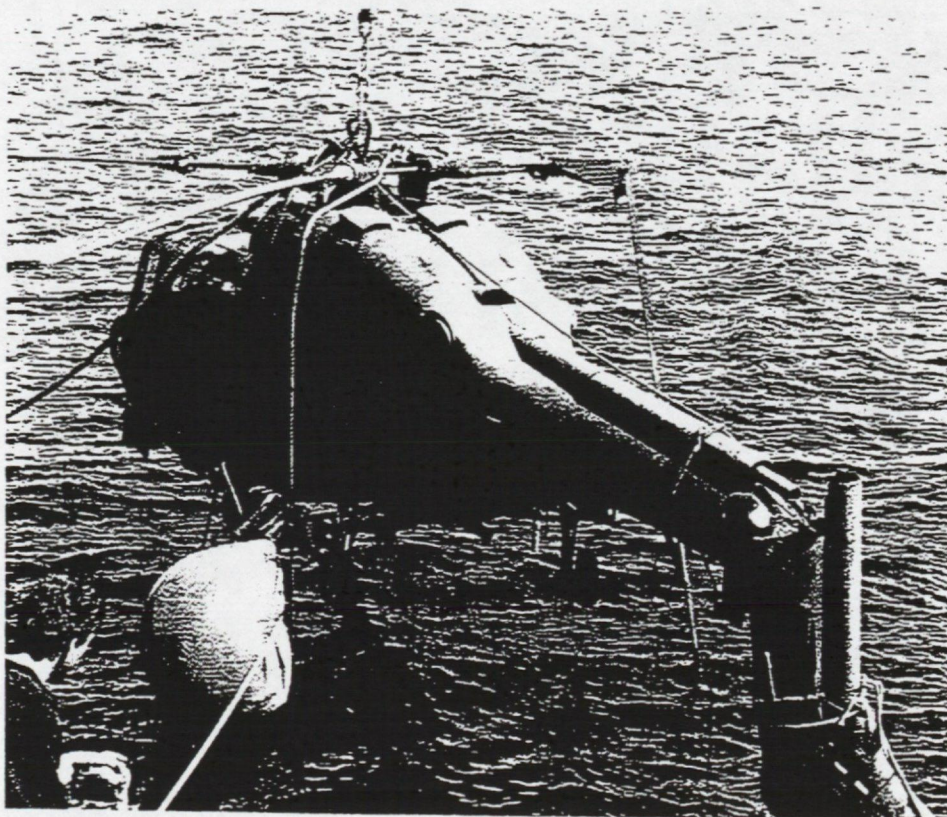
Figure 10    Damage to rear fuselage of the Lynx helicopter shown in Figure 9

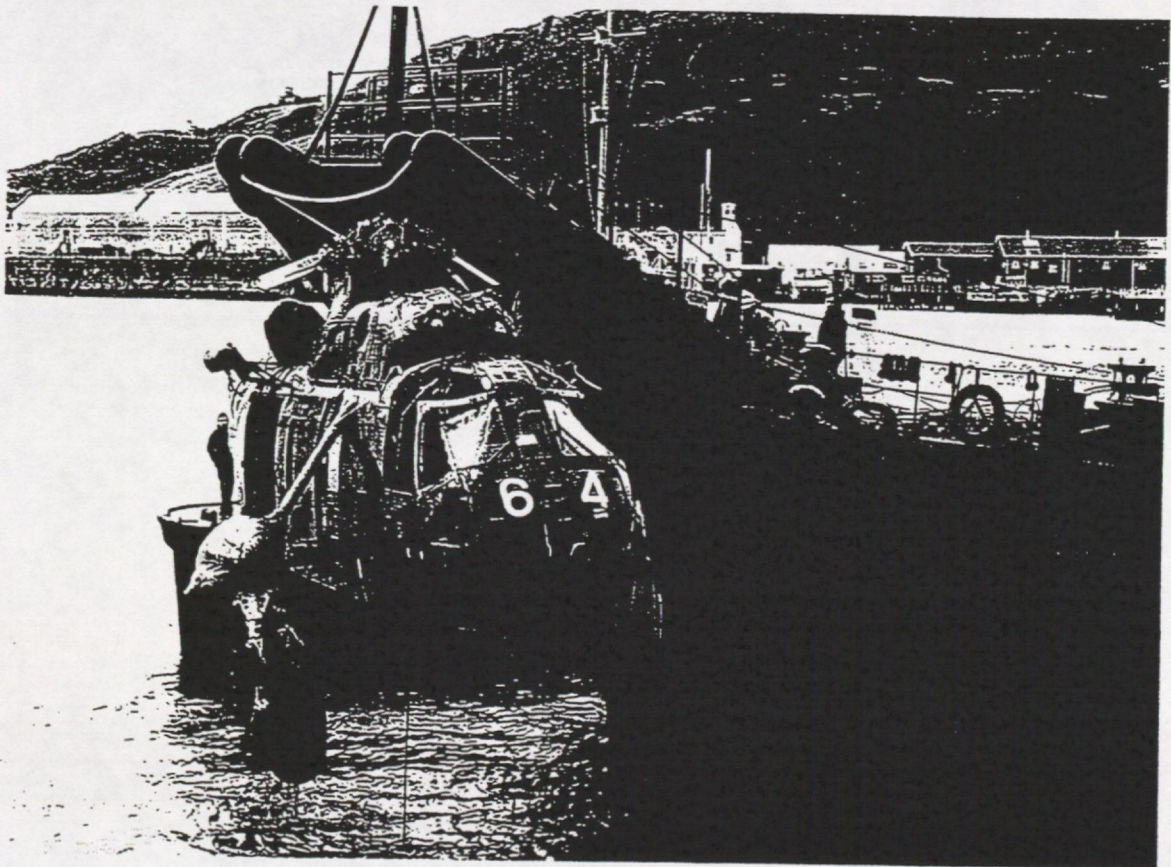
Figure 12 Damage to a Sea King helicopter following a limited control descent

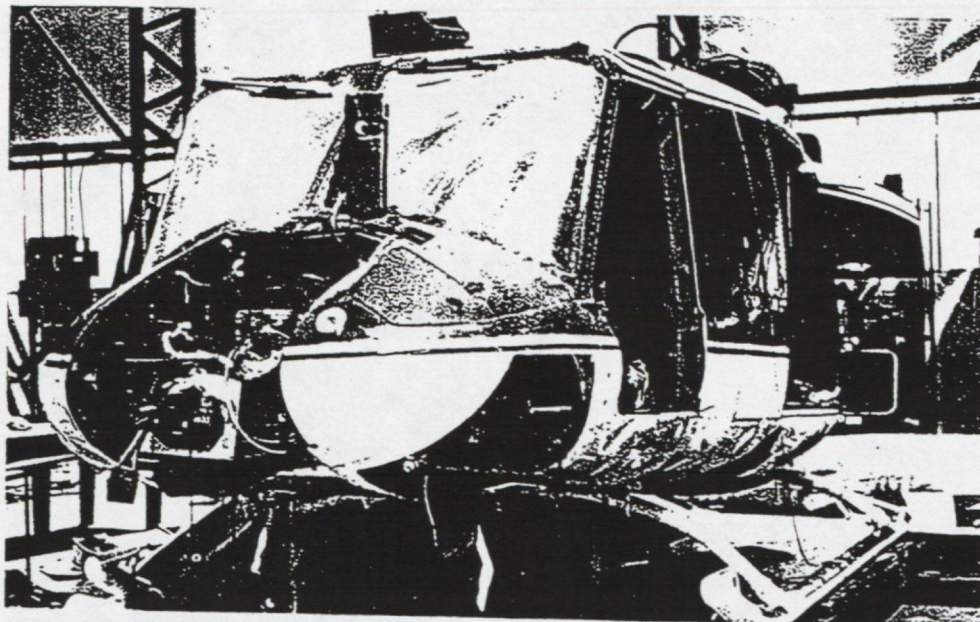
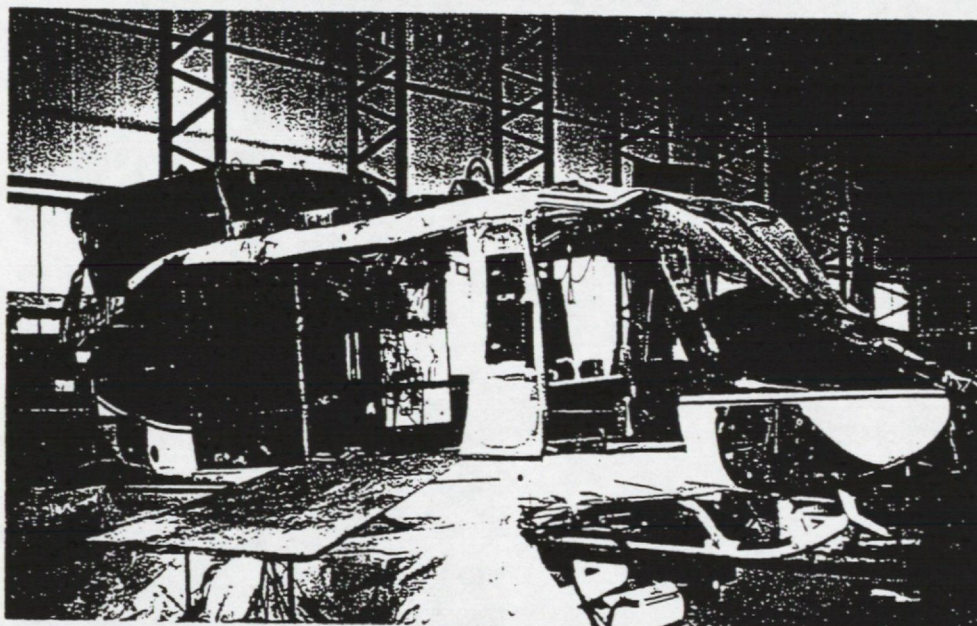
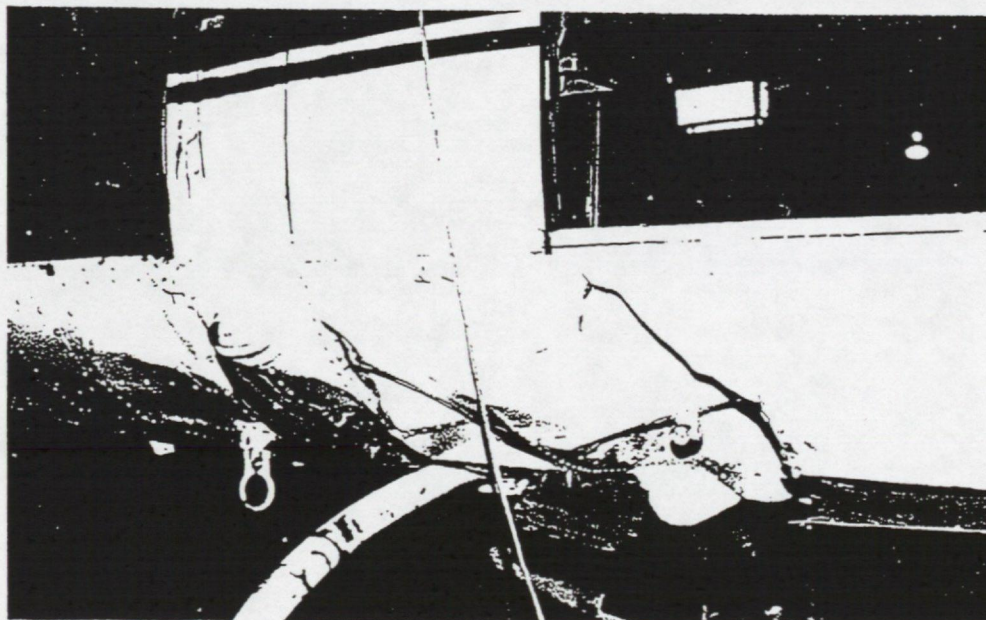
Figure 13 Damage to a Bell 212 following a limited control descent

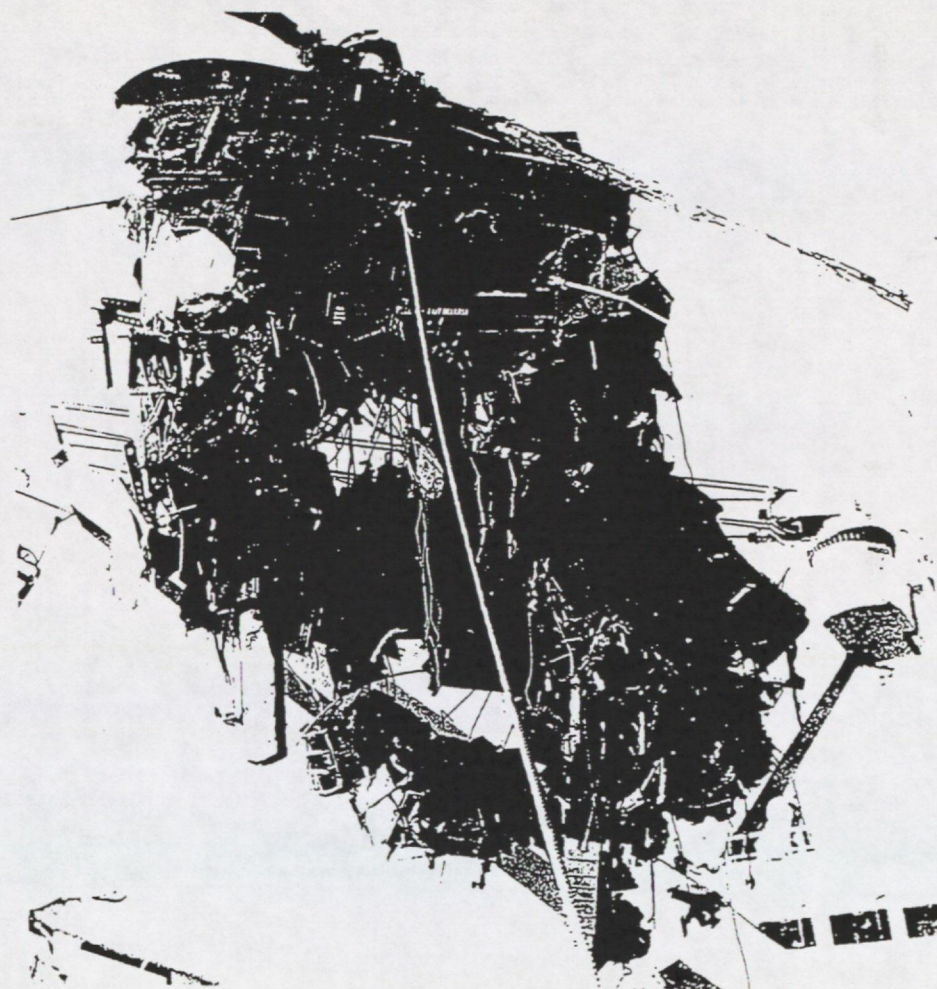
Figure 14 Breakup of a Sea King helicopter following a high forward speed fly-in water impact

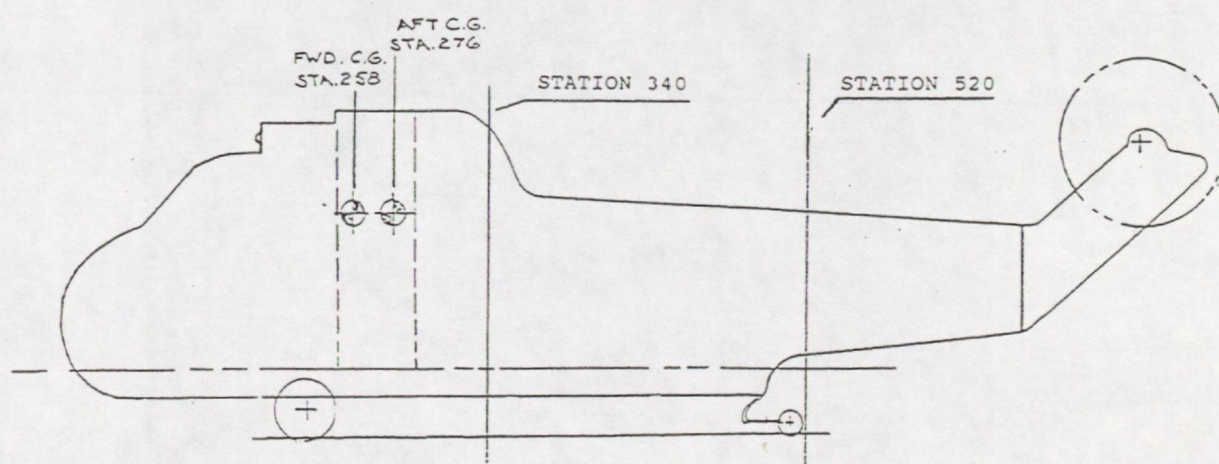
Figure 15 Position of airframe failures for the accident shown in Figure 14

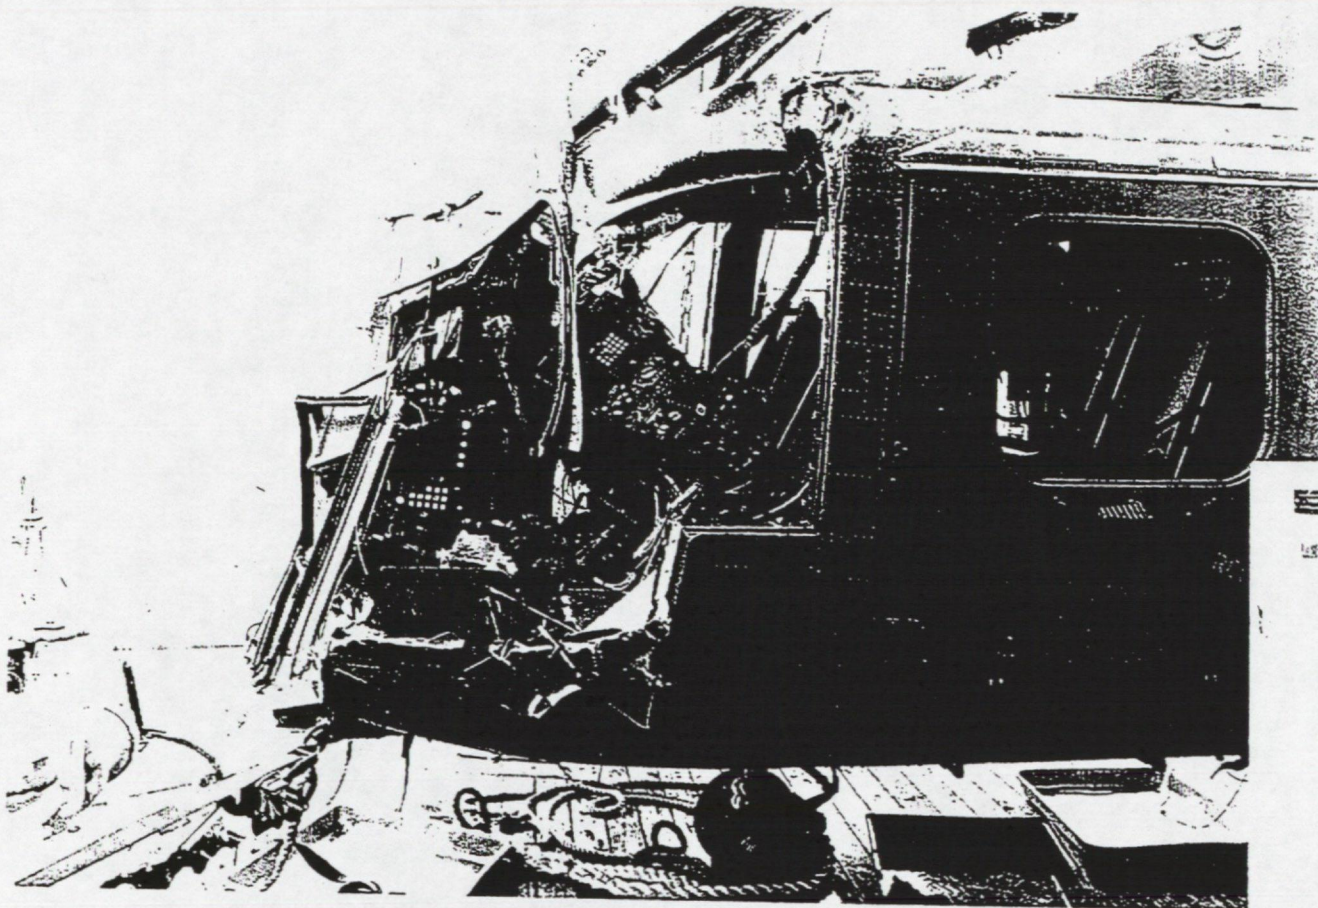
Figure 16 Damage to forward fuselage of a Navy Lynx following a fly-in water impact

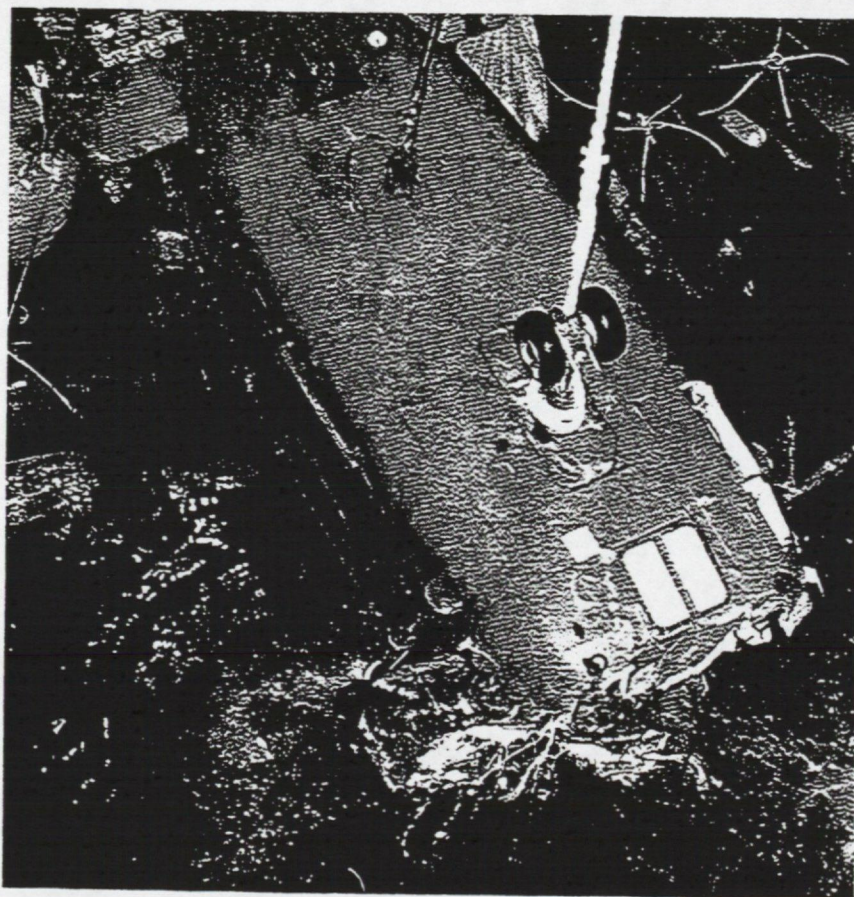
Figure 17 Underside of fuselage for the Navy Lynx shown in Figure 16

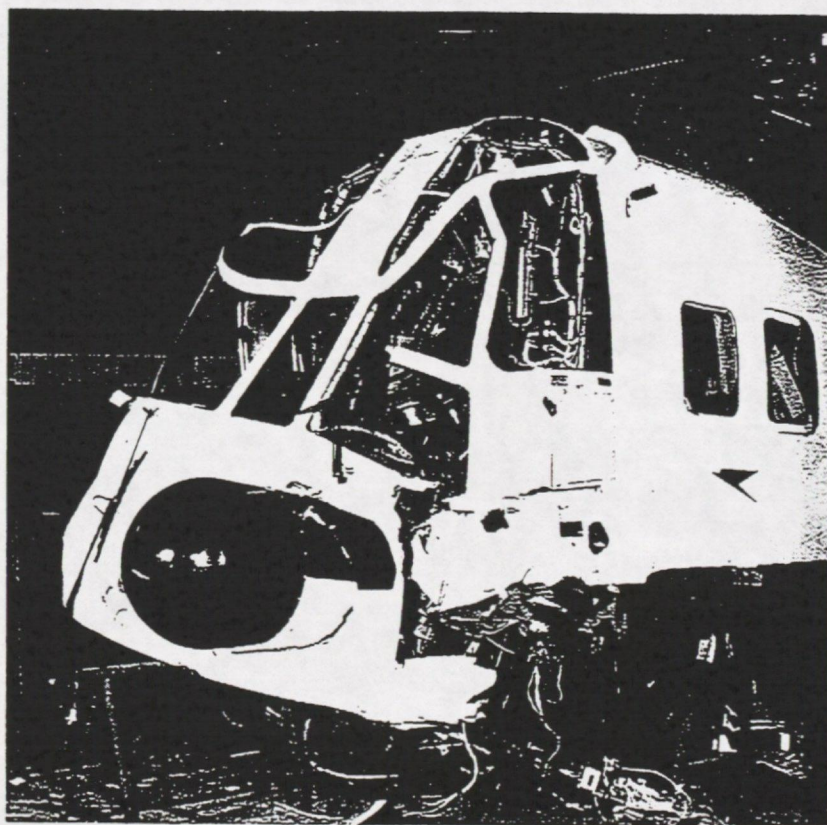
Figure 19 Damage to the forward fuselage for the accident shown in Figure 18

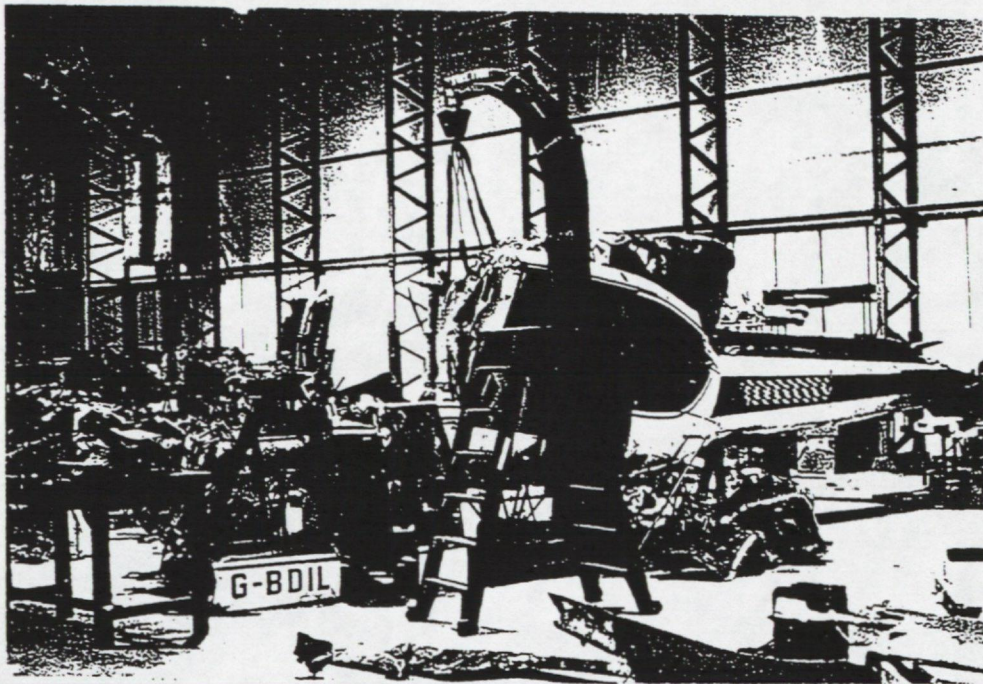
Figure 20 Structural damage to a Bell 212 following a high forward speed fly-in accident

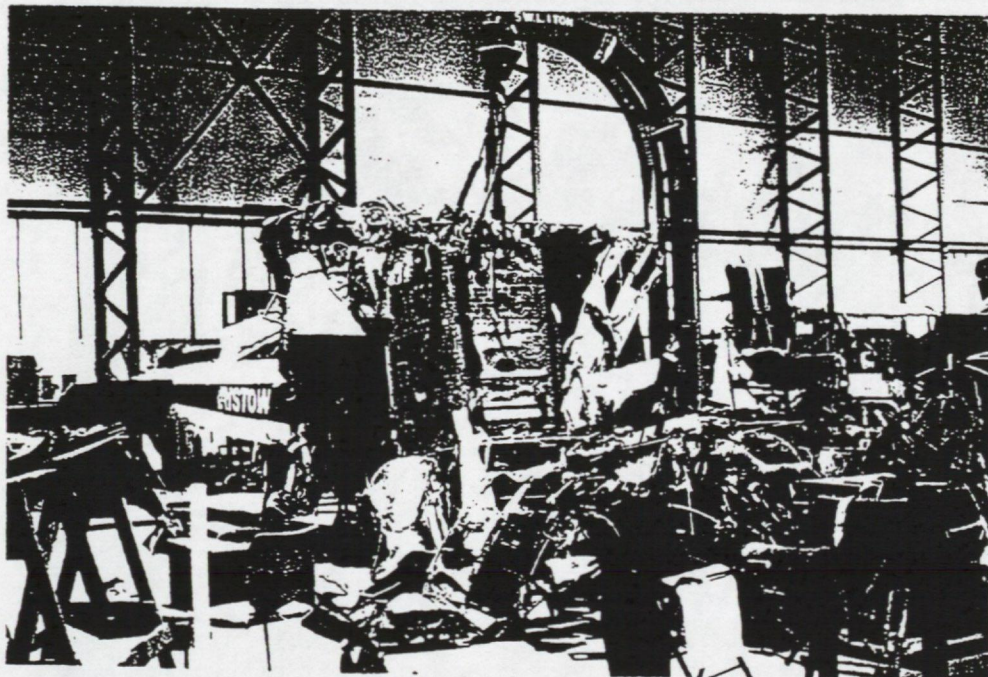
Figure 21 Starboard view of the accident in Figure 20 showing catastrophic fuselage failure

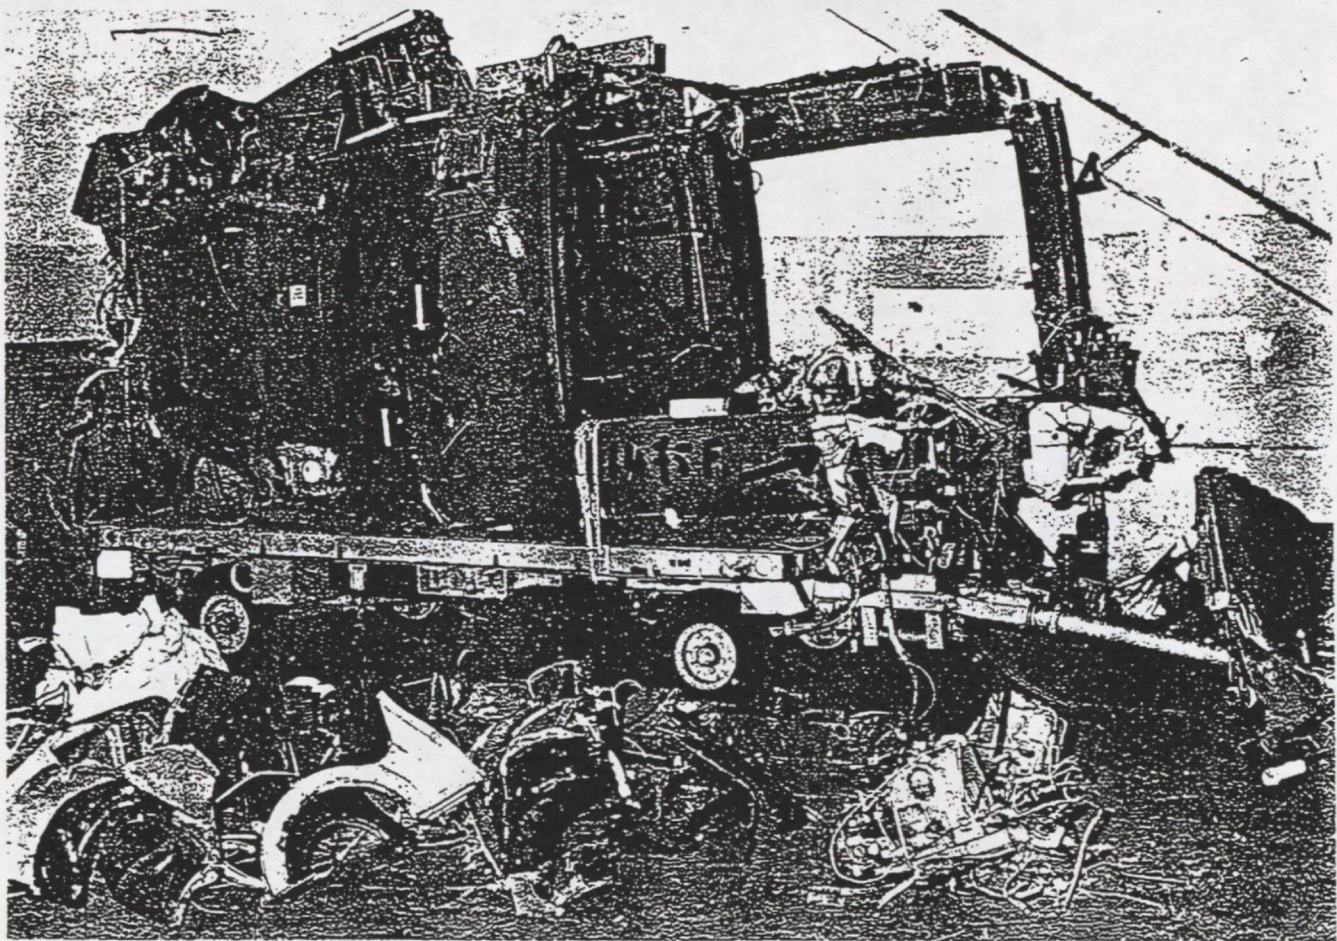
Figure 22 Structural damage to a Navy Lynx following a high forward speed fly-in accident

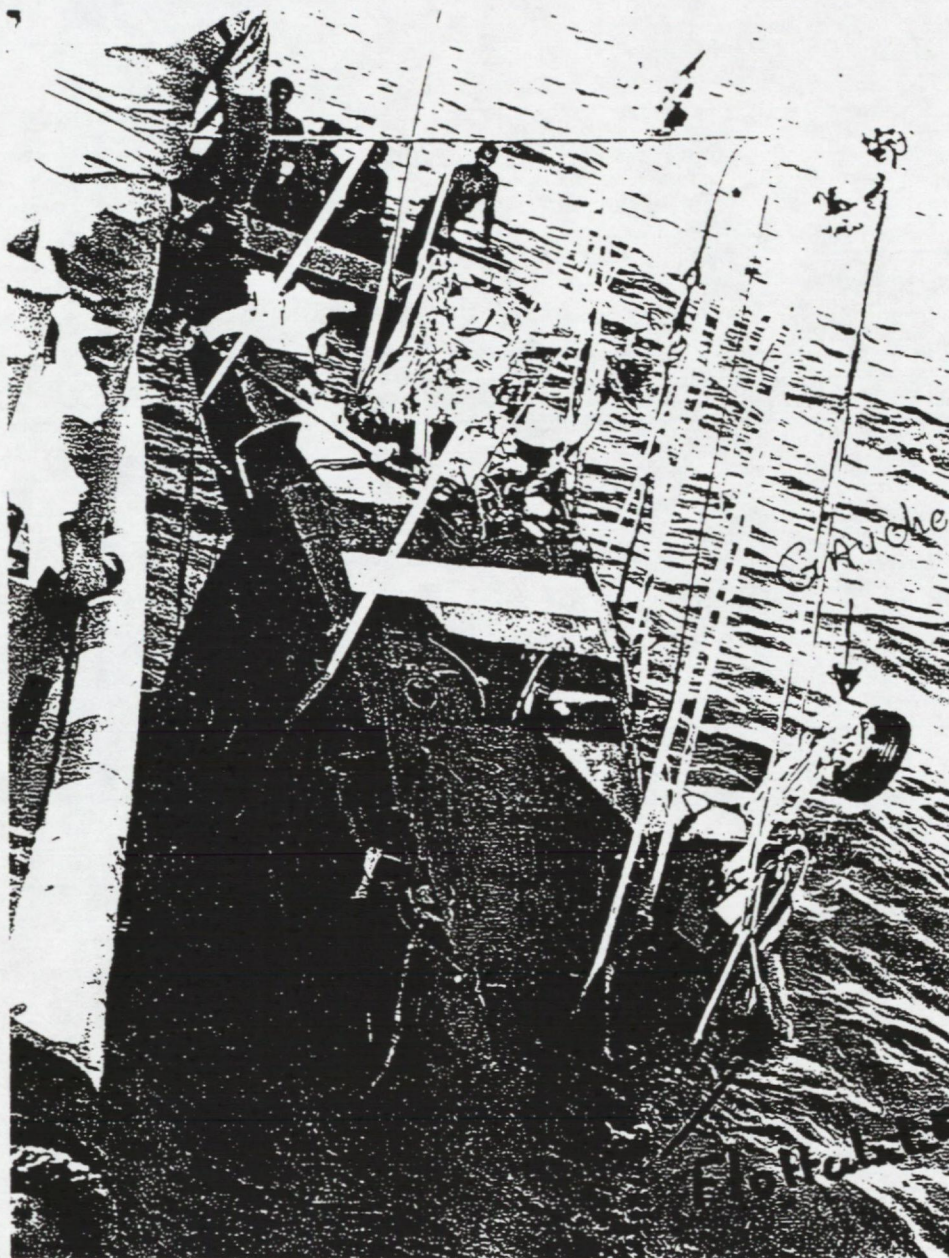
Figure 23 Lower surface of the aircraft shown in Figure 22

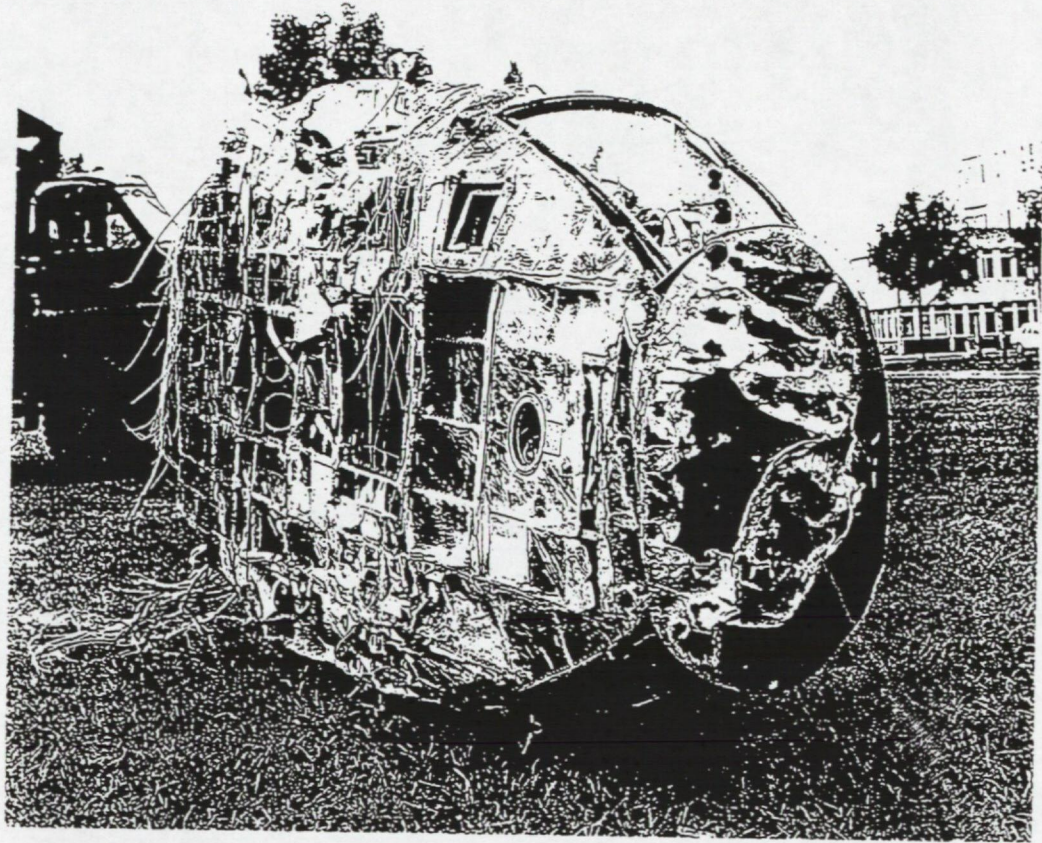
Figure 26 Damage to lower fuselage of an Army Lynx helicopter
