COMMISSION OF
INQUIRY INTO THE
AIR ONTARIO CRASH
AT DRYDEN, ONTARIO

Final Report

Volume I

By Order in Council PC 1989-532 dated the 29th of March, 1989, I was appointed Commissioner to inquire into the contributing factors and causes of the crash of Air Ontario Flight 1363 Fokker F-28 at Dryden, Ontario, on March 10, 1989, and report thereon, including such recommendations as I may deem appropriate in the interests of aviation safety.

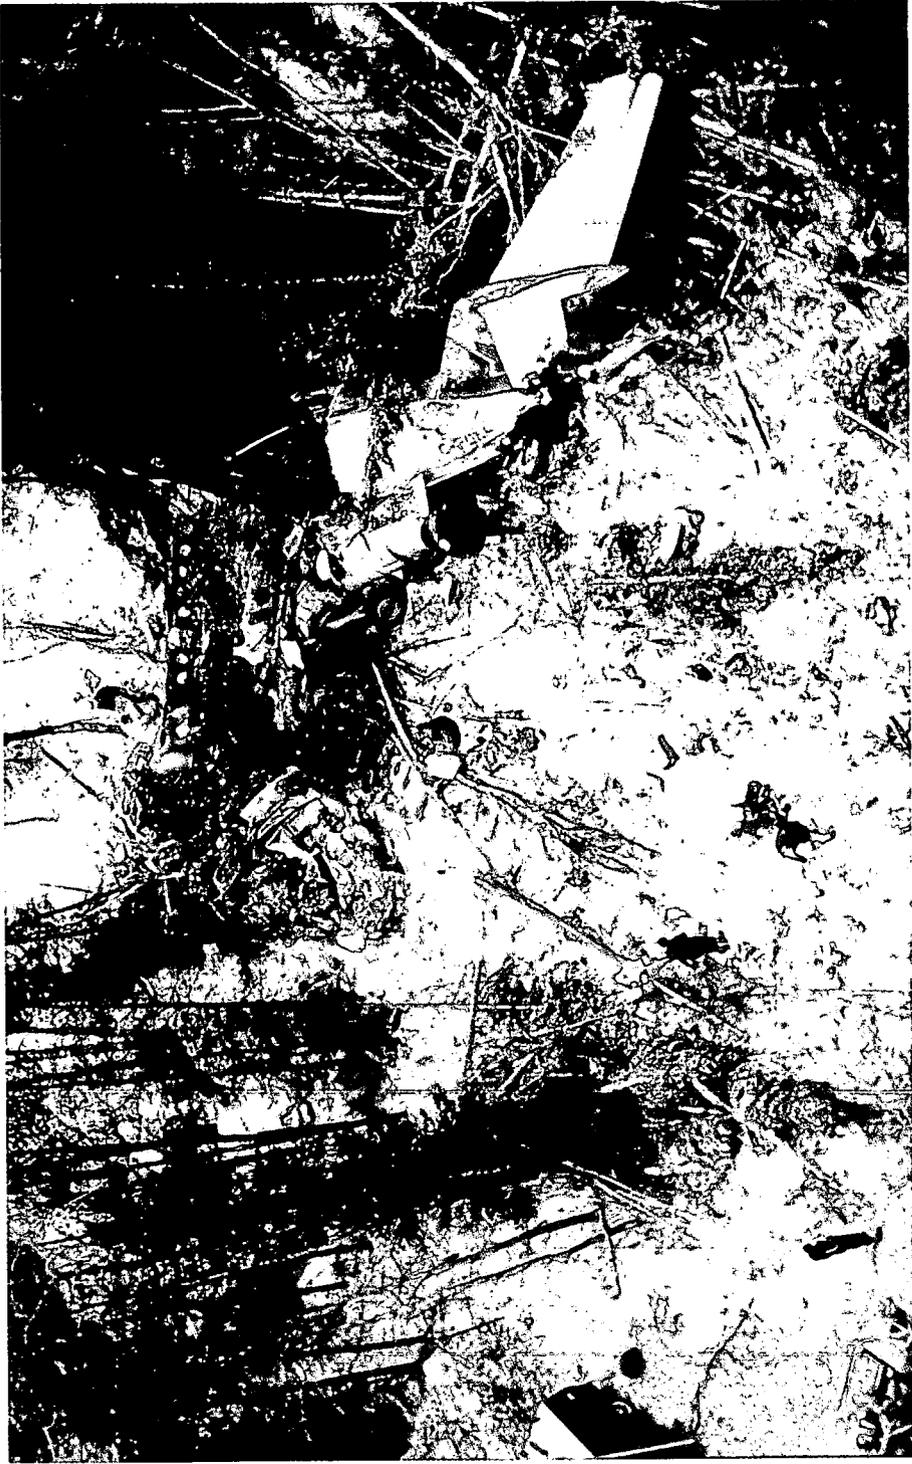
An aerial view of the wreckage of C-FONE, showing the aircraft in three pieces. The Air Ontario designator is clearly visible on the tail section.

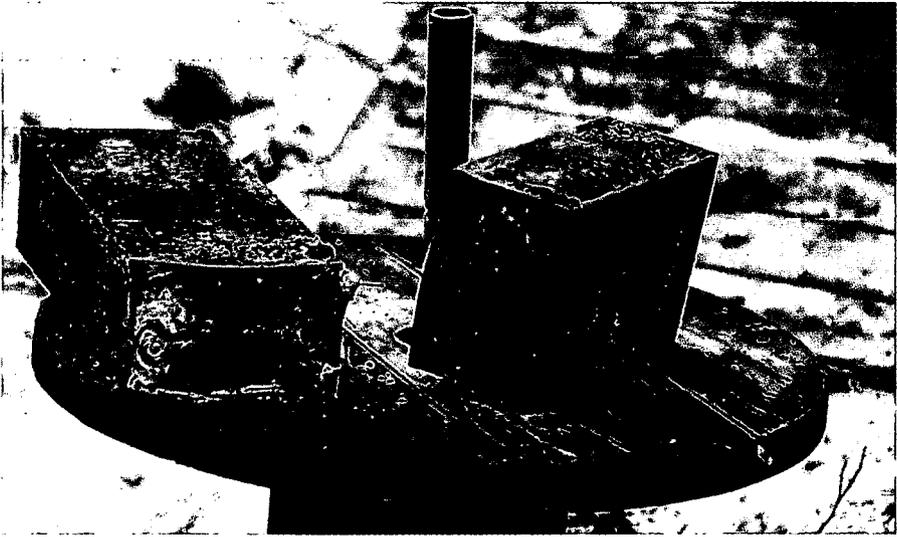
The cockpit voice recorder and flight data recorder were recovered, buried in debris, approximately 24 hours after the crash. On disassembly, it was discovered that the recording medium of both recorders had been destroyed by severe heat damage.

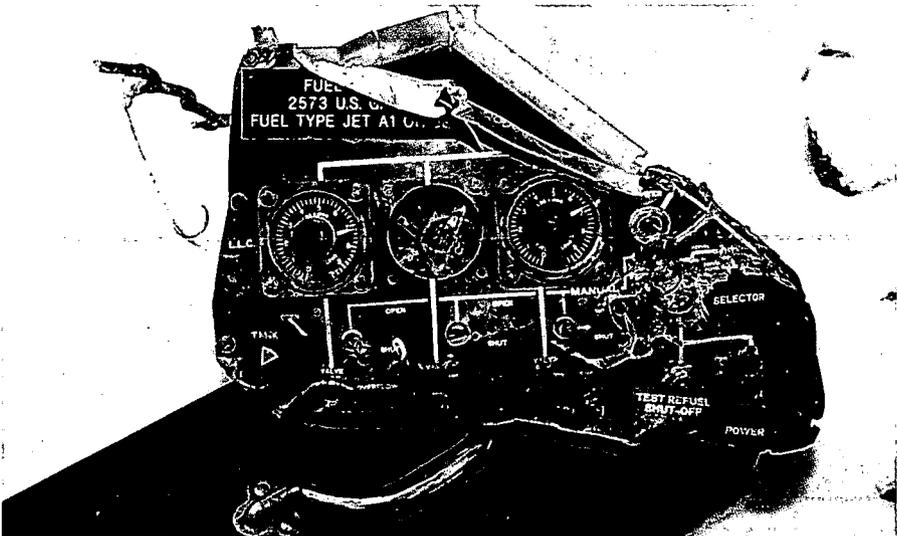
The refuelling panel, located in the wing, shows a fuel load of approximately 14,000 lbs.

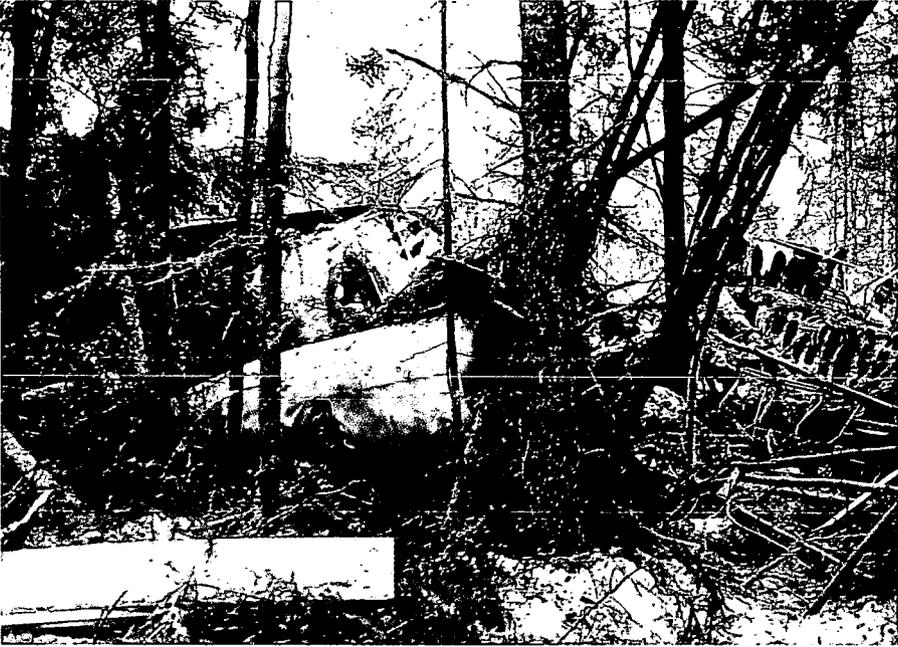
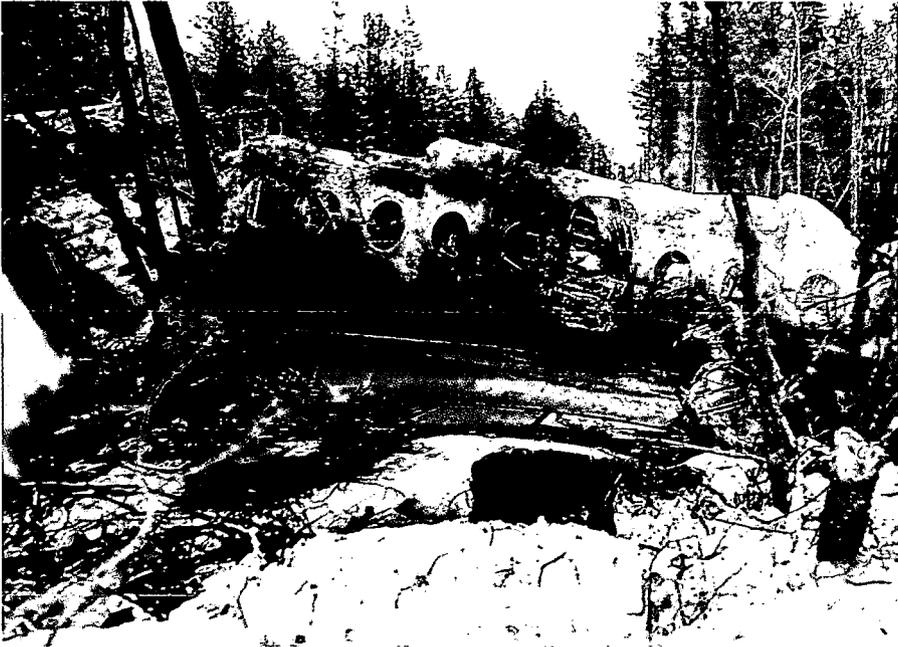
The wreckage was carefully photographed in situ at the crash site by the investigators: top, right engine; bottom, rear section of the right side of the fuselage.
