## Investigation Summary Report

AAIS Case N° AIFN/0007/2013

# Aircraft Damage Due to Impact by Wind Blown Containers

Operator: Flydubai  
Type: Boeing 737-800  
Registration: A6-FDE  
Location: Dubai International Airport  
State of Occurrence: United Arab Emirates  
Date of Occurrence: 6 April 2013

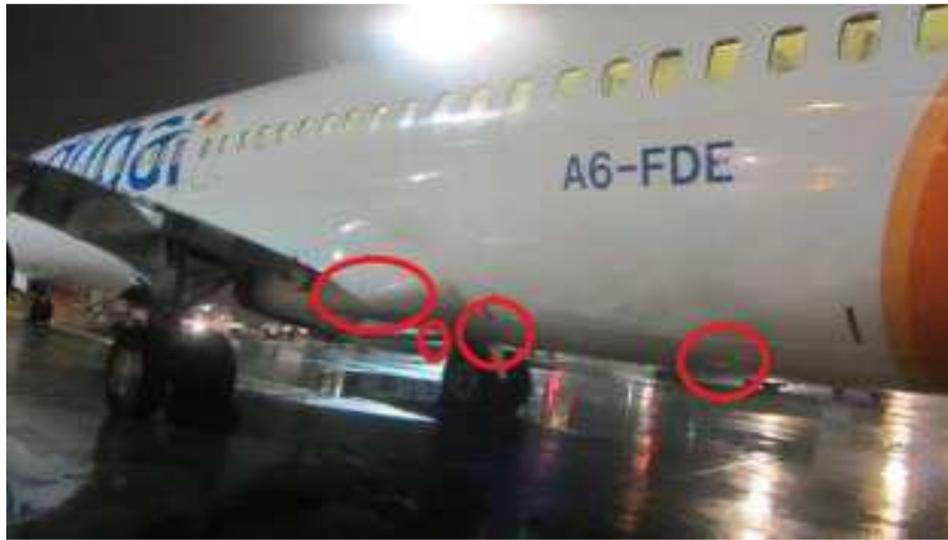
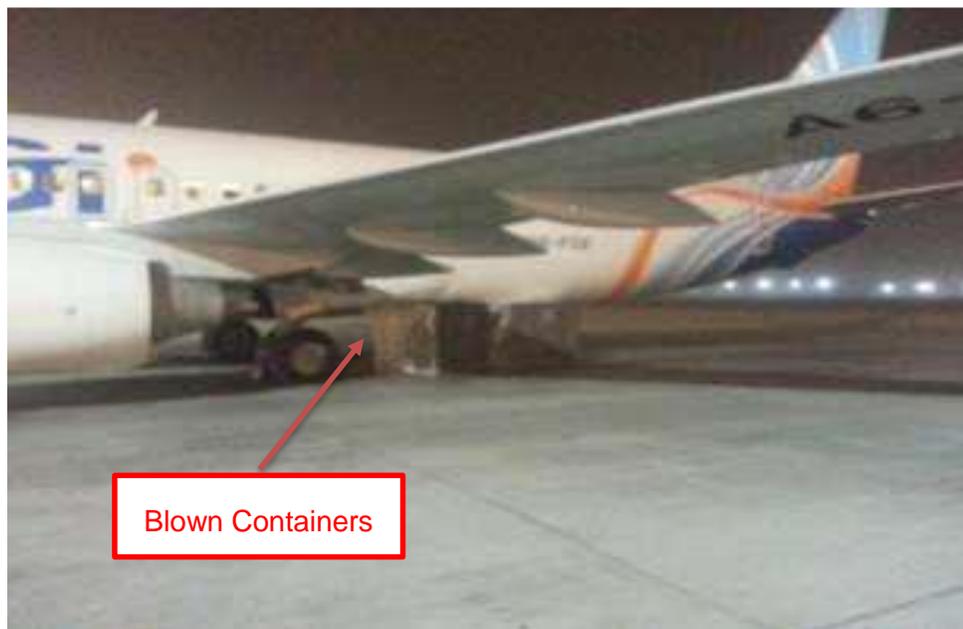
Figure 1. Damage to the Aircraft

It was found that two empty containers, which were blown off 10F dollies had impacted the Aircraft causing damage. The fuselage sustained two tears and a puncture to the port side, aft of the wing. Staff who were present at the scene attempted to stop the containers and whilst doing so, one of the Flydubai maintenance personnel sustained minor bruising to his nose and forehead.

- Beyond limit dent on LH lower fuselage between station (ST) 727E and 727F, stringers 24I and 25I
- Beyond limit dent on fuselage lower skin between ST 727G and 727H, stringers 24L and 25L
- Beyond limit puncture on fuselage lower skin between ST 727J and 747 stringers 24L and 25L
- Puncture on LH wing to body fairing (194fl)
