# Aviation Investigation Final Report

<b>Location:</b>	Lanai, Hawaii	<b>Accident Number:</b>	DCA15LA011
<b>Date &amp; Time:</b>	October 16, 2014, 14:47 Local	<b>Registration:</b>	N301KH
<b>Aircraft:</b>	Boeing 737 330	<b>Aircraft Damage:</b>	Substantial
<b>Defining Event:</b>	Aircraft loading event	<b>Injuries:</b>	3 None
<b>Flight Conducted Under:</b>	Part 121: Air carrier - Non-scheduled

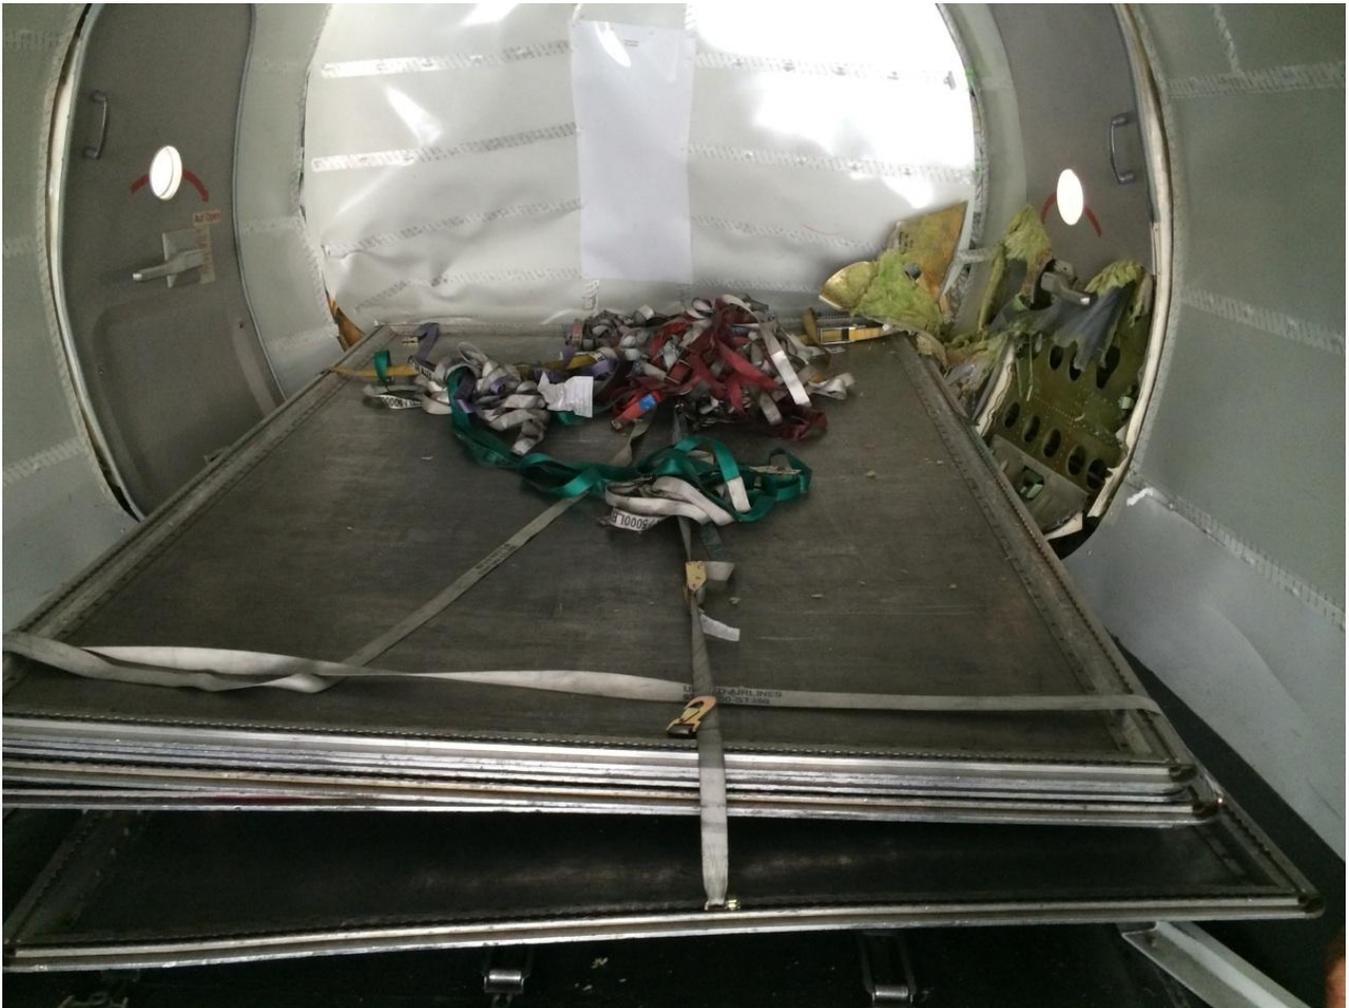
The cargo floor locks will only secure the bottom pallet when engaged properly and not the stacked pallets. The decision was made to secure the stacked pallets with a cargo strap which was insufficient to keep the pallets from moving. Even though it was stated that during the loading process that the locks were "up" and locked, when the Marshaller entered the airplane he observed the locks between station 8 and 9 were down/unlocked. In addition, there was damage found to the right hand forward and aft locking mechanisms, implying these locks were used but failed due to overload.

The National Transportation Safety Board determines the probable cause(s) of this accident to be: the improper loading and securing of the cargo pallets, which shifted on departure, resulting in substantial damage to the aft pressure bulkhead.&nbsp;nbsp;

Per company procedures, Marshaller A performs a post arrival check of the aircraft and verifies the content of the cargo before unloading can begin. Marshaller A noticed that all of the pallets were loaded into position 9, that none of the locks between position 8 and 9 were up, and the straps holding the sheets had allowed the sheets to shift aft making contact with the aft pressure bulkhead. Post event examination revealed that the aft pressure bulkhead had substantial damage, left aft (L2) door panel was damaged, and the right hand forward and aft pop up locking mechanism "claws" were detached/torn from their seat tracks. (See Figure 1)

Figure 1: Pallet cookie sheets and damage to aft pressure bulkhead
