# Interim Report

Type of Occurrence:	Serious Incident
Date:	20 January 2016
Location:	Munich
Aircraft:	Airplane
Manufacturer / Model:	Airbus Industries / A320-216
Injuries to Persons:	None
Damage:	Minor damage to aircraft
Other Damage:	Damage to two de-icing vehicles
Source of Information:	Investigation by BFU
State File Number:	BFU 16-0055-EX
Date of Publication:	March 2016

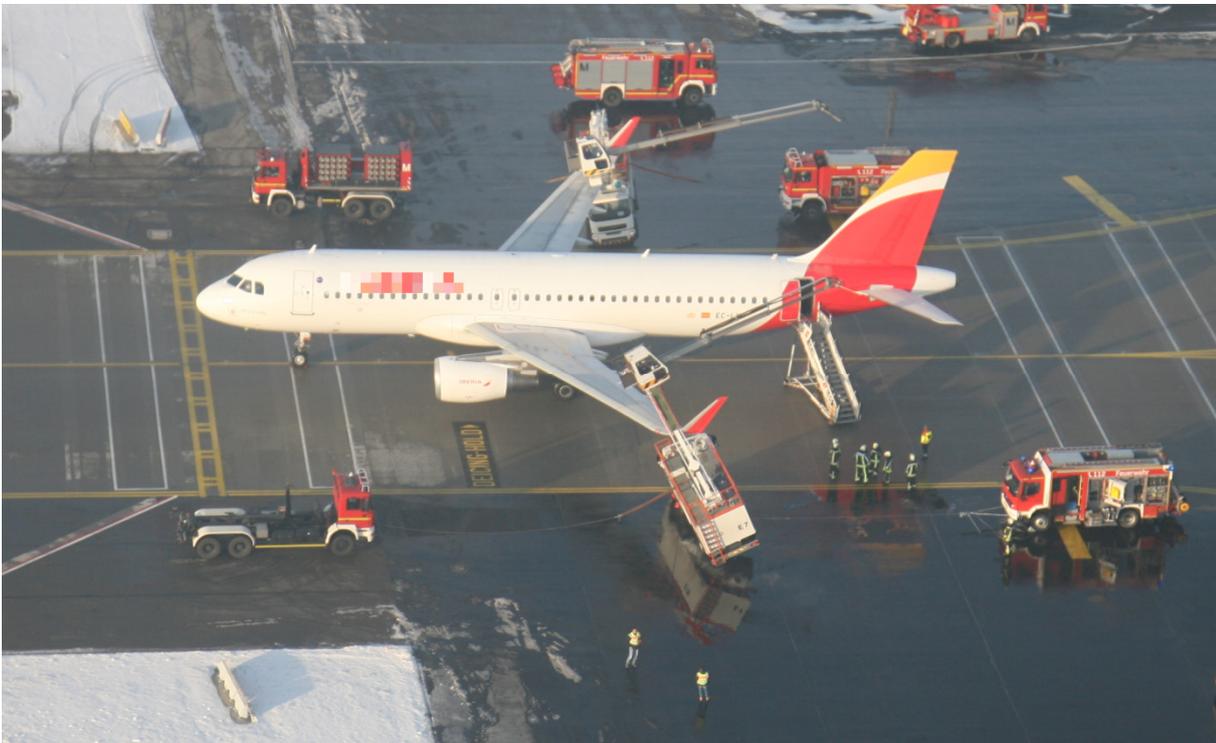
The serious incident occurred at DA14 approximately 160 m north of runway 26L. The aircraft's nose landing gear stood on the centre line of the taxiway. The fuselage nose was immediately north of the CAT II/III hold bar, about 7.5 m behind the de-icing hold marking.

Position of the airplane and the de-icing vehicles after the collision

The airplane's wings' transition zones with the sharklets had collided with the booms of the de-icing vehicles.

The drivers' cabs of the de-icing vehicles stood abeam of the corresponding edge marking of the taxiway. The vehicles had tipped by about 20° and therefore they stood on their left or right wheels, respectively.

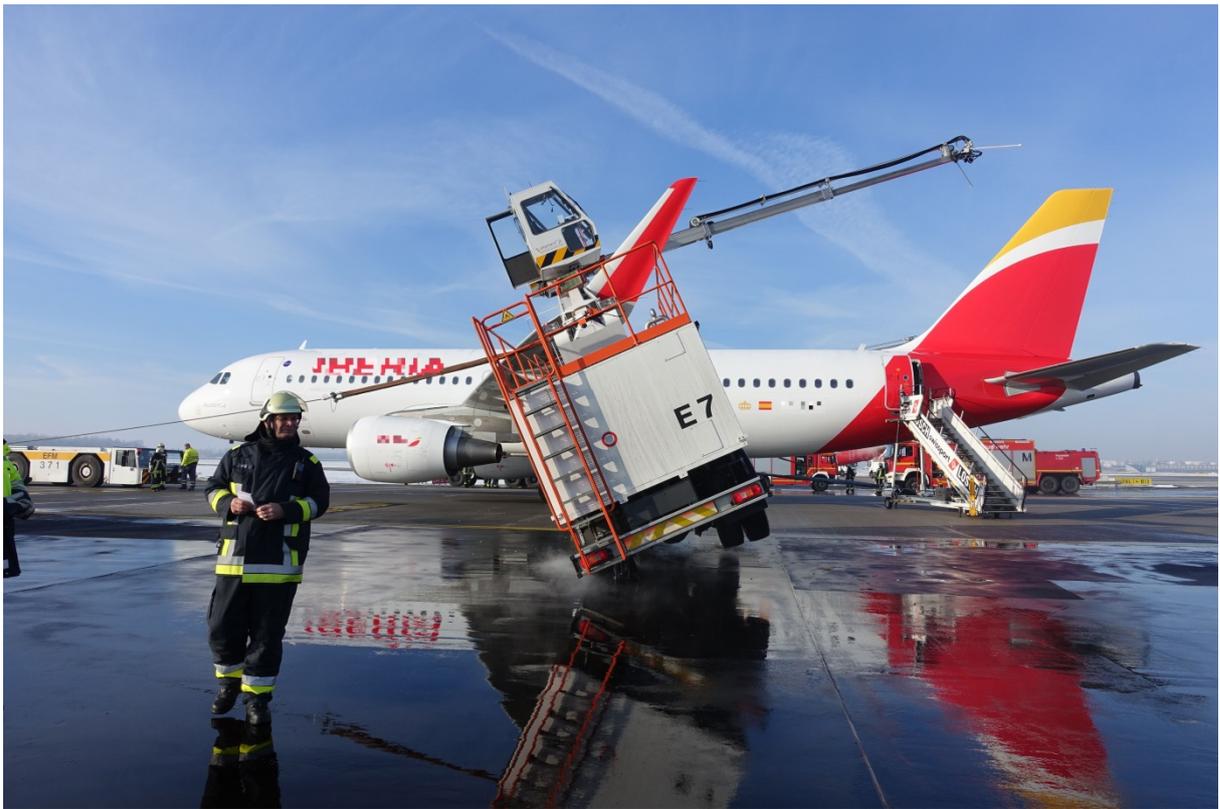
The aircraft’s wing tips collided with the de-icing vehicles.

Position of the Aircraft after the collision

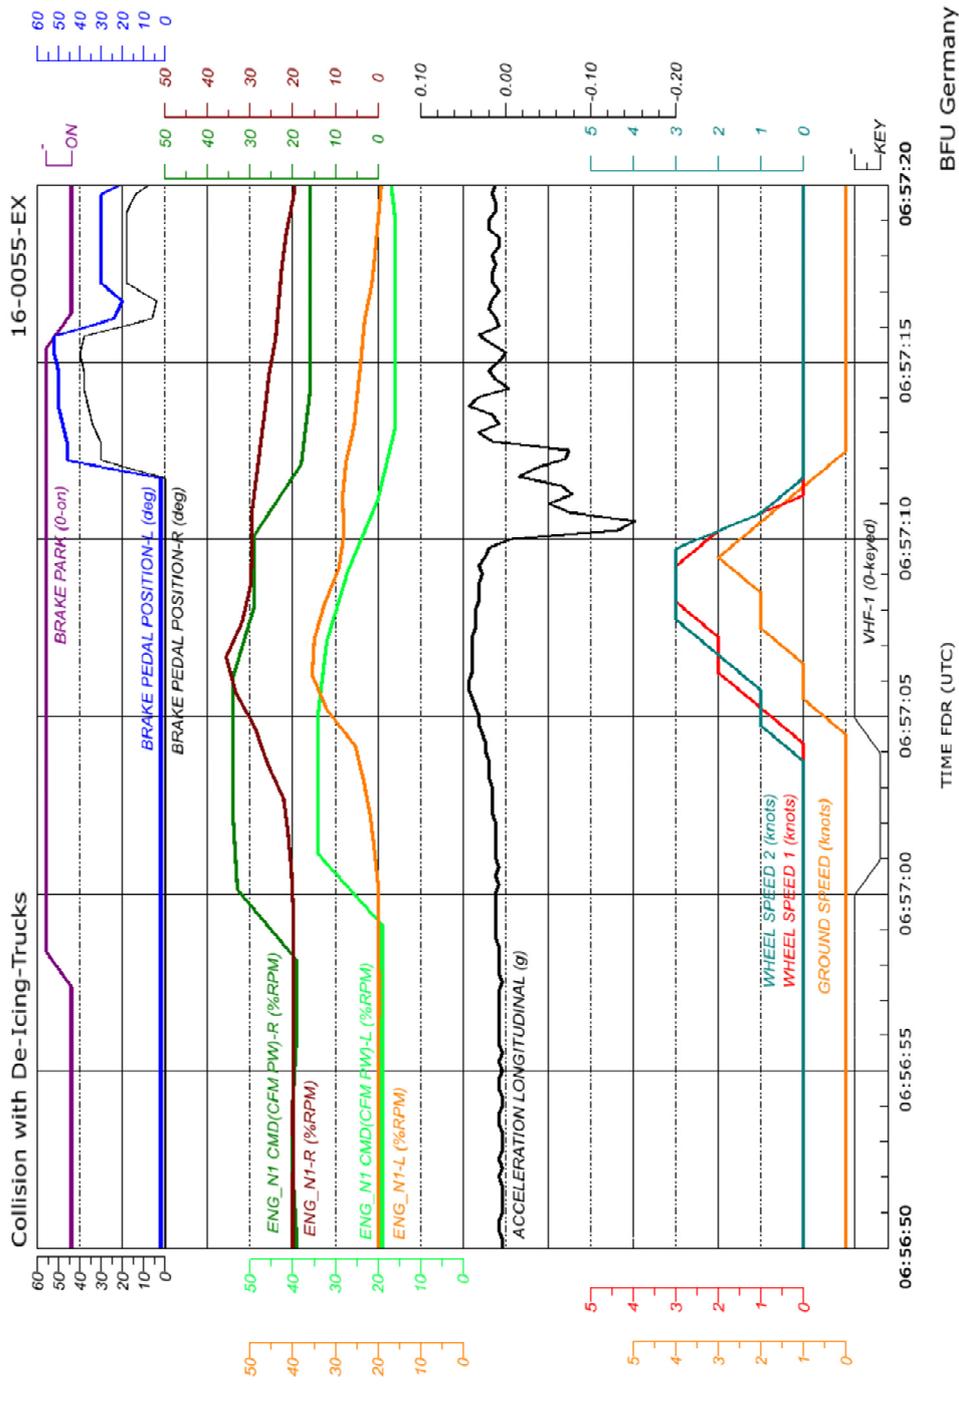
Excerpt FDR recording

The recording of the Flight Data Recorder (FDR) showed that at 0756:57 hrs the parking brake was released and the thrust levers of both engines were pushed forward. The engine thrust N1 started to increase at 0757:00 hrs and the airplane began to move. The speed increased to approximately 3 kt. At 0757:10 hrs the FDR recorded a change in longitudinal acceleration from 0.02 g to -0.15 g. Two seconds later the wheel brakes were actuated and at 0757:16 hrs the parking brake was set again.
