ACCIDENT

Aircraft Type and Registration:	Boeing 787-9 Dreamliner, G-CKWB	
No & Type of Engines:	2 Rolls-Royce Trent 1000-J3 Ten turbofan engines	
Year of Manufacture:	2018 (Serial no: 38788)	
Date & Time (UTC):	12 August 2019 at 0915 hrs	
Location:	London Gatwick Airport	
Type of Flight:	Commercial Air Transport (Passenger)	
Persons on Board:	Crew - 10	Passengers - 342
Injuries:	Crew - None	Passengers - None
Nature of Damage:	Damage to tail cone	
Commander's Licence:	Airline Transport Pilot's Licence	
Commander's Age:	51 years	
Commander's Flying Experience:	18,084 hours (of which 4,492 were on type) Last 90 days - 186 hours Last 28 days - 56 hours	
Information Source:	Aircraft Accident Report Form submitted by the pilot

Synopsis

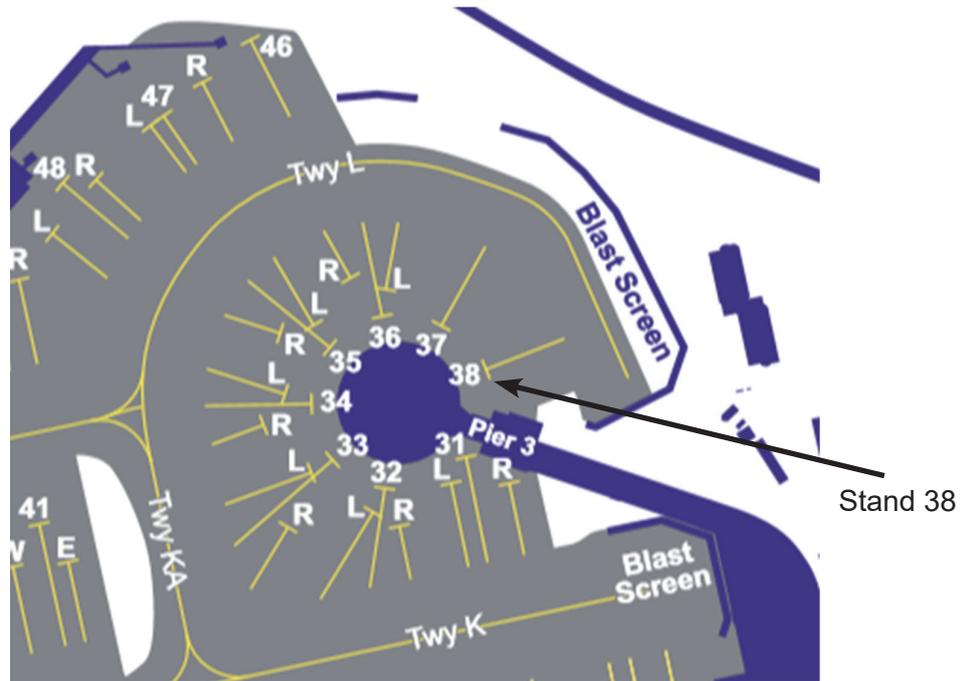
Figure 1

The aircraft was parked on Stand 38 at Gatwick ready to push back. Stand 38 is in a corner of the ramp with blast screens on two sides (Figure 1).

Position of Stand 38 at Gatwick

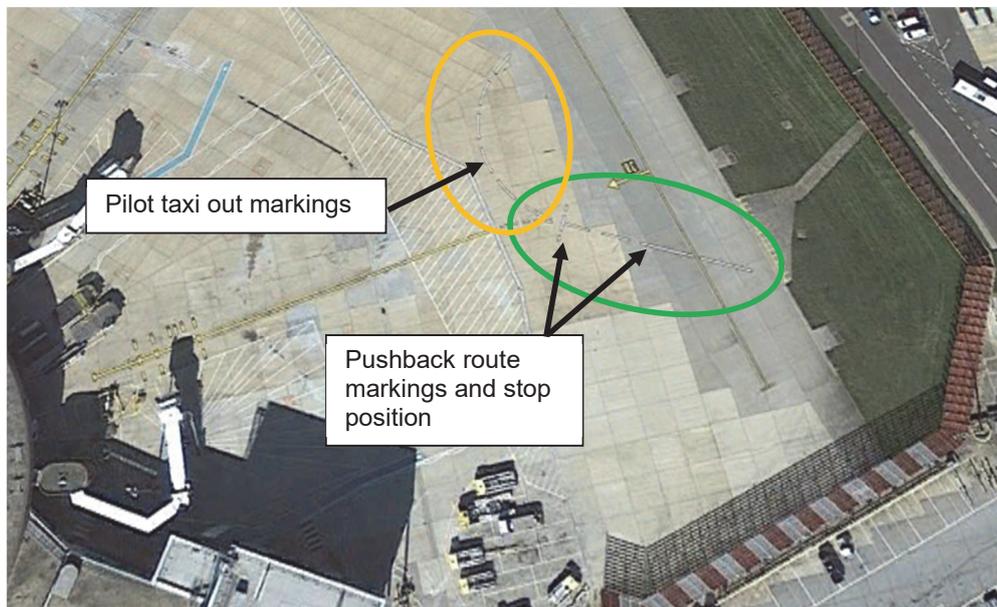
Figure 2

Due to the confined nature of the stand, special procedures are used so that sufficient clearance from the blast screens is maintained both during the pushback and subsequent taxi out. The apron has a line on the ramp to indicate to the pushback tug driver where the aircraft should be pushed to and where the nose wheel should be before the aircraft is disconnected from the tug. The pushback requires the aircraft to be positioned by the driver at an angle to the taxiway, and markings are also provided for the guidance of the flight crew when taxiing for departure. There is insufficient room for an aircraft to be pushed back onto the centreline of the taxiway at right angles to the stand. The markings for the pushback are shown in Figure 2.

Apron markings Stand 38

- A 'STOP' mark was painted on the ramp beside the nosewheel stop line on Stand 38 to make it clear that the aircraft should not be pushed back further than this line. This mark matches others at Gatwick where the pushback is limited by the confined space.

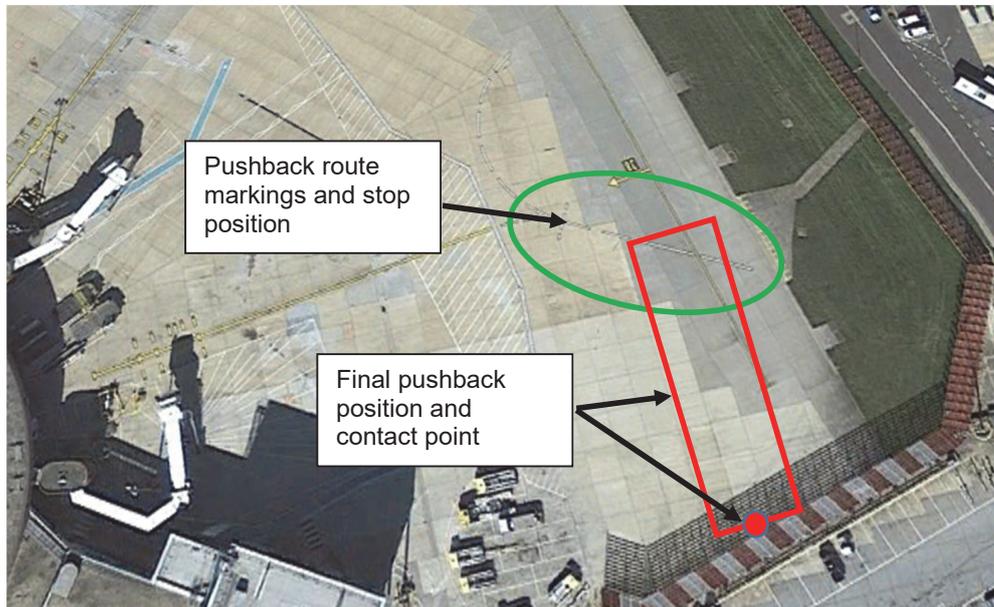
Figure 3

At 0910 hrs, the crew received permission to push back from Stand 38. The tug driver began the pushback, and CCTV showed the aircraft pushing straight back along the yellow line for the initial part of the pushback before beginning to deviate from the route markings off the back of the stand. The headset operator signalled to the driver to slow down, with

the intention of directing him to pull the aircraft forward into the correct position but, before this could be done, the aircraft tail cone struck the blast screen. The final position of the aircraft is shown at Figure 3.

Final pushback position

The APU exhaust fairing was subsequently found to be damaged.

G-CKWB was not pushed from the stand onto the required line or stopped at the correct point. This meant that the aircraft came into contact with the blast screen and the APU exhaust fairing was damaged. As a result, the aircraft was withdrawn from service for repairs.

- Use of Stand 38 by the operator was suspended temporarily.
- The aircraft operator decided to prepare a risk assessment on the use of additional ground staff to watch the wingtips and tail of aircraft during the pushback. The airport operator agreed to consider this assessment once it was complete.
- Notices were issued by the aircraft operator to all pushback crews to remind them of the procedures and importance for stopping a pushback should the aircraft deviate from the centreline.
- Additional training was given to headset operators to increase their understanding and awareness of pushback hazards.
