Statement 2022-71

Accident to OH-LKK (Embraer ERJ-190) in Copenhagen (EKCH) on 7-2-2022.

ISSUED JUNE 2022

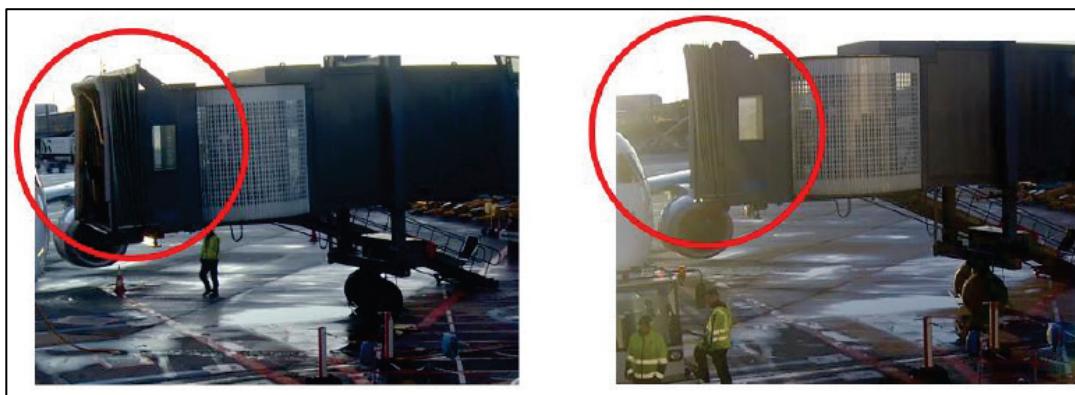
Photo 1.

The photo to the left presents the angle between the passenger boarding bridge platform and the aircraft at initial arrival of the aircraft. The photo to the right presents the angle between the passenger boarding bridge platform and the aircraft at reconnection.

The actual angle between the passenger boarding bridge platform and the aircraft caused no detection by the centrally located built in proximity sensors of the passenger boarding bridge. The left corner of the passenger boarding bridge platform made contact with the aircraft fuselage, and the passenger boarding bridge continued movement puncturing the aircraft fuselage skin below the forward entrance door.

Because of the accident, the handling agent took preventive actions ensuring a standardization of bridge operator reconnection docking procedures.

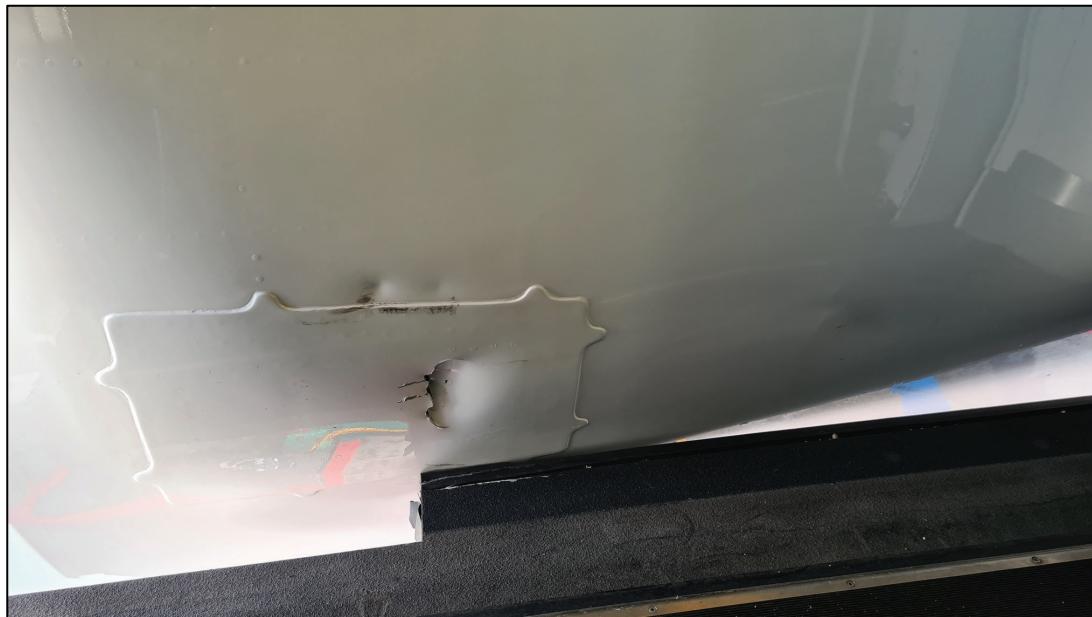
The structural damage to the aircraft fuselage skin prevented the aircraft from being pressurized.

Photo 2. Damage to the aircraft fuselage skin.
