KOMITE NASIONAL KESELAMATAN TRANSPORTASI REPUBLIC OF INDONESIA

FINAL KNKT.19.05.10.04

Aircraft Accident Investigation Report

PT. Batik Air Indonesia Airbus A320; PK-LZJ Sultan Hasanuddin International Airport Republic of Indonesia 25 May 2019

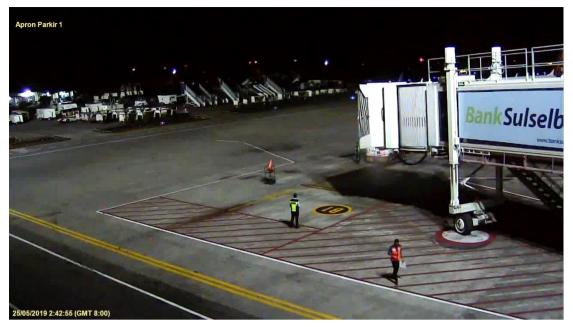
Figure 4: The blocked view of parking stand B1 CCTV

The CCTV camera located on the parking stand B1 was unable to provide clear view of the pushback maneuver as the view was blocked by the passenger boarding bridge (figure 4).

- 14. The view to the parking stand B1 on the CCTV system that was blocked by the passenger boarding bridge resulted in the pushback maneuver did not completely visible by the AMC officer. This condition might have made the AMC officer never noticed pushback maneuvers on the parking stand B1 that were not follow the available guidance lines. Without any incident, the pushback maneuvers on the parking stand B1 that were conducted deviating from the guideline was unnoticed.

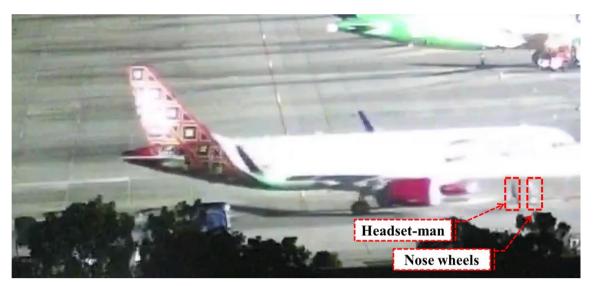
Figure 6: The zoomed-in view of the ATS provider CCTV display showed the headset-man position during pushback

The Air Traffic Services (ATS) provider also utilized CCTV system for security purposes. One of the CCTV cameras located outside the tower building facing to the apron recorded the push back maneuver. Based on the CCTV record, throughout the pushback maneuver, the headset-man position as such that the nose wheels were behind him (figure 6).

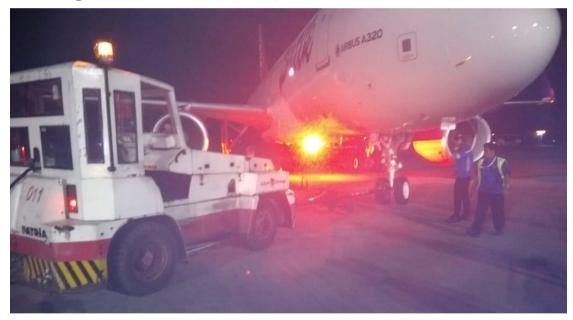
Figure 9: The position of the towing tractor and when the aircraft stopped after the accident

After the bump, the towing tractor driver stopped the towing tractor and the aircraft stopped by facing south east. The aircraft was undamaged.

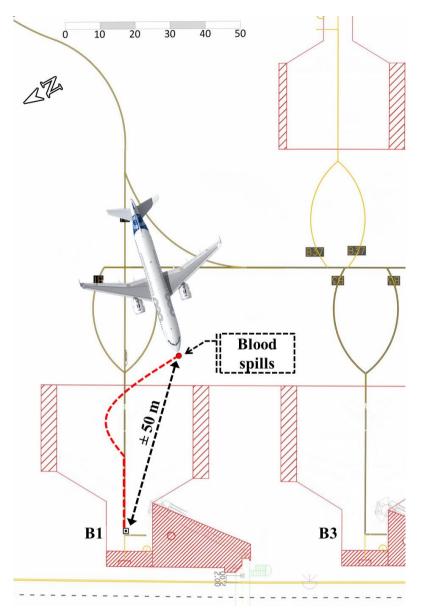
Figure 10: The illustration of the nosewheels movement during pushback maneuverer (red dot line)

The location of the blood spills on coordinate $5^{\circ}4'32.86''S$; $119^{\circ}32'55.67''E$, about 50 meters from the beginning of parking stand B1, was considered as the location when the nose wheel passed over the headset-man right foot.

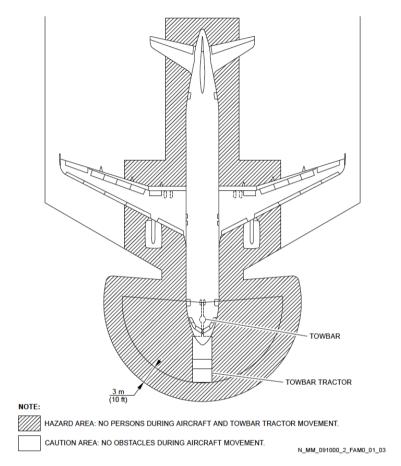
Figure 11: The hazard area during towing operation as describes in the Batik Air AMM for Airbus A318/A319/A320/A321

The towing procedure on subtask 09-10-00-584-064-A described that during the towing operations, while the aircraft moves, all persons must be at a minimum distance of 3 meters or 10 feet from the wheels and the tractor. The hazard area during towing operations were illustrated on the following figure:

The Batik Air Aircraft Maintenance Manual (AMM) for Airbus A318/A319/A320/A321 described hazard area during towing operation, which required all person must be at a minimum distance of 3 meters from the wheels and the tractor when the aircraft moved.
