# AIR ACCIDENT INVESTIGATION SECTOR

## SERIOUS INCIDENT INVESTIGATION REPORT

### Pushback Collision

Airbus A330-243 [A6-EYN]  
Boeing 777-300 [A6-ETD]  
Abu Dhabi International Airport [AUH]  
Terminal 1, Stands 121 and 122  
May 06 2012

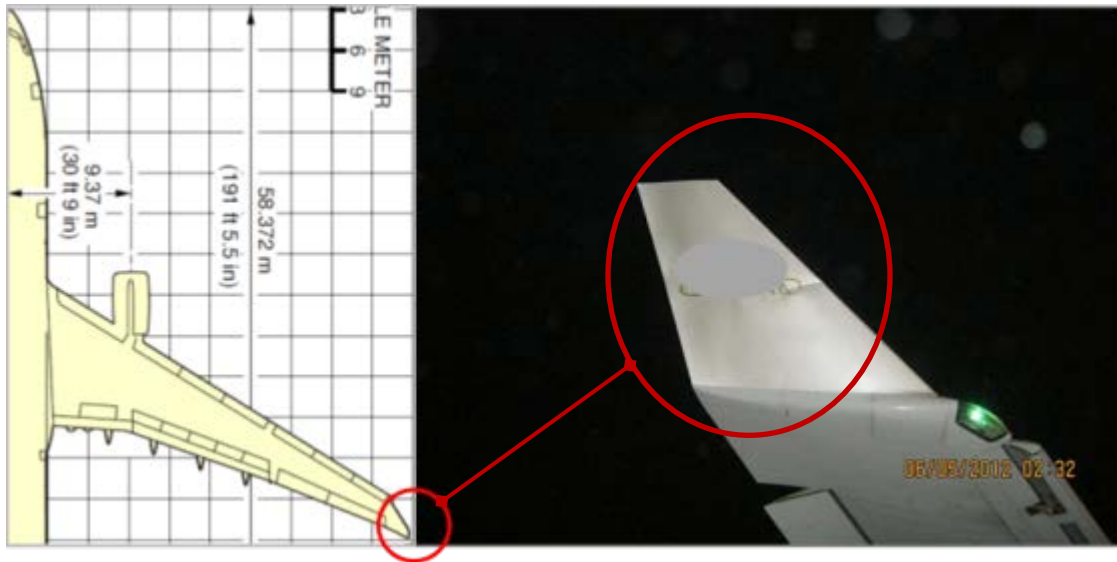
Figure 2 Airbus A330 Wingtip Damage

The right hand wingtip/winglet assembly was damaged beyond acceptable dispatch requirements. The wingtip/winglet was removed as per the CDL. The aircraft was dispatched in accordance with the approved manuals.

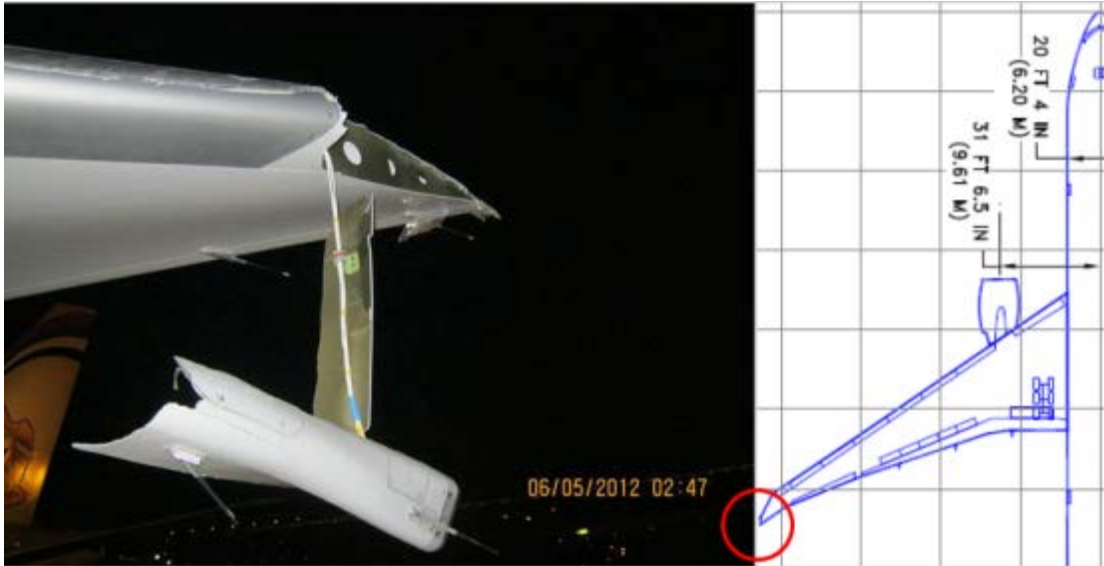
Figure 3 B777 LH Wingtip Damage

The left hand wingtip/winglet assembly was damaged beyond acceptable dispatch limits. Significant structural damage to the secondary structure component assembly required the assembly replacement.

The aircraft was declared AOG, the passengers were disembarked and aircraft towed to a repair facility.

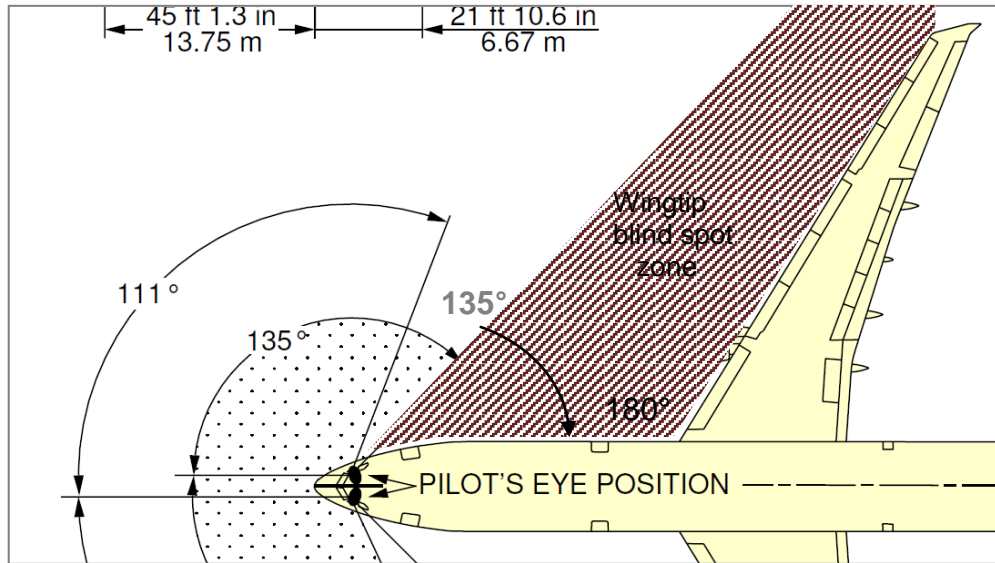
Figure 4 Visibility from A330 Cockpit in a Static Position

Pilot's view from the First Officer position when seated, head up in the F.O. seat, with the seat restraints attached [seat belts] is limited to a cone range of 135° from the aircraft's longitudinal axis.

From 135°-180° from the static position is a wingtip blind spot. The visual field of the human eye spans approximately 120 degrees of arc from the static position, most of the arc range is peripheral vision only.

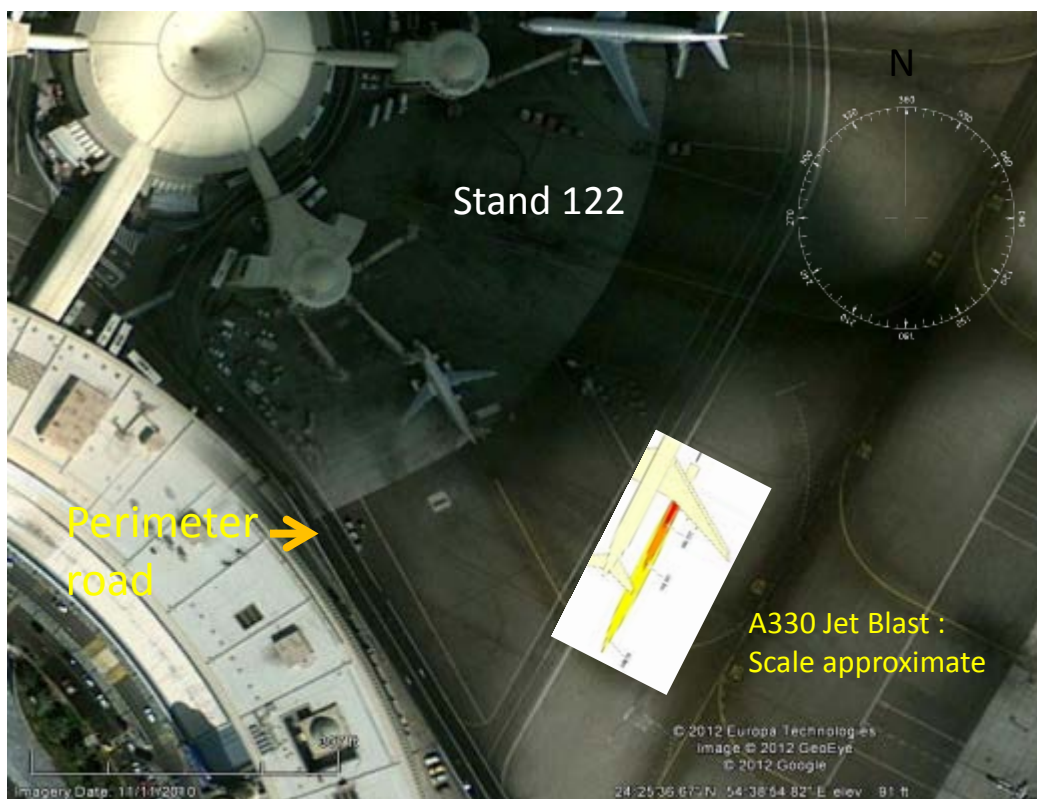
Figure 9 Overview Engine Exhaust and the Perimeter Road Boundary

There is currently no requirement to friction test the airside boundary roads or make safety risk assessment for jet blast induced vehicle displacement.

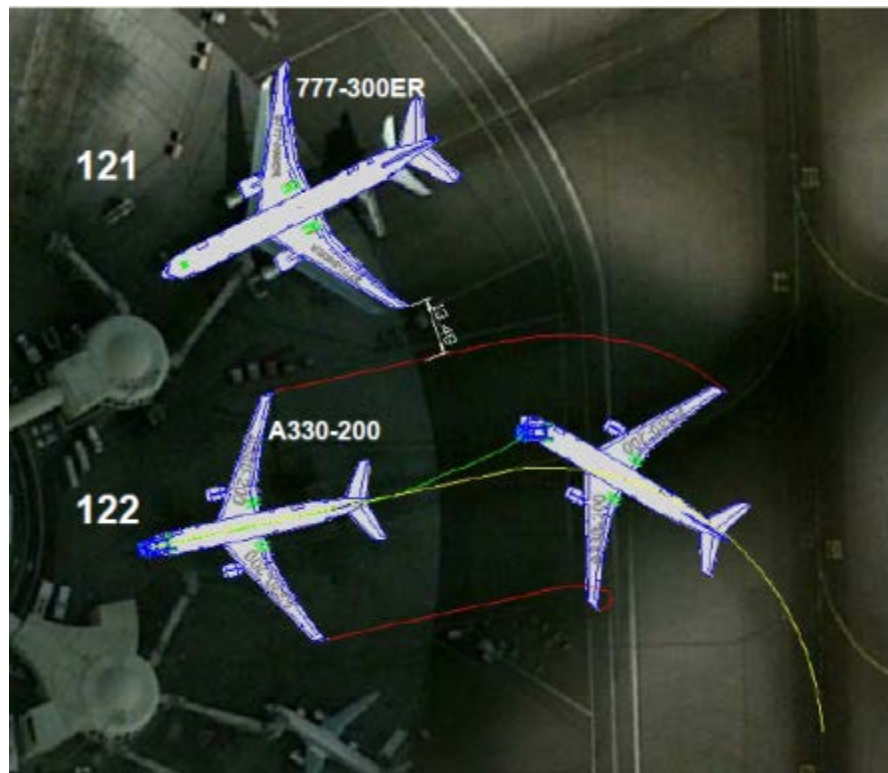
Figure 12 PathPlanner<sup>3</sup> optimal push back radial from T1/stand 122

If the A330-200 is pushed back towards the taxi lane center-line in such a way that the main landing gear follows the lead-in line on Stand 122, there is no collision risk and adequate wingtip clearance is achieved.

Consequently, the A330-200 wingtip track (red) is at a distance of ~13m from the 777-300ER wingtip. This wingtip margin is well above the ICAO value of 7.5m.

For this wingtip collision to occur the A330 -200 Main Landing Gear centroid has to have been approximately 13meters off-track displaced to the starboard [right-side].

The pushback practice of displacing the pushback center-line to the tractor drivers left and beginning a progressive aircraft turn to the drivers right-hand side was not an approved or documented practice with no signalling of turn initiation points predefined.

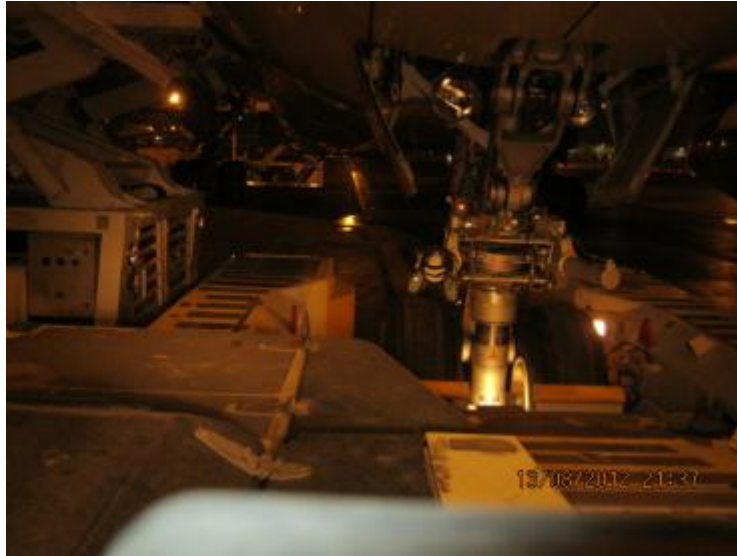
Photo 2 - Push back drivers View

The drivers view of the wingtips is limited when seated and in low ambient light conditions.

A wing walker was not employed, although several ground handling personnel who judged that a collision was probable did attempt to communicate with the driver and headset man. The headset man sitting in the tractor can, facing away from the pushback direction was a contributing cause to this incident.

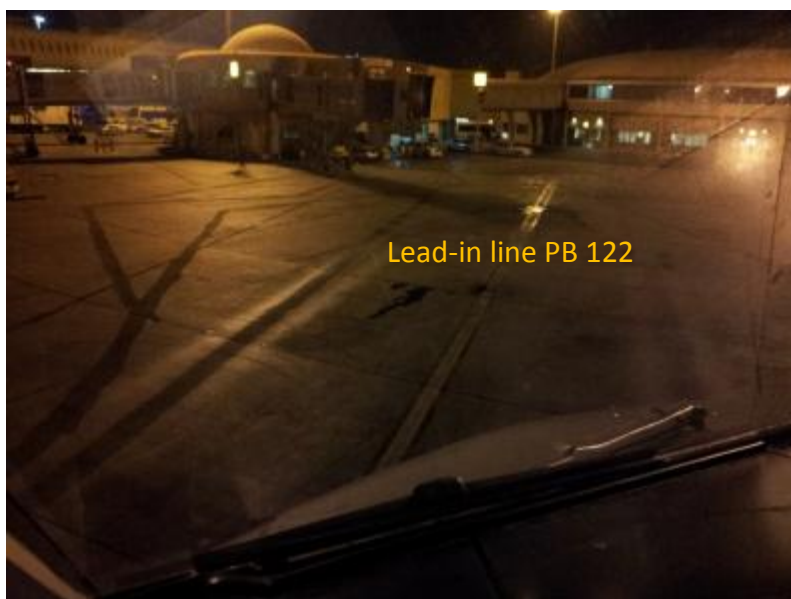
Photo 3 Cockpit View After Wingtip Contact looking forward

Wing walkers are not used for the pushback from this parking stand. The minimum 7 meter wingtip to wingtip clearance distance is achieved if the pushback is performed on the correct radial from the pushback stand. Actual, nominal separation distance is 13.4 meters [dry wing] based on a Path planner analysis
