Factual Report

Identification

Type of Occurrence:	Serious incident
Date:	11 August 2015
Location:	Frankfurt/Main
Aircraft:	Airplane
Manufacturer / Model:	The Boeing Company / B 747-8
Injuries to Persons:	Some persons suffered minor injuries
Damage:	Aircraft undamaged
Other Damage:	Two vehicles (passenger buses) damaged
Information Source:	Investigation by BFU
State File Number:	BFU 15-1075-5X

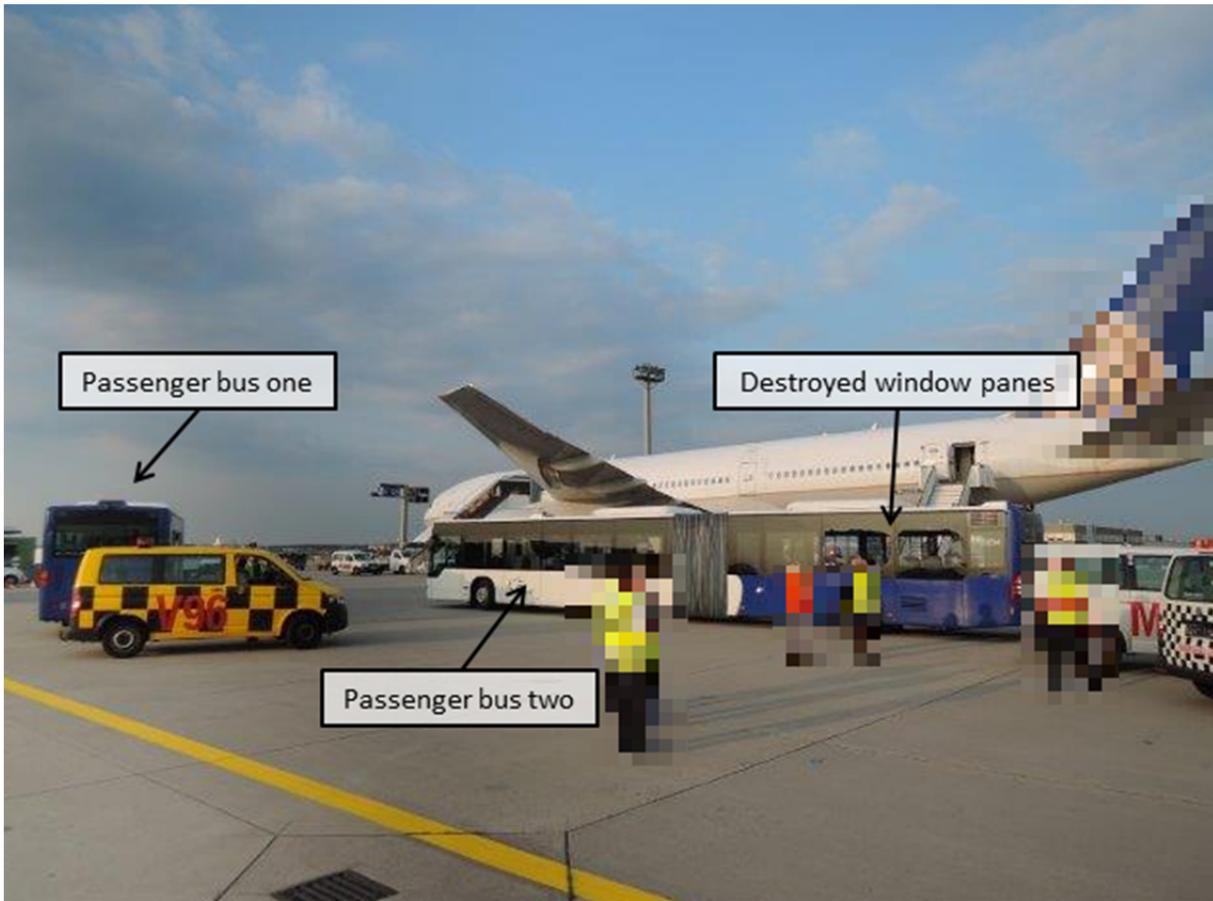
View on parking position V129 in westerly direction

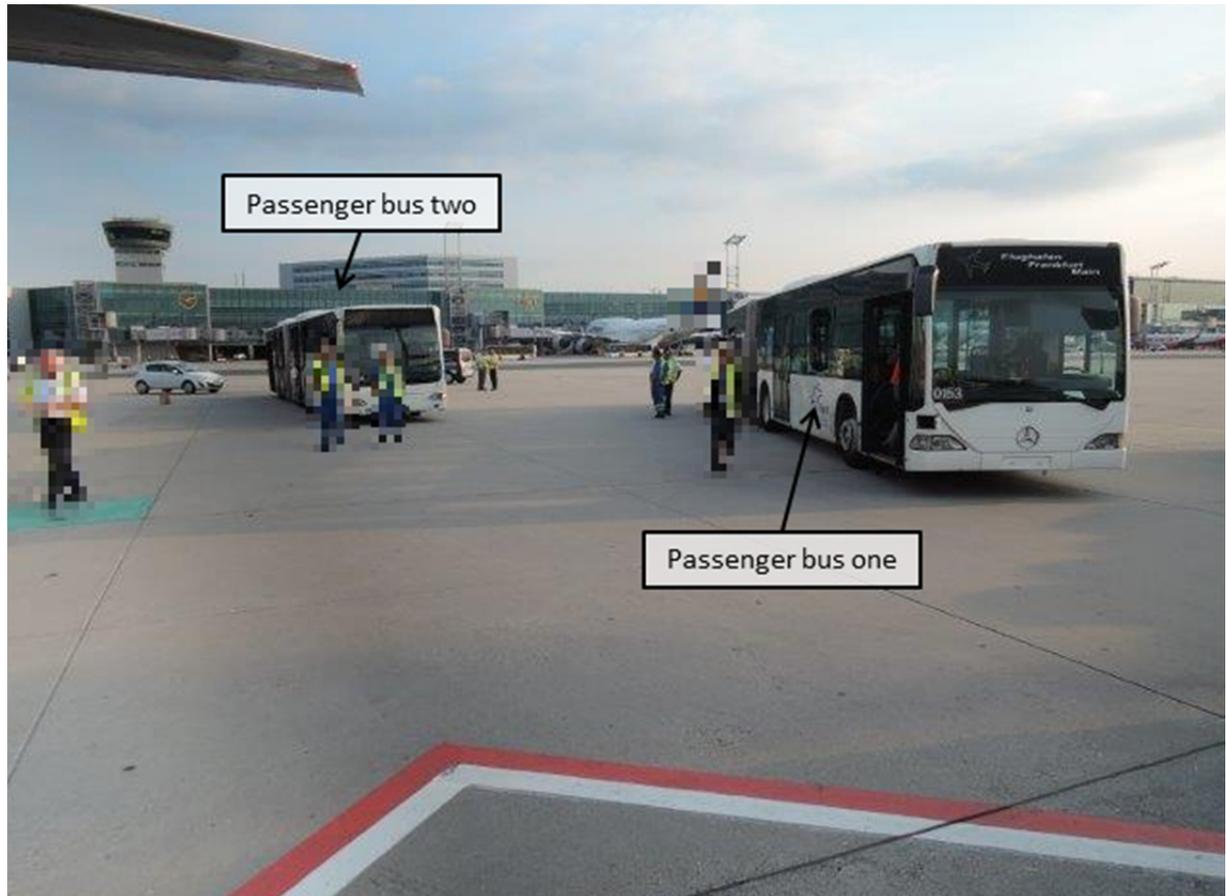
On the right side of the first vehicle one window between the front and centre access door had been destroyed. The aft left engine cover of the vehicle had been torn from its mounting and deformed. Two windows at the aft left side, abeam of the rear axle, of the second bus, which was positioned at parking position V129, had been destroyed. The fracture pieces burst through the open rear door (right) of the vehicle on to the apron. Witnesses stated that the pieces had scattered across parking position V129.

Damaged passenger busses on V129

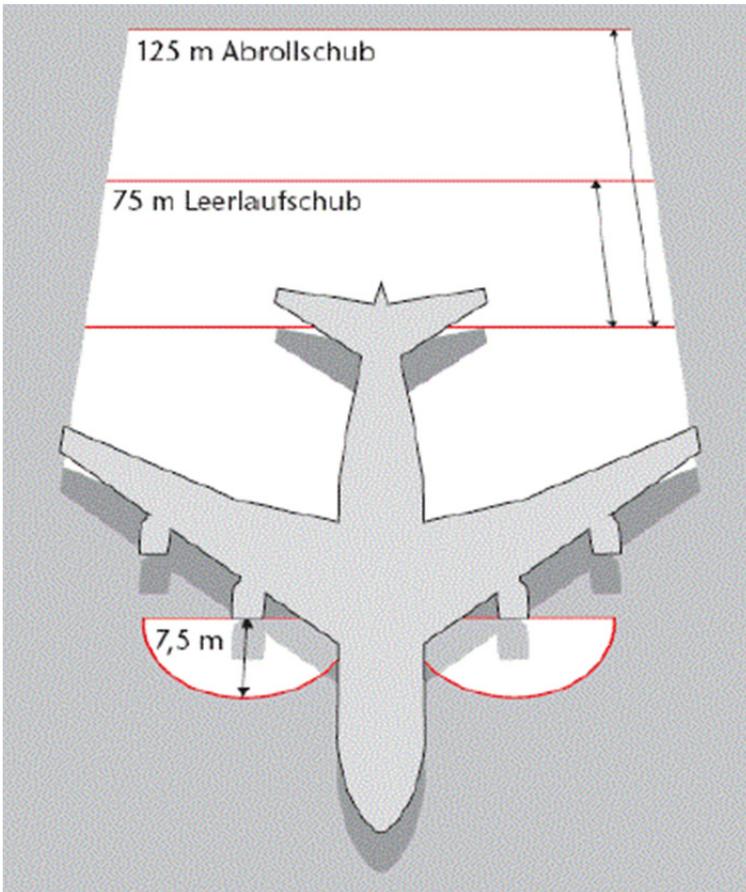
The traffic and registration regulations 1.3 (7) of Frankfurt/Main Airport stipulated the following: *“Behind aircraft taxiing autonomously (rolling thrust) by means of turboprop engines a safety distance of 50 m, and with jet engines of 125 m has to be adhered to. The operator describes in the Operations Manual Part-B (OM-B) 2-3-10 Taxi the use of thrust during taxiing: “[...] Idle thrust is adequate for taxiing under most conditions. A slightly higher thrust setting is required to begin taxiing. [...]. Breakaway power should be limited to 40% N1!” OM-B 2-1-70 states: “One or two engine(s) should be shutdown for environmental reasons and fuel saving, taking into account*

Safety distance behind taxiing aircraft

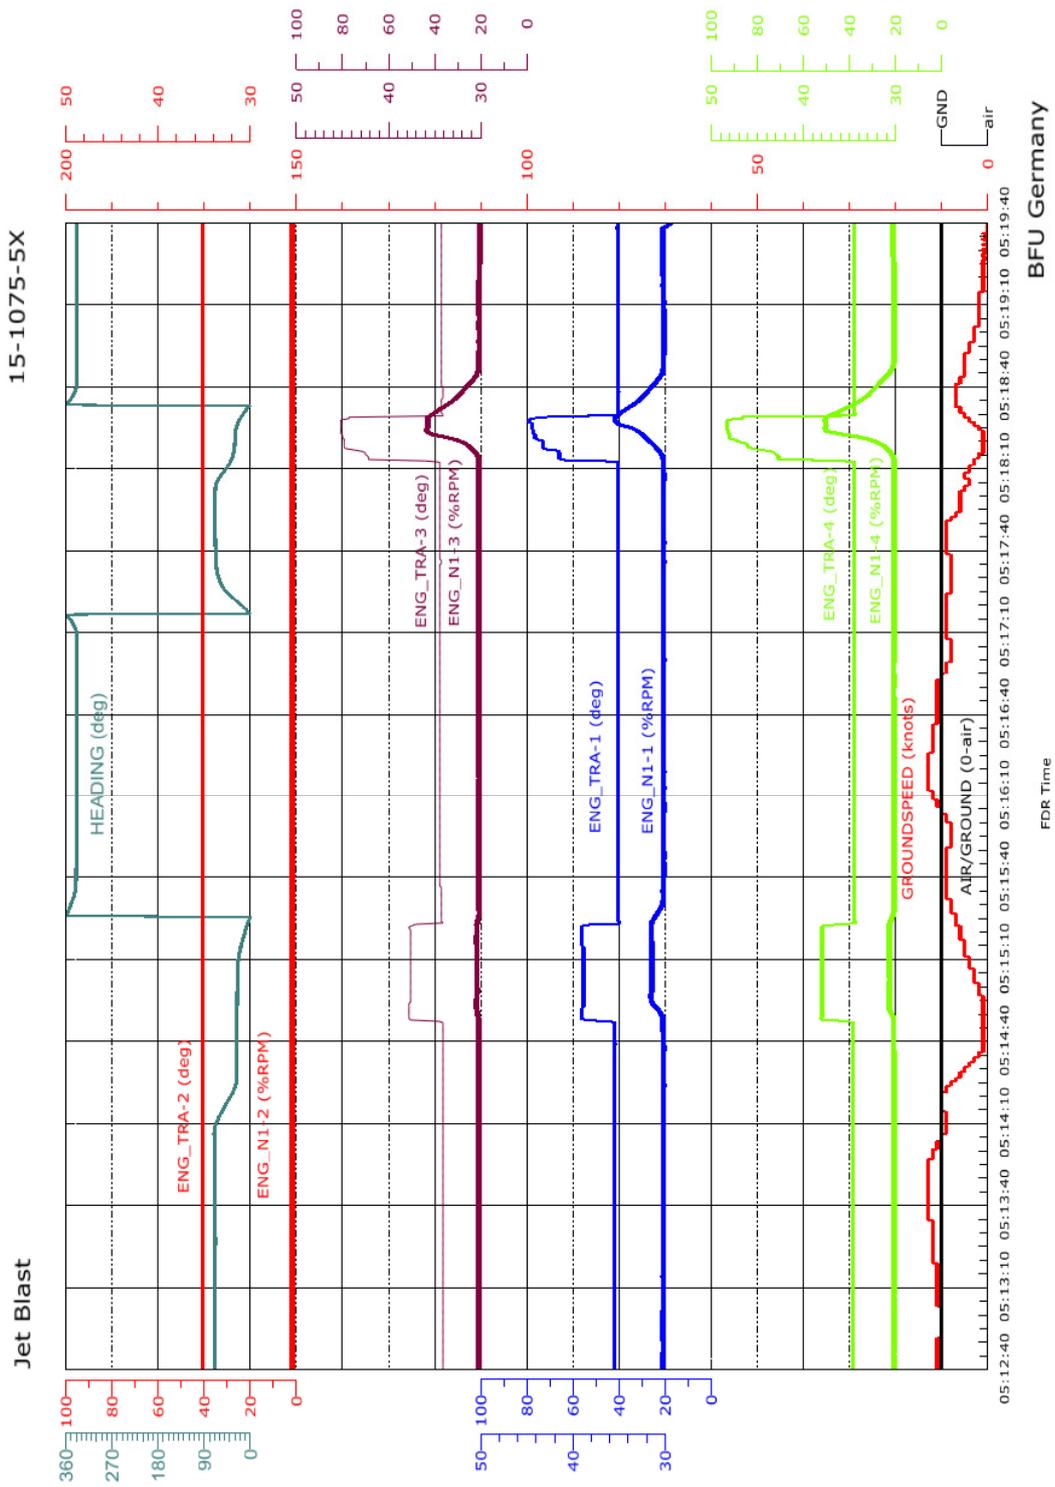
FDR data graph

The Flight Data Recorder (FDR) recording showed that the heading of the aircraft changed approximately 10 minutes and 58 seconds after the landing over a time of 35 seconds from 070° to 330°. During this time period the recorded groundspeed decreased from 5 kt to 1 kt and increased again to 7 kt. At the same time the FDR recorded an increase of engine rpm N1 of engine #4 (right outer engine) to 50%. Engine rpm of the engines #1 and #3 were recorded with 40% N1 and 43% N1, respectively. Engine rpm of engine #2 was 0% N1.
