ACCIDENT

Aircraft Type and Registration:	1) Boeing 737-8AS, EI-ENL 2) Boeing 737-8AS, EI-DLJ
No & Type of Engines:	1) 2 CFM56-7B turbofan engines 2) 2 CFM56-7B26 turbofan engines
Year of Manufacture:	1) 2011 (Serial no: 35037) 2) 2005 (Serial no: 34177)
Date & Time (UTC):	28 June 2014 at 0546 hrs
Location:	London Stansted Airport
Type of Flight:	1) Commercial Air Transport (Passenger) 2) Commercial Air Transport (Passenger)
Persons on Board:	1) Crew - 6 Passengers - 161 2) Crew - 6 Passengers - 178
Injuries:	1) Crew - None Passengers - None 2) Crew - None Passengers - None
Nature of Damage:	1) Right winglet detached 2) Right tailplane damaged and severe damage to APU installation
Commander's Licence:	1) Airline Transport Pilot's Licence 2) Airline Transport Pilot's Licence
Commander's Age:	1) 39 years 2) 49 years
Commander's Flying Experience:	1) 12,200 hours (of which 6,200 were on type) Last 90 days - 264 hours Last 28 days - 80 hours 2) 16,408 hours (of which 12,857 were on type) Last 90 days - 232 hours Last 28 days - 62 hours

Information Source:	AAIB Field Investigation

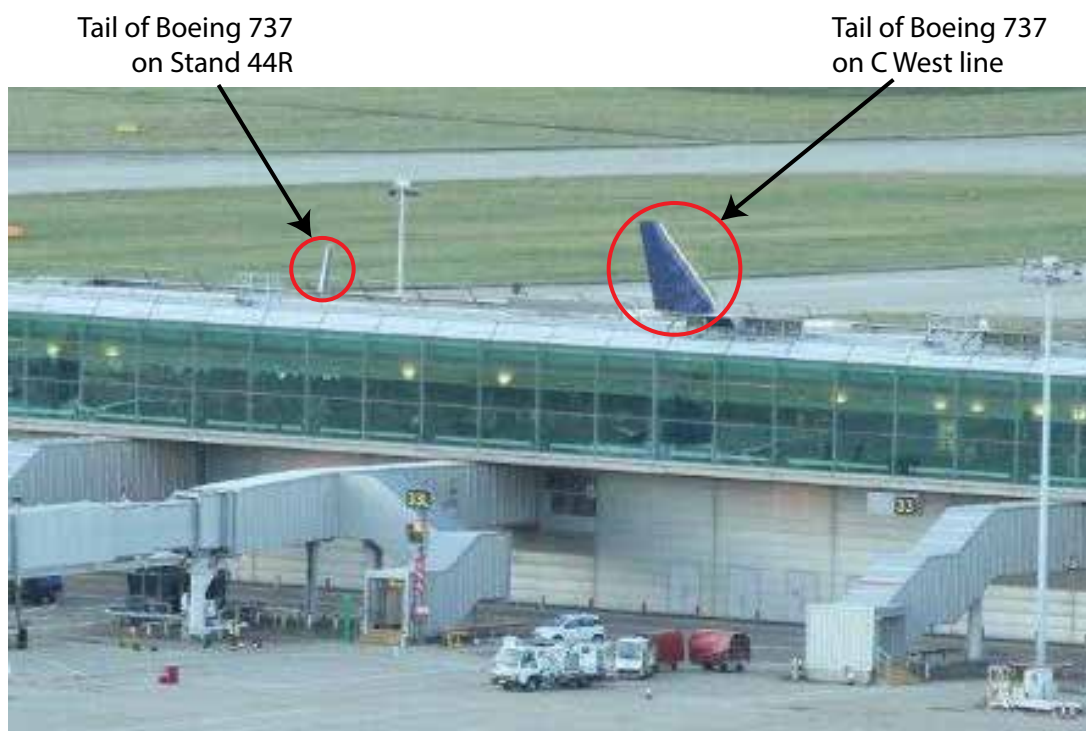
Figure 2

A pier obscured the controller's view of Stands 43 and 44 and only the fins of aircraft on the 'C West' line could be seen from the Visual Control Room (VCR) (Figure 2). The crew of EI-ENL saw a B737 on Stand 44R as they turned onto the 'C West' line but they did not appreciate that it was commencing pushback. After completing the turn, the co-pilot looked to his right and realised that the tail cone of the other B737, was now moving towards him. He told the commander to stop and the commander started to turn left, away from the conflict, and to apply the brakes. Three and a half seconds after the co-pilot started speaking, the winglet of EI-ENL impacted the leading edge of the right horizontal stabiliser on EI-DLJ. The winglet was forced under the tail cone of EI-DLJ where it penetrated the APU bay and fragmented. The pilots of EI-ENL felt the aircraft "touch" before they brought it to a halt a few metres further on.

A view from the VCR looking towards Stands 43 and 44 with a Boeing 737 parked on Stand 44R and another taxiing along the 'C West' line

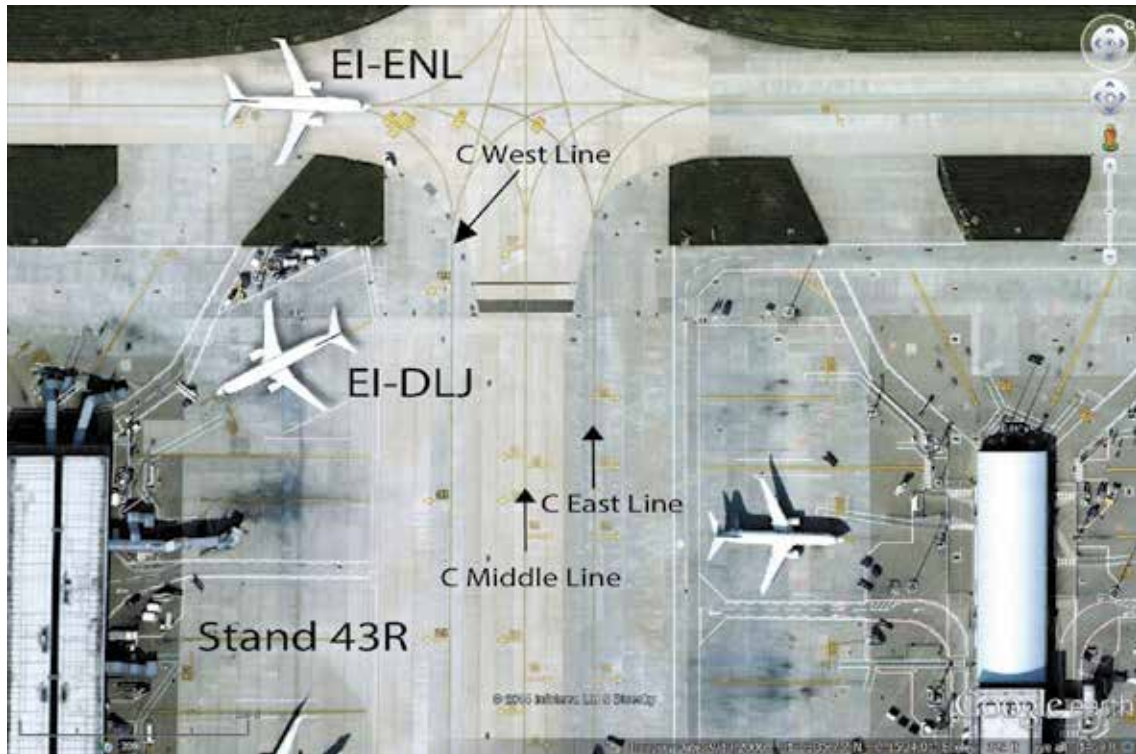
Relative position of EI-ENL when EI-DLJ push back commenced (composite image)

¹⁴ See Figure 3 to view the angular difference between the lead-in line for Stand 44R and the 'C West' line.

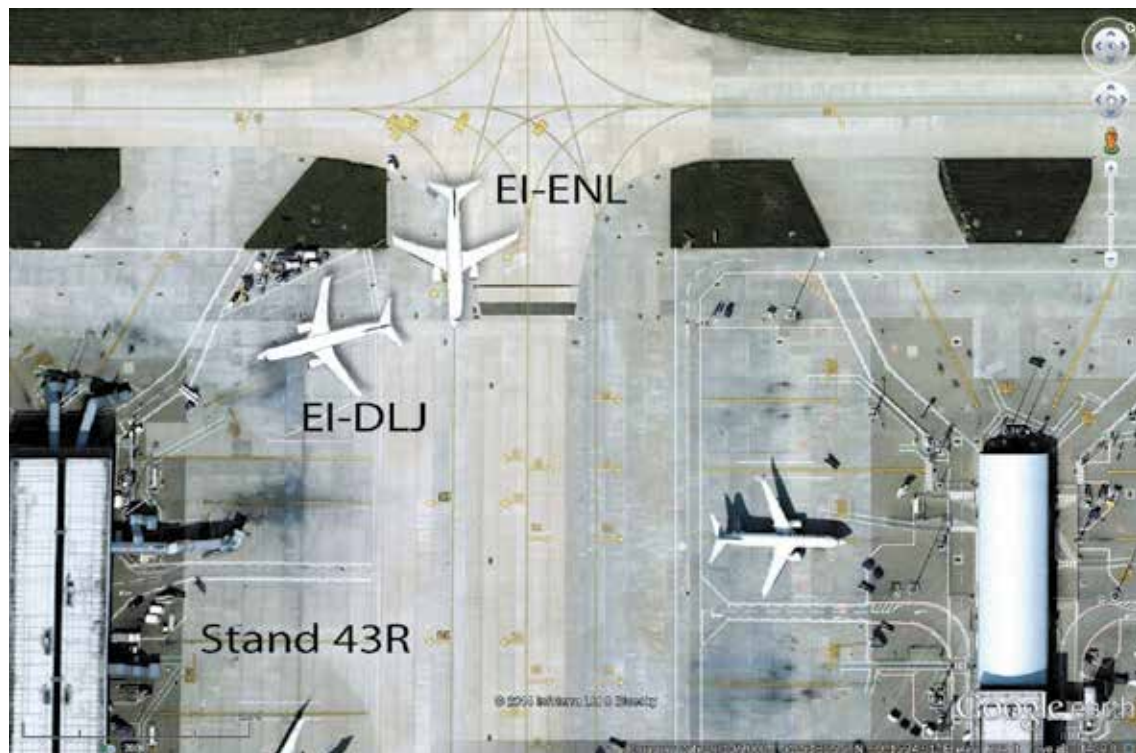
Figure 4

Position of EI-ENL when co-pilot observed EI-DLJ moving (composite image)

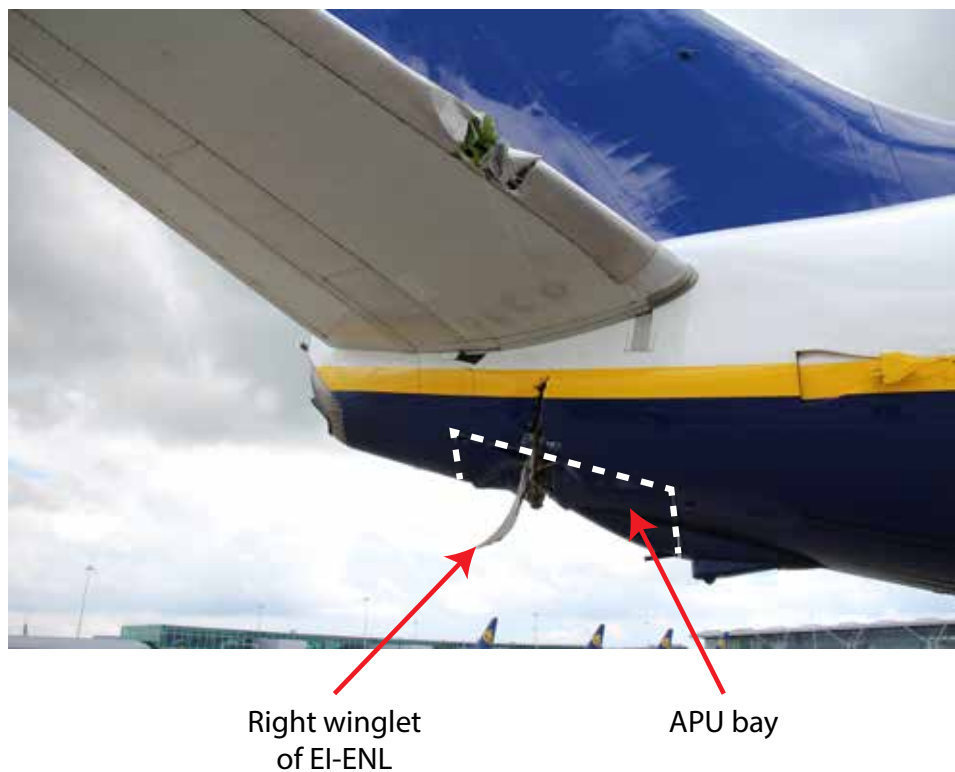
Figure 5

The right winglet of EI-ENL had struck the right tailplane of EI-DLJ before piercing its APU bay and severely damaging the APU. The winglet detached and remained embedded in the bay (Figure 5). The APU's automatic shutdown⁵ process operated and closed the fuel shut-off valve on the forward bulkhead of the APU bay, preventing a fuel leak which would have been substantial.

Right winglet of EI-ENL embedded in the APU bay of EI-DLJ

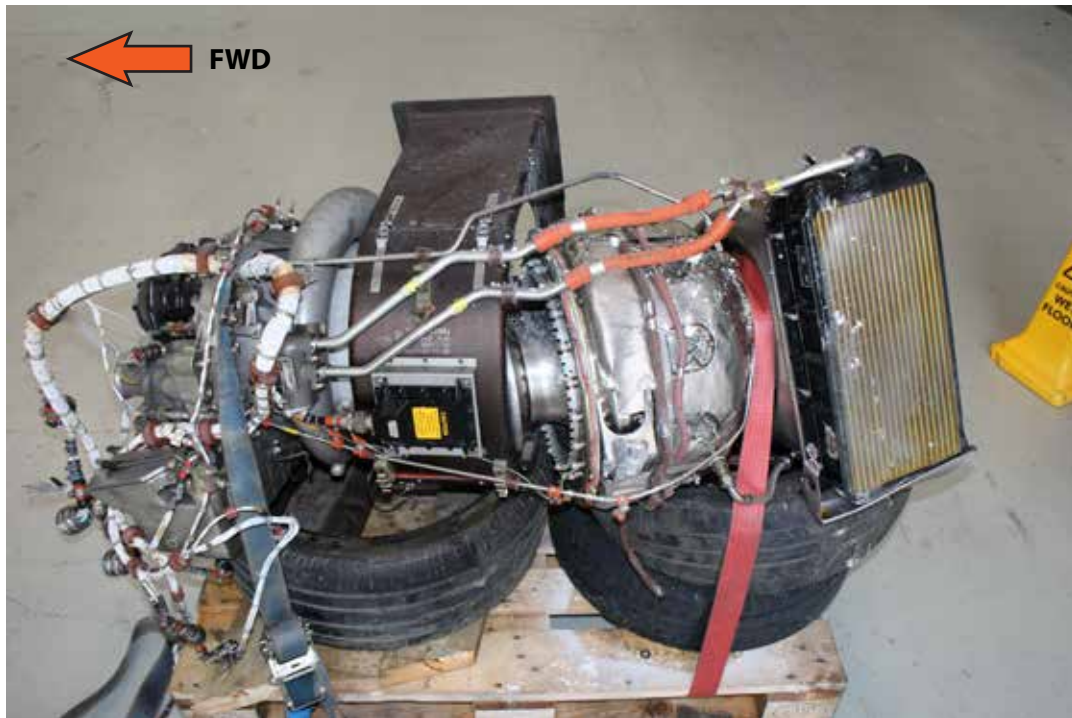
Figure 6

The APU was significantly damaged by the winglet (Figure 6). The impact severed main casings, fuel and oil pipes as well as causing damage to its mountings and bay. A small quantity of fuel and lubricating oil escaped, but there was no fire.

Underside of APU after removal, showing extent of the damage

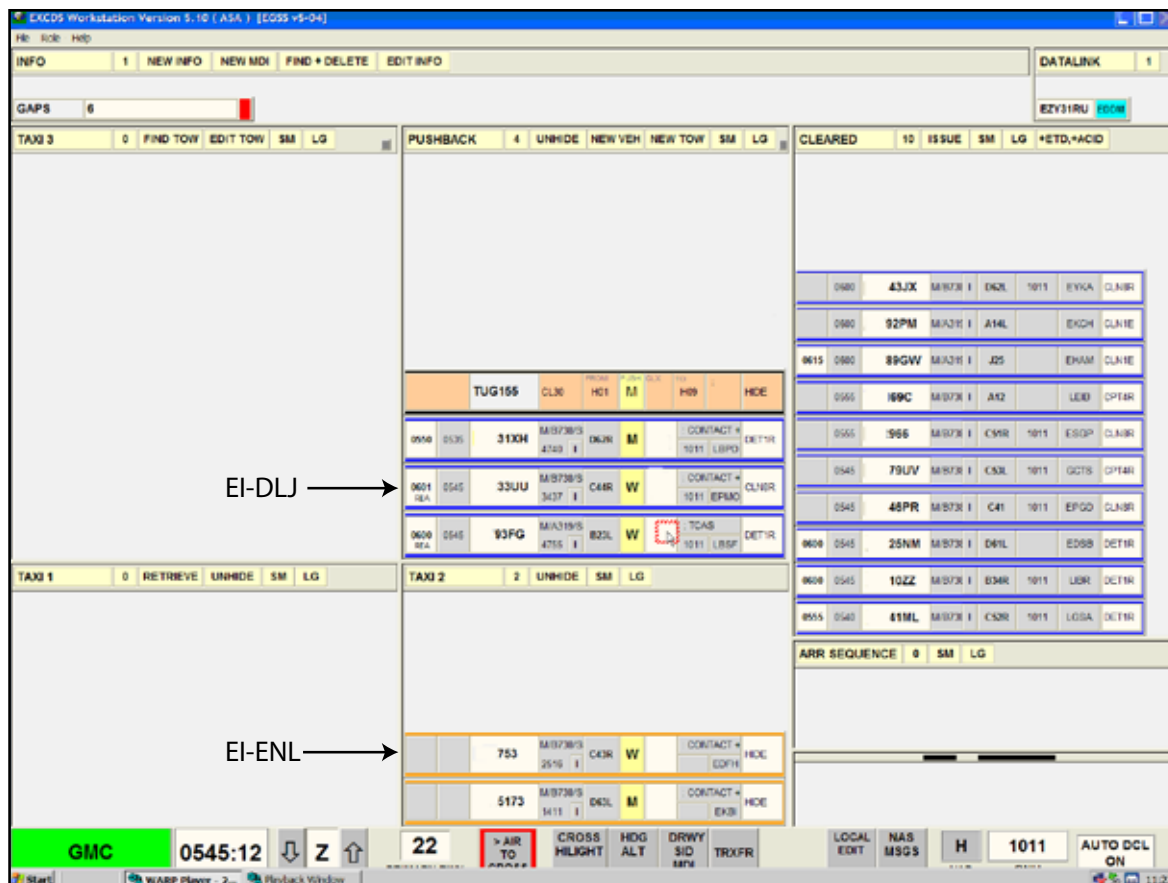
The left EFPS screen just before the collision (operators’ identifiers removed)

The controller's situational awareness relies on his integration of information gained by looking outside, by monitoring the A-SMGCS and by checking the EFPS. Figure 7 shows that as EI-ENL taxied in, its strip appeared along with that of one other aircraft in the 'Taxi 2'¹² bay of the left hand screen. The data on the strip included the radio callsign, the allocated stand (C43R) and a 'W' for the 'C West' line. Before EI-DLJ requested push and start, there were several progress strips in the 'Cleared' bay but only three other strips in the 'Pushback' bay. It was these three strips along with the two strips in the 'Taxi 2' bay that needed to be checked before EI-DLJ was given instructions. The right EFPS screen (not illustrated) showed the scheduled departures that had not yet been given a departure clearance. There was a steady stream of departure clearances to be given over the radio; the controller's workload was therefore almost continuous.

The report produced by NATS Stansted recommended that development of EFPS should be explored, to find out if it could highlight when more than one aircraft has been given an instruction to use the same cul-de-sac taxi line. This idea has since been incorporated into a nationwide project to evaluate surface management tools at UK airports. NATS is reviewing available technology, and methods for monitoring and checking the instructions given by Ground controllers, with the aim of quickly resolving any errors that are made. The project encompasses the control of aircraft pushbacks and the extra difficulties that exist when there is no headset communication between the flight crew and the ground team. Consideration is being given to the concept of having “Standard Pushback” procedures for each stand and to the idea of passing radio instructions for pushback directly to the tug driver. The project aims to identify an enhanced surface management tool which will provide conflict resolution and for this to be trialled at a major UK airport.
