EMERGENCY MANDATORY PERMIT DIRECTIVE

Number: 2022-004-E

Reality Escapades and Sherwood Scouts

ATA 25 – Cockpit Seats – Seat Locking and Secondary Seat Restraint – Inspection

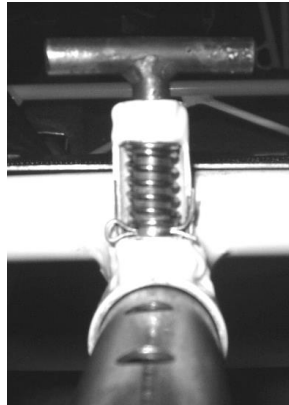
- 1) Before further flight from the effective date of this MPD, accomplish the following:
 - 1.1) Confirm both seats have full fore and aft travel. Ensure the tee-handle locking pin system is working correctly and fully engaging into the seat adjustment track beneath the seat (Figure 1).

Figure 1: Tee-handle seat locking pin (fully engaged) looking at the front of the seat looking aft.

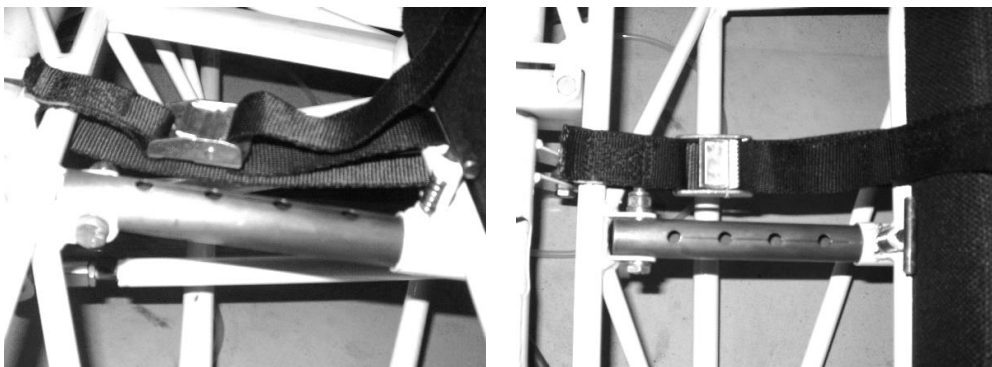
- 1.2) It is recommended that the horizontal bar of the tee-handle is painted RED for clarity.
 - 1.3) Ensure that the secondary restraint system cam lock strap is in good condition (clean, with no fraying on the webbing and no corrosion on the camlock), correctly positioned, correctly orientated and fully functioning (Figure 2).

Figure 2: Secondary seat restraint strap location and orientation

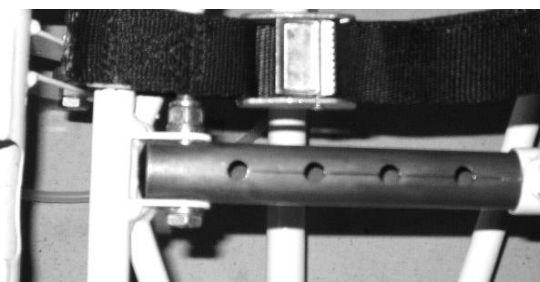
- 1.5) Inspect the seat adjustment track and note any witness marks that might indicate that the pin is not running central to the adjustment track (Figure 3).

Figure 3: Witness marks seen to run in central alignment with the seat adjustment holes is correct. Witness marks seen either side of the seat adjustment hole centre lines is not correct.

- 1.6) If upon inspection, a misalignment of the seat adjustment track to the locking pin is found or there is difficulty operating the seat locking mechanism, consultation must be sought from the LAA, BMAA or The Light Aircraft Company (as appropriate) before further flight.
