EMERGENCY MANDATORY PERMIT DIRECTIVE

Number: 2022-005-E

Hawker Hurricane and Sea Hurricane

ATA 32 – Undercarriage – Undercarriage Fork End Fittings – Inspection / Replacement

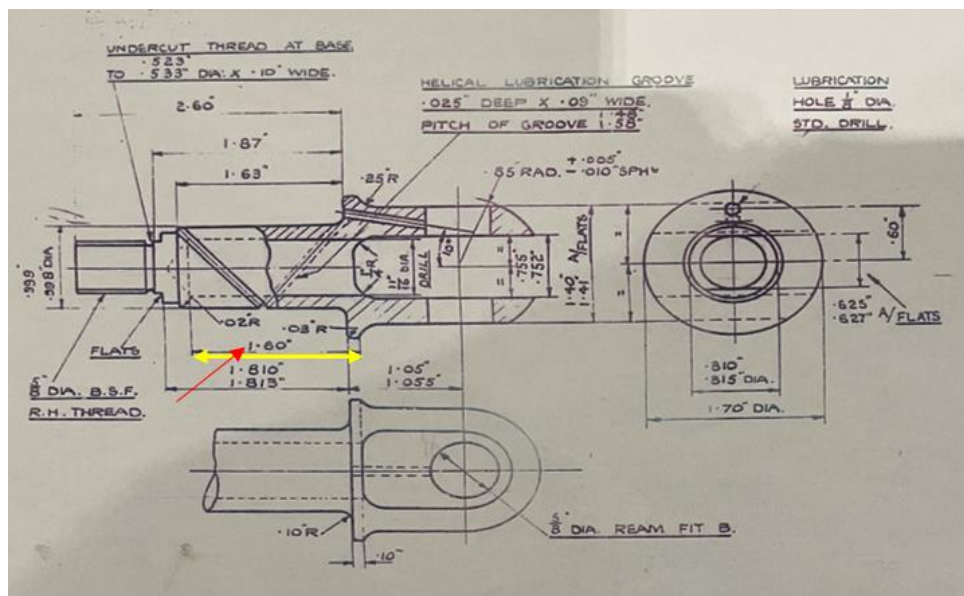
Figure 2: Part No: A73450

Further investigation has shown that during restoration of aircraft or wing assemblies, replacement fork end fittings (Part No: A73450) have been manufactured incorrectly and installed. Non-conforming parts have the counterbore drilled to 1.8 inches instead of the drawing dimension of 1.6 inches (Figure 2). As a result, the material thickness is reduced causing a reduction in strength. This could cause the MLG to collapse during ground manoeuvres or upon landing.
