Civil Aviation Authority  
**SAFETY NOTICE**  
Number: SN-2023/003

## Risk of Controlled Flight into Terrain during 3D BARO-VNAV and 2D Approaches (Altimeter Setting Procedures)

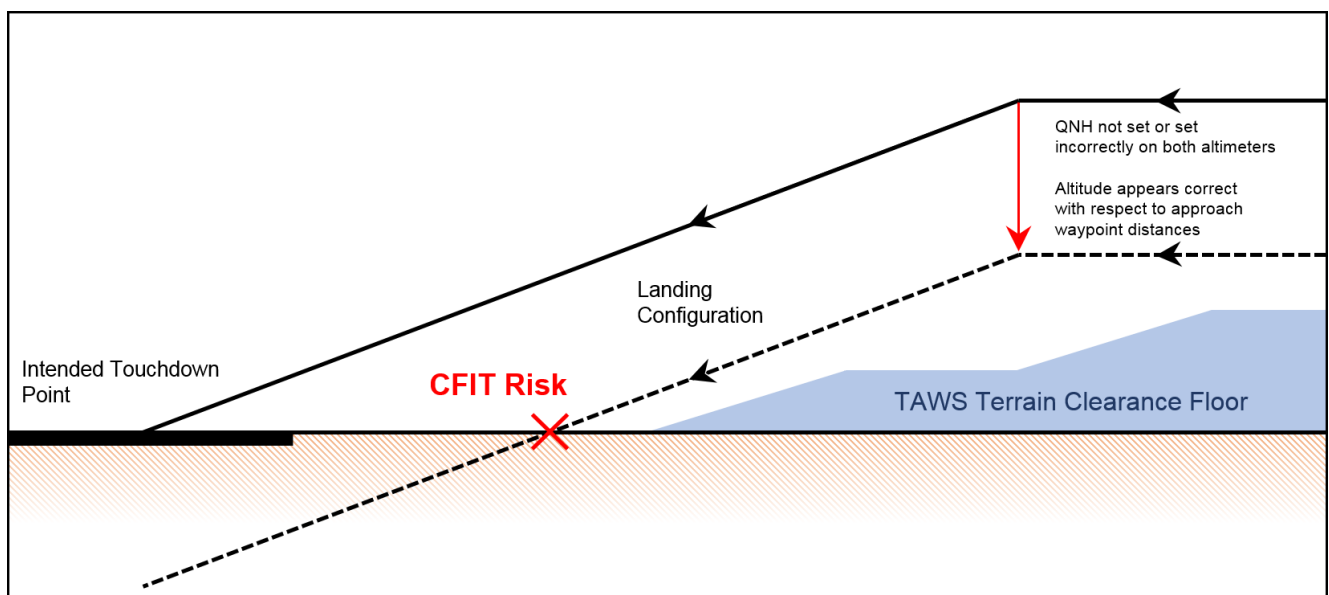
## 2 Diagram

- 1.6 Non-precision approach procedures (NPAs) and approach procedures with vertical guidance (APVs) rely heavily on the accuracy of altitude information provided by the pressure altimeters. If the appropriate pressure setting is set incorrectly on the altimeter sub-scale, the aircraft could be significantly above or below the safe vertical profile as determined by the procedure.
- 1.7 The risk of setting incorrect QNH may increase in a congested R/T environment, during times of high cockpit workload, or when transitioning to an approach via a Standard Terminal Arrival Route (STAR).
- 1.8 It is emphasised that a Terrain Awareness Warning System (TAWS) may not provide a ground proximity alert close to an aerodrome when the aircraft is in the landing configuration.

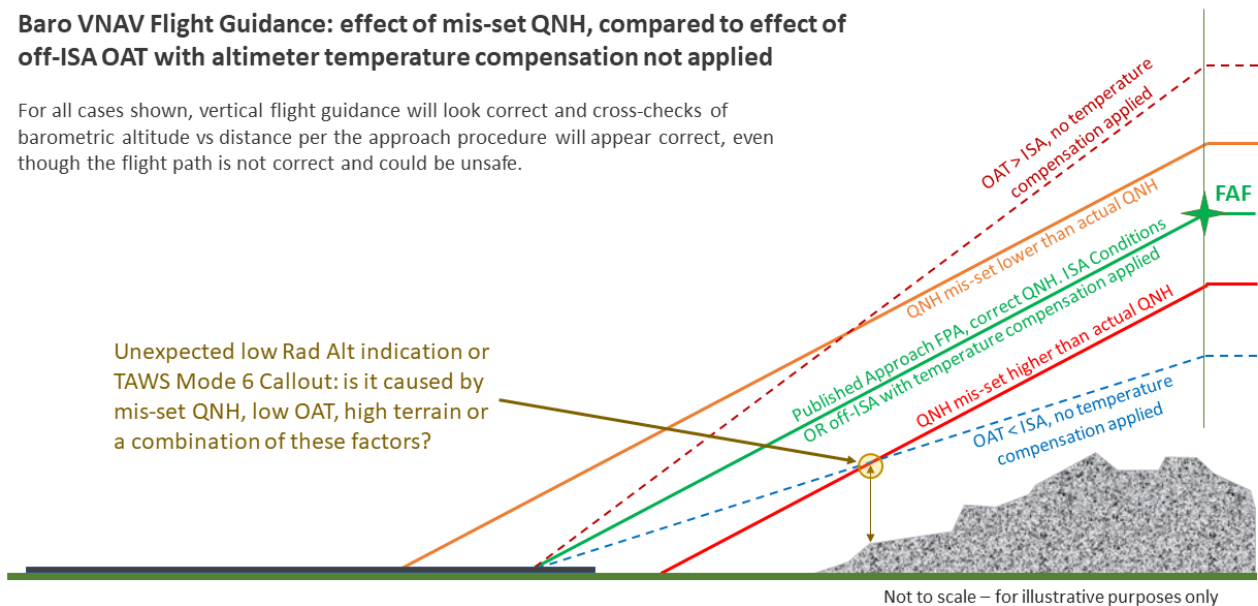
**Baro VNAV Flight Guidance: effect of mis-set QNH, compared to effect of off-ISA OAT with altimeter temperature compensation not applied**

- 3.7 Operations at temperatures differing from ISA will cause Barometric Temperature Error. Even a small difference from ISA temperatures can cause the approach flightpath to be steeper or shallower than published. Whilst this is allowed for in instrument procedure design within charted limits, it changes the relationship between indicated Barometric Altitude and Radio Altitude (RA) during the approach. This might make it more difficult to detect a mis-set QNH or could give the appearance of a mis-set QNH when in fact the flightpath error is caused by non-ISA temperatures. The diagram below refers. For further information see [here](#).

For all cases shown, vertical flight guidance will look correct and cross-checks of barometric altitude vs distance per the approach procedure will appear correct, even though the flight path is not correct and could be unsafe.
