Appendix 14.10 Conservation Management Plan

Shetland Space Centre Conservation Management Plan

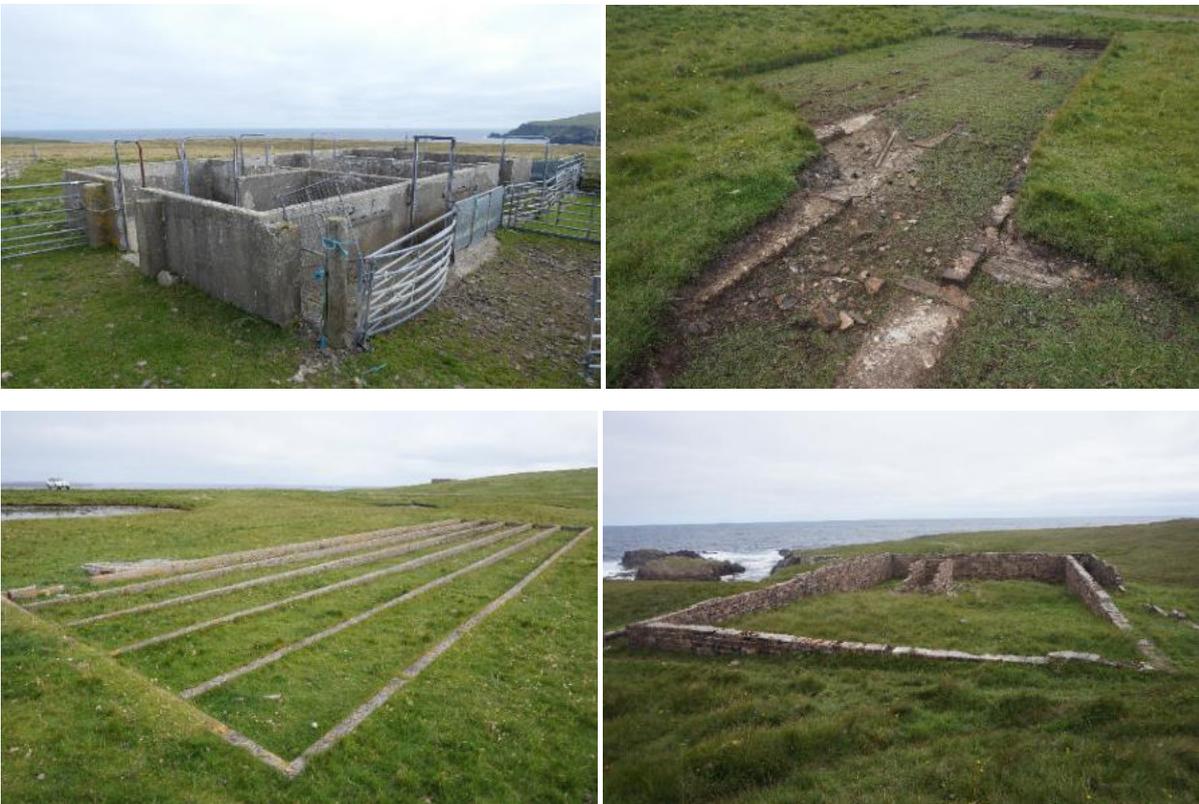
Figs. 7 to 10: Most ancillary structures comprise lowered brick walls, sleeper walls and concrete foundations.

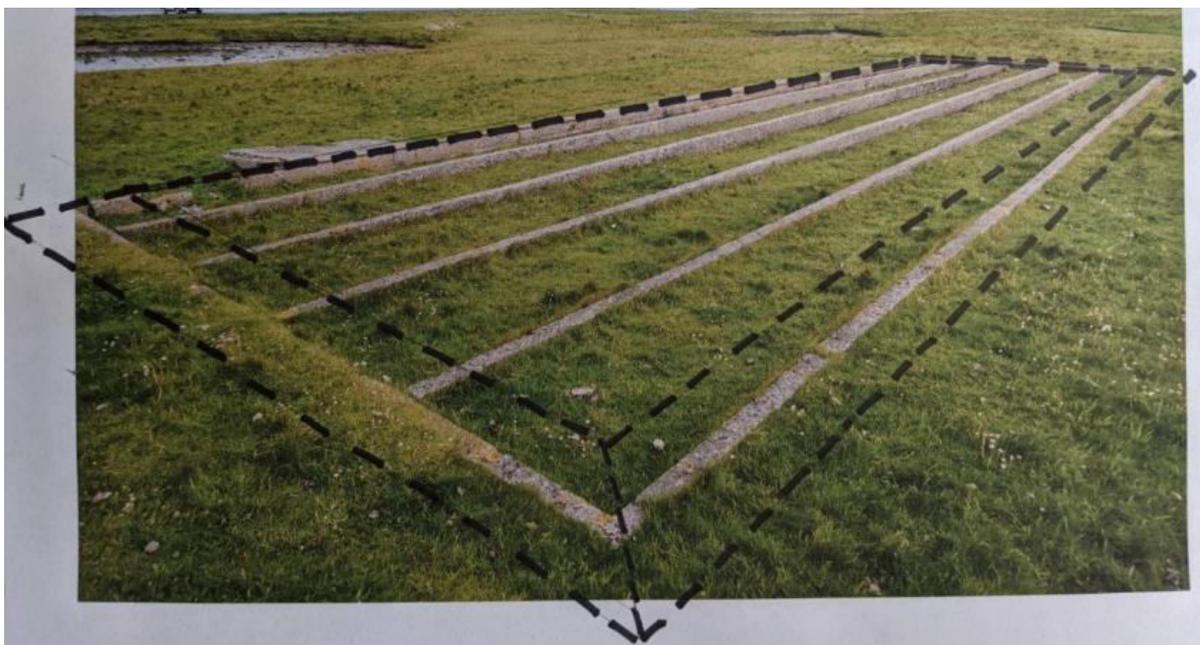
Fig. 11: Consider burying vulnerable foundations and footings. This would require accurate recording beforehand, which would allow future understanding of the site and could be used as a basis for interpretation. Final details require further discussions, however, the structure could be separated using geotextile membrane and gravel, before covering with sloping soil and grass which would allow the feature to be clearly visible.

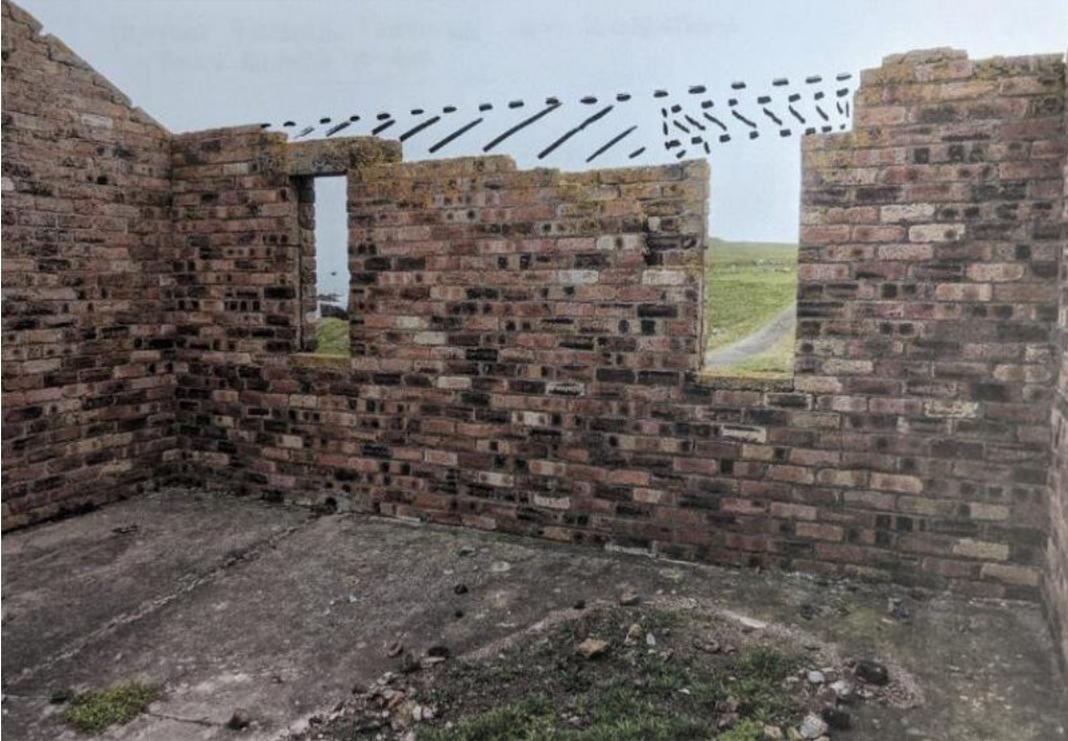
Fig. 12: To minimise water ingress into the cavity wall of the Guard Hut, and the displaced lintel and brickwork could be reinstated to wallhead level to allow capping like that originally placed over the gable wallheads. This work would reduce the rate at which the cavity wall ties will deteriorate.

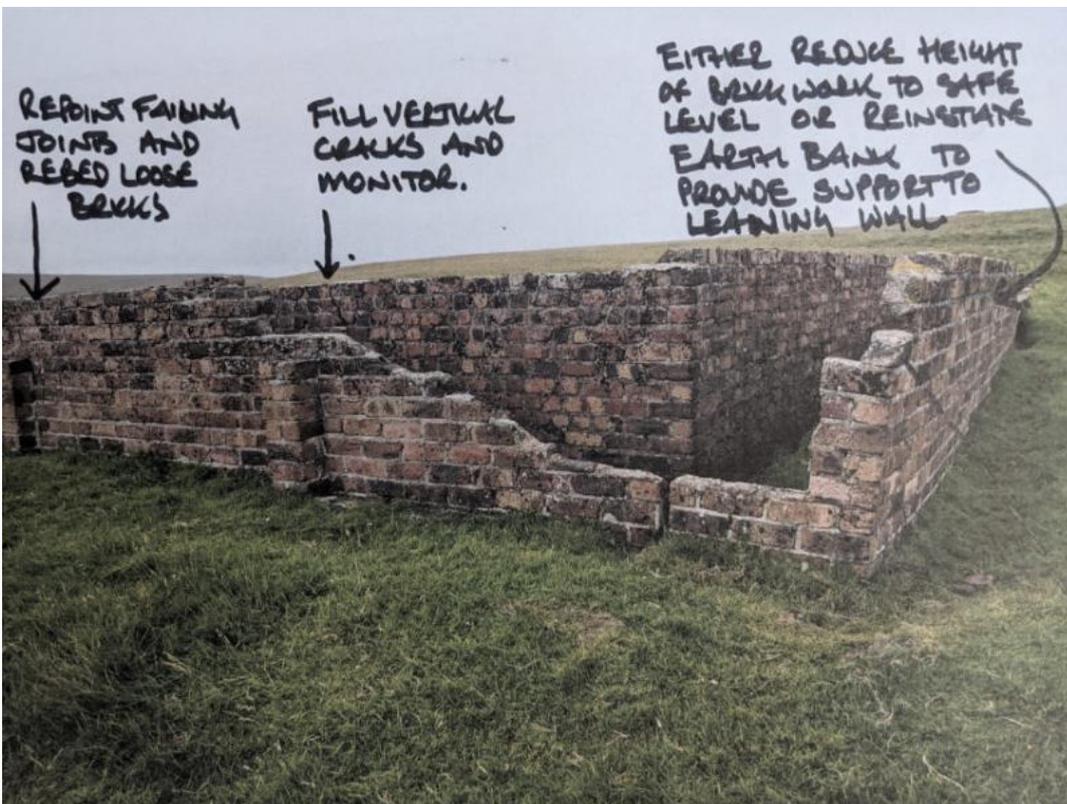
Fig. 13: Proposed repair options for the brick footings of site ref: 90.

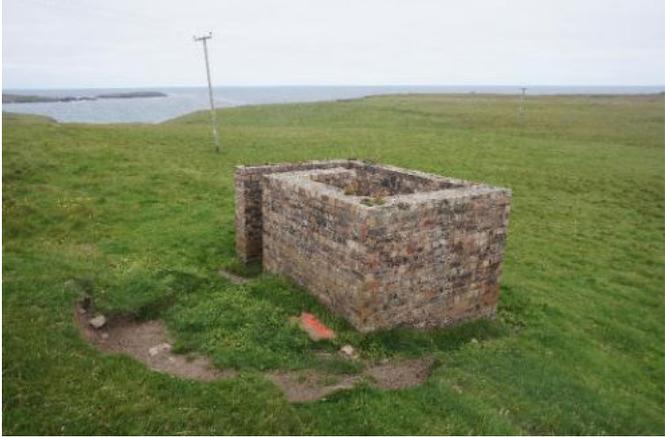
Condition:			
<p>Fair: Minor localised open, cracked and failing mortar joints, including to exposed wallhead which is supporting vegetation growth. Minor localised damaged bricks. Structure is not plumb or level indicating subsidence but appears stable as no structural cracking visible.</p>			
Recommendations:			Priority:
1.	Repoint open and defective joints, especially skyward facing joints. £200.00		Desirable

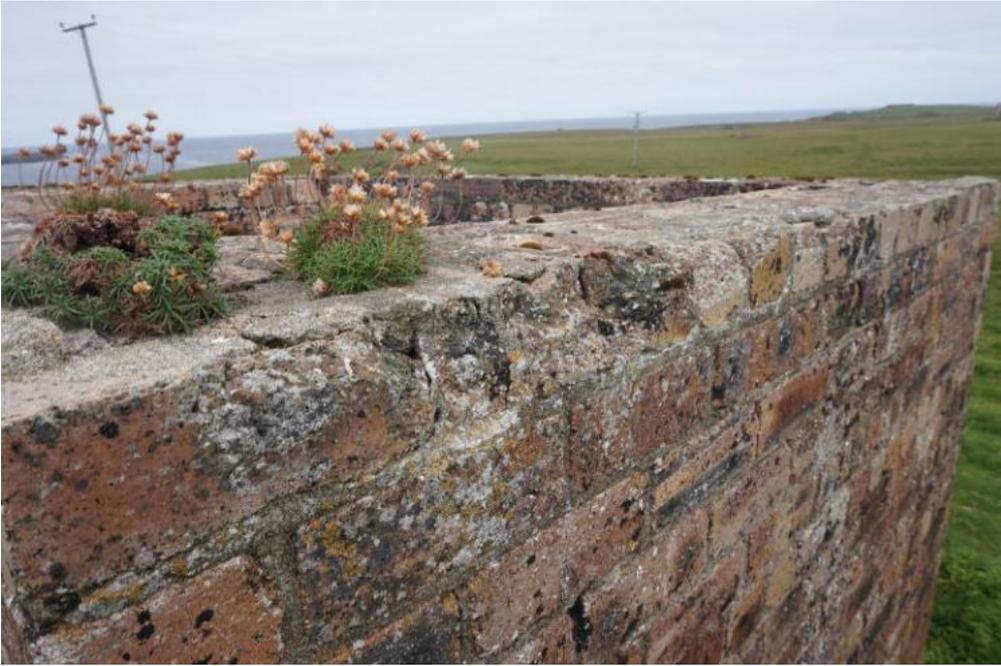
Localised damaged brickwork and defective joints. Vegetation growth at wallhead.

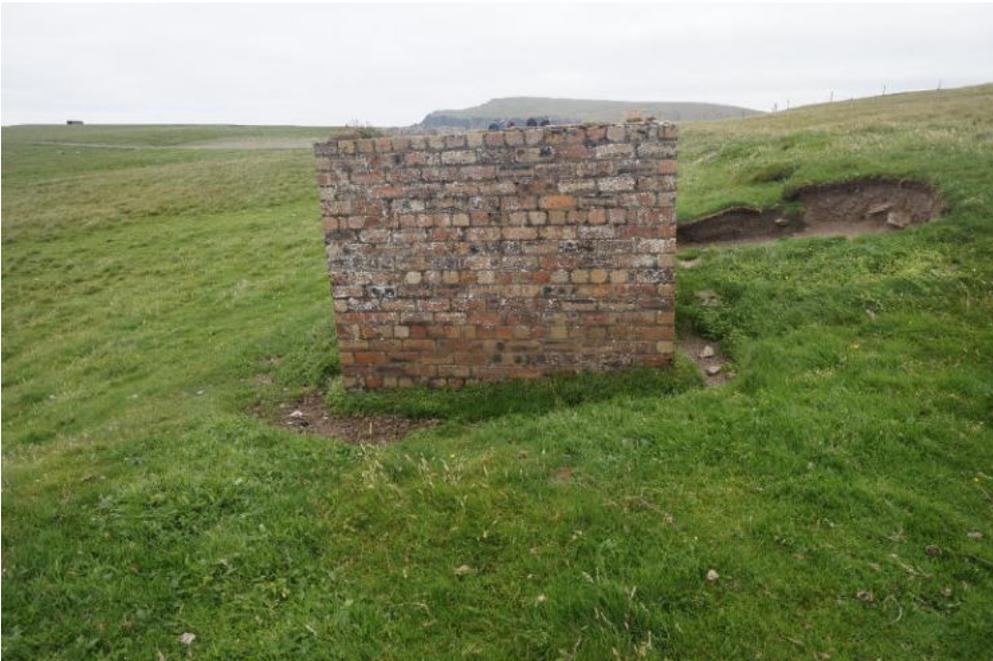
No structural cracking was observed despite the walls not being plumb or level.

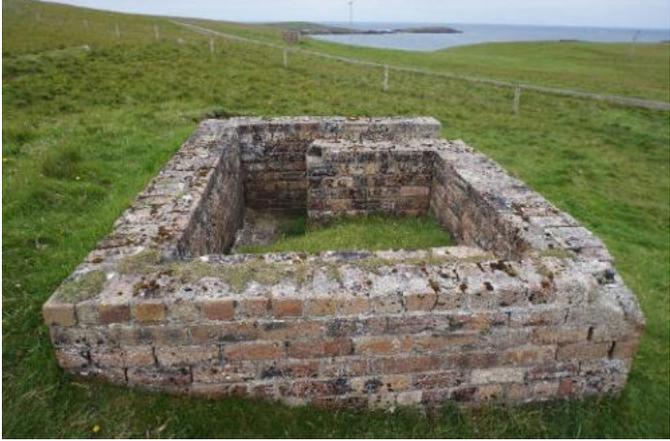
Condition:			
Fair: Localised open, cracked and failing mortar joints throughout, including to exposed wallhead which is supporting vegetation growth. Damaged and missing brickwork to wallhead.			
Recommendations:			Priority:
1.	Repoint open and defective joints, especially skyward facing joints. Consolidate around damaged brickwork in southeast corner to minimise risk of further loss in this area. £400.00		Desirable

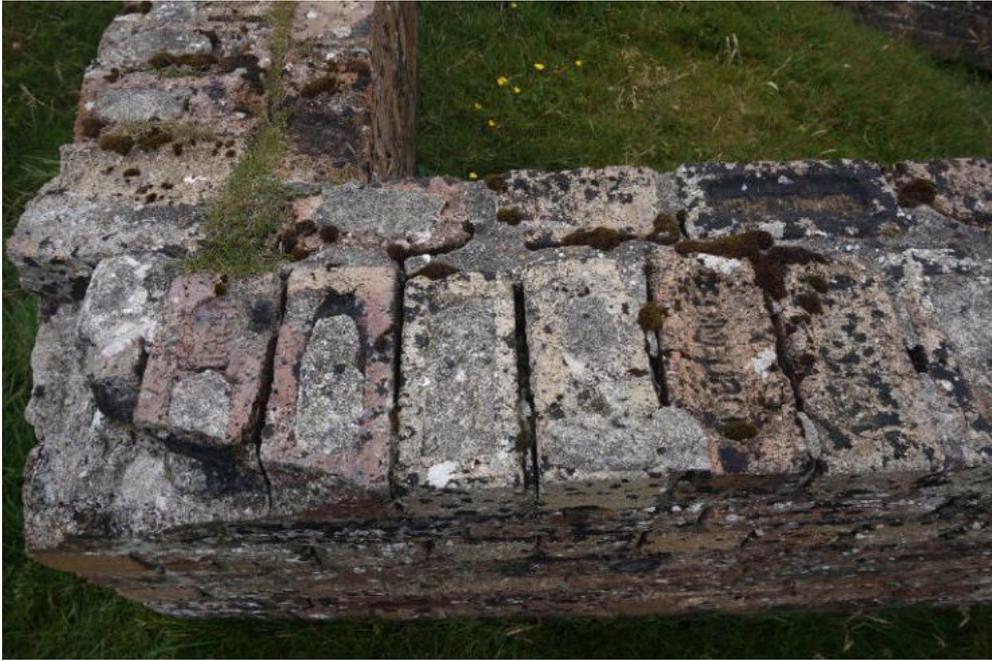
Open and defective wallhead joints and damaged brickwork in southeast corner.

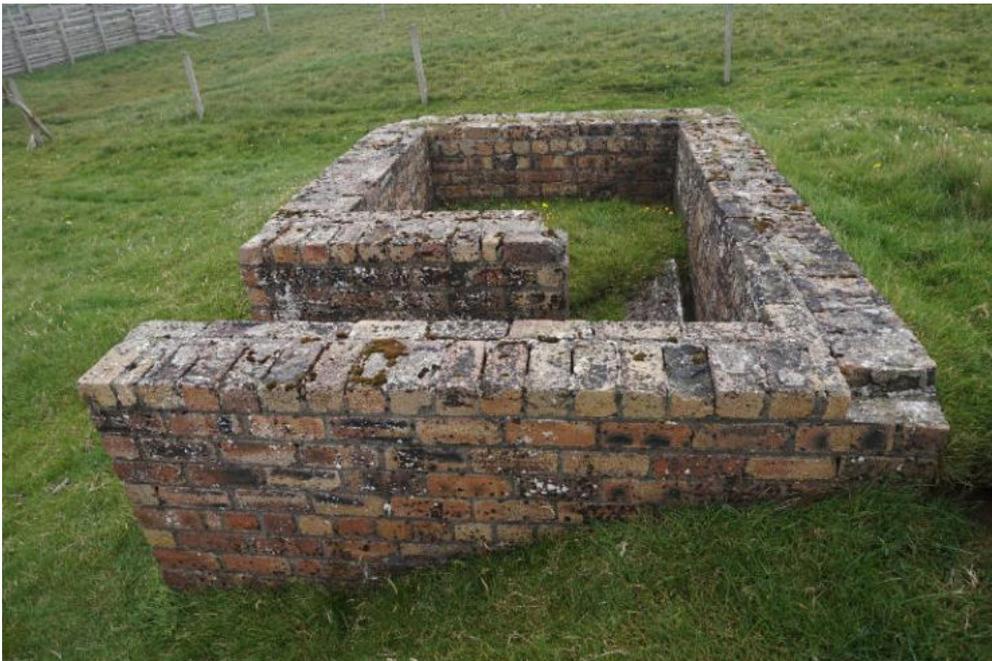
North Elevation: Missing and damaged brickwork and defective mortar joints.

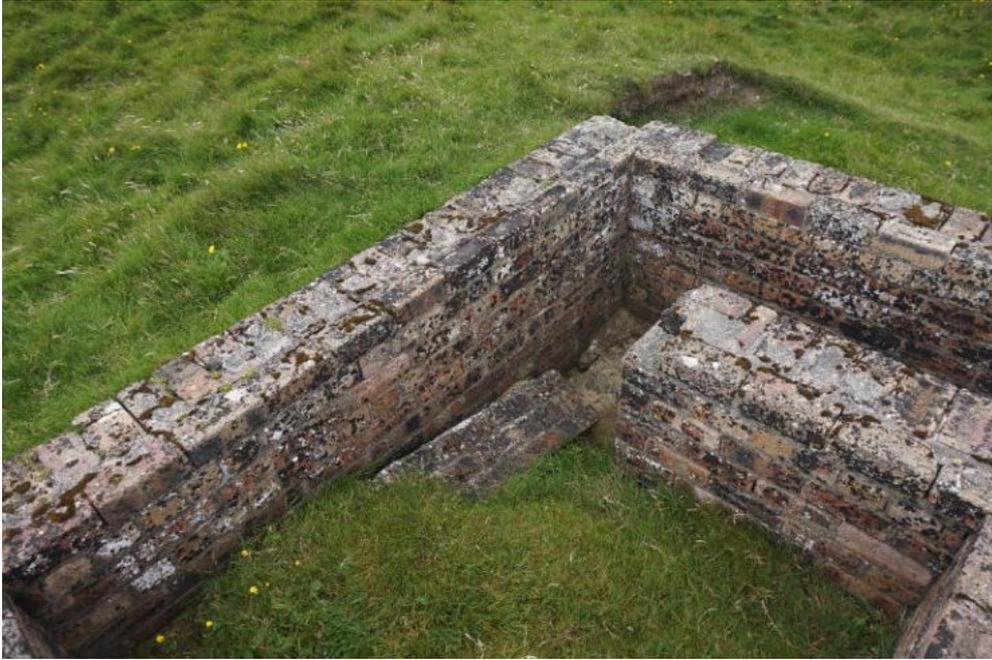
Significant soil and grass accumulations internally and displaced brickwork and concrete.

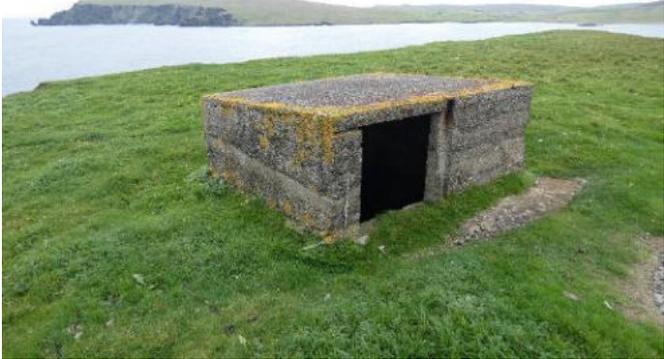
Condition:			
<p>Fair: Constructed with poorly mixed and compacted concrete with cracking visible at lift lines approx. mid point of external walls and at roof junction. Structurally stable. Localised disaggregation and surface loss externally. Poor coverage to reinforcement causing localised spalling and rusting staining to roof structure. Leaching saturation and damp staining internally, exacerbated by the flooded floor. Lichen growth externally.</p>			
Recommendations:			Priority:

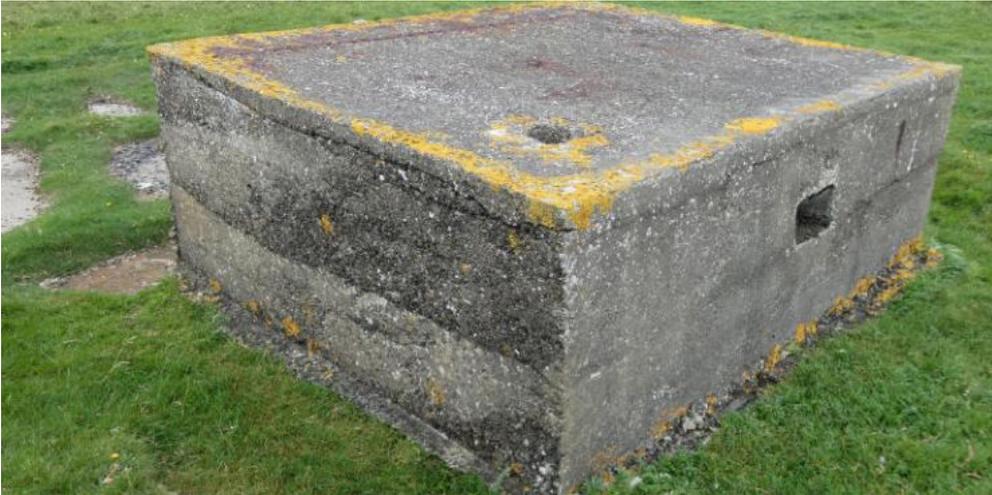
Cracking at lift lines on external walls and at the junction with the roof slab. Poorly mixed and compacted concrete with minor surface disaggregation, cracking and spalling. Lichen growth on all faces.

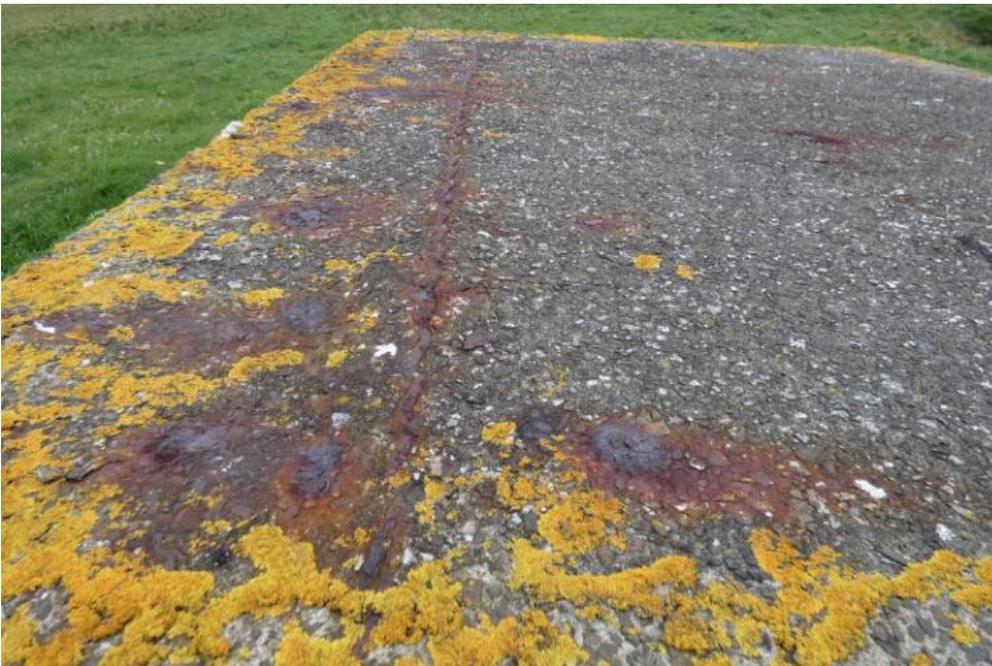
Poor coverage has exposed reinforcement externally on the roof slab.

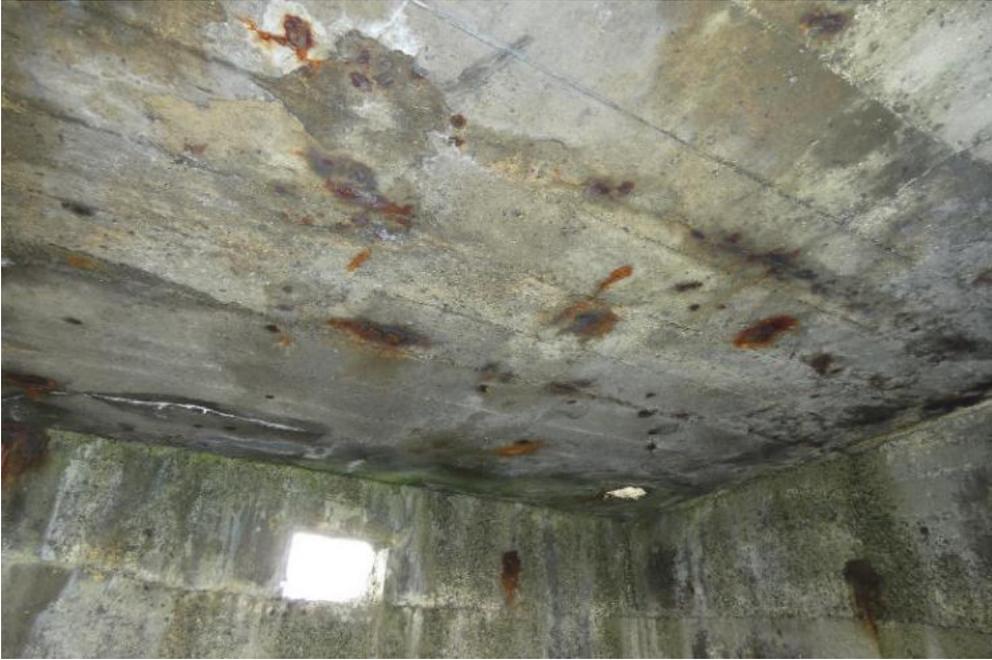
Hairline cracking, rust staining, leaching and discolouration to the soffit of the roof structure.

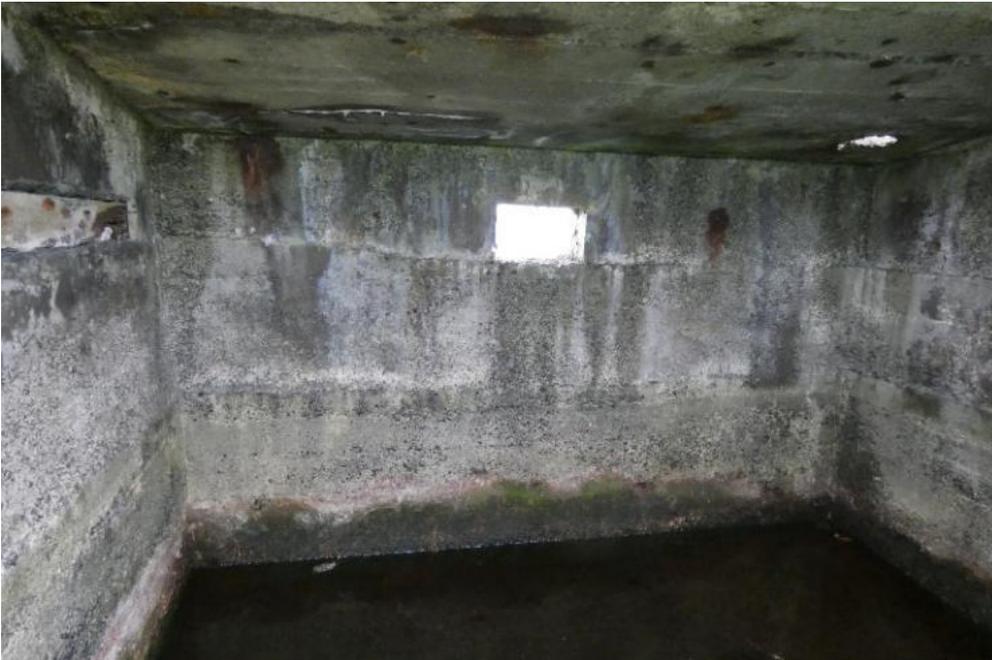
Hairline cracking, rust staining, leaching and discolouration to the walls exacerbated by flooding internally.

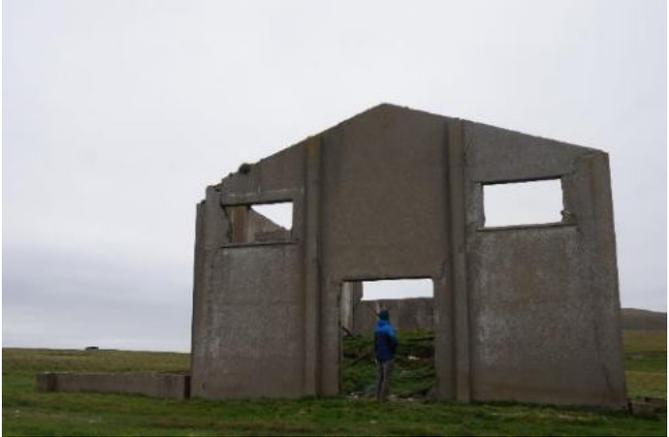
Site No.	77	Site Name:	Power House
Description:		General Photograph:	
<p>Cement rendered one-brick-thick brick-masonry walls with external and internal piers, the latter appear to have been built to support steelwork carrying an unknown intermediate structure, now removed or buried under collapse debris. The roof structure has collapsed but can be seen to have comprised steel Fink-type trusses spanning onto the external walls. Rendered lean-to extension to east elevation and three concrete bases with rendered brick perimeter footing to the south. Precast reinforced concrete window cills and lintels. North facing and lean-to windows have been infilled with concrete blocks. Evidence for steel framed windows in openings. Internal floor obscured by accumulations of soil, animal faeces, grass and the collapsed steel roof structure and asbestos cement roof finish.</p>

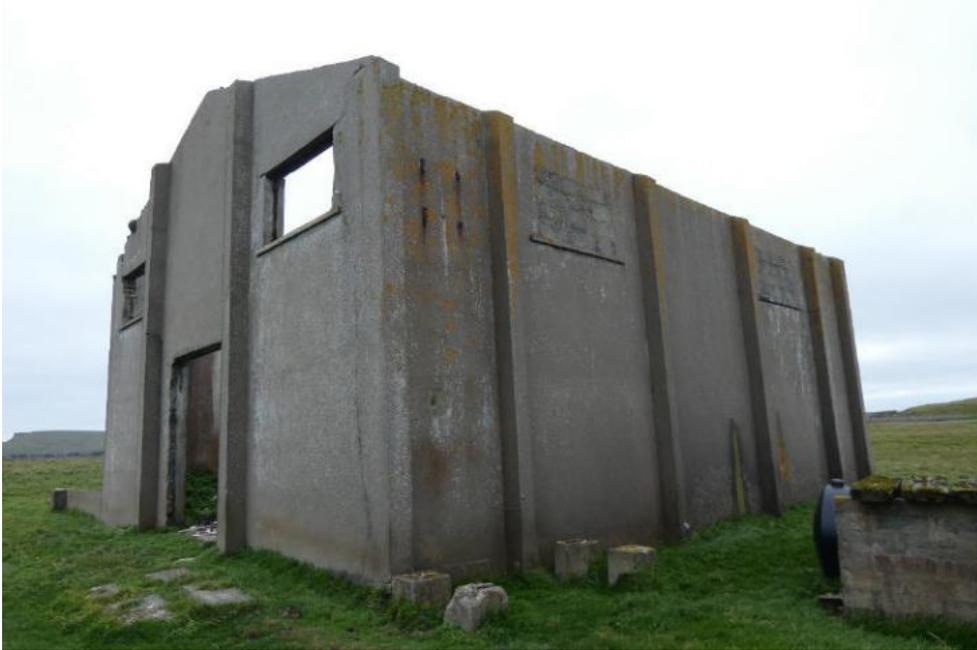
The northeast corner of the building. Note the vertical crack in the east elevation at the corner: there is no continuity between the west or south walls – they are free-standing elements.

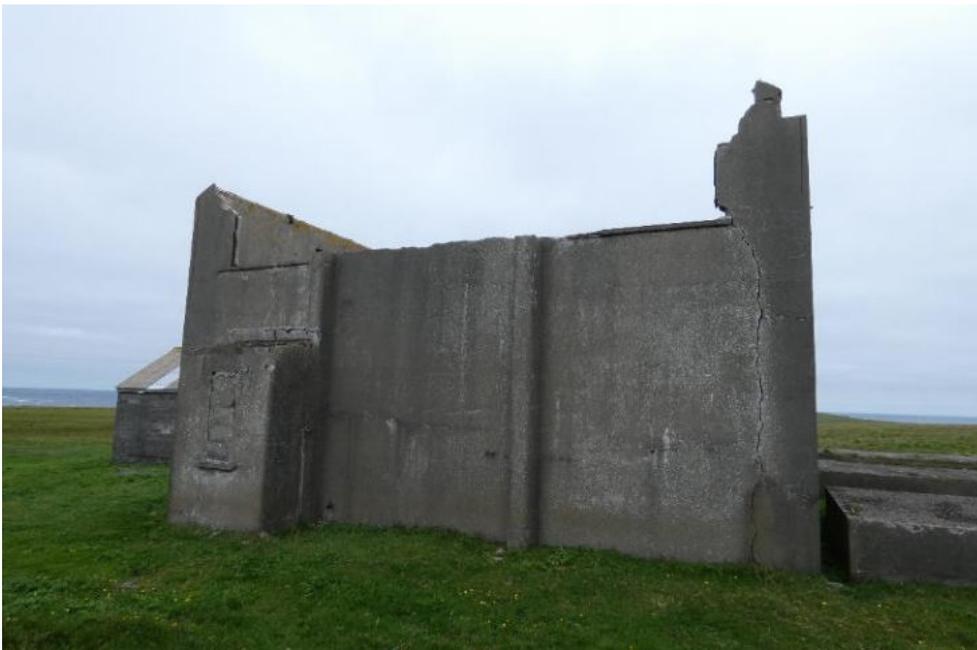
West elevation. The triangular gable has collapsed, falling inwards. Note the full-height crack to the south corner: there is no continuity between the west or south walls – they are free-standing elements.

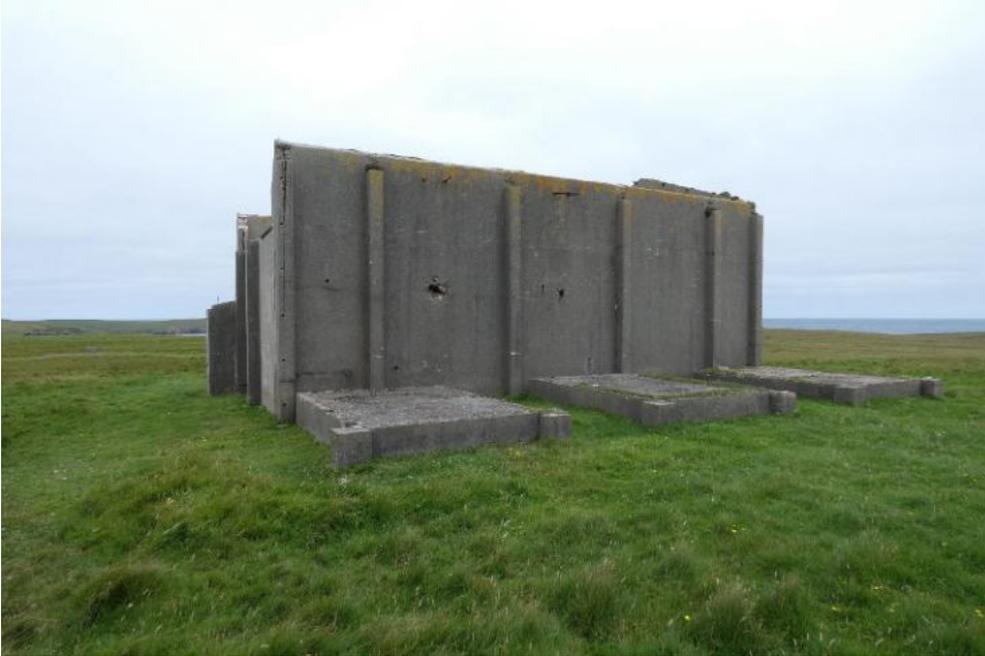
South elevation. See photos 2 and 4. This wall is a tall, thin, free-standing element.

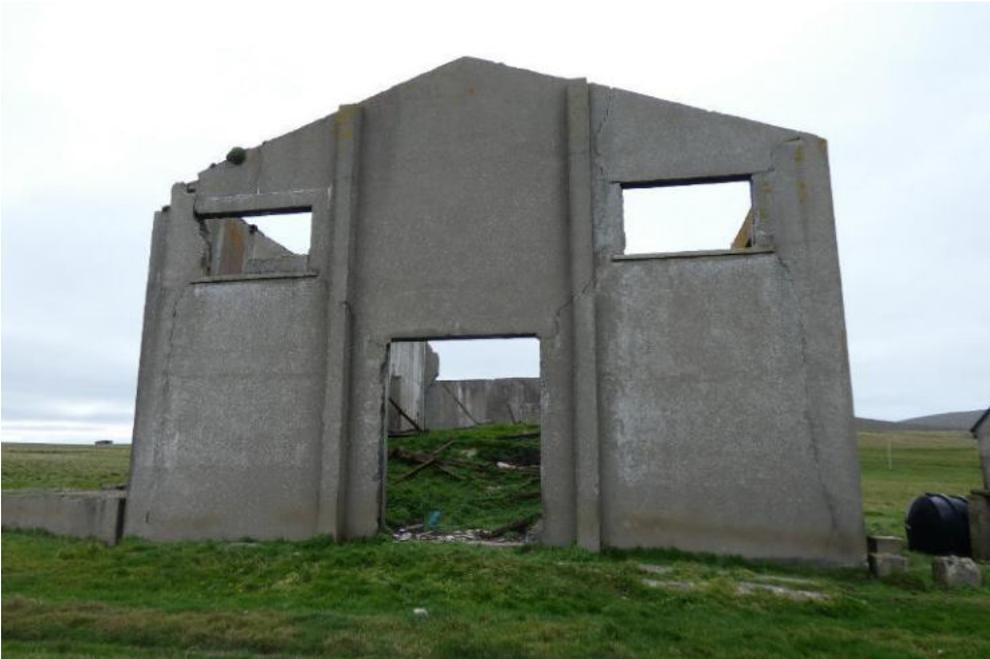
East elevation. Note the vertical cracking at each corner. Note the diagonal cracking between the entrance opening and both window openings and how this cracking continues up to wallhead: this elevation is a stack of independent, thin, tall, wall panels sitting atop each other.

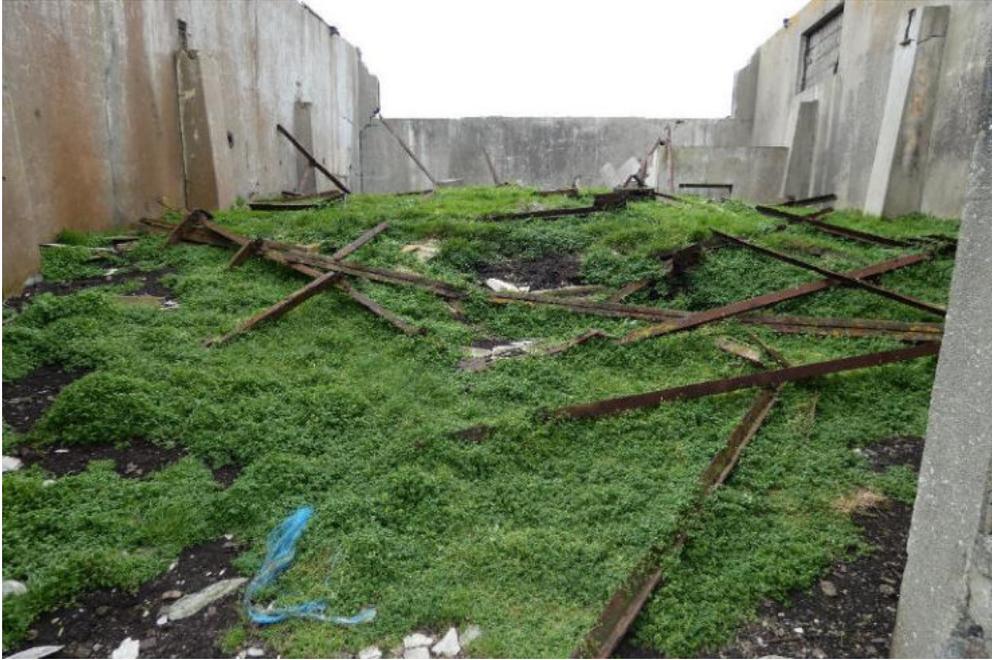
Inside the building. Note remains of the roof structure and asbestos roof tiles.

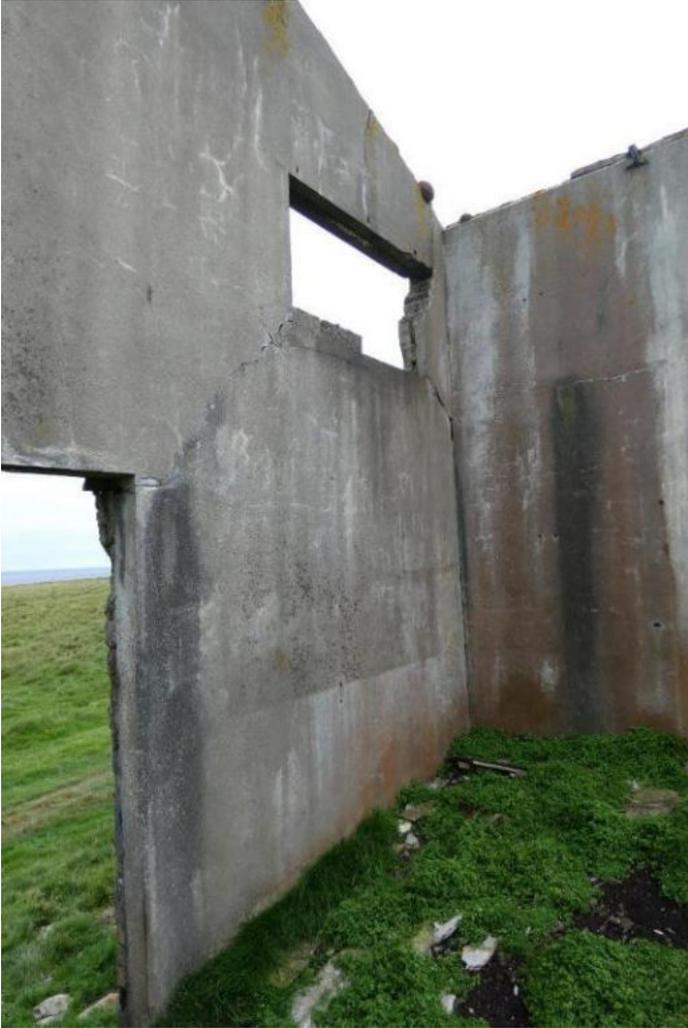
Internal view of east gable. Note how the cracking is right through the masonry.

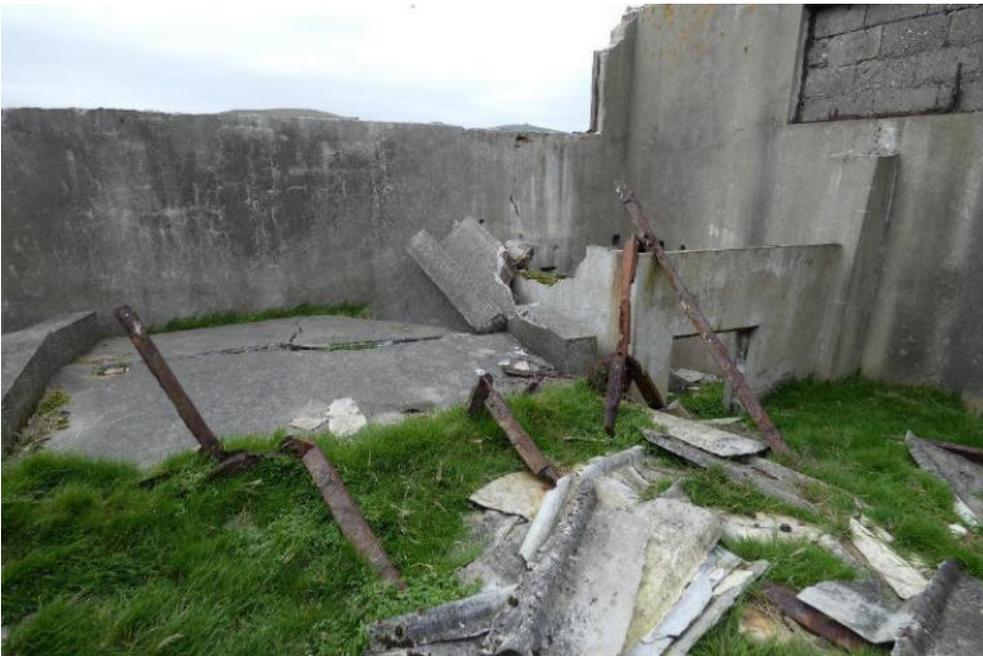
Inside of the west gable. The collapsed upper section can be seen on the floor.

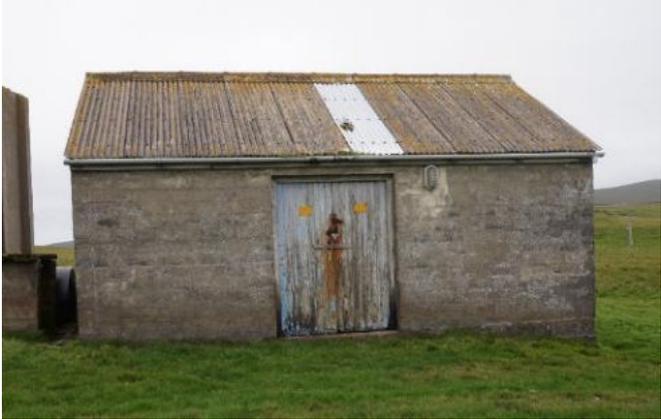
Condition:				
<p>Fair (locally poor): roof coverings appear weather tight. Blocked gutter to east, damaged to west. Missing downpipes. Concrete block walls in good condition. Cracking to lintol over north window. External joinery in poor decorative condition. Rotten boards to north window and localised rot to doors and frame.</p>				
Recommendations:				Priority:

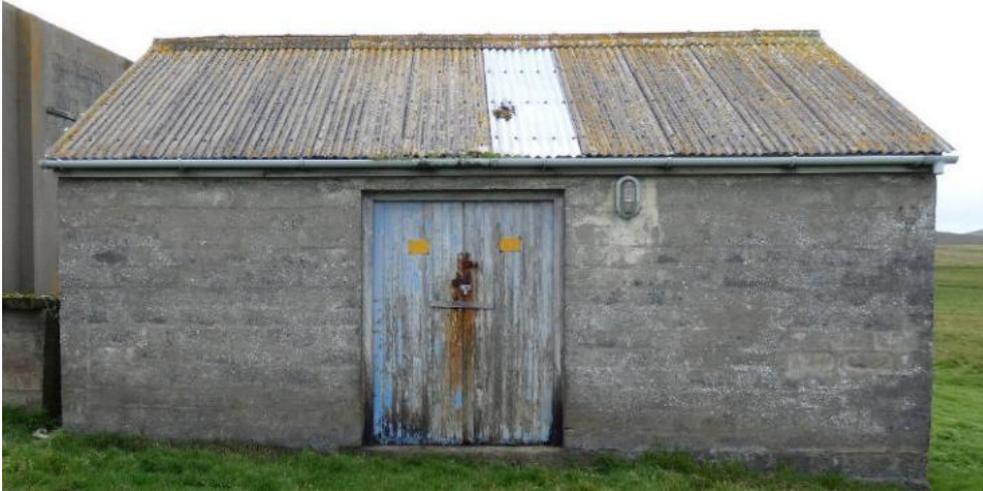
East elevation: Replace rainwater goods. Joinery repairs to doors prior to full joinery redecoration.

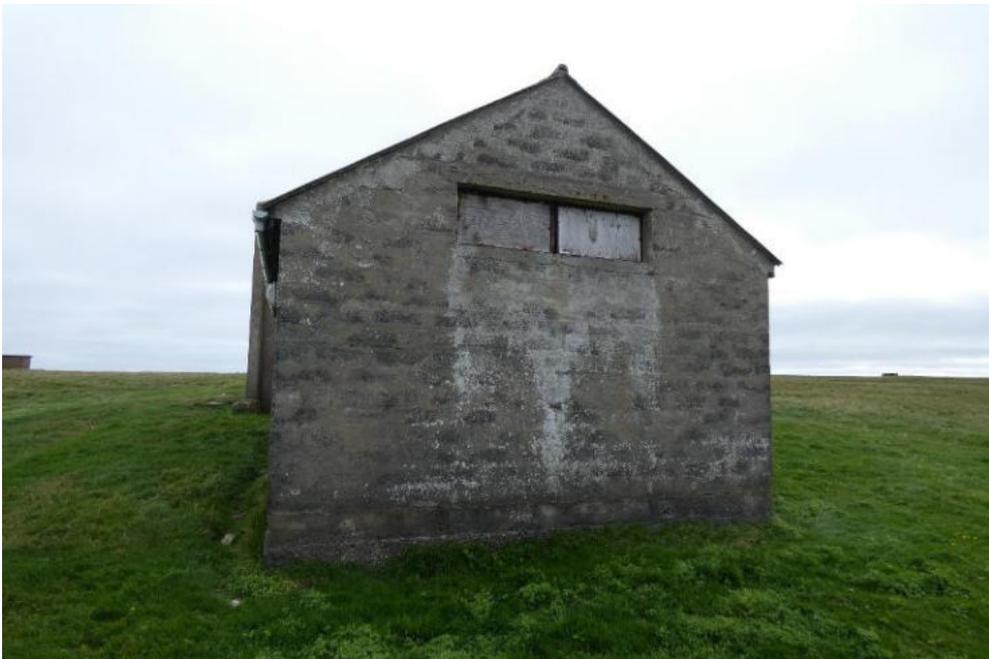
North elevation: Repoint cracked lintol and monitor. Replace boards to window and decorate.

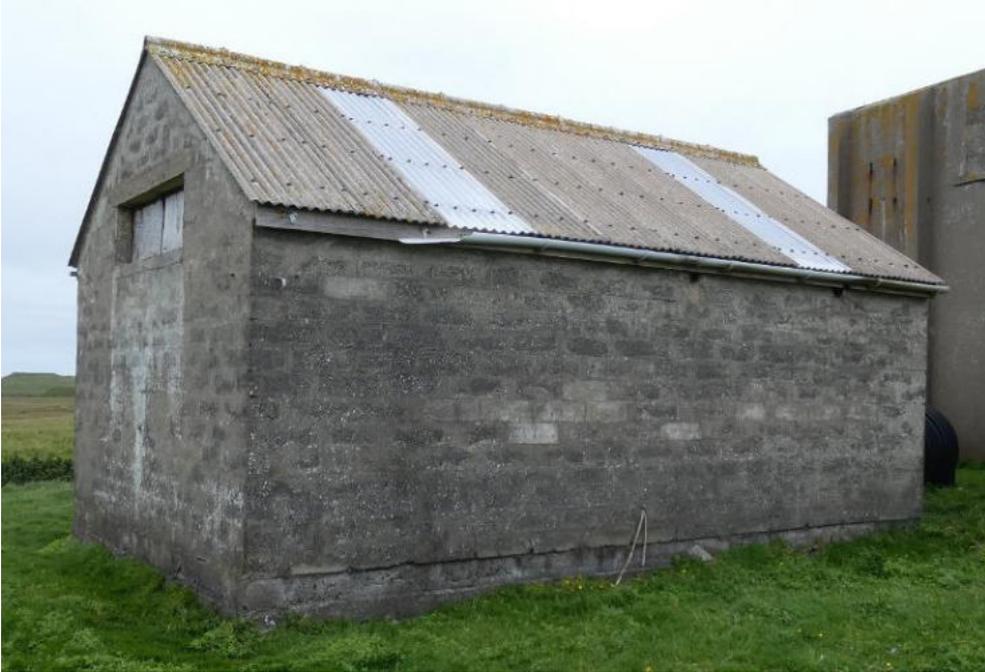
West elevation: Replace rainwater goods. Decorate facia.

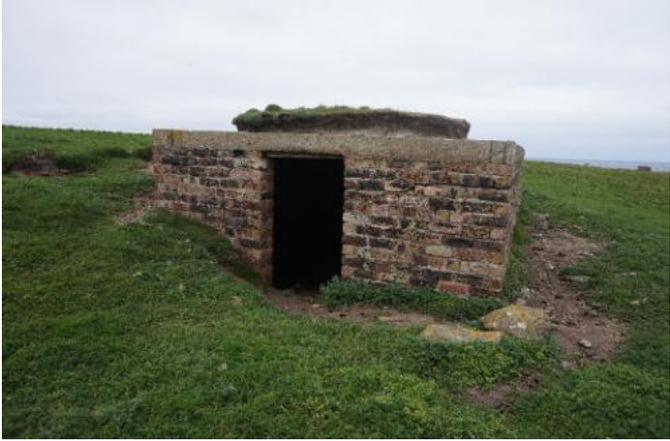
Condition:			
<p>Fair: Localised open, cracked and failing mortar joints throughout, especially immediately below roof slab on external faces where cracked and locally spalling brickwork was also observed. Internal brickwork damp and stained from saturated ground conditions, supporting moss and algal growth. Localised leaching on brickwork internally below roof slab. Rust staining to underside of roof slab, but structurally stable; no spalling concrete. Minor cracking to concrete externally immediately above junction with brickwork. Vent pipe blocked by soft capping</p>

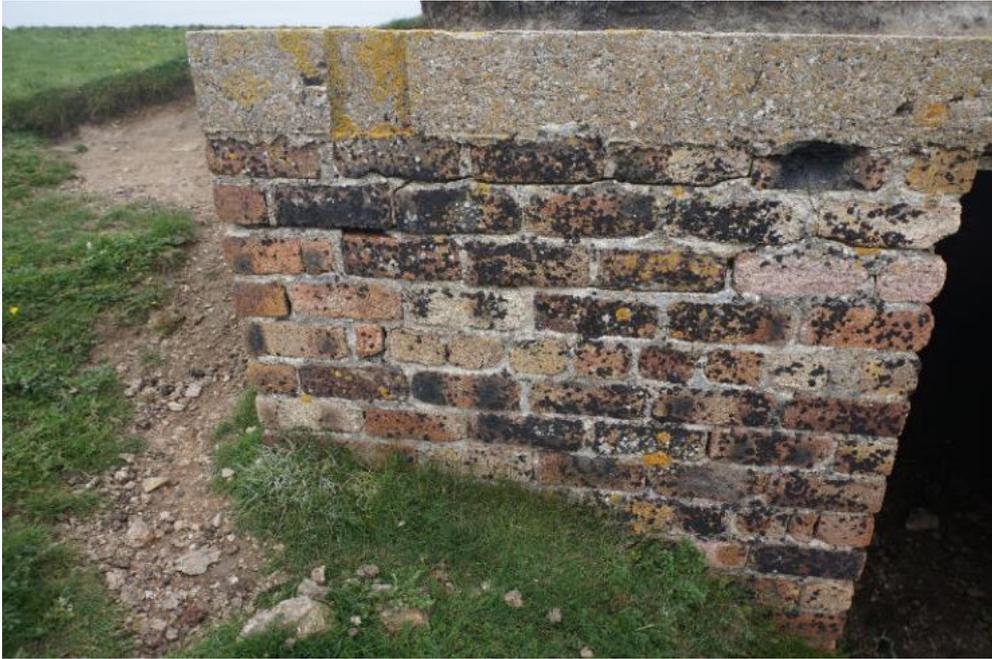
Cracked and failing mortar joints, and localised damaged brickwork.

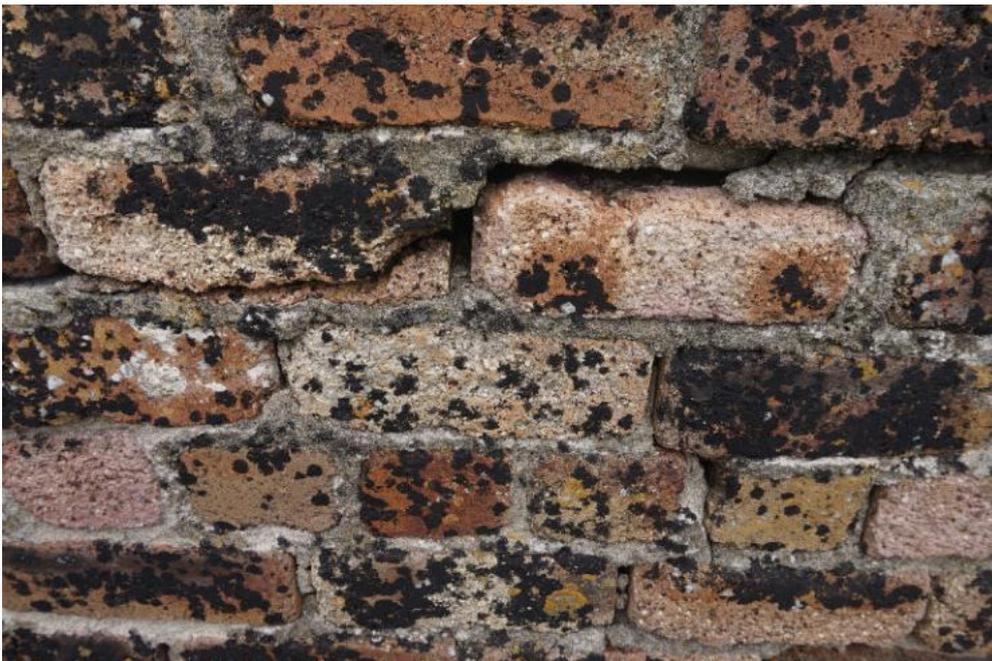
Damaged areas should be repointed to minimise further damage from water ingress and freeze/thaw.

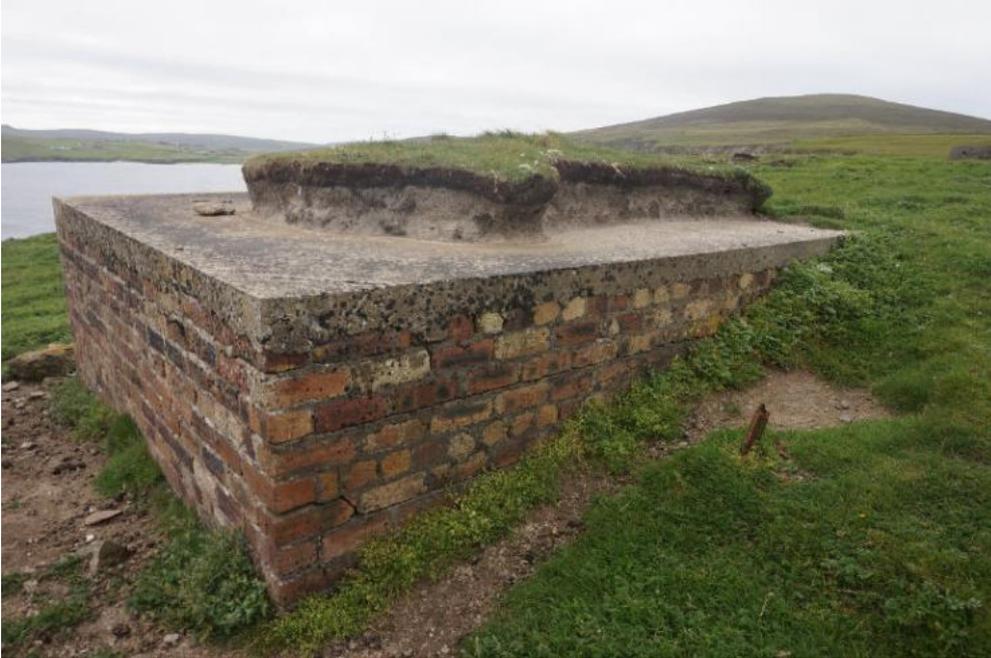
The worse affected areas are immediately below roof slab level, although repairs are required locally elsewhere. Cracked / open bed joints to the upper parts of the masonry are indicative of movement induced by drying shrinkage of roof slab.

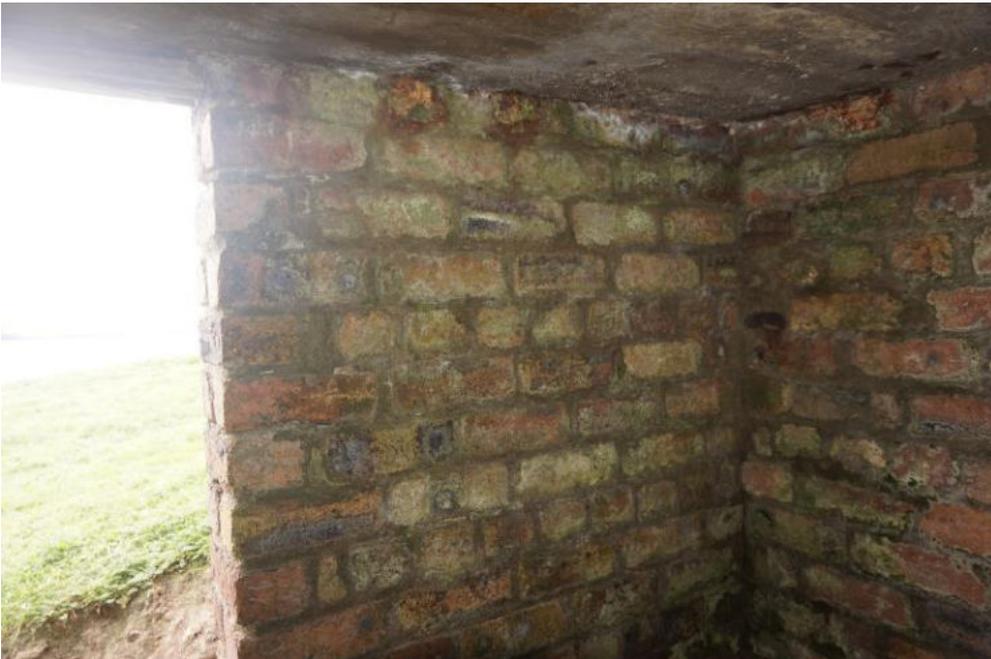
Localised leaching internally below the roof slab.

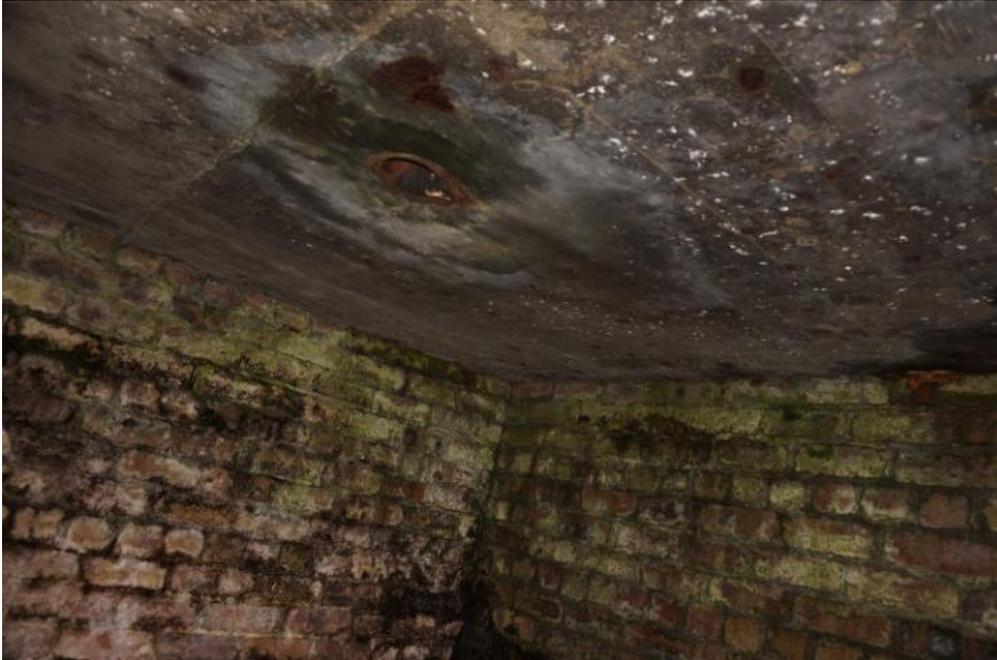
The vent pipe is blocked from above by soil and grass. Localised rust staining was observed on the soffit of the roof slab. No obvious spalling of the concrete.

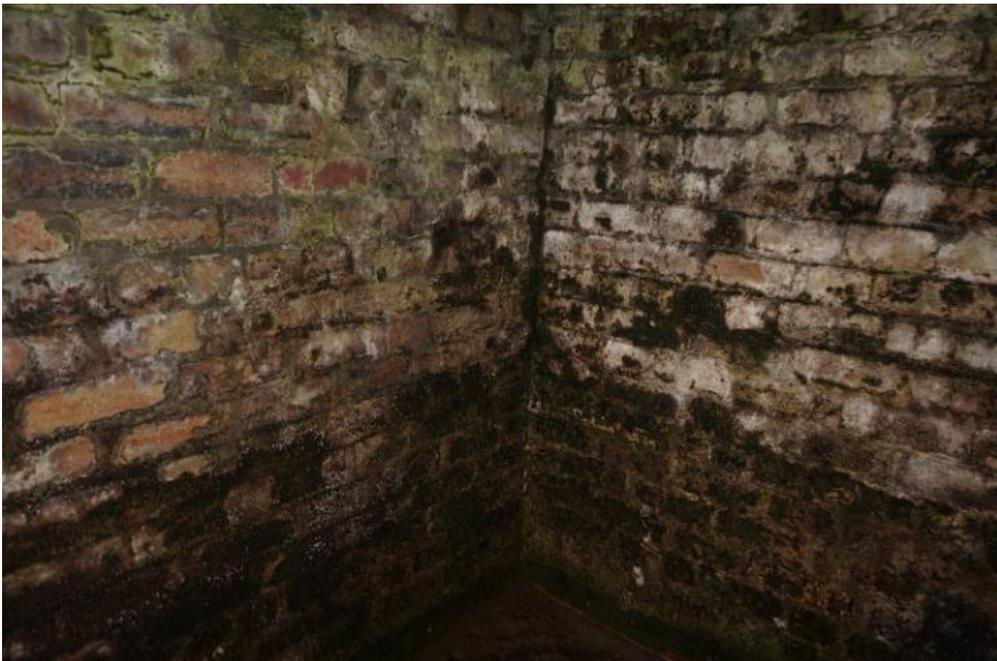
Damp stained brickwork internally from saturated ground conditions.
