Appendix 14.10 Conservation Management Plan

Shetland Space Centre Conservation Management Plan

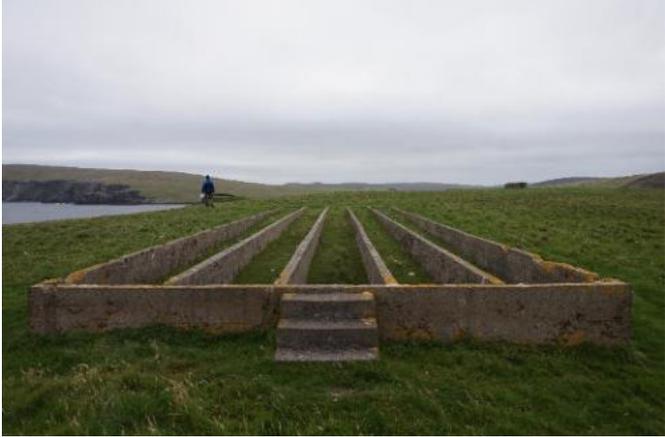
Condition:			
<p>Fair (locally poor): Despite cracking and localised spalling in the vicinity of surviving corroding wallplate fixings, and damaged/missing areas being visible throughout, the concrete walls remain stable. As much of the damage is limited to the perimeter footings, it suggests it was caused during demolition of the superstructure and removal of the wallplate fixings, or a result of later corrosion and spalling.</p>			
Recommendations:			Priority:

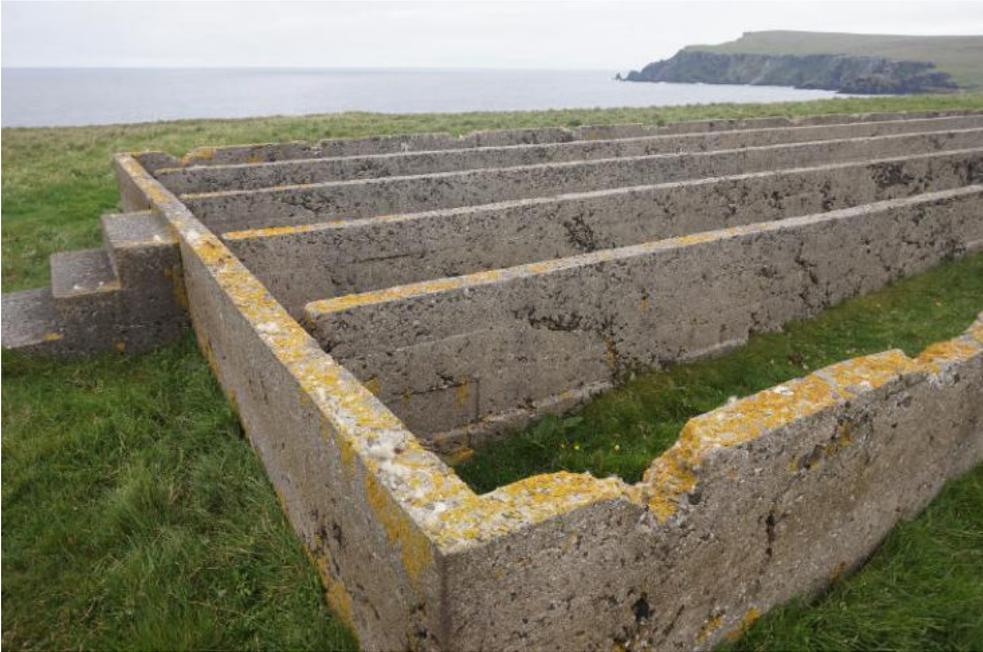
Damaged concrete is limited to the perimeter walls, suggesting it was caused during demolition works and removal of the wallplate fixings or when the fixings corroded at a later date causing localised spalling. Note poorly mixed and compacted concrete.

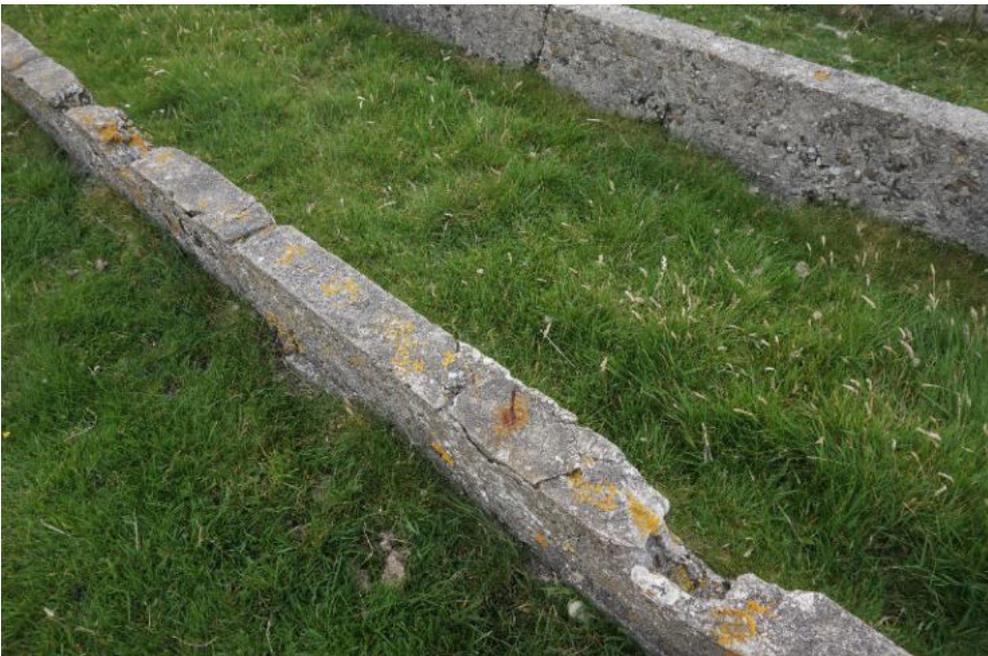
Localised spalling where corroded wallplate fixings survive.

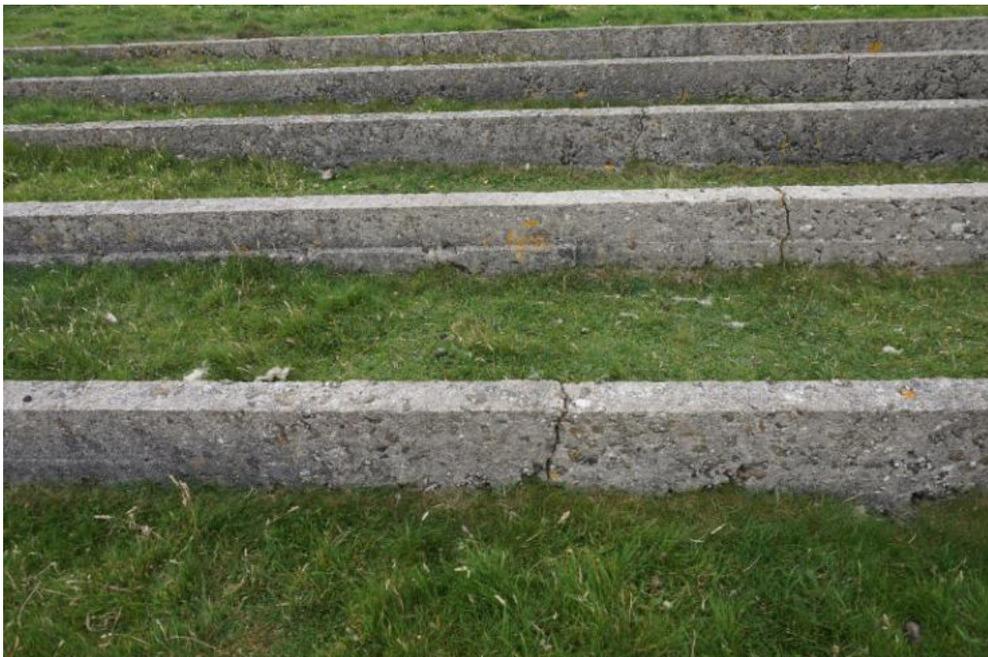
Despite the cracking which was observed throughout, the stability of the concrete walls appears unaffected.

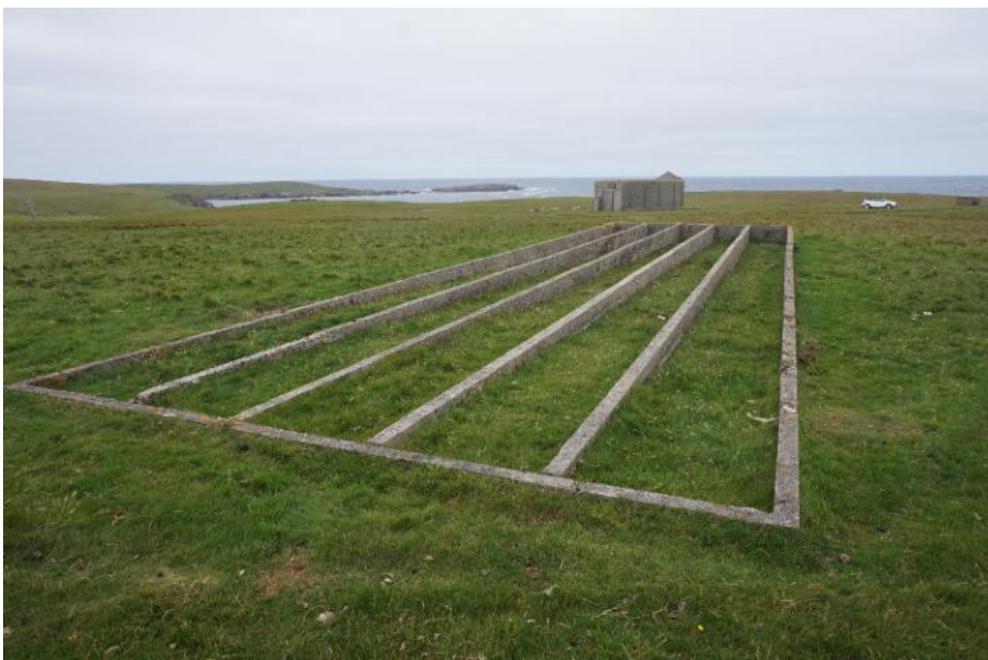
The greatest potential future risk to the concrete footings is from increased numbers visiting the site. Any future repairs to make good cracks or spalled areas should be informed by regular inspections to assess if their condition worsens. The option of burying the remains should be considered. This will not only protect the structure but will also reduce health and safety risk to visitors.

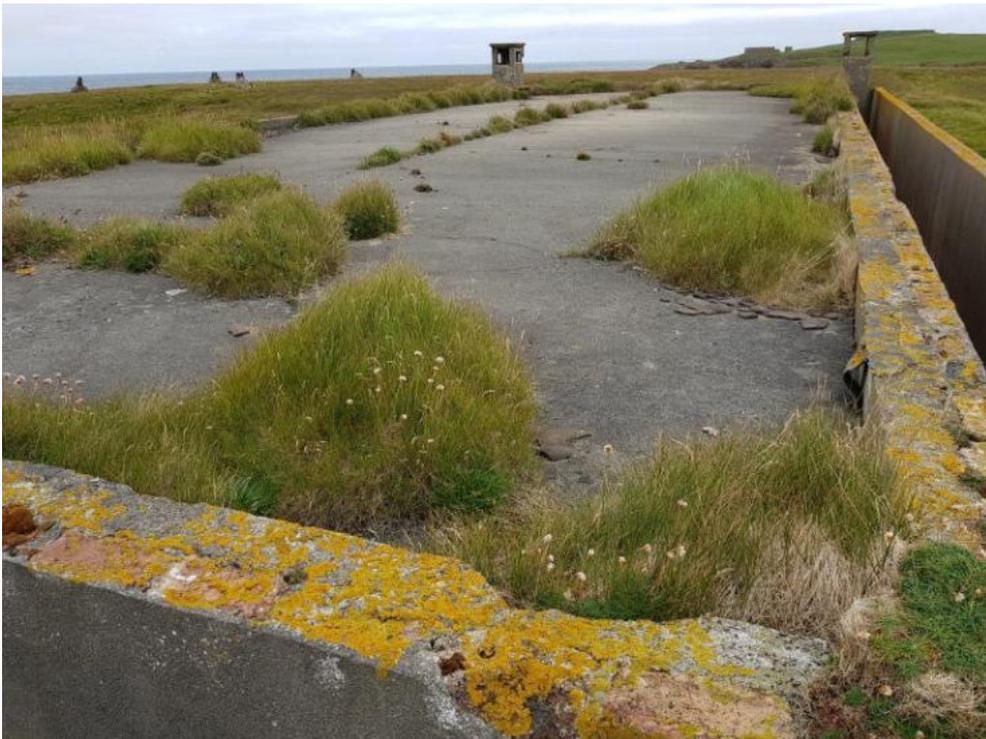
Looking across the roofscape. Note cracked asphalt, vegetation and missing concrete copes from wallheads.

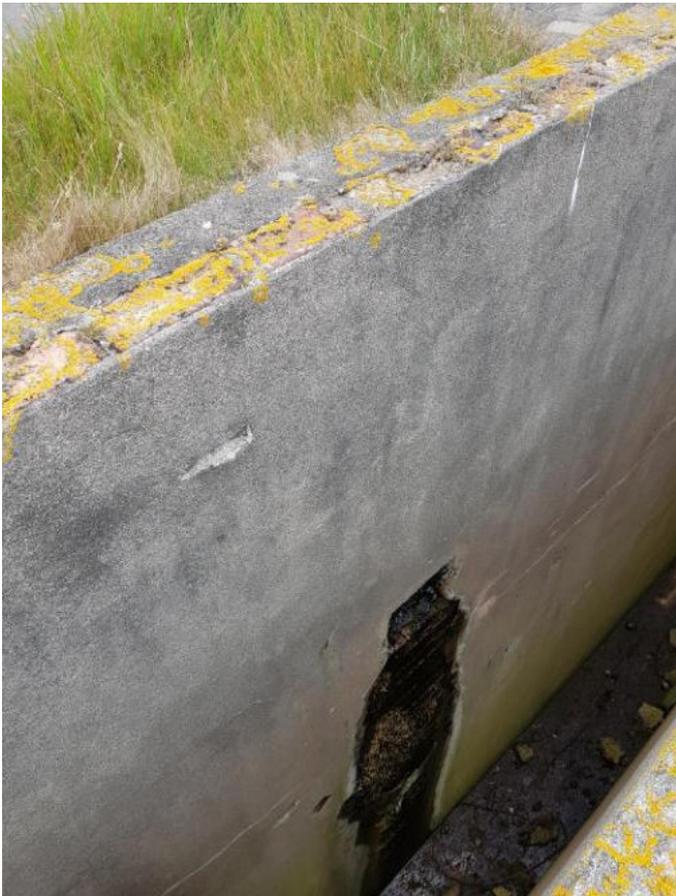
The outlet from the roof runs down into the wall and discharges part-way up it. Outlet is blocked by vegetation. Not loss of render from below the discharge point.

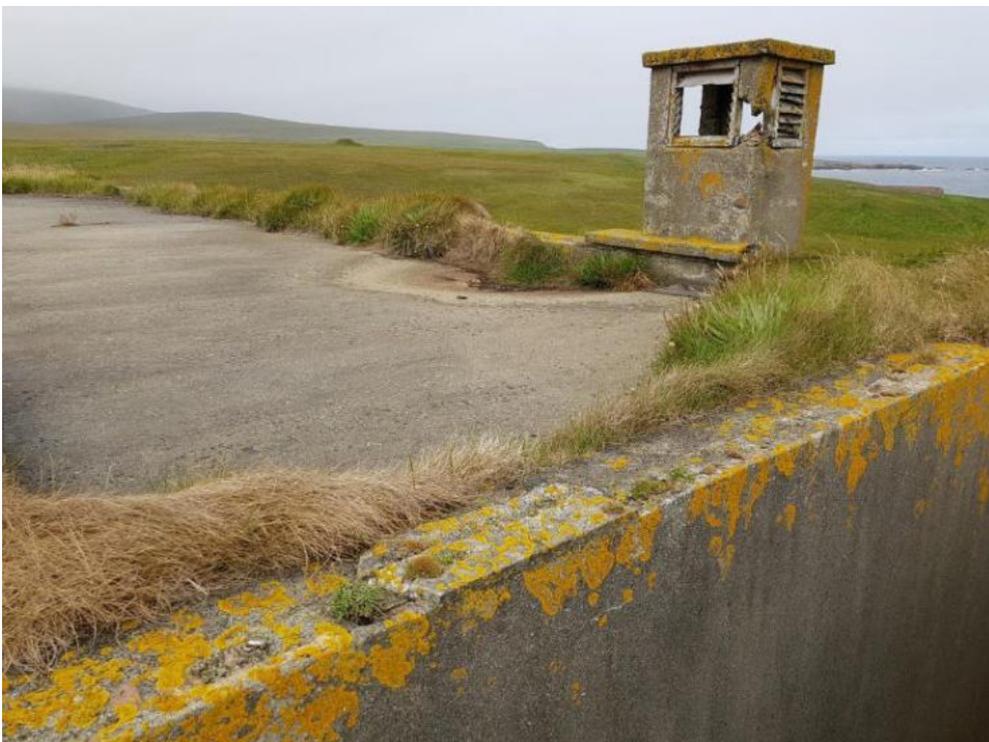
As 6. Note broken leg of RC cap to chimney – see next photo.

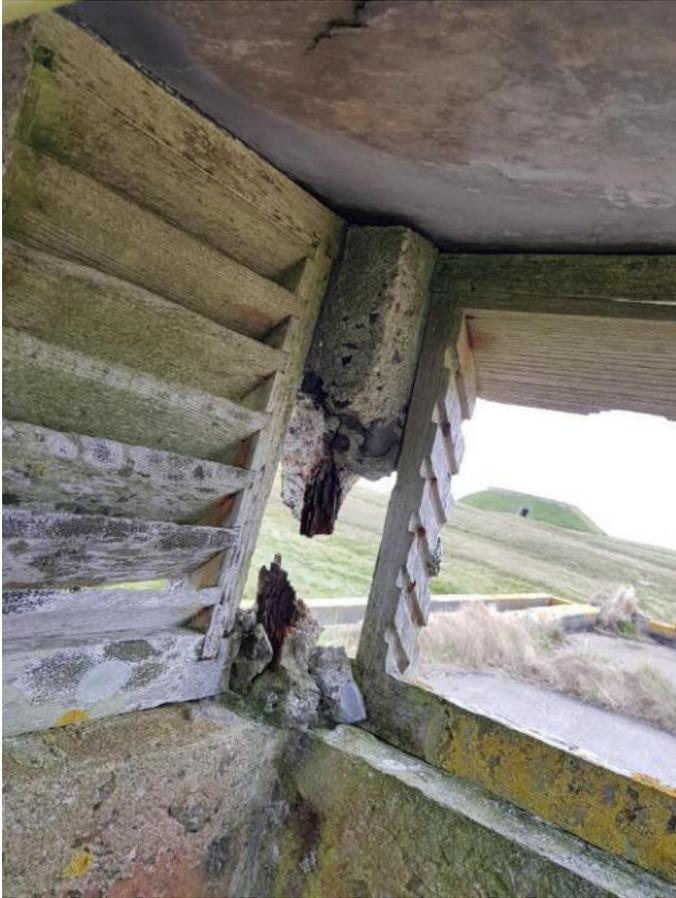
From previous, inside chimney. Chimney is generally of brick construction with an RC base and cap. This leg of the cap is broken as a result of expansive corrosion of its reinforcement. As long as the roof slab is securely fixed to the surviving legs then no further action need be taken at this time.

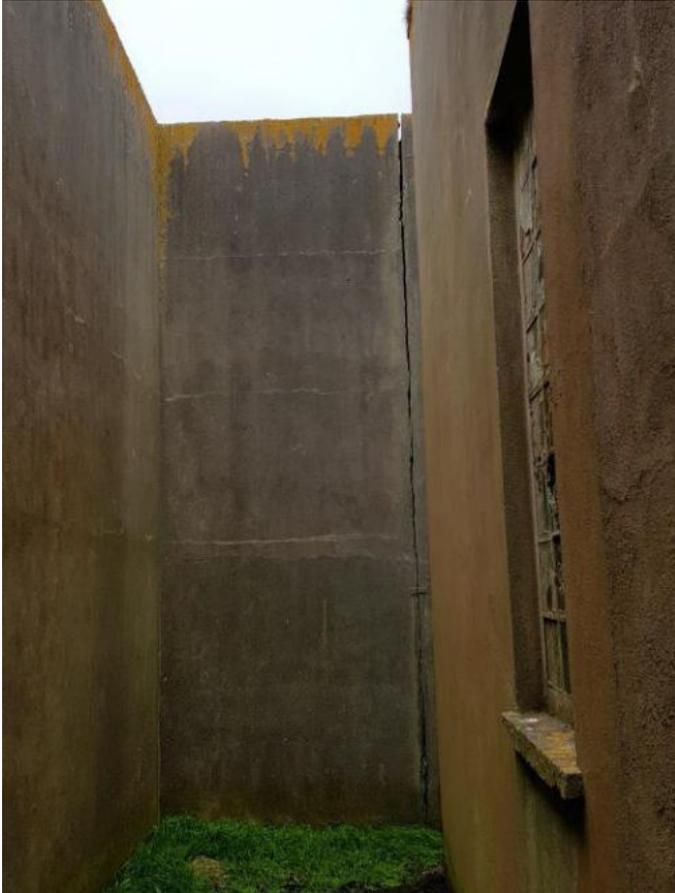
Looking along the external perimeter. The crack in the blast wall seen in the distance may actually be a deliberate joint – possibly true for other similar apparent cracks. Uncracked cement ‘tell tales’ placed across these cracks suggest there has been no recent movement (tell tales are dated 1942)

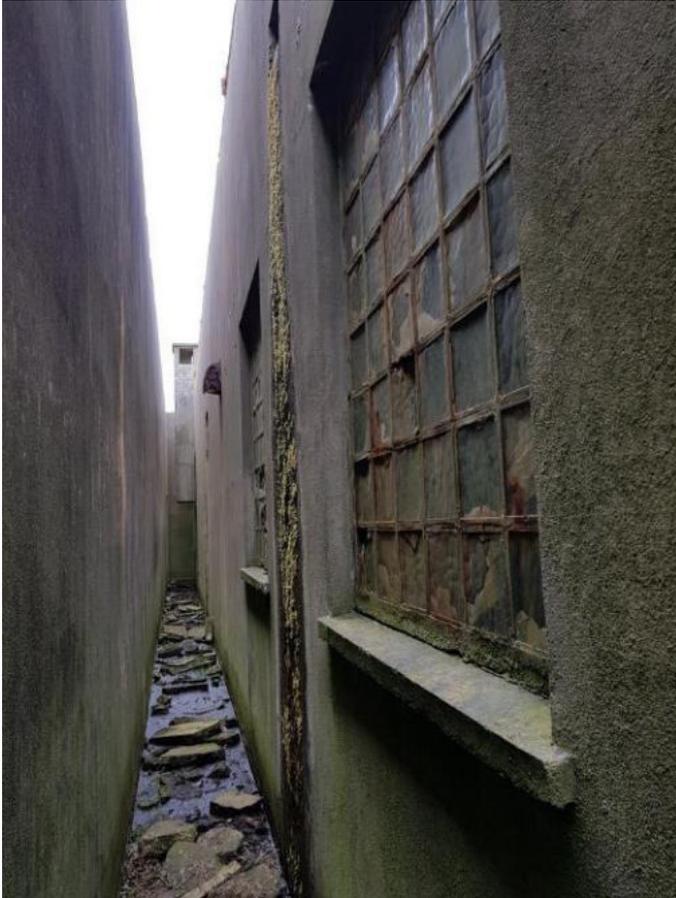
Note debris and build up of water in external perimeter.

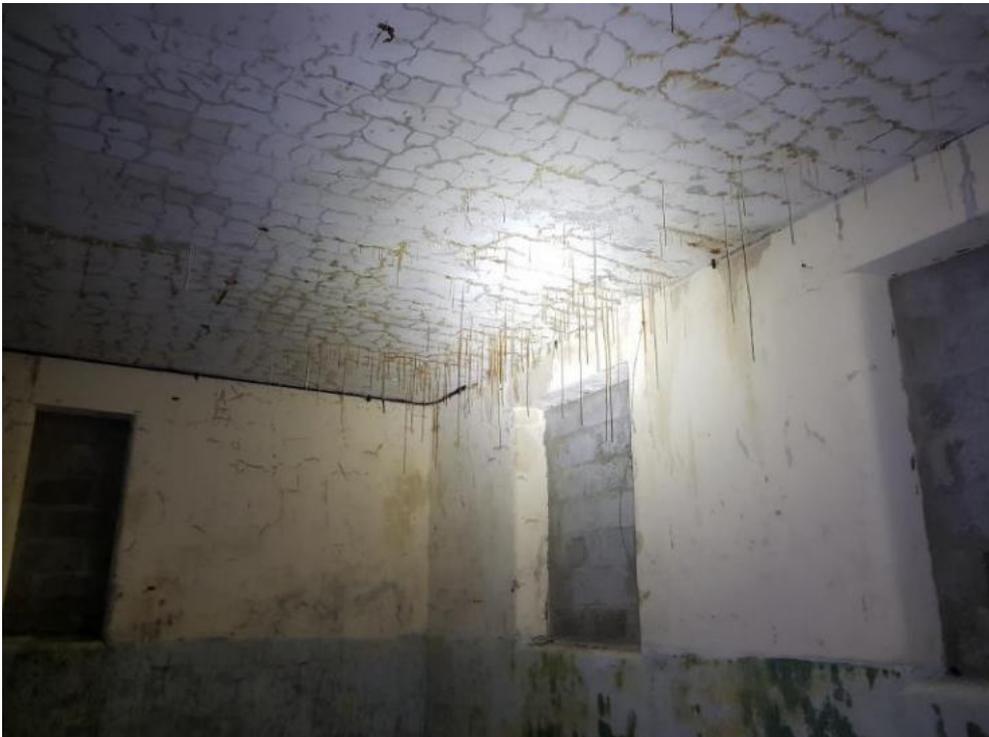
Water ingress through the roof slab obvious, indicated by the stalactites from the roof and cracking of the plaster.

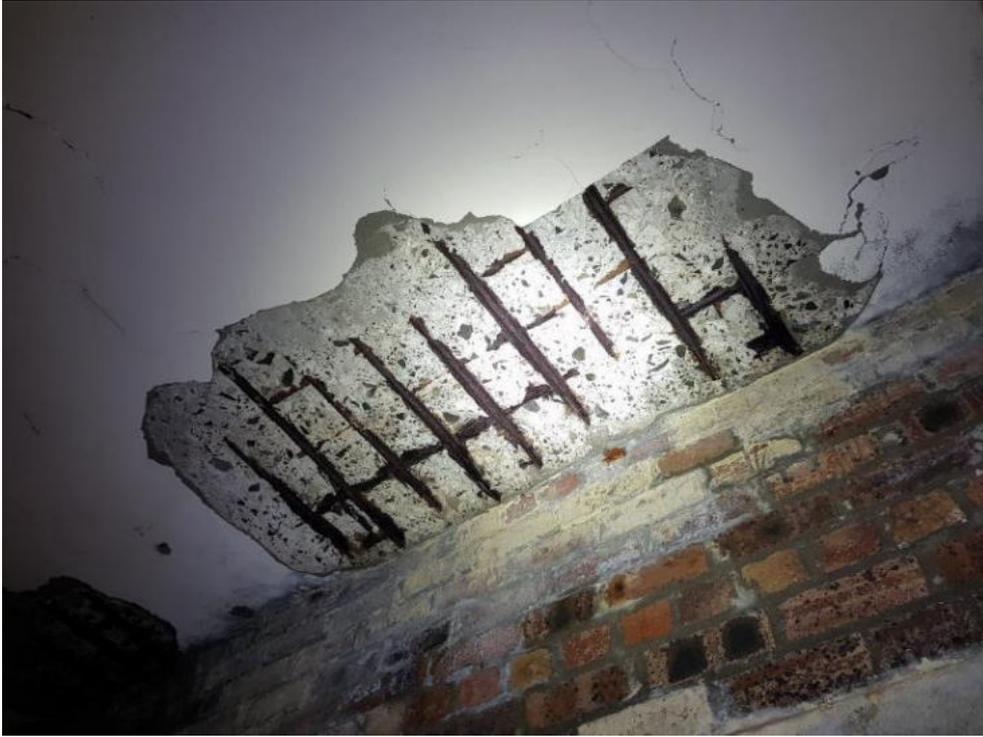
Spalling concrete caused by expansive corrosion of reinforcement.

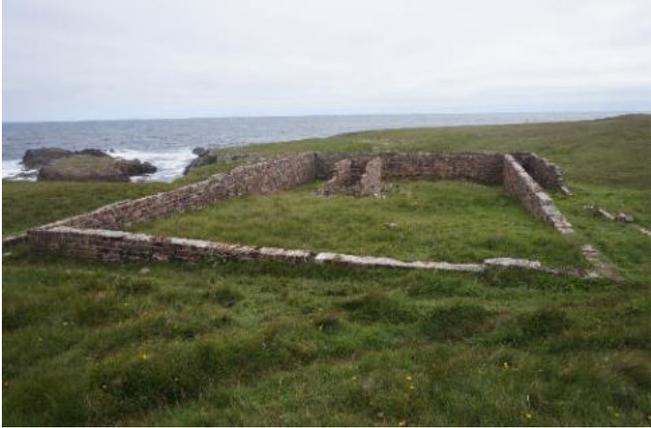
Condition:			
<p>Poor:</p> <p>General – open and defective skyward facing joints supporting vegetation growth throughout, locally elsewhere to wall faces. Localised loose brickwork, spalling and damaged brickwork prevalent to exposed wallheads. Fallen/displaced brickwork throughout, but most noticeable within the void between the east inner and outer skins, and around the central feature.</p> <p>Outer skin – recent area of collapse at the north end of the east wall adjacent to structural cracking and a pronounced leaning section of the adjoining north wall, an indication of subsidence and general instability, possibly exacerbated by demolition activities, at the northeast corner.</p> <p>Inner skin – vertical cracks to east and west walls.</p> <p>Central feature – spalling, damaged and loose brickwork to exposed wallheads</p>

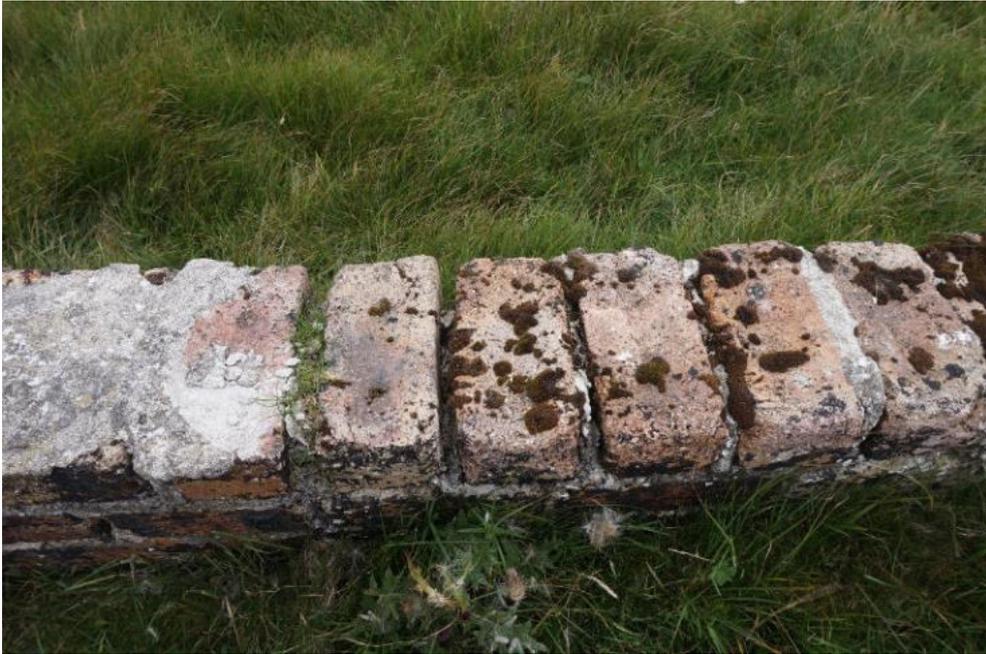
Open and defective wallhead joints were observed throughout. Several localised loose bricks were found on all walls.

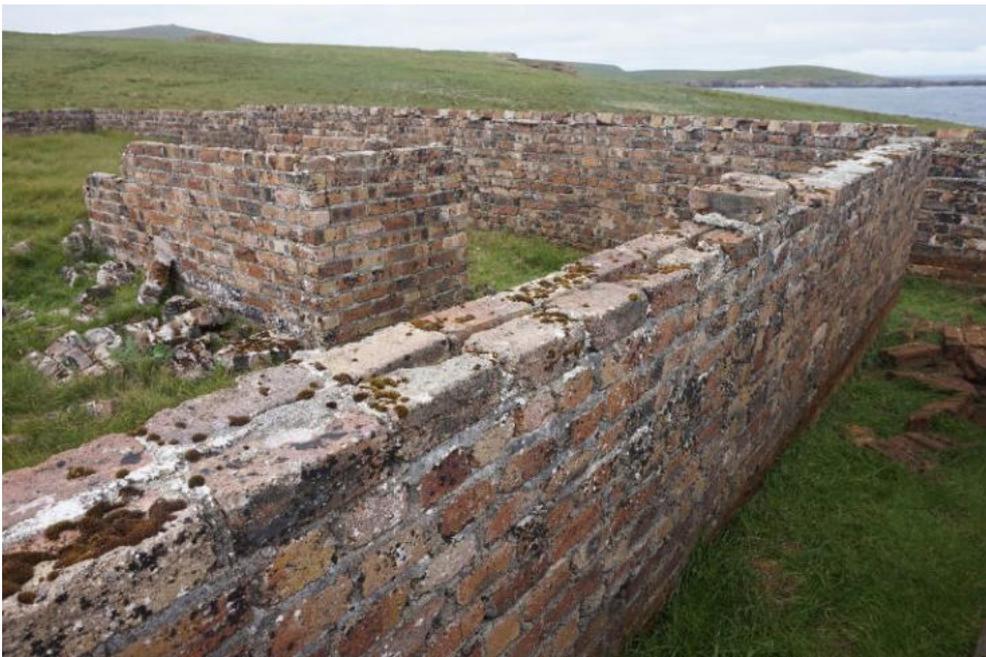
Failing wallhead joints should be repointed and loose bricks rebedded.

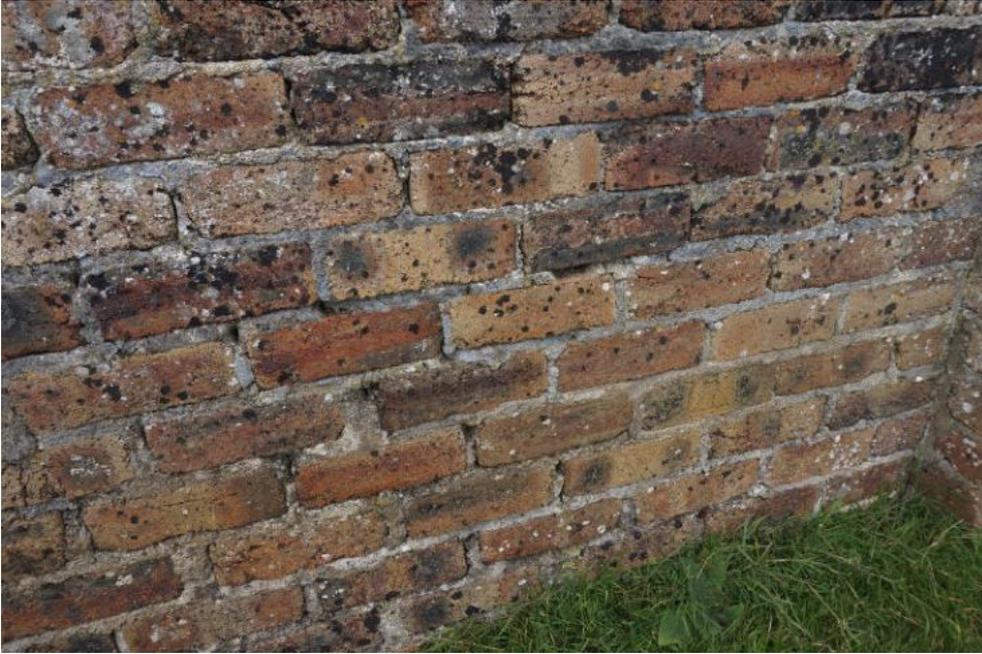
Localised open and failing joints visible on all wall faces.

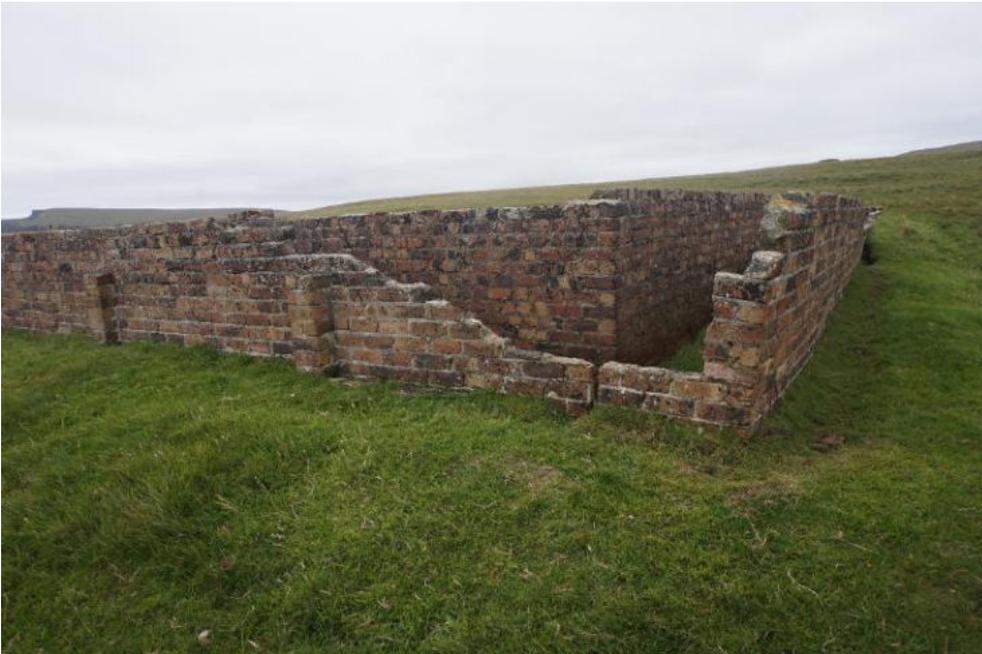
Structural issues in the northeast corner. Vertical cracks on the east elevation of the inner and out skins and a pronounced lean to the north wall of the outer skin. Cracks should be repointed and monitored to assess ongoing movement. The leaning outer skin should either be made safe by extending the earth banking eastwards to prevent further outward rotation or taken down to a safe height. The external wall generally does not have inherent stability generally. This issue should be addressed if increased footfall is expected.

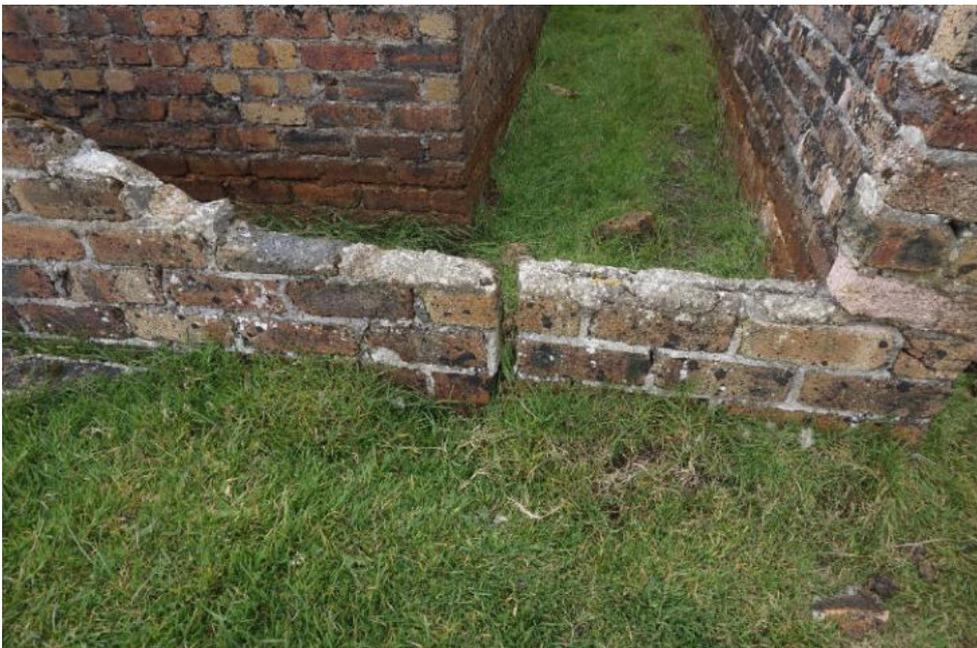
Cracked brickwork to the east facing half brick thick outer skin adjacent to the leaning north wall.

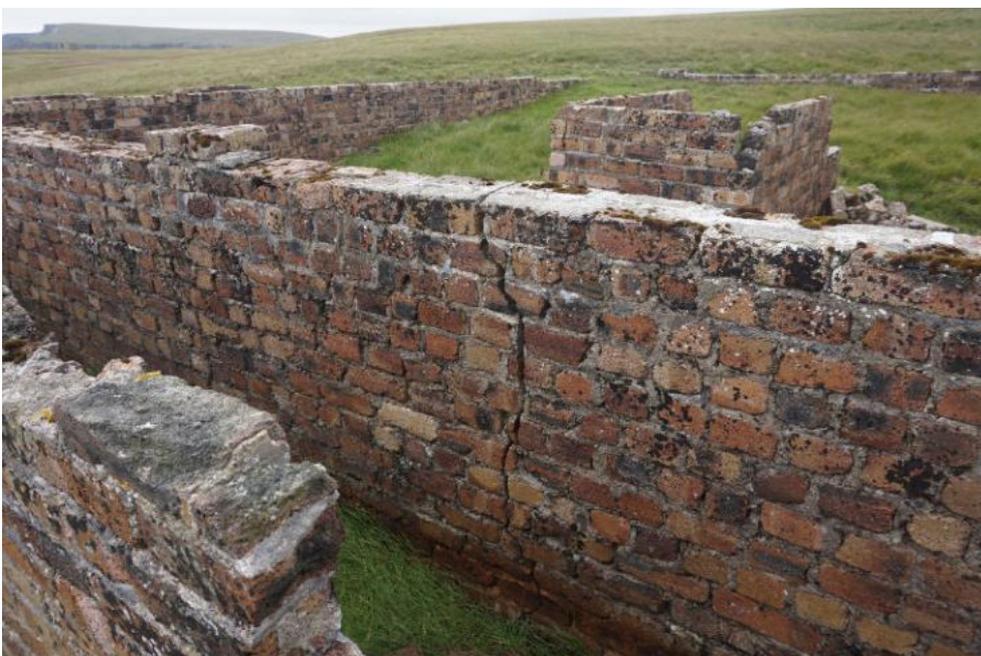
Cracked brickwork to the single brick thick east facing inner skin. Cracks should be repointed to allow future monitoring.

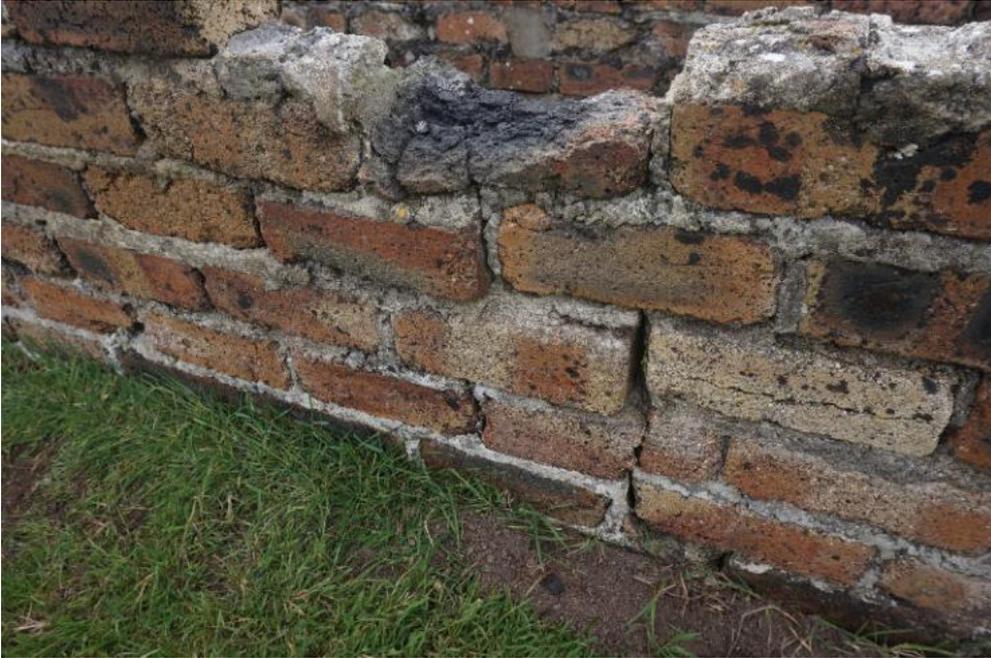
Ideally, damaged wallhead brickwork should be retained, with failing surrounding joints repointed and consolidated to minimise future loss. However, localised removal and replacement of badly damaged bricks should be anticipated.

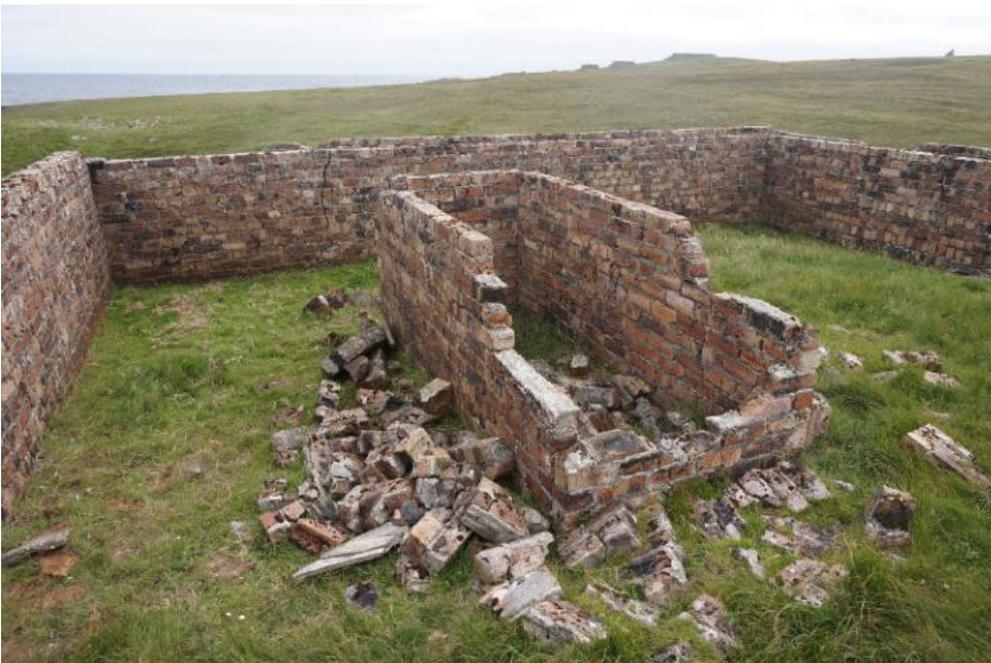
After a full recording exercise, fallen and displaced brickwork should be removed to reduce health and safety risk if increased footfall to the site is anticipated in future. As with the other walls, intervention is required to make good defective joints and loose brickwork, especially to wallheads. The long walls do not have inherent stability generally. This issue should be addressed if increased footfall is expected.

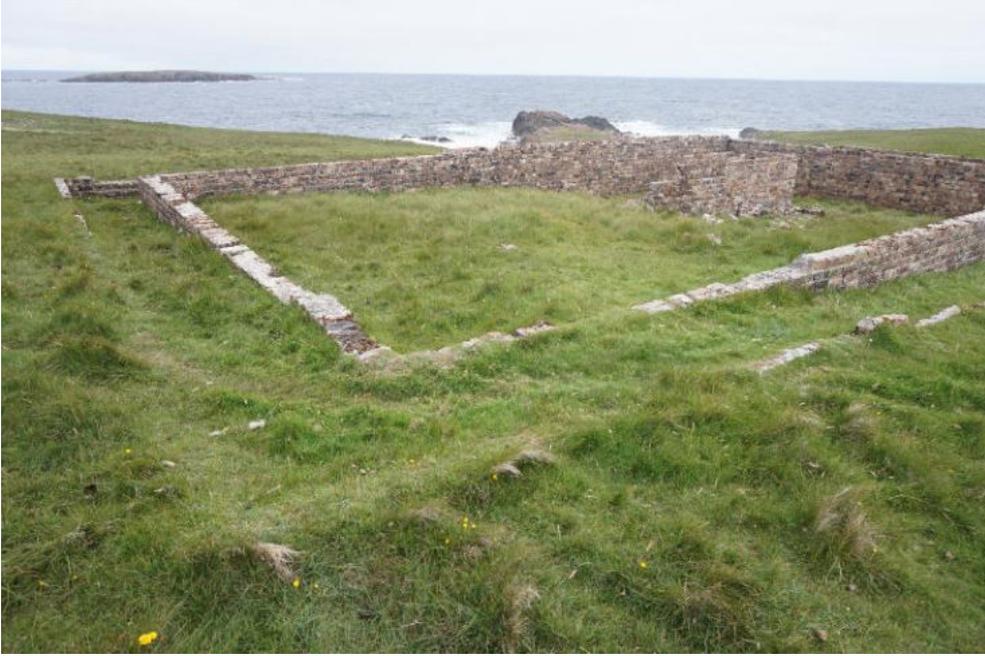
Buried sections of brickwork should not be disturbed.

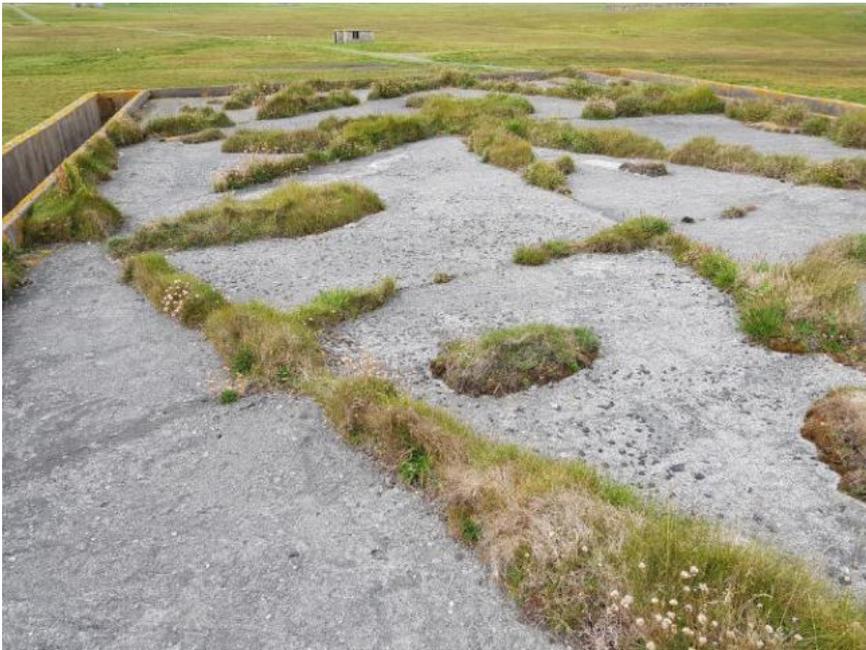
General view across the roof. The roof is laid to falls. The original asphalt protective covering remains but in poor condition. The growth pattern in the vegetation is indicative of where the finishes are cracked and allowing greatest concentration of water ingress into the roof slab.

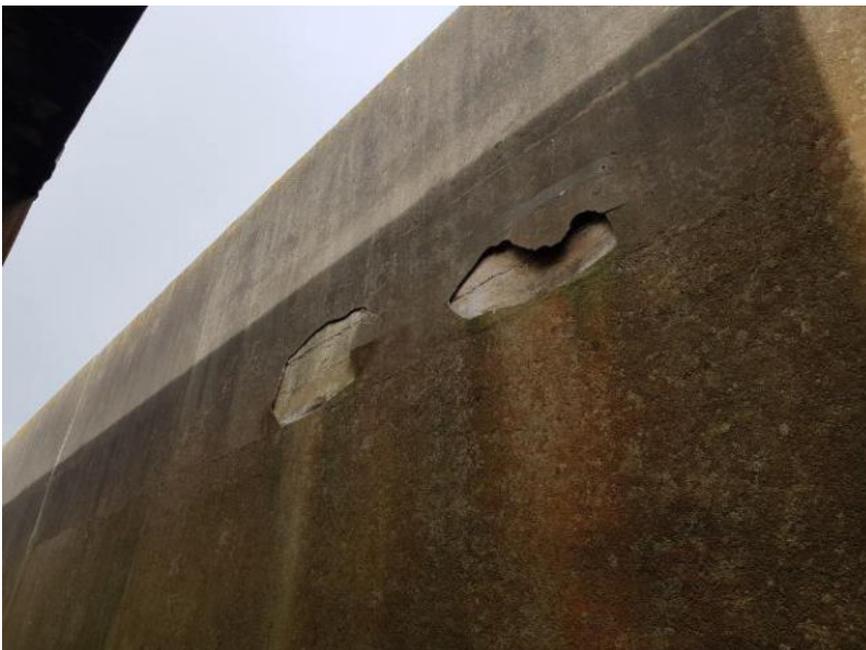
Failing render from the faces of the RC blast walls. note the smooth surface of the exposed substrate, with no obvious formed key to receive the render.

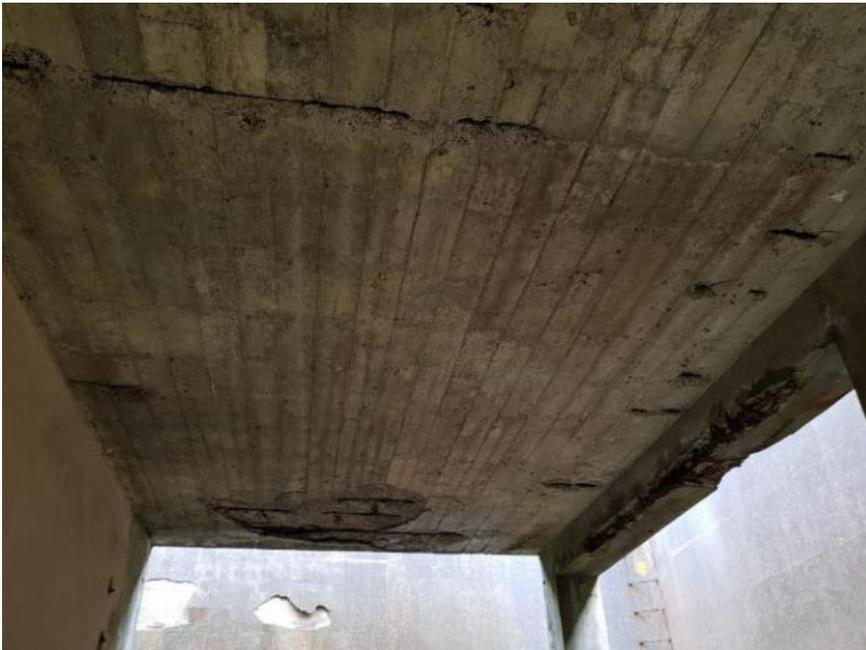
Underside of the porch roof showing areas of spalling concrete to the roof generally, concentrated at the downstand RC beams. This loss of concrete is attributable to expansive corrosion of the embedded reinforcement owing to uncontrolled water ingress throughout the concrete.

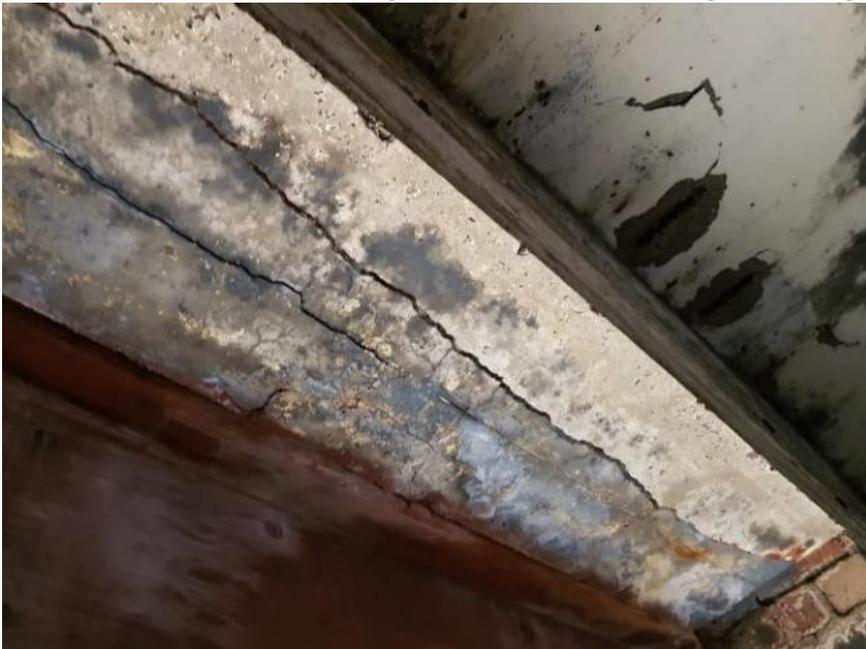
As previous – an RC lintel to the main entrance.

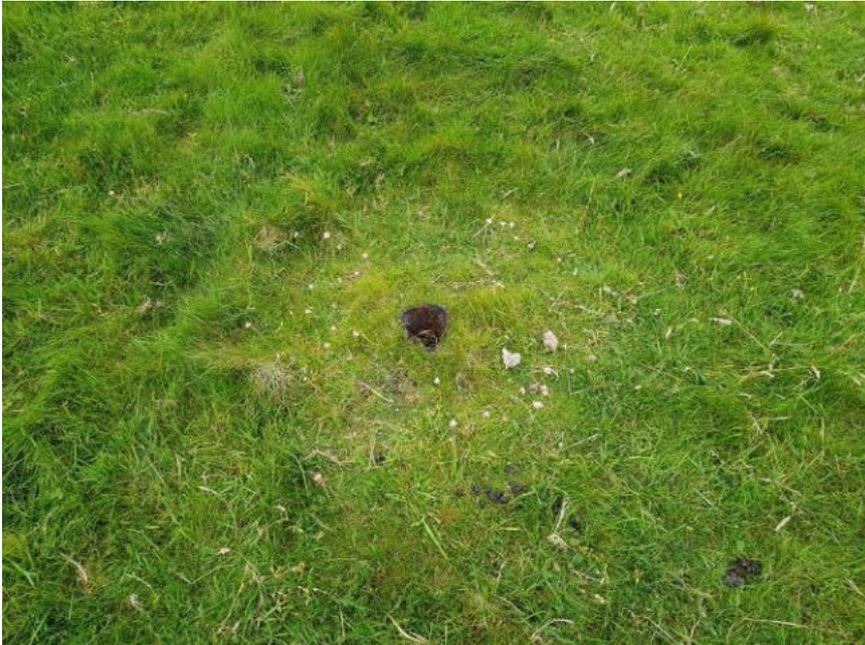
Projecting remains of a former camouflaging netting support post. The posts are severely corroded with sharp jagged ends.

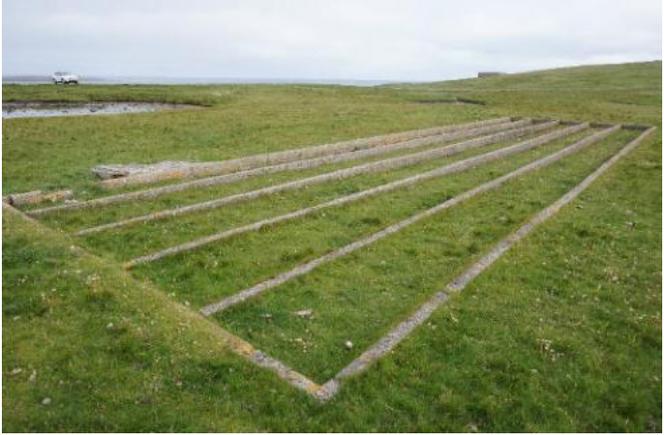
Condition:			
<p>Fair (locally poor): Cracking visible throughout, however the stability of the walls appears unaffected. Localised cracking and spalling in the vicinity of embedded ferrous fixings. Localised damaged and displaced concrete at western end of north footing adjacent to the entrance platt. Localised spalling and disaggregation at the eastern end of one of the centre footings. The entrance platt is misaligned, with localised cracking, spalling and disaggregation, but stable.</p>			
Recommendations:			Priority:

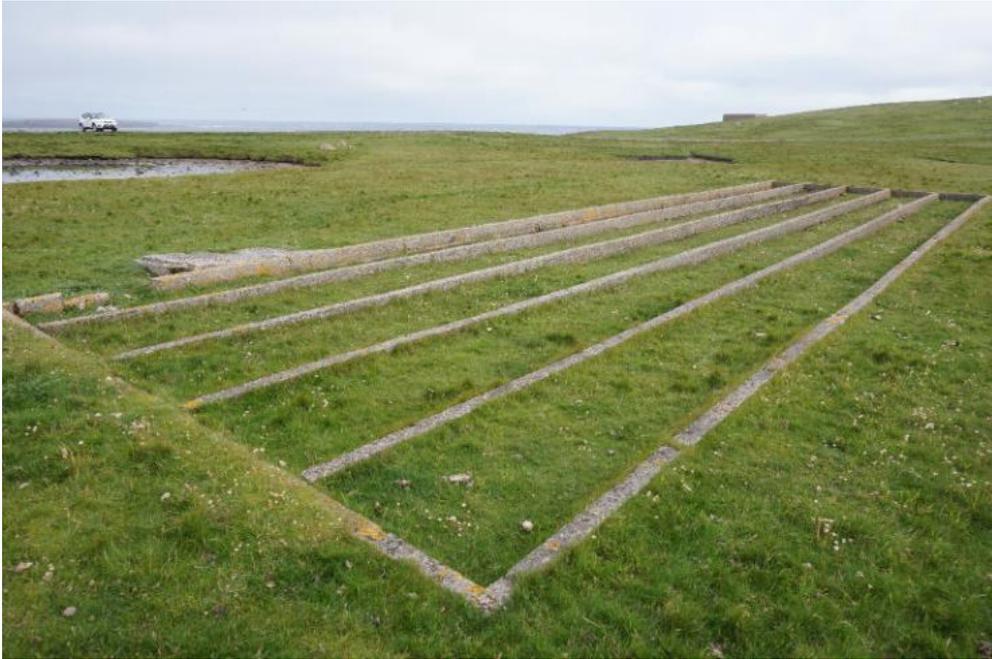
Sections of concrete at the eastern end of the structure are partially buried. The structure is generally stable, however, if increased footfall is anticipated, localised repairs and/or wholesale burying should be considered to protect the concrete and to reduce health and safety risk.

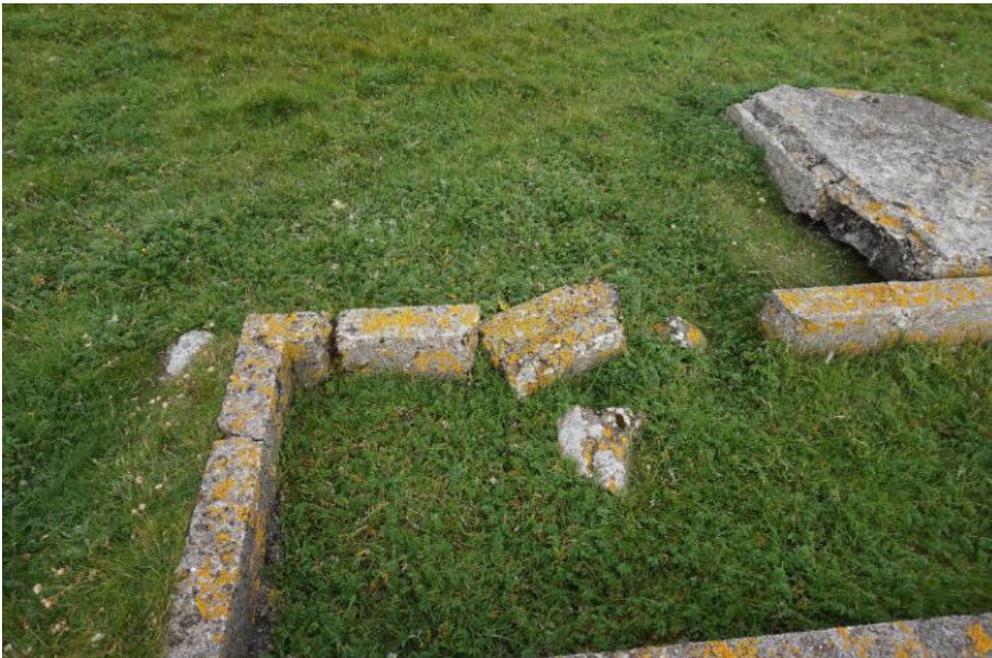
Localised damage and displacement of the western end of the north perimeter sleeper wall.

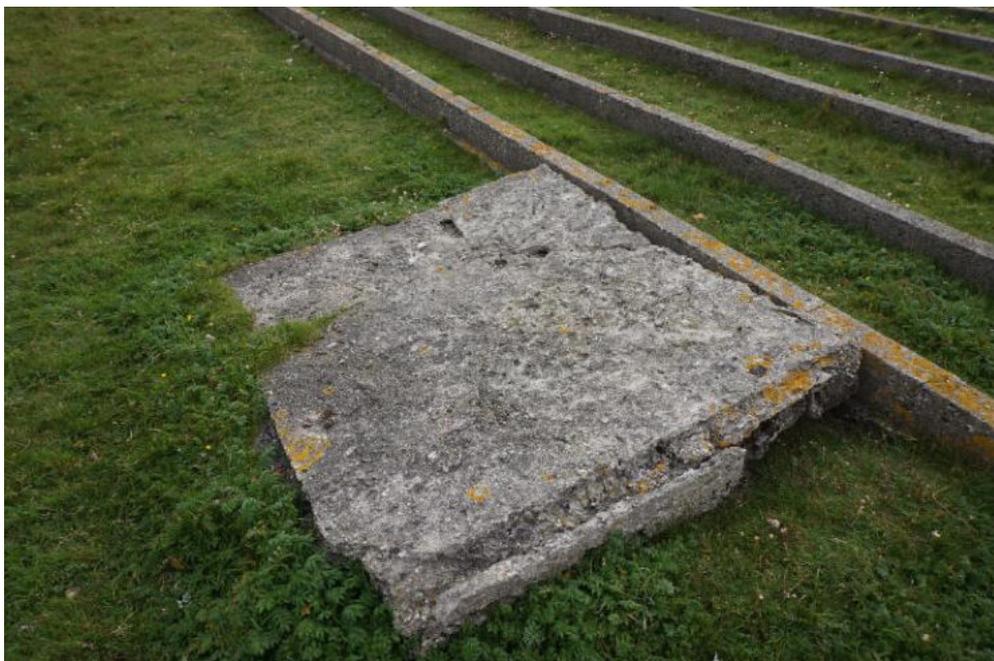
The entrance platt remains stable despite misalignment and localised cracking, spalling and disaggregation.

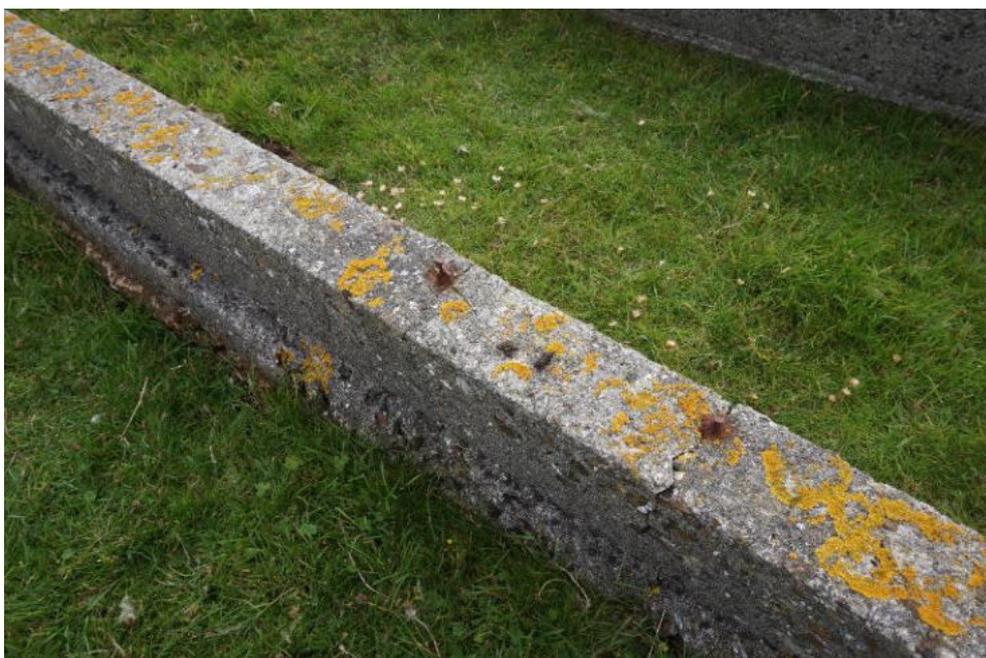
Cracking and spalling in the vicinity of embedded ferrous fixings which would have been used to secure timber wallplates.

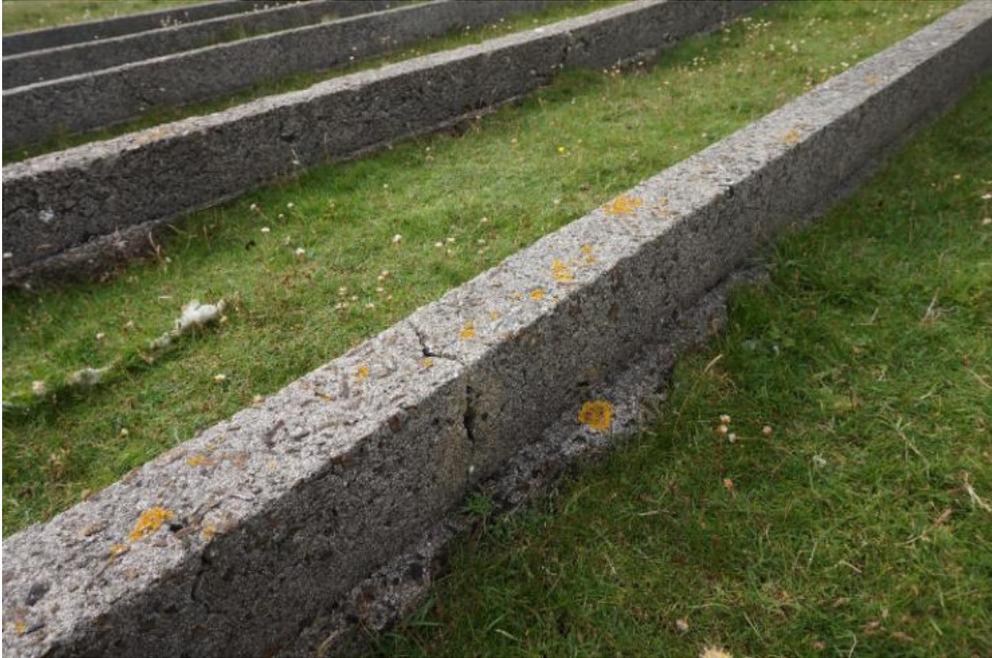
Despite widespread cracking, the walls remain stable.
