Appendix 14.10 Conservation Management Plan

Shetland Space Centre Conservation Management Plan

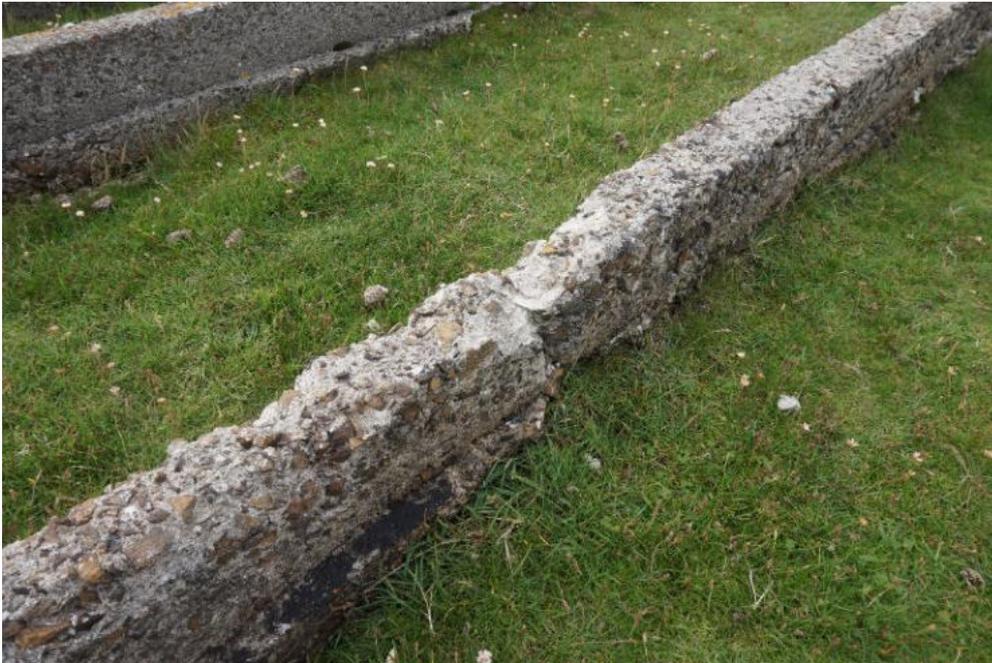
Localised spalling and disaggregation at the eastern end of one of the centre sleeper walls.

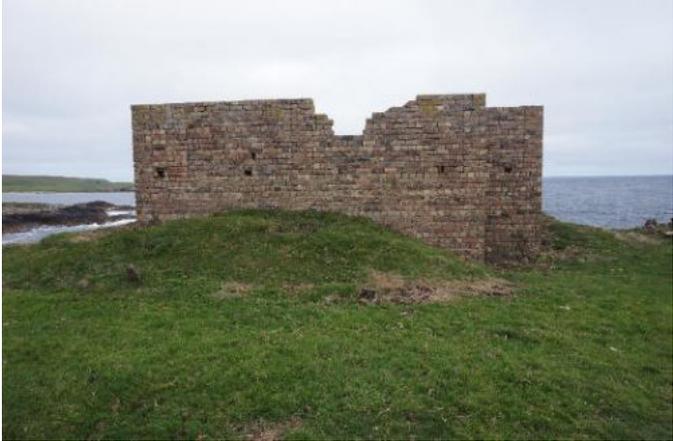
Condition:			
<p>Fair: with localised issues of instability arising from either low-quality of original construction. Open and failing skyward facing joints to wall head and locally elsewhere on wall faces.</p> <p>Vertical cracking on all faces, most visible at upper level where the single brick thick brickwork panels are poorly tied to the 1.5 brick thick piers, and locally at lower levels, including centrally on the north, east and west elevations. There is significant cracking at the northeast corner where the north and east walls are poorly tied, with similar cracking at the southeast corner, both areas potentially affected by poor ground conditions affecting the foundations.</p> <p>Internally, the small rectangular brick structure and concrete base are in a stable condition</p>			
Recommendations:			Priority:

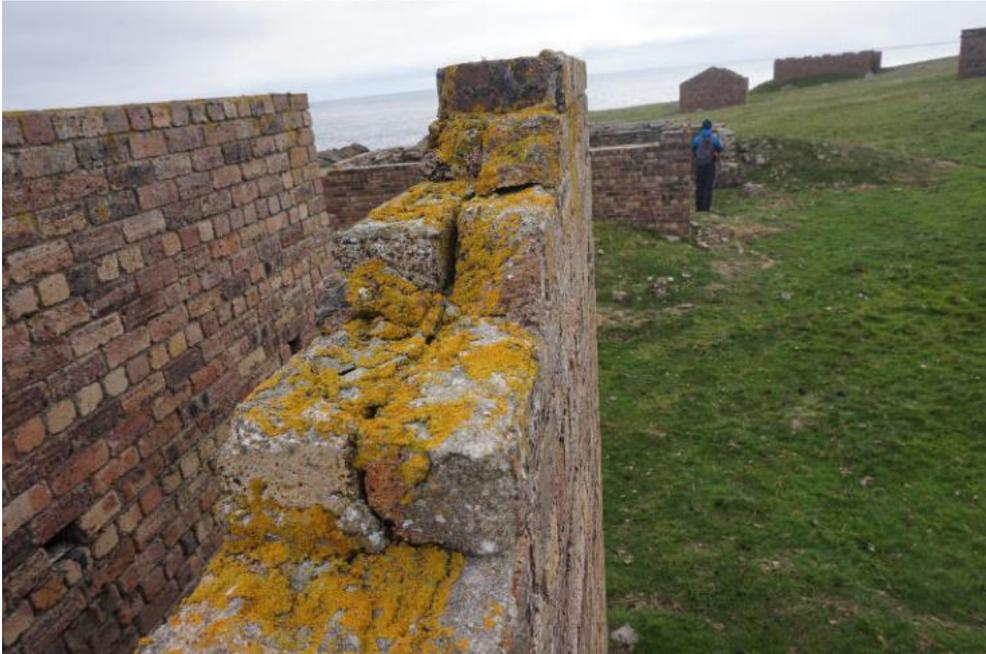
Failing skyward facing joints should be repointed.

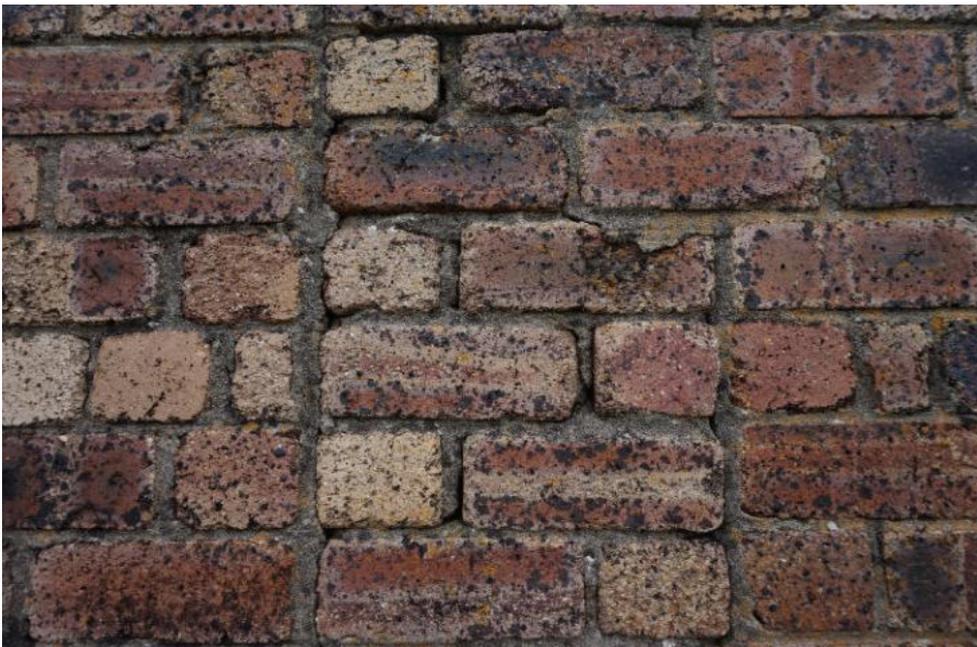
Localised failing wall face joints and minor cracking should be repointed. Note poor continuity between pier (middle of photo) and adjacent panels – see also photos 5 and 6.

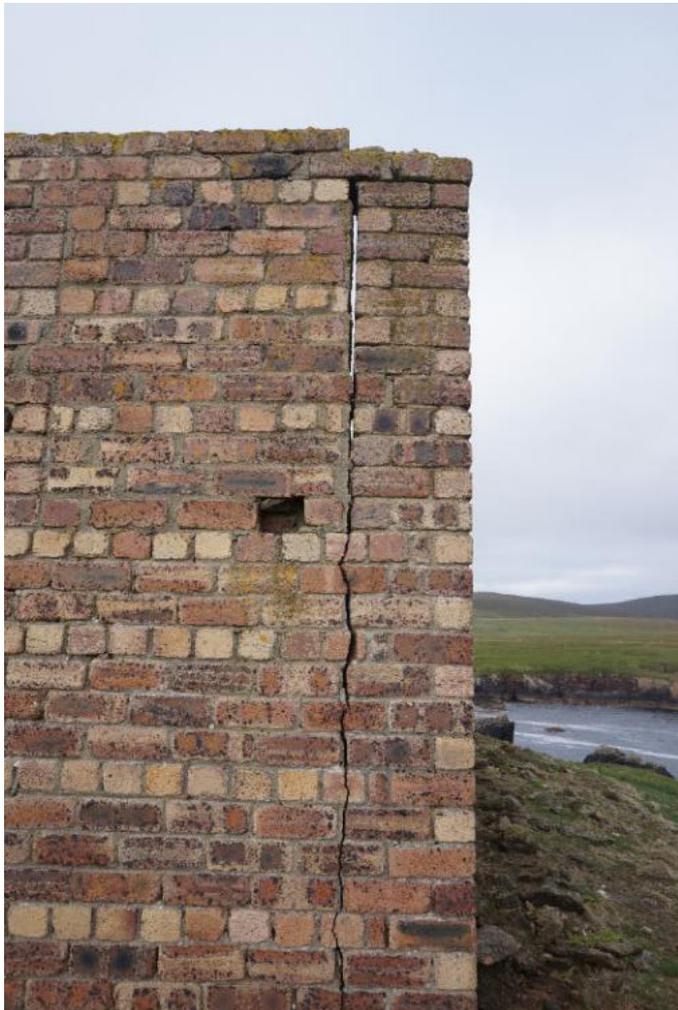
Cracks at the northeast (lower image) and southeast corners where brickwork is poorly tied and are likely to be exacerbated by poor ground conditions affecting the foundations. Stitching across these cracks is recommended.

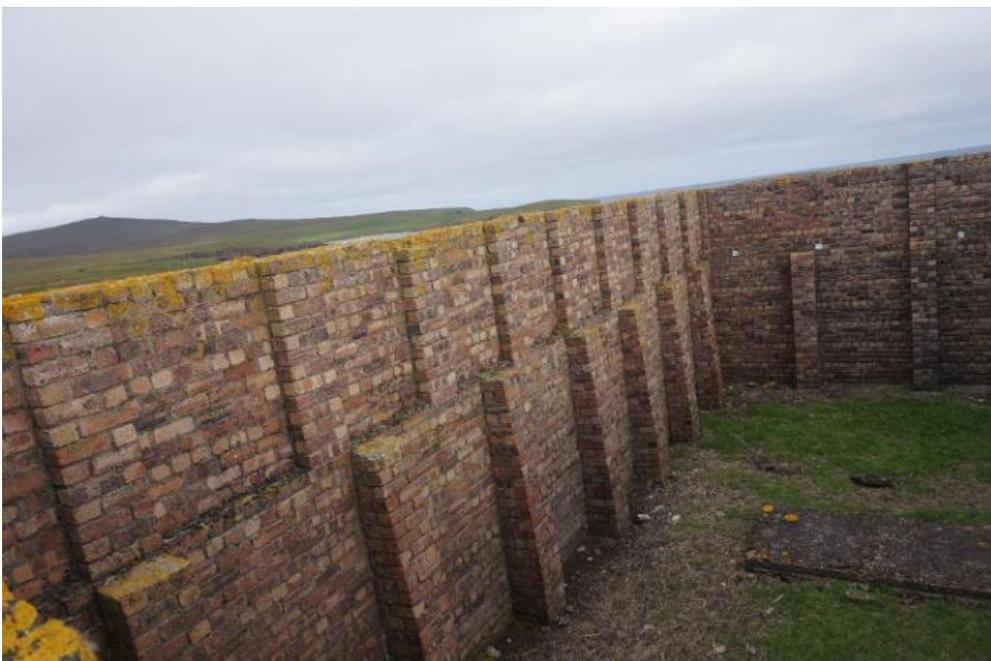
Cracks at higher levels are aligned with the upper piers which are poorly tied to the adjacent thinner single brick thick infilled brickwork. See also Photo 2

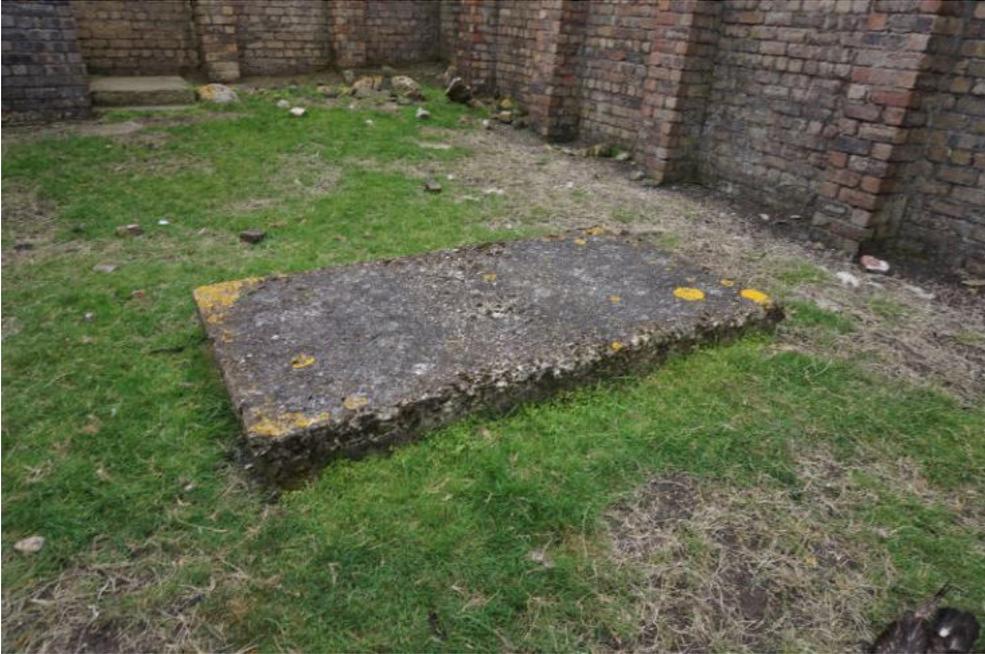
The concrete base internally is in good condition.

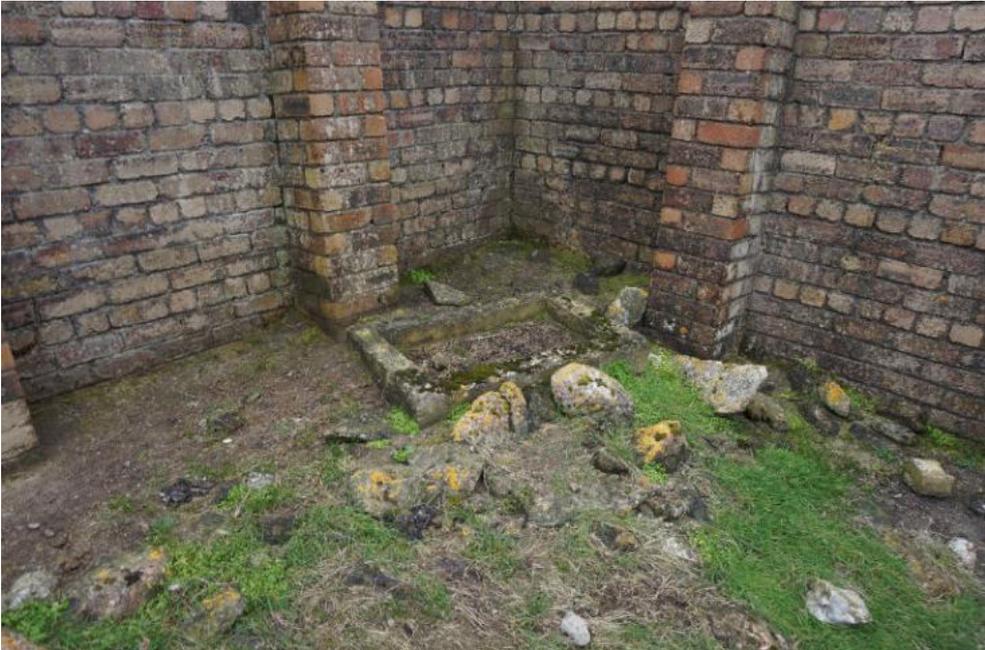
The small rectangle brick structure internally is in good condition. There are loose stones and bricks throughout the grass covered floor internally.

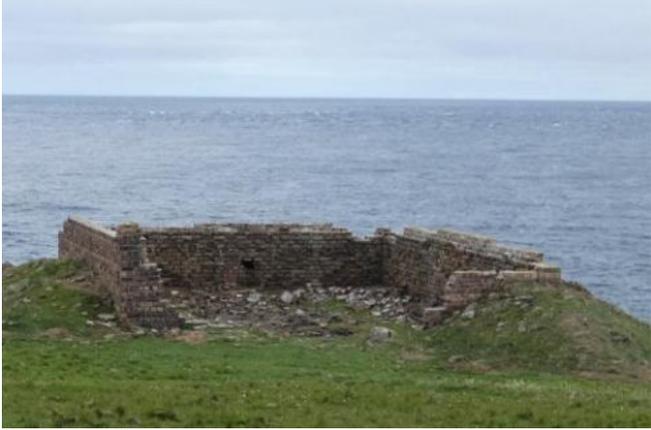
Condition:			
<p>Poor: Badly fire damaged having previously been used by the local fire service for training drills. Upper sections of walls have collapsed with loose brickwork lying in close proximity of the structure. Surviving lower brickwork is fire damaged, with internal faces vitrified, many becoming detached from the masonry, and all joints friable. Externally, there is loose bricks to wallheads and around the south facing opening, and localised cracking, failing joints and cracks elsewhere.</p>

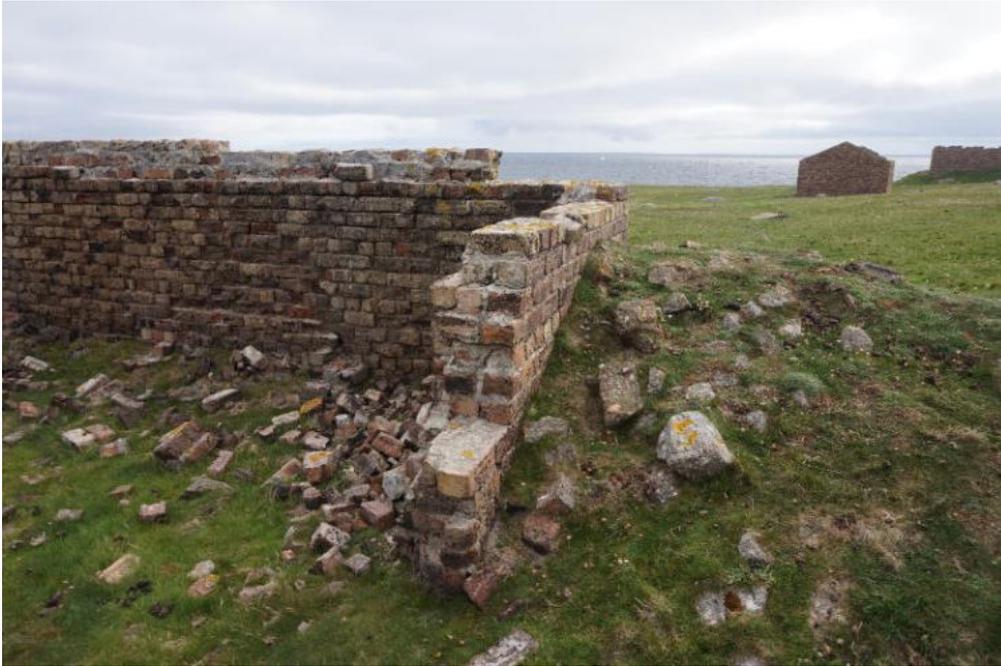
Fallen brickwork should be removed to allow safe access to carry out repairs and to minimise health and safety risk if increased footfall is anticipated. Upon completion of the brick repairs, consider reinstating the earth banking to increase the stability of the fire damaged walls.

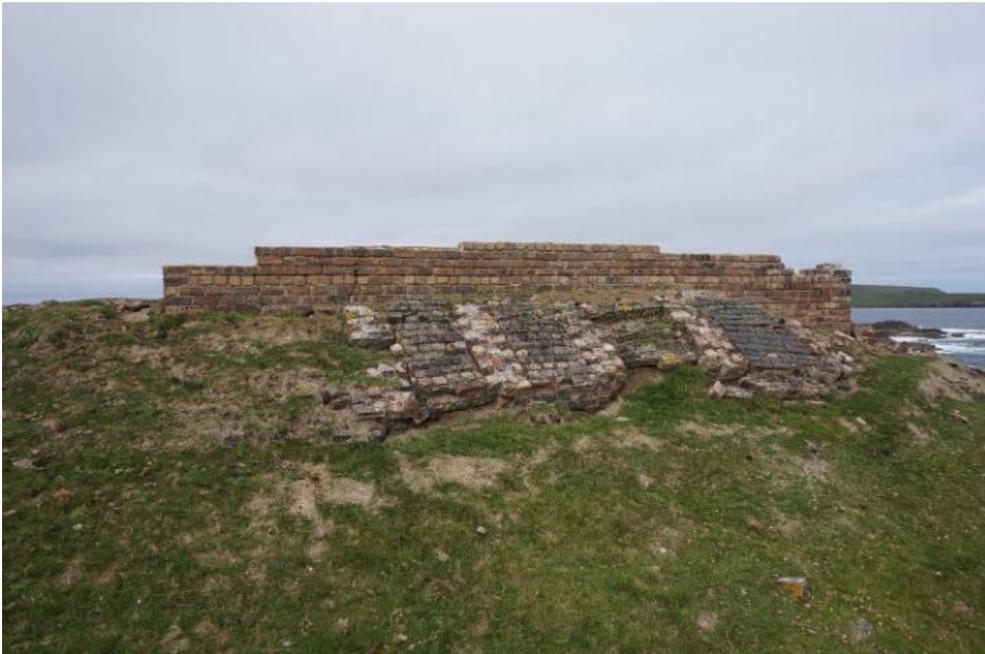
The collapsed brickwork from the east elevation, which appears to have fallen in one large intact section, could potentially be left or buried.

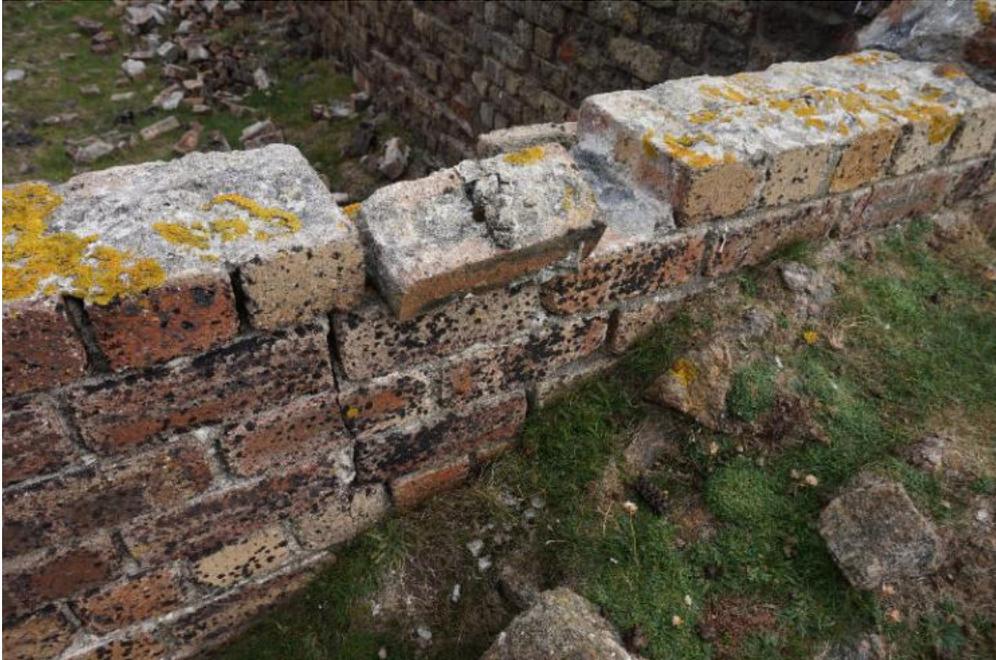
Defective skyward facing joints should be repointed, with allowance for resetting loose brickwork.

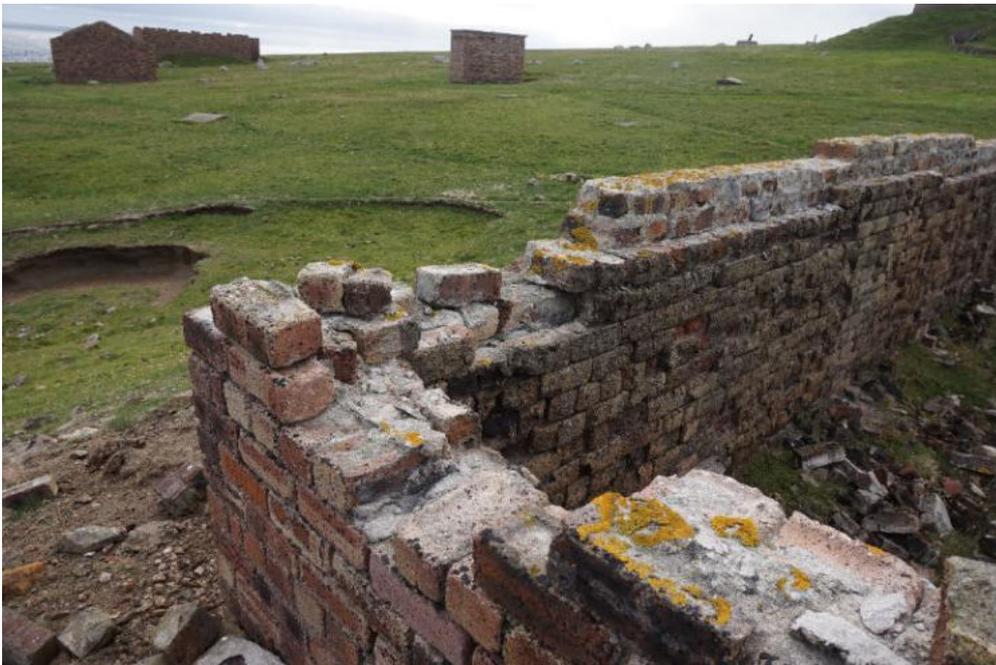
Loose wallhead brickwork and failing joints.

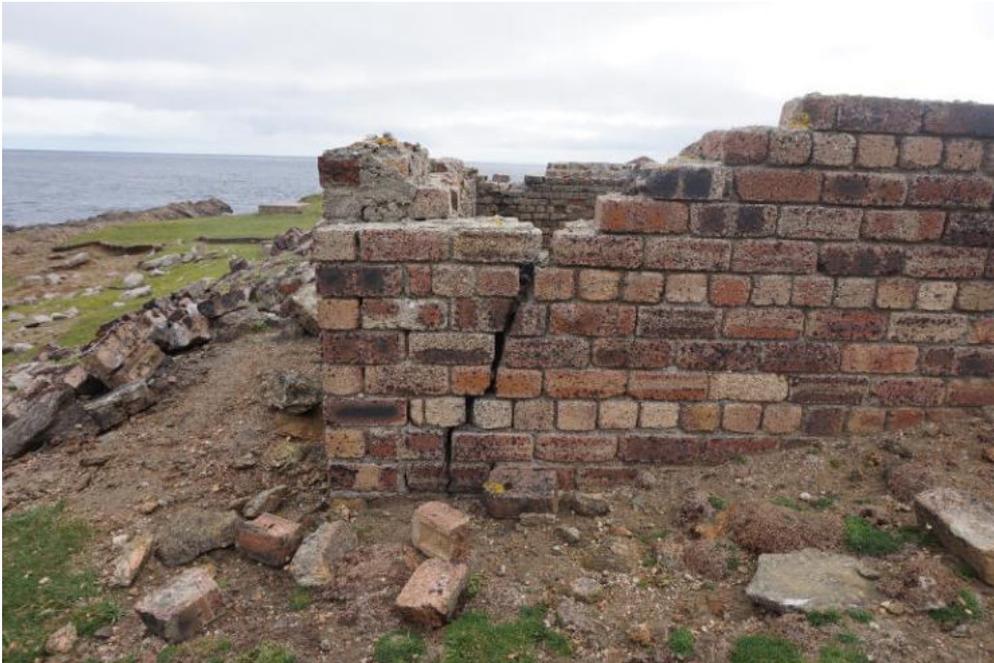
Repoint failing joints and cracks on external faces. Consider reinstating / increasing the height of the earth banking to provide additional support to the fire damaged walls.

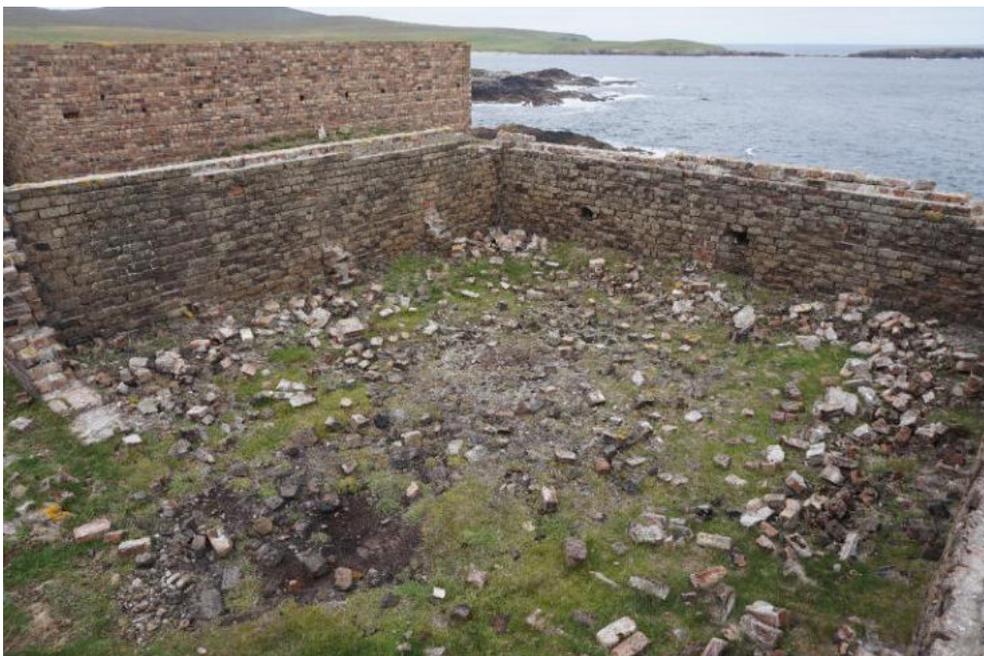
General view internally.

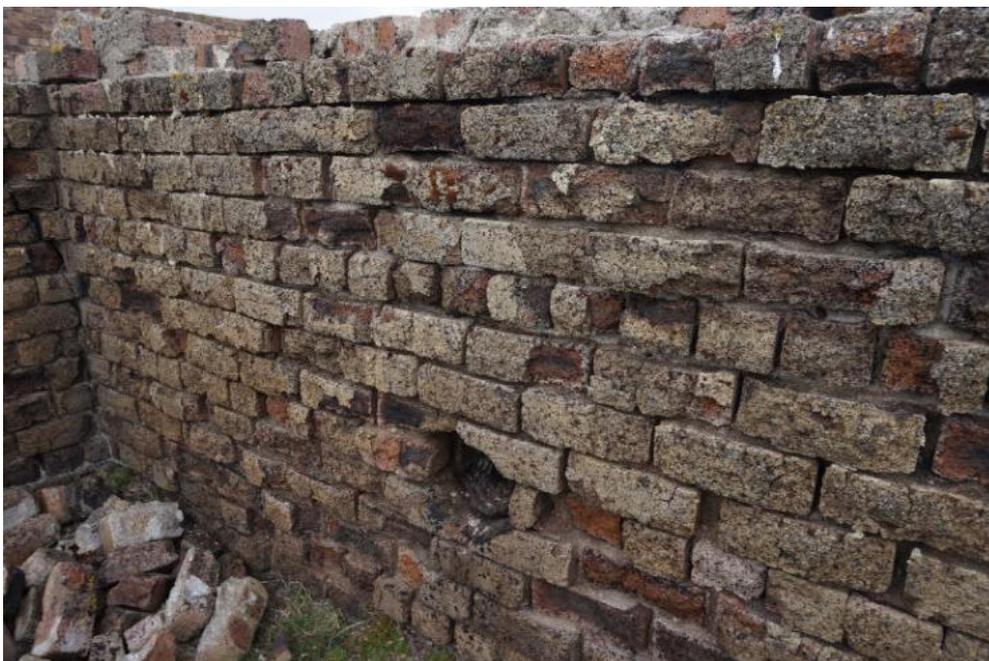
The internal faces are badly fire damaged, requiring extensive consolidation including repointing, resetting loose bricks and replacing badly damaged bricks.

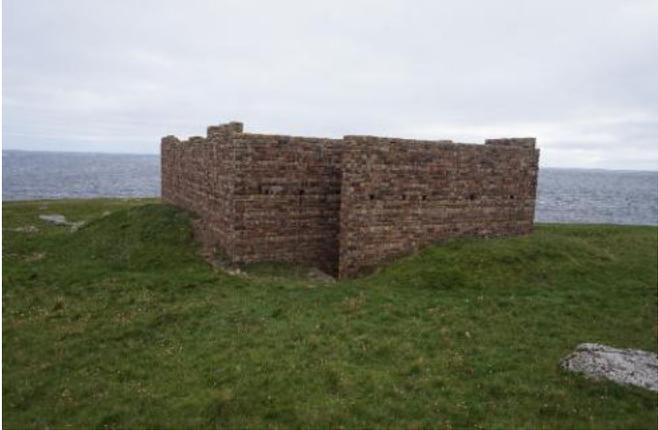
Condition:			
<p>Fair: Open and failing skyward facing joints to wall head and locally elsewhere on wall faces.</p> <p>Missing section of brickwork c.0.5m² (built up with dry bedded stonework) on east elevation above internal ground level with crack above extending vertically following line of poorly bonded bricks. Cracking elsewhere at upper level where the single brick thick brickwork is poorly tied to the 1.5 brick thick piers, and locally at lower levels.</p>

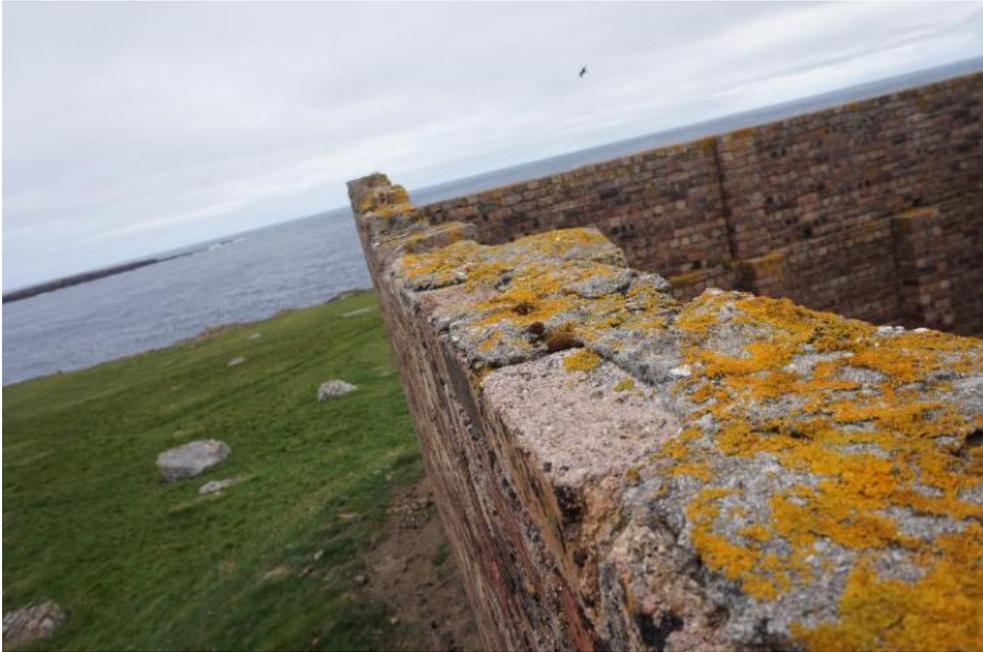
Failing skyward facing joints should be repointed, with allowance for rebedding loose bricks.

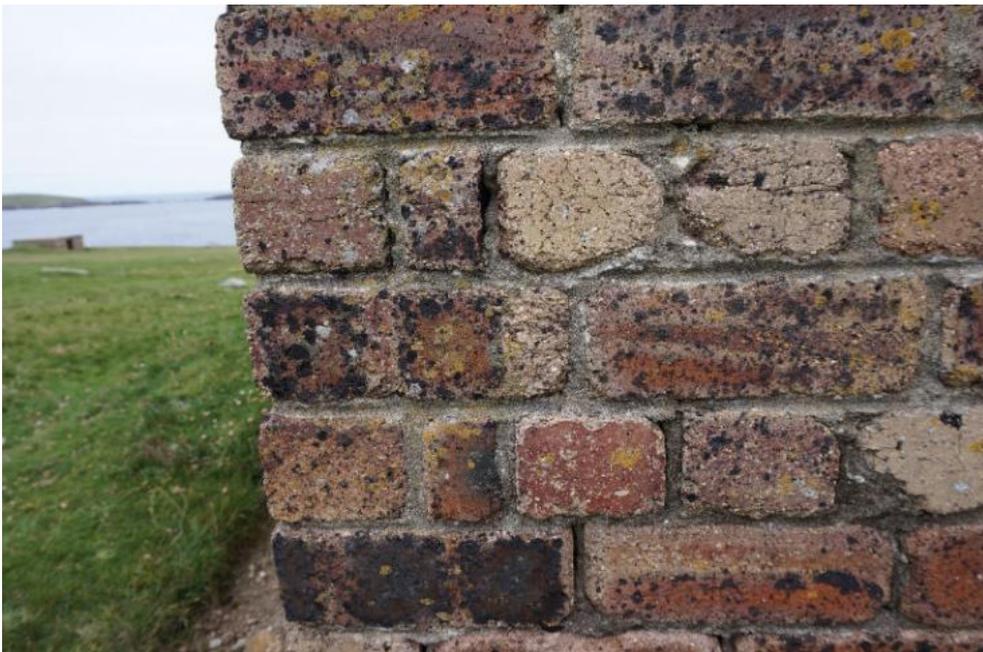
Localised filling wall face joints and minor cracking should be repointed.

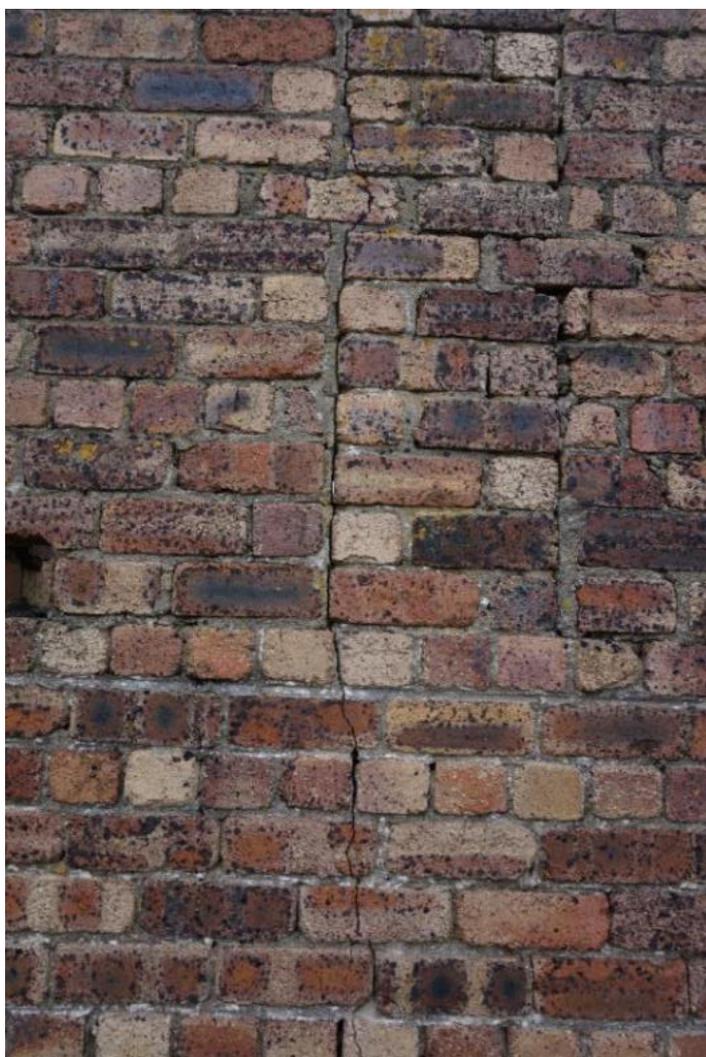
A vertical crack extends from a section of missing brickwork at ground level internally on the east wall. The brickwork panels either side of the pier (seen just off-centre) are poorly tied across the pier.

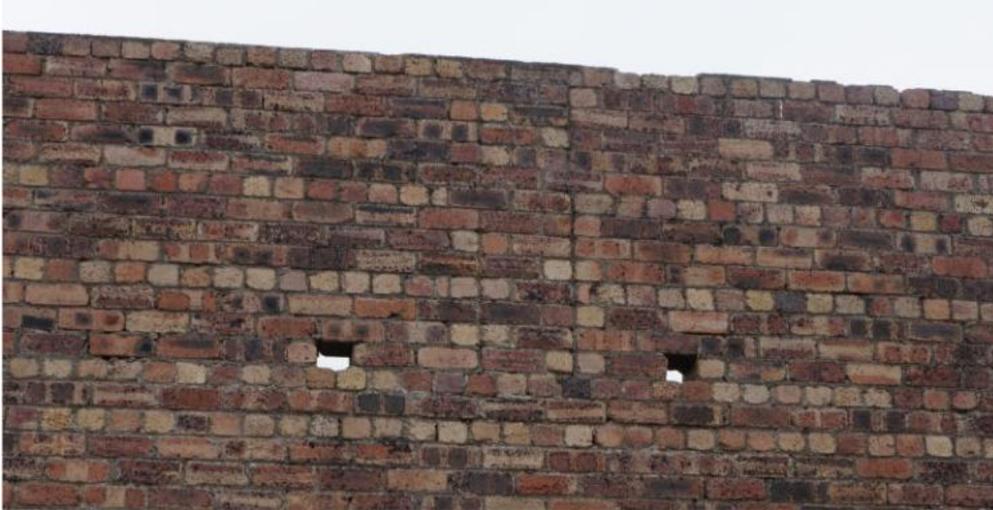
Cracks at higher levels are aligned with the upper piers which are poorly tied to the adjacent thinner single brick thick infilled brickwork.

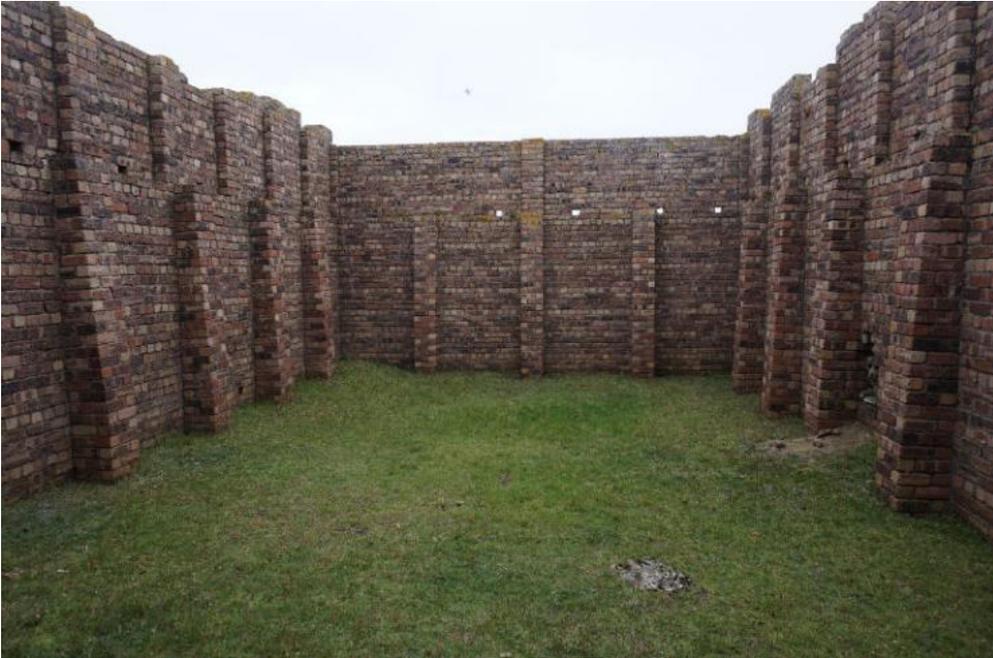
Internal general view.

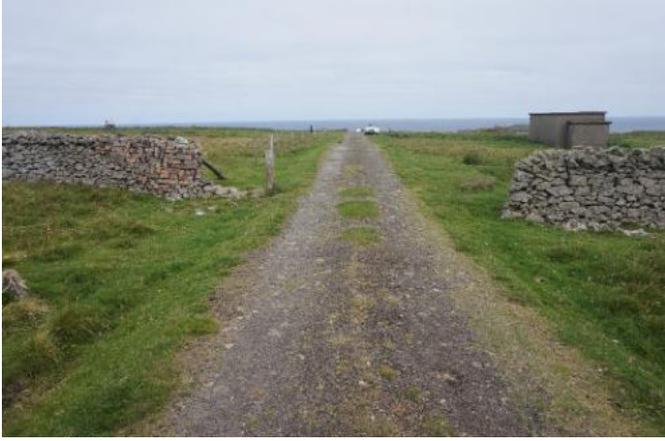
Condition:			
<p>Good: Localised missing coping stones to the north section of wall. Bulging section c.10m² at c.30m north of the access road. Timber post is rotten.</p>			
Recommendations:			Priority:

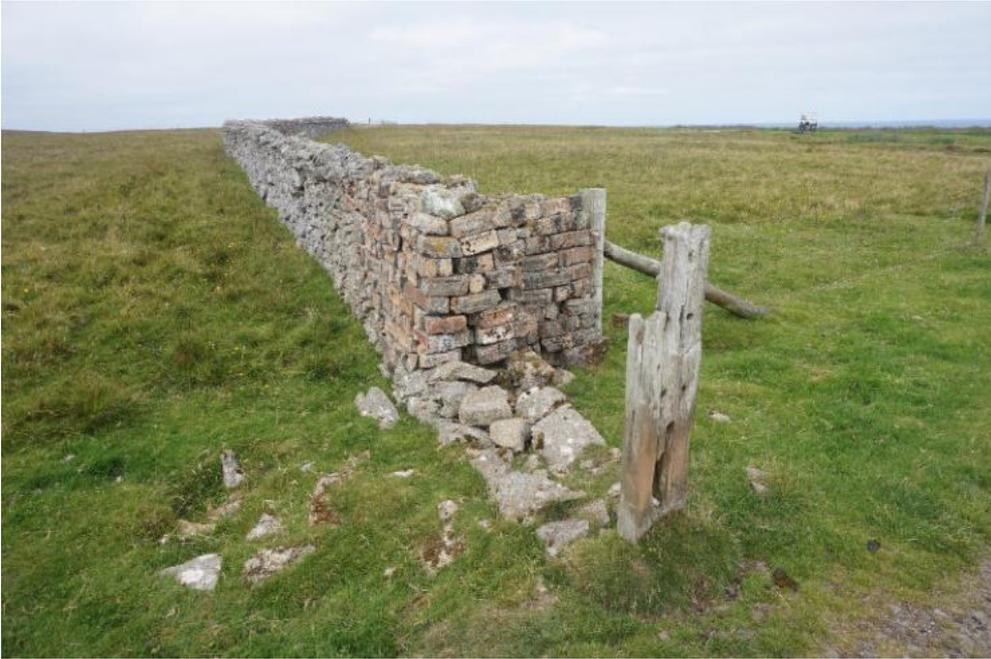
General view north: Brick repairs immediately north of the access road. The repairs remain functional. Rotten timber gate post.

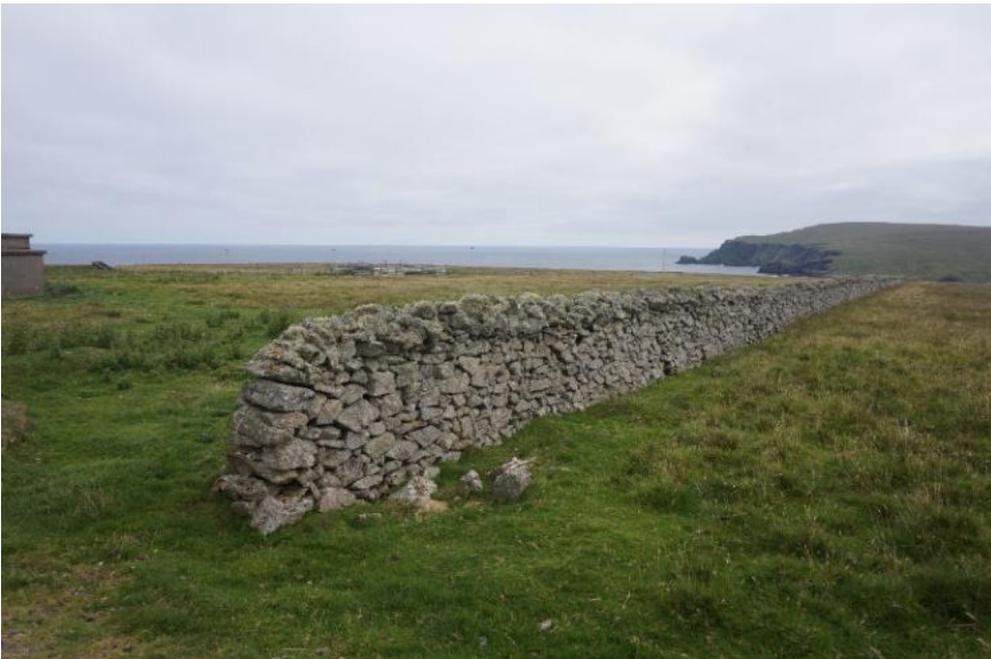
General view south: Copes should be regularly check and loose/displaced stones reset.

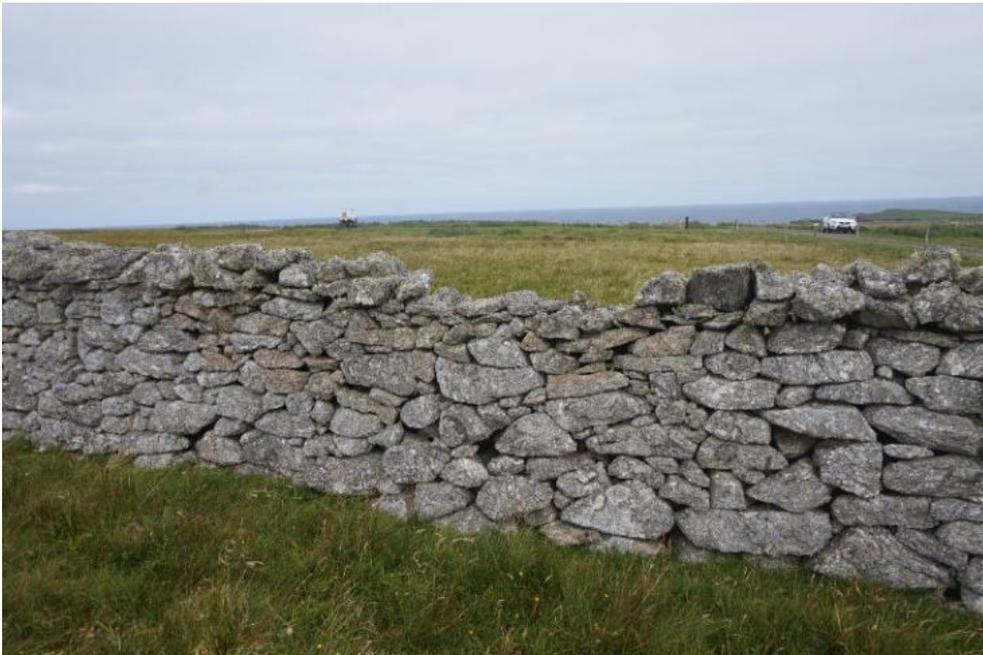
Displaced cope stones should be reinstated.

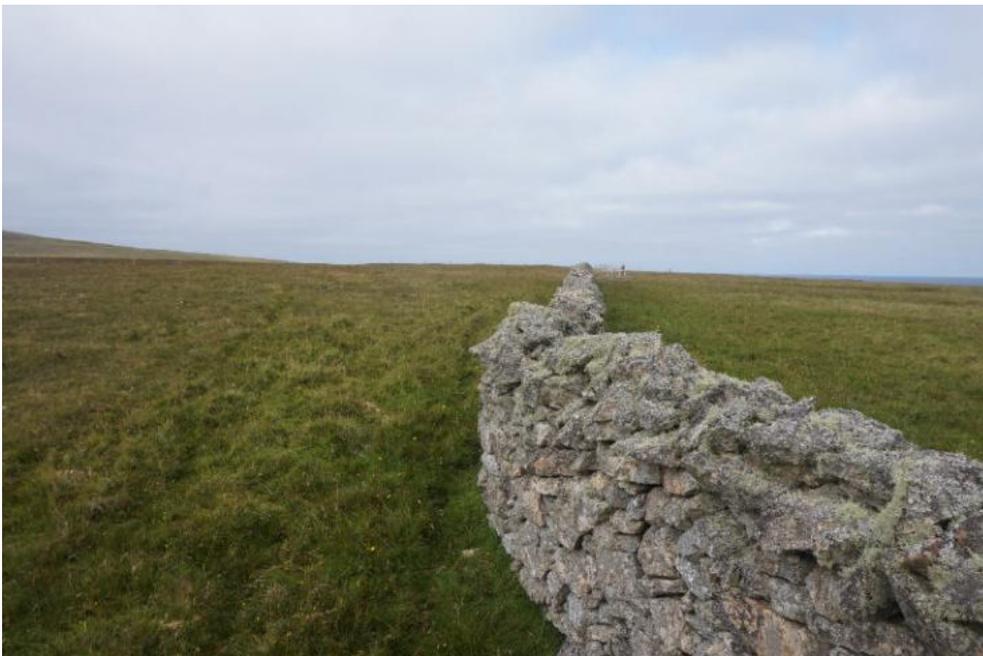
Monitor the bulged section and allow repairs/rebuilding if its condition worsens.

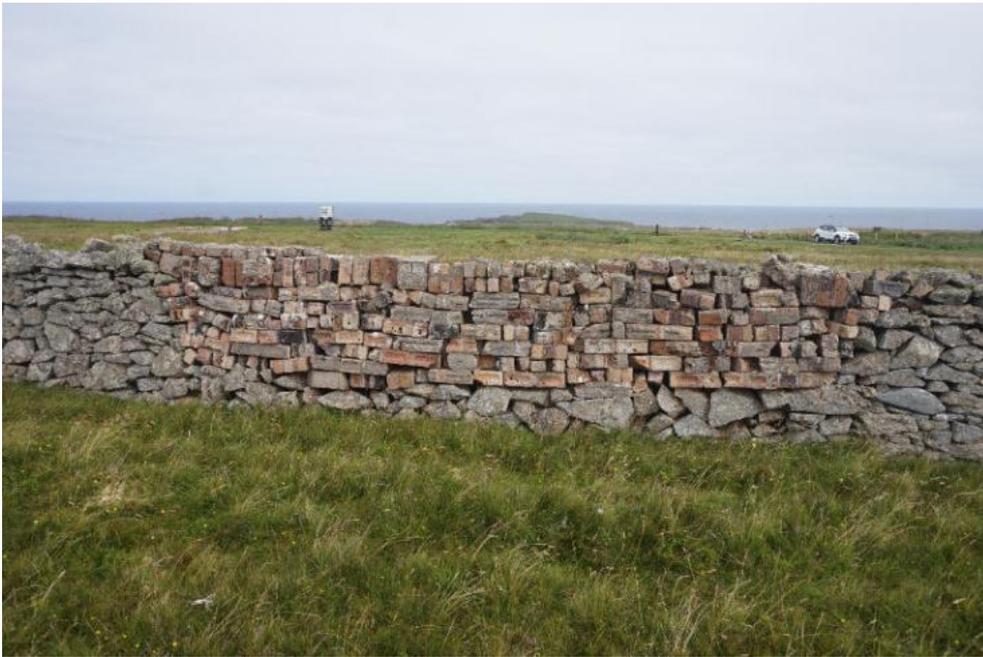
The repair using salvaged bricks c.40m north of the access road remains in good condition.

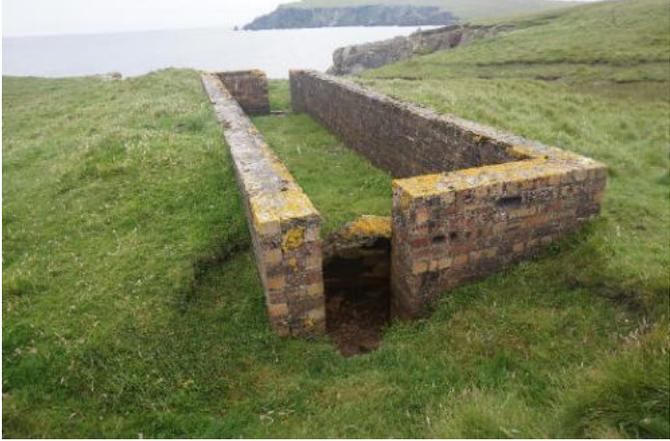
Condition:			
<p>Fair: Localised open, cracked and failing mortar joints throughout, including to exposed wallhead which is supporting vegetation growth. Damaged and missing brickwork to wallhead and at south opening.</p>			
Recommendations:			Priority:
1.	<p>Record and monitor future condition, with provision for localised repointing of open and defective joints, especially skyward facing joints. £100.00</p>		Desirable

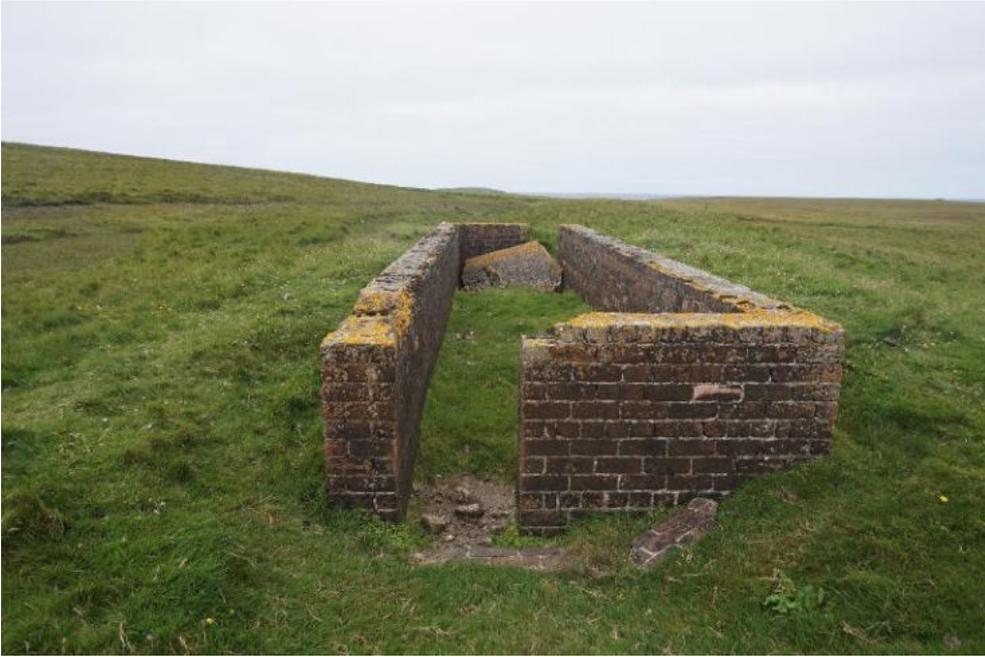
View from south showing missing wallhead brickwork, and displaced bricks and concrete roof slab.

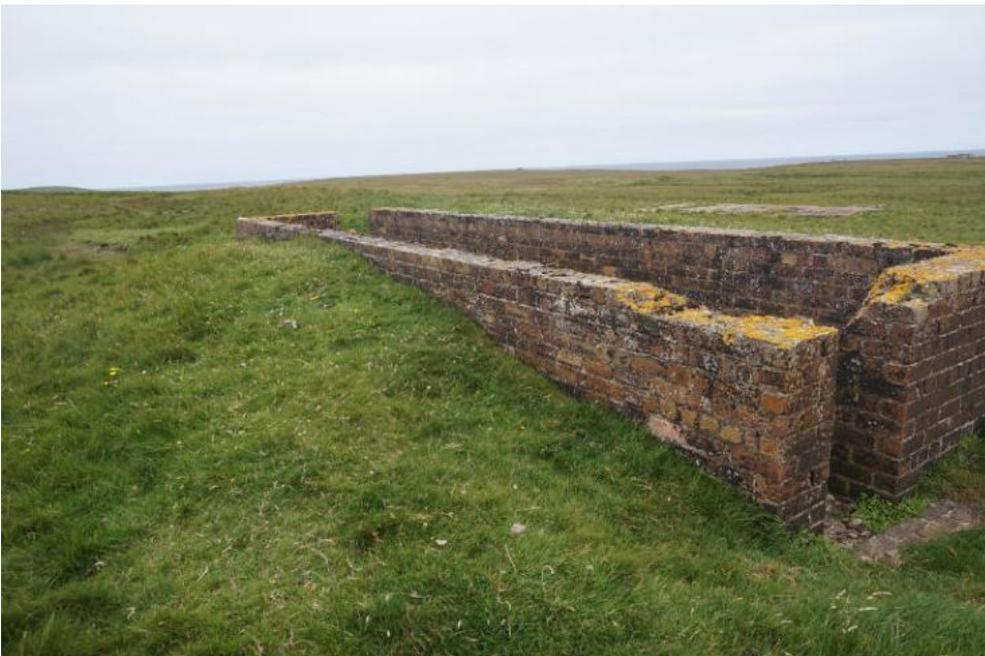
Despite localised failing mortar joints, and damaged and missing brickwork, the structure is in a stable condition.

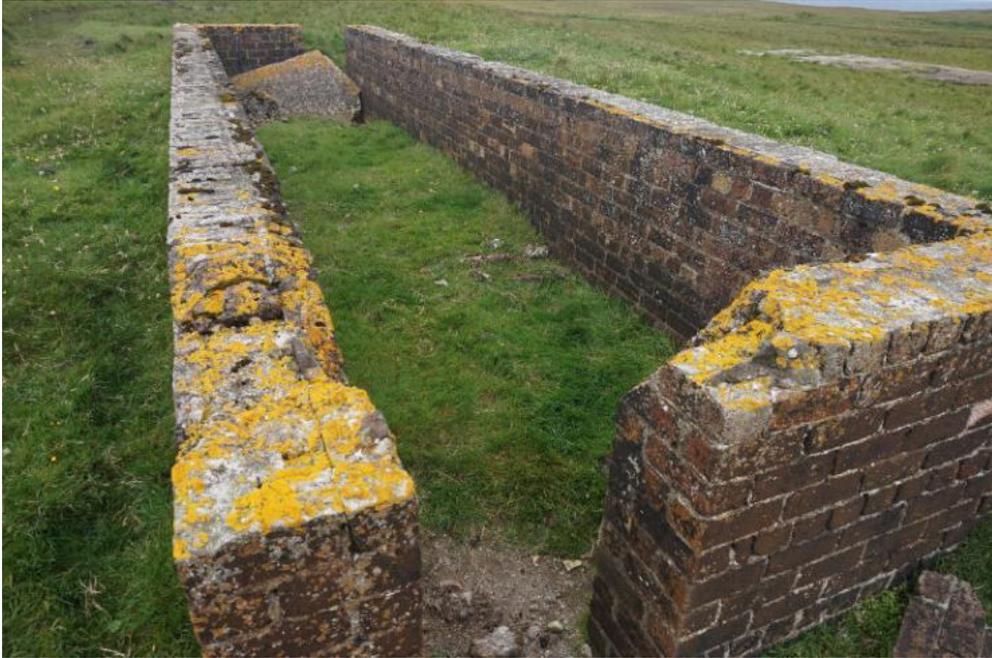
General internal view from south.

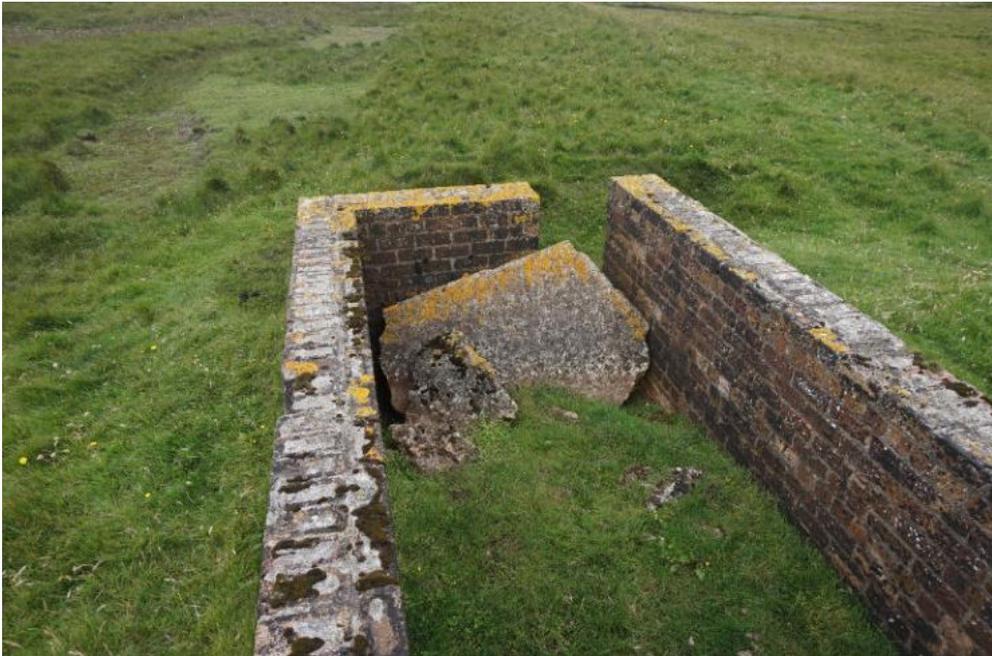
Internal ground levels have increased due to accumulations of soil, and fallen brickwork and concrete.

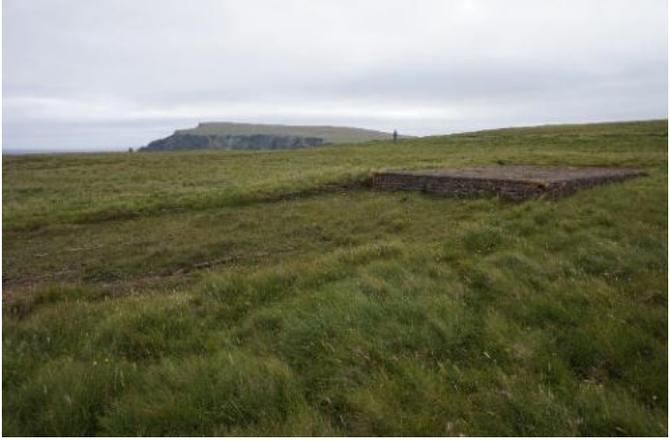
Condition:			
Poor: Loose and displaced brickwork throughout east portion, with failing mortar joints throughout. Cracked and disaggregated concrete floor slab supporting vegetation growth, and localised missing/damaged wallhead brickwork and failing joints to the west portion.			
Recommendations:			Priority:
1.	Record as existing and consider burying to protect footings and concrete from further damage from exposure and increased footfall. £5000.00 – Provisional cost		Necessary

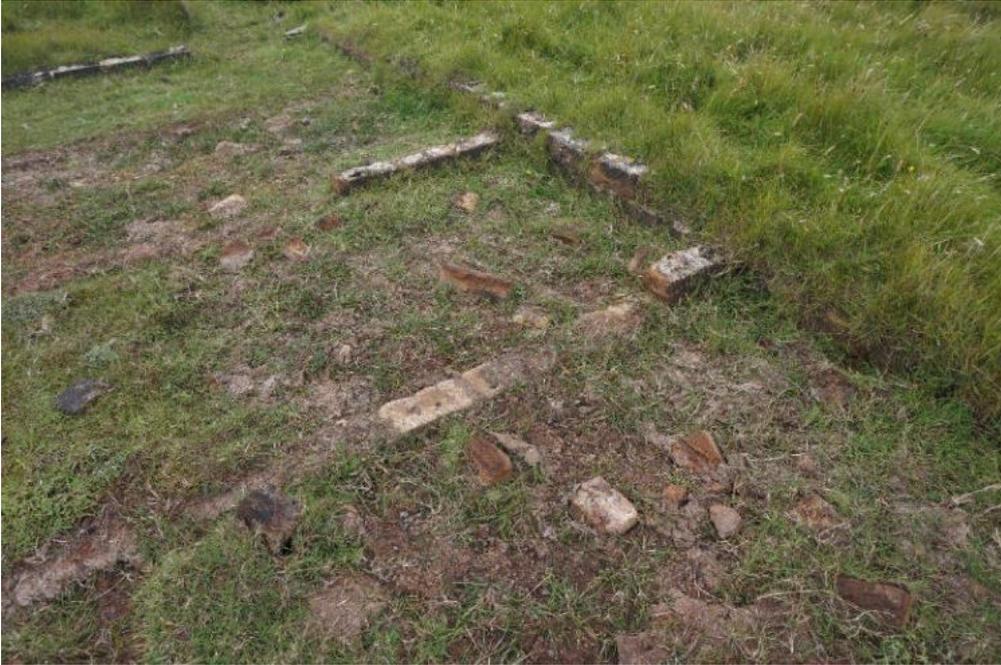
There is loose and displaced brickwork throughout the east portion. Consideration should be given to burying them to protect them from exposure to weathering and from the impact of increased footfall to the site.

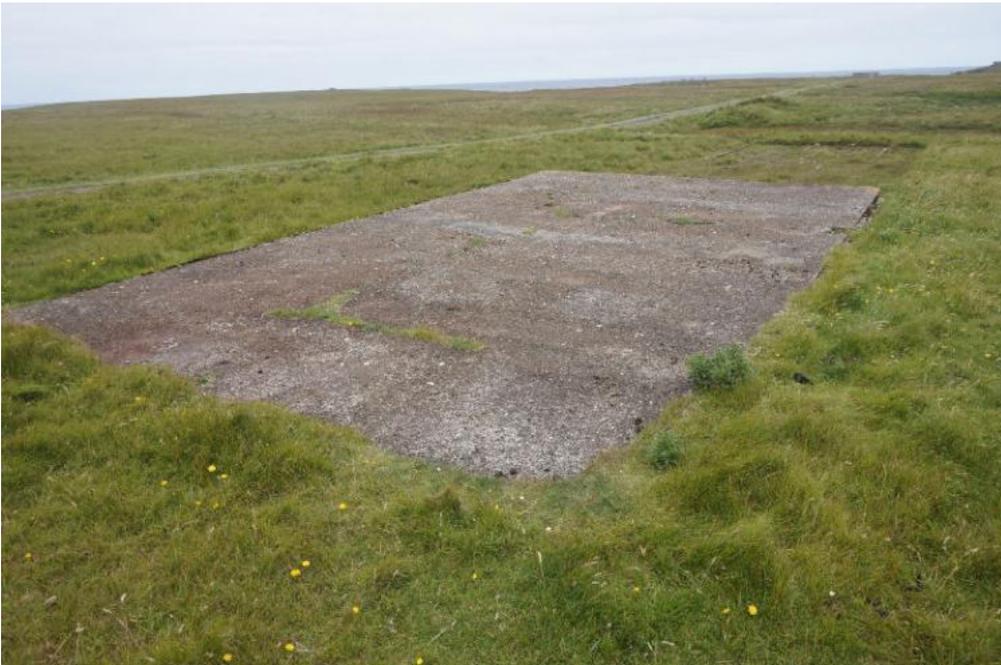
General view from southwest of west portion comprising concrete floor slab surrounded by part buried brick footings.
