Appendix 14.10 Conservation Management Plan

Shetland Space Centre Conservation Management Plan

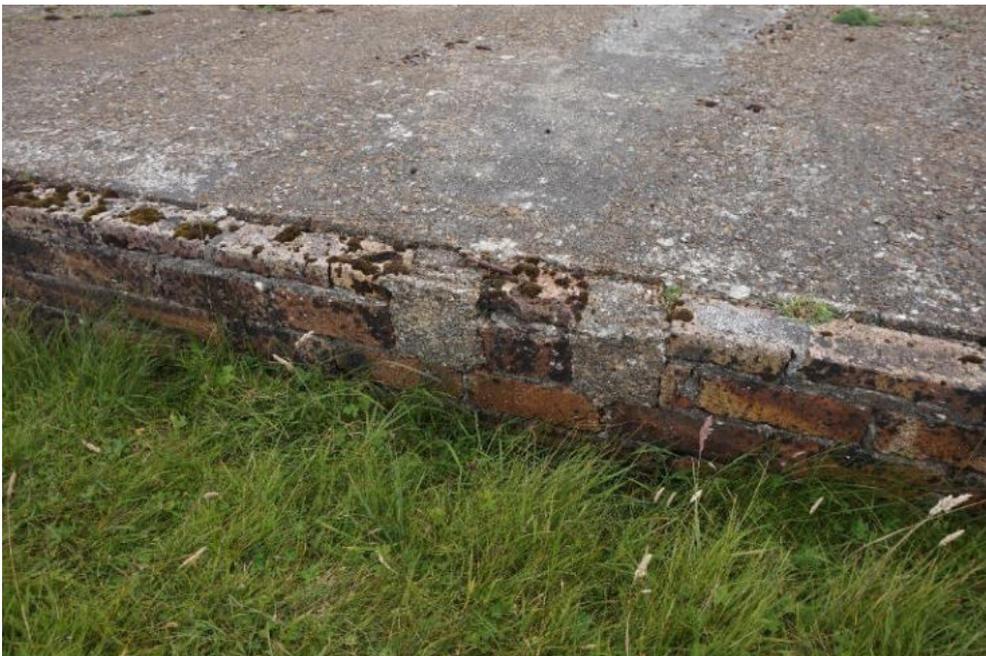
Stumps of reinforced concrete superstructure visible on the footings of the north and south elevations. Note cracked and failing mortar joints.

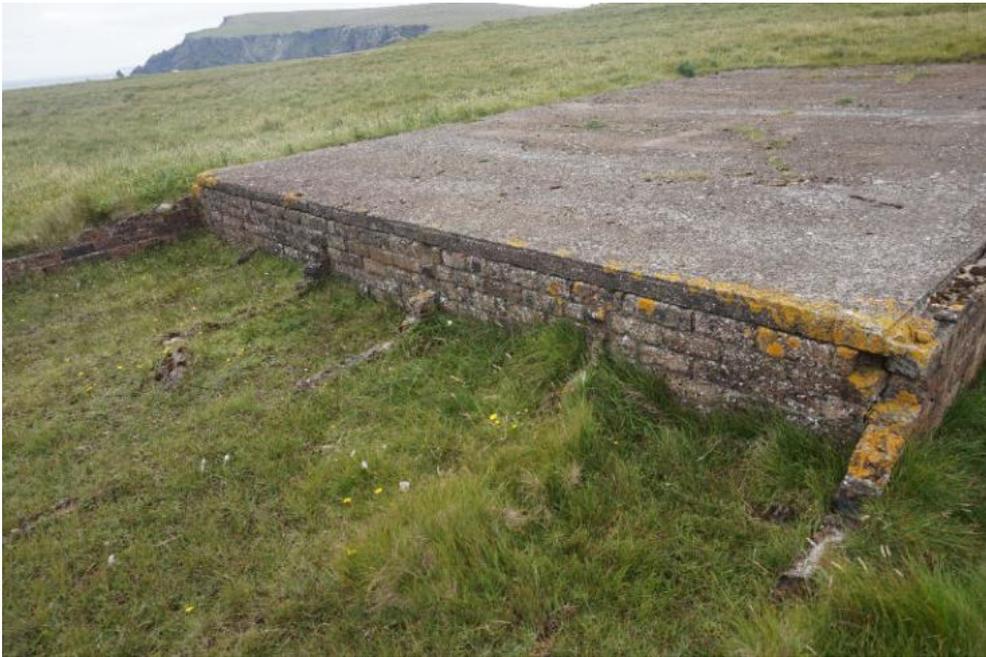
East face of west portion with failing joints and damaged brickwork.

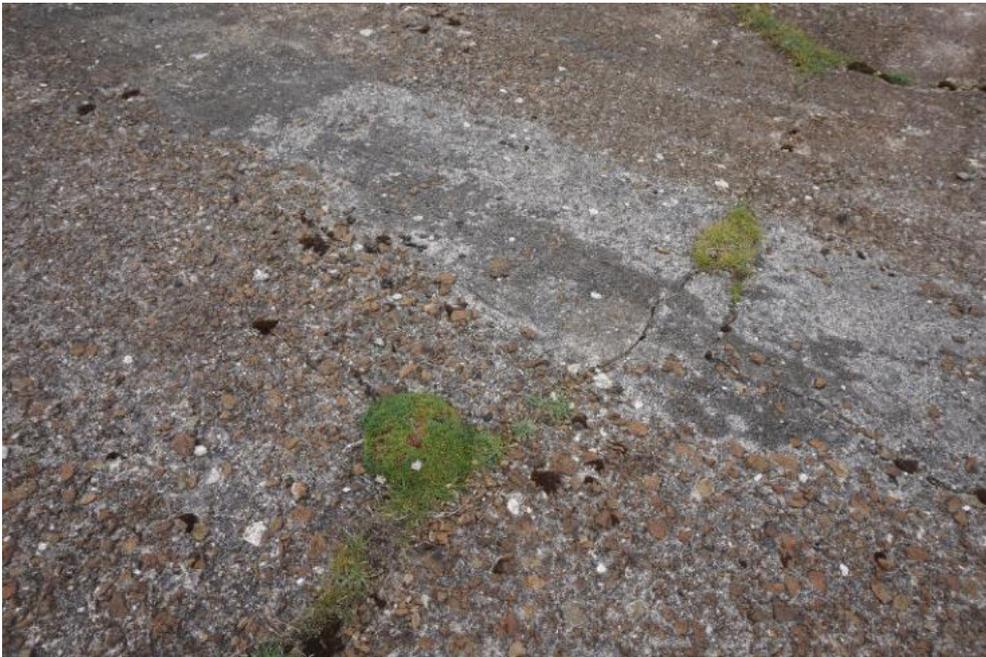
Cracked and disaggregated floor slab supporting vegetation growth.

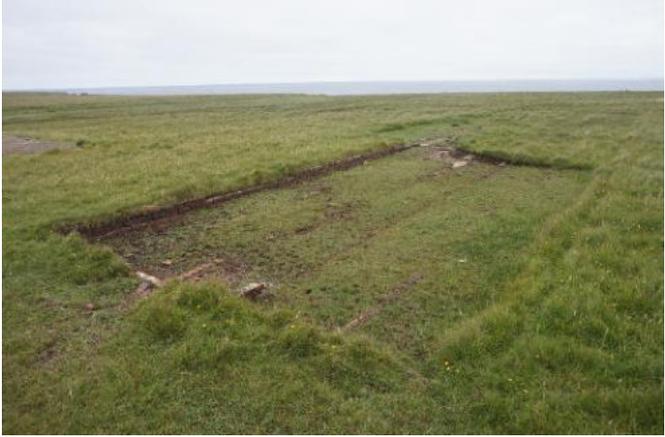
Condition:			
Poor: Loose and displaced brickwork in all areas, with failing mortar joints throughout. Exposed concrete strip foundations are disaggregating. Displaced bricks, timber and metal work lying between footings at south end of the site.			
Recommendations:			Priority:
1.	Record as existing and consider burying to protect footings and concrete from further damage from exposure and increased footfall. £5000.00 – Provisional cost.

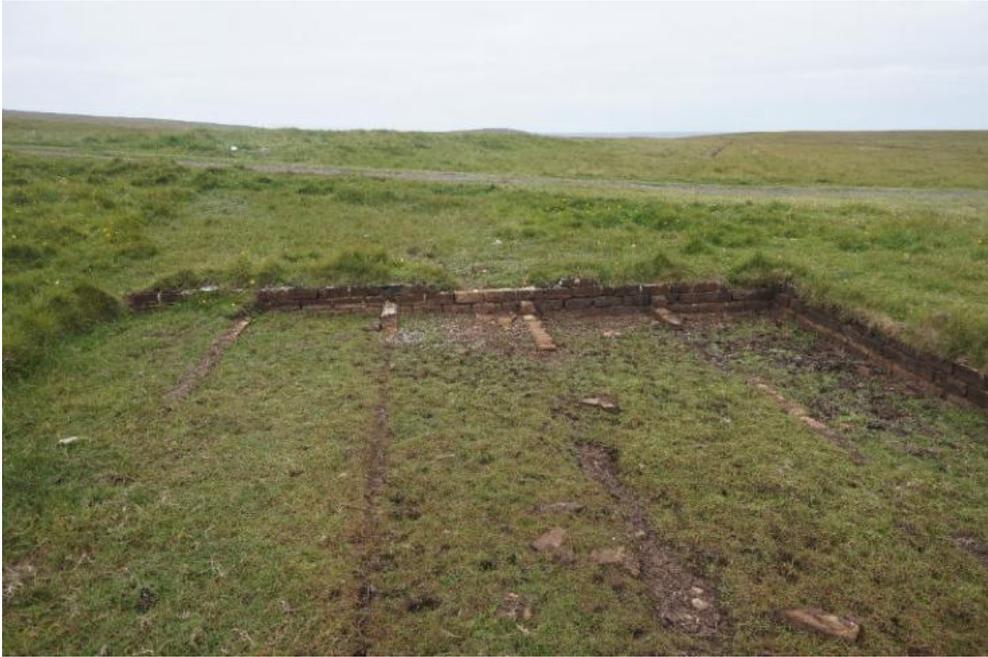
Internal view showing part buried footings with loose bricks and failing mortar joints. Note displaced brickwork. Consideration should be given to burying them to protect them from exposure to weathering and from the impact of increased footfall to the site.

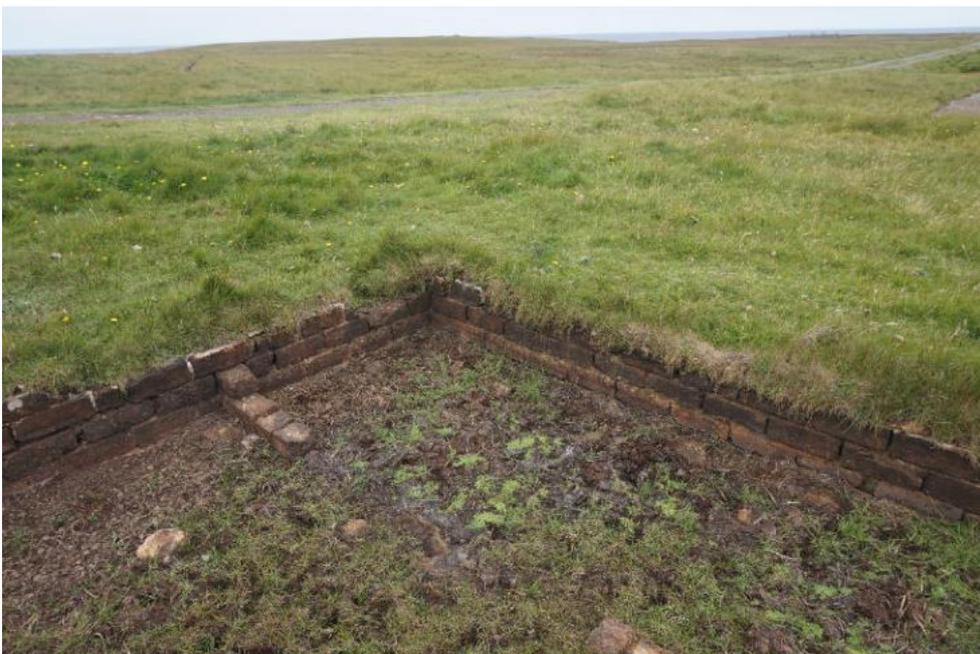
Part buried footings with loose bricks and failing mortar joints in northeast corner.

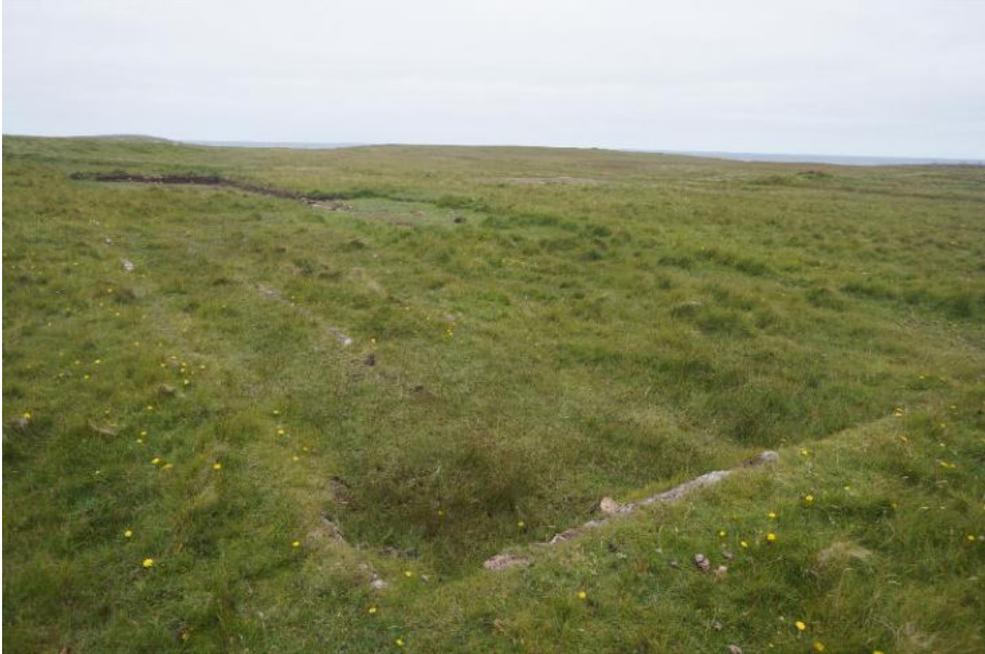
General view from south showing mostly buried footings and foundations.

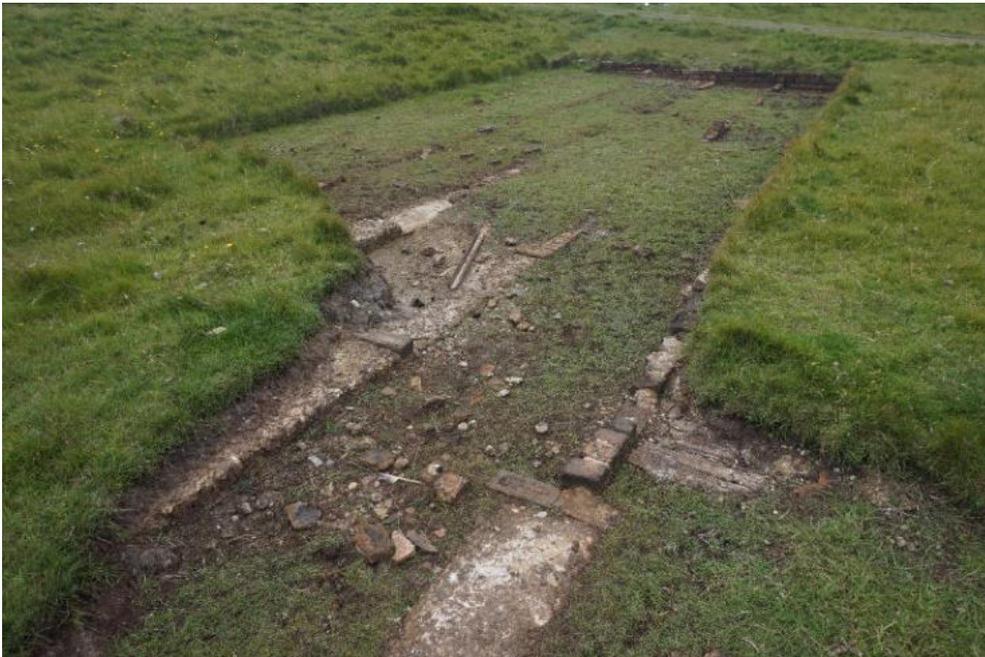
Loose brick footings, disaggregated concrete strip foundations and displaced bricks, timber and metal work at southern portion of the structure.

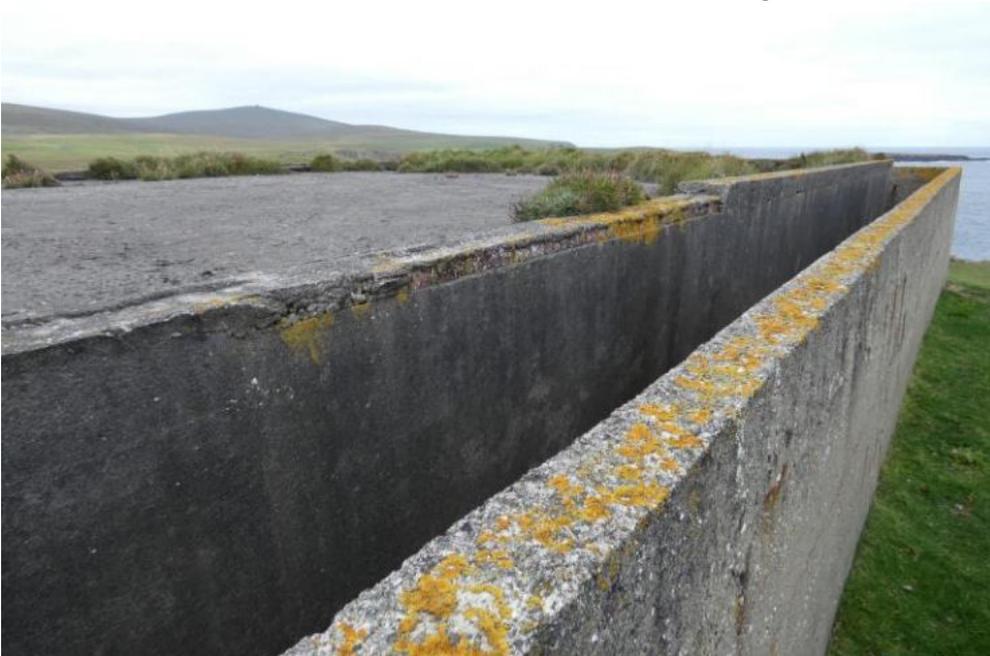
Looking across the surface of the roof. Note missing parapet copes and vegetation growing on roof.

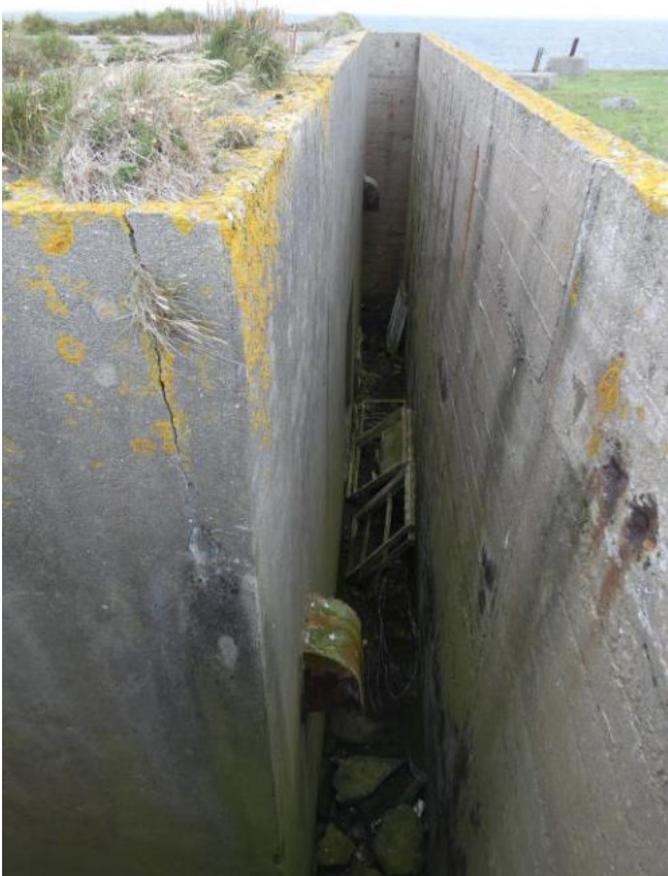
Note the debris across the floor of the perimeter lightwell. Note crack in the render of the building.

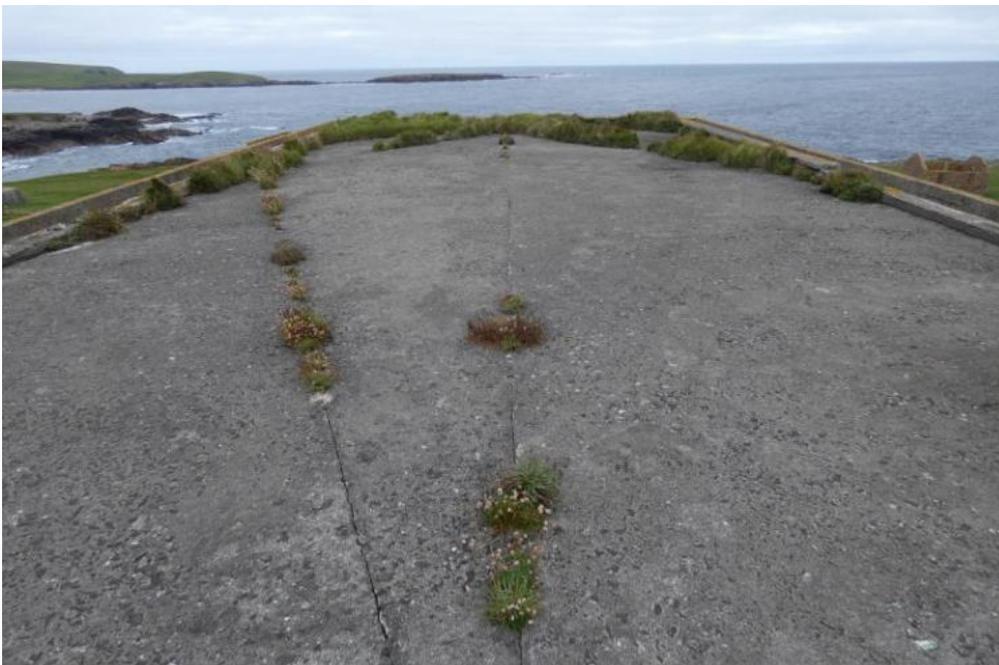
General view across the roof. Note cracking of the asphalt and vegetation growing from those cracks.

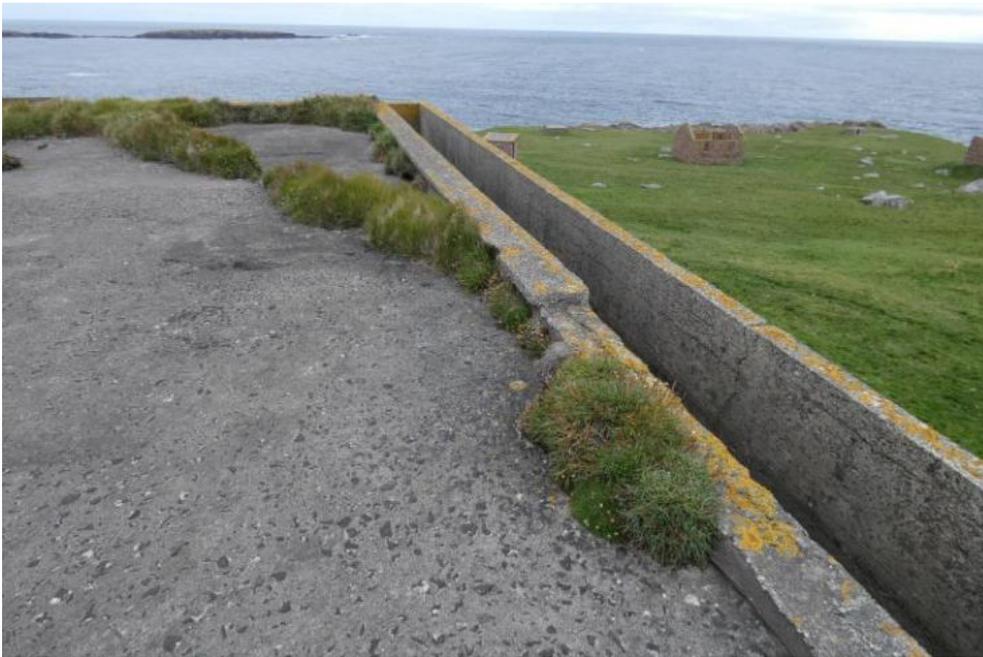
The roofscape. Note missing copes from parapet.

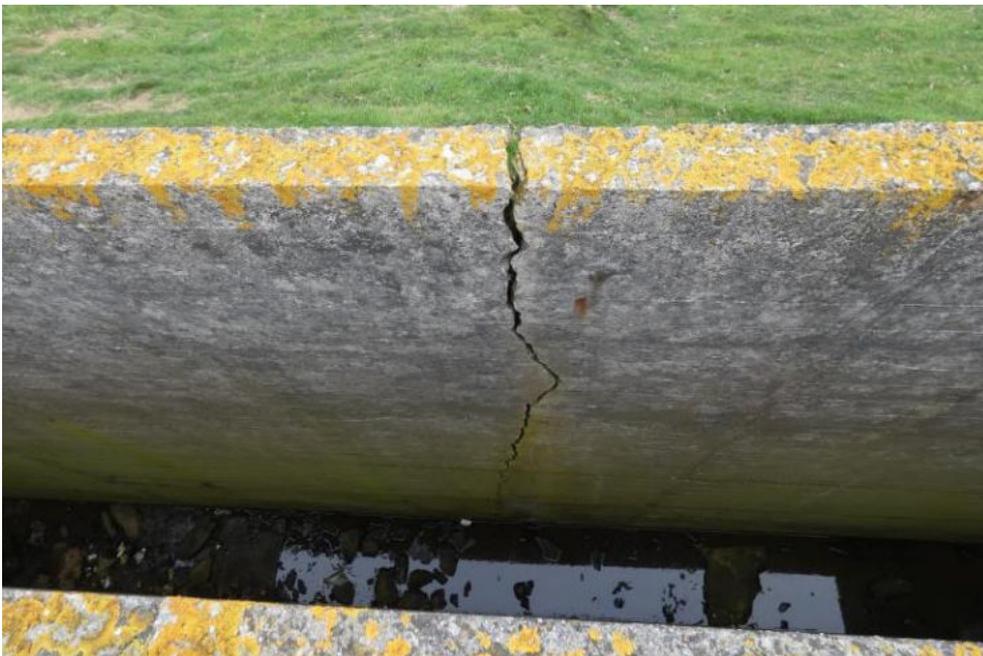
Vertical cracks in the blast walls are wider at the top of the wall than the bottom, indicating foundation movement. the provision of horizontal reinforcing bars appeared to be small.

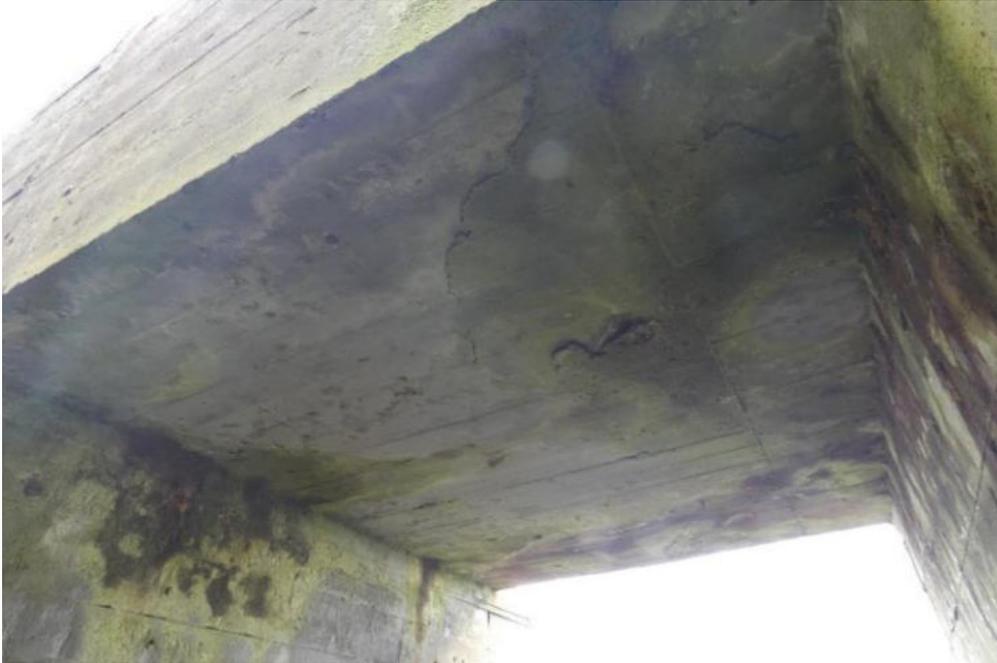
Spalling concrete and render finishes from the soffit of an access tunnel roof.

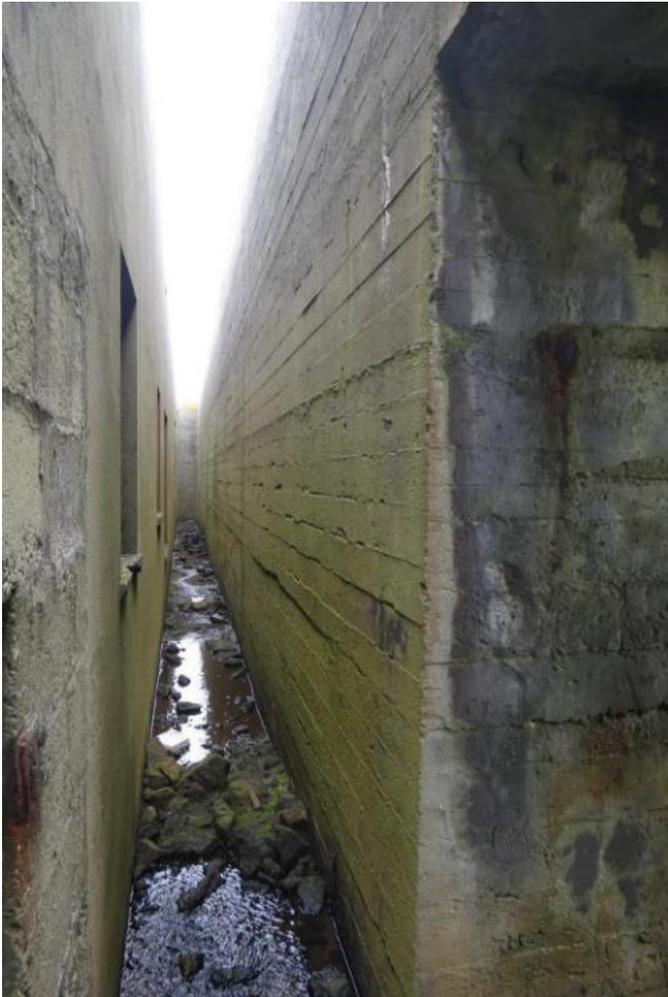
Looking between the blast walls and building proper. Note build up of debris and water.

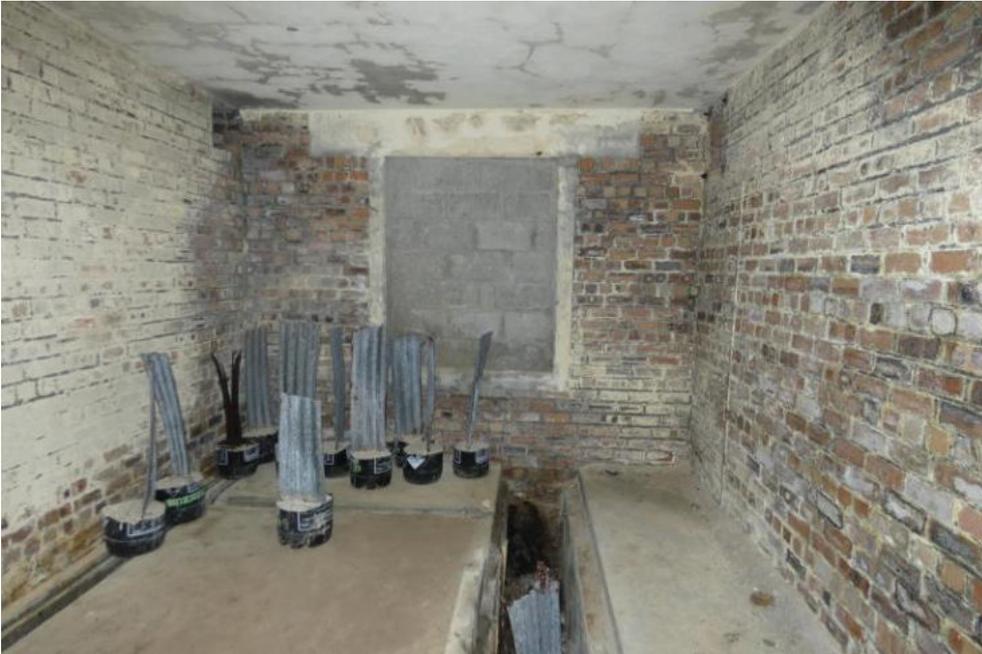
As 10. Note cracked ceiling plaster and indications of general dampness in the brick masonry.

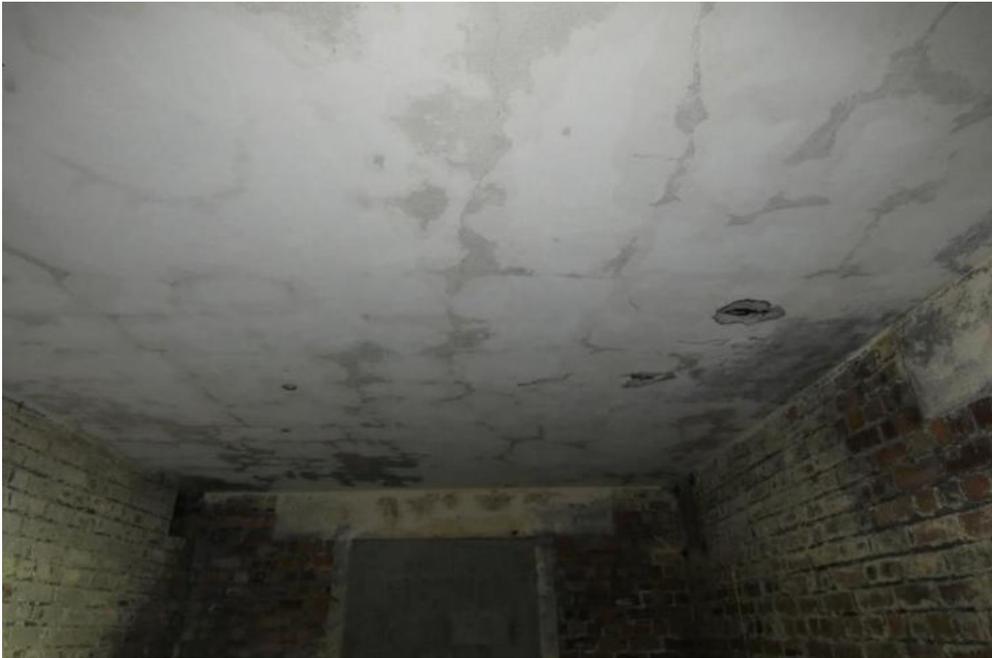
Note cracking of ceiling plaster.

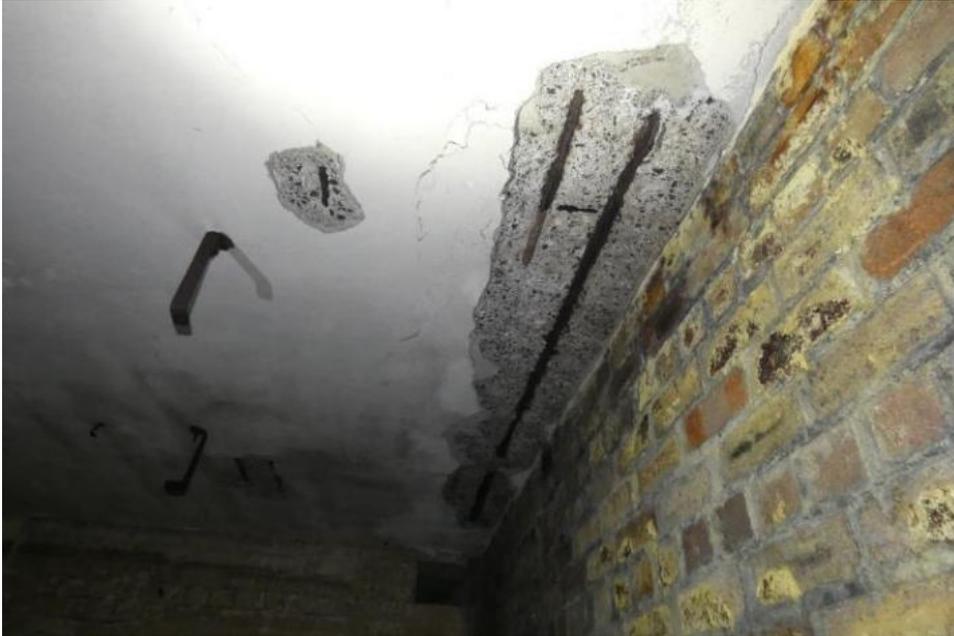
In places, expansive corrosion of reinforcement is causing spalling of concrete from roof soffit.

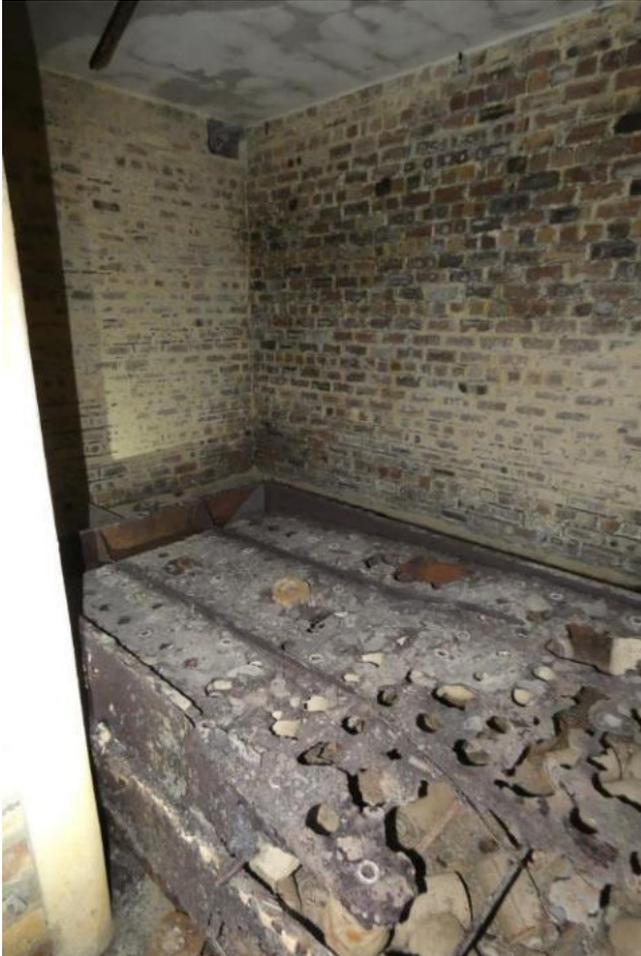
Remnants of equipment survive in places.

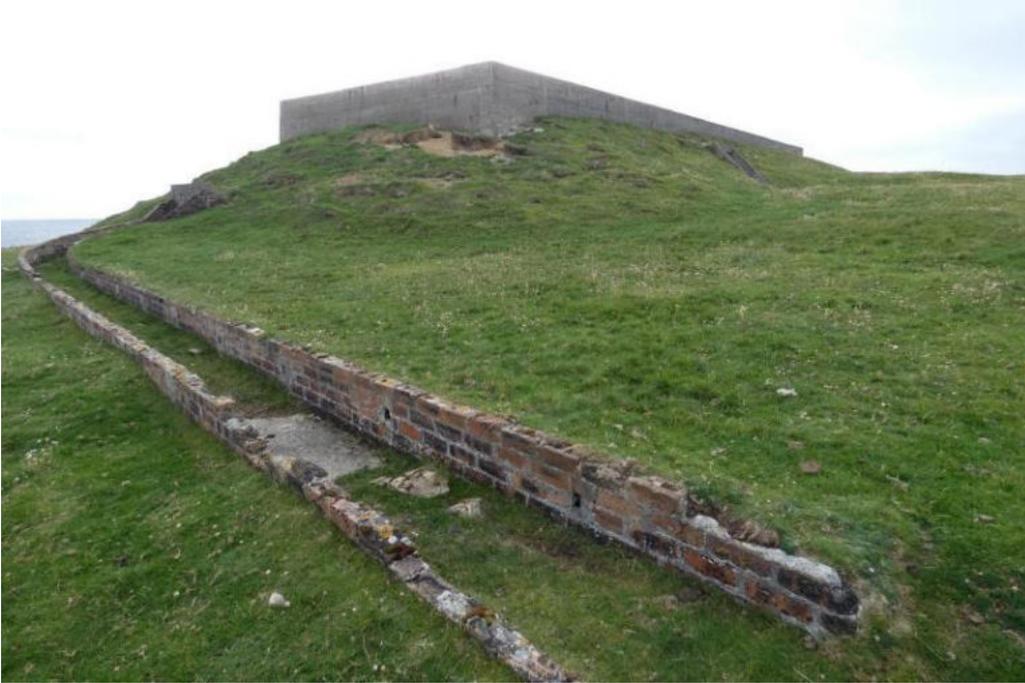
The external brick service trench. Note general deterioration of top courses of its masonry. Note also the loss of material from the embankment about the blast walls.

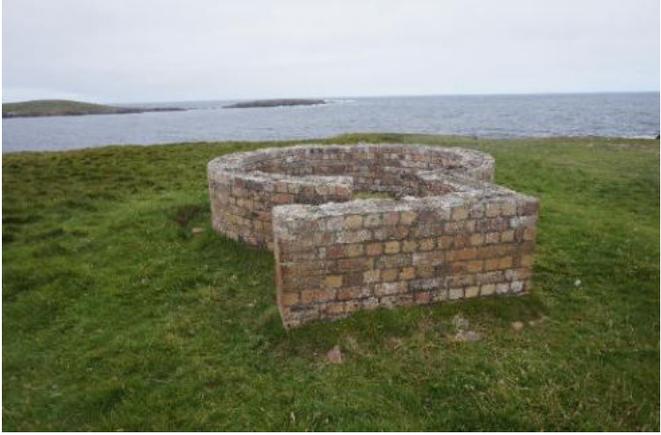
Condition:			
Fair: Localised open, cracked and failing mortar joints, including to exposed wallhead which is supporting vegetation growth. Minor damaged brickwork to wallhead.			
Recommendations:			Priority:
1.	Record and monitor future condition, with provision for localised repointing of open and defective joints, especially skyward facing joints. £100.00		Necessary

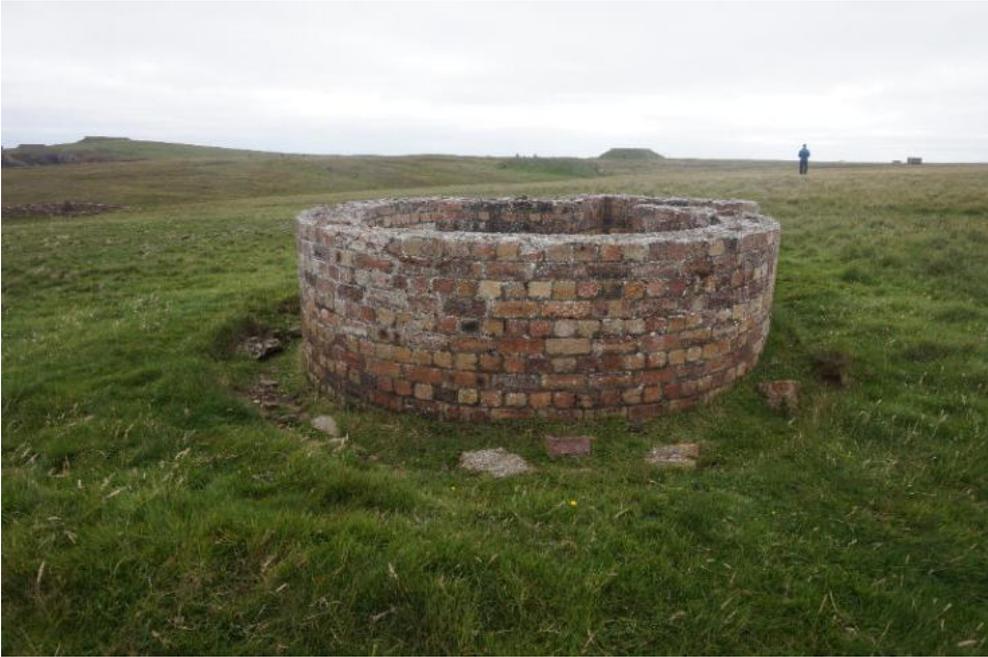
General view from south showing damaged wallhead brickwork and localised failing joints to wall face. Displaced bricks around base of wall.

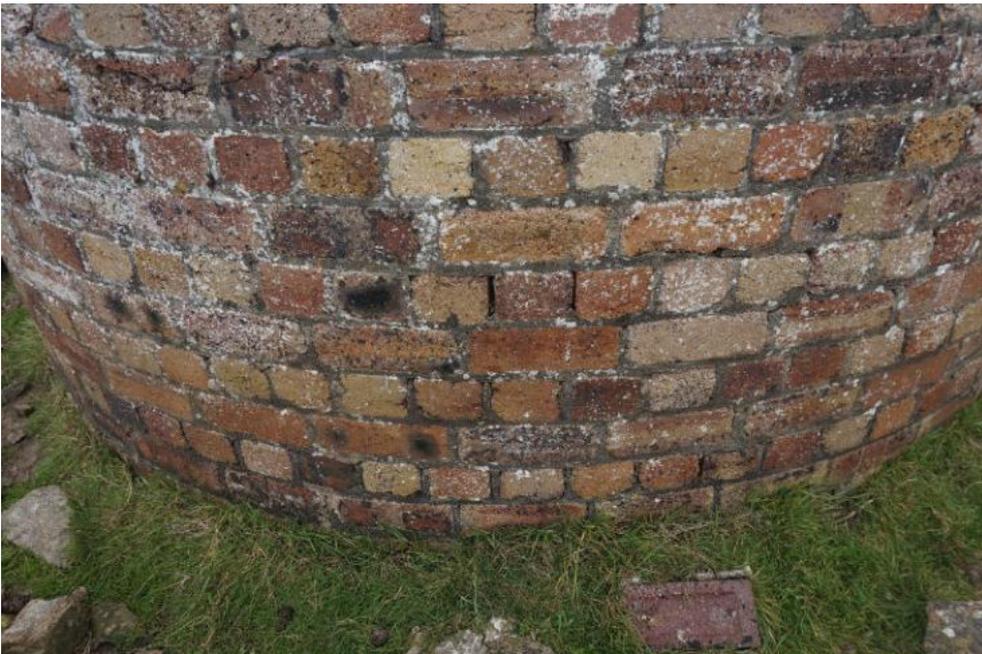
Localised failing joints to wall face.

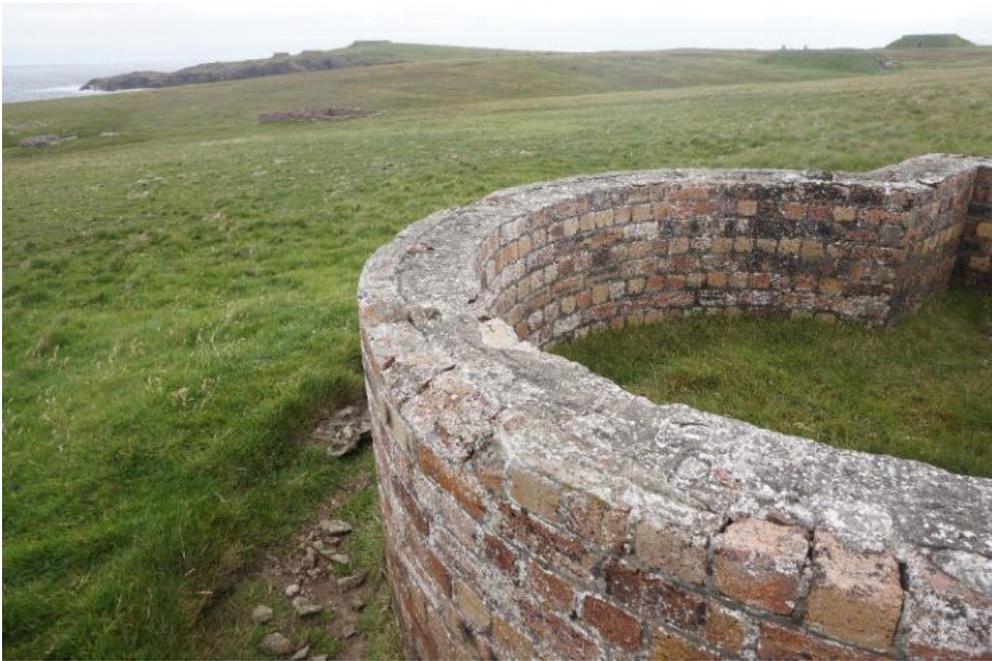
Localised open joints and damaged brickwork to wallhead.

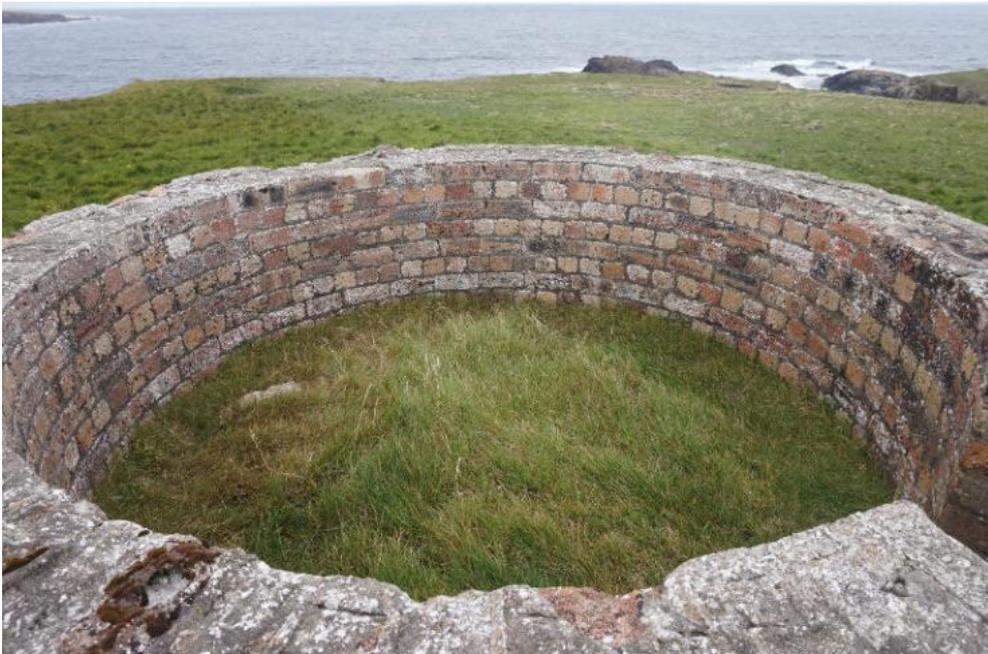
General internal view.

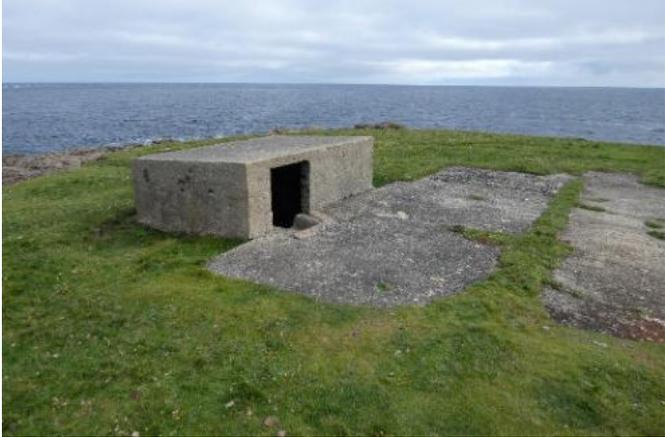
Condition:			
<p>Fair: Constructed with poorly mixed and compacted concrete. No structural distress evident. Localised minor cracking, disaggregation, spalling and surface loss externally. Poor coverage to reinforcement causing localised spalling and/or rusting staining to the external north wall, and roof structure externally and internally. Discolouration and damp staining internally. Hardstanding cracked supporting vegetation growth.</p>			
Recommendations:			Priority:

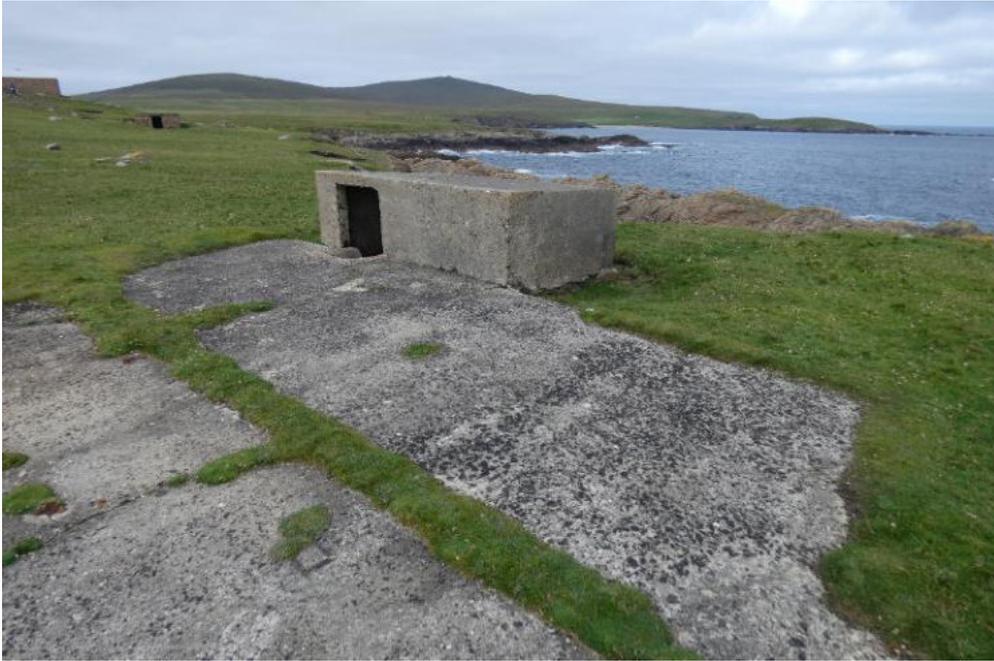
General view showing cracked hardstanding which is supporting vegetation growth.

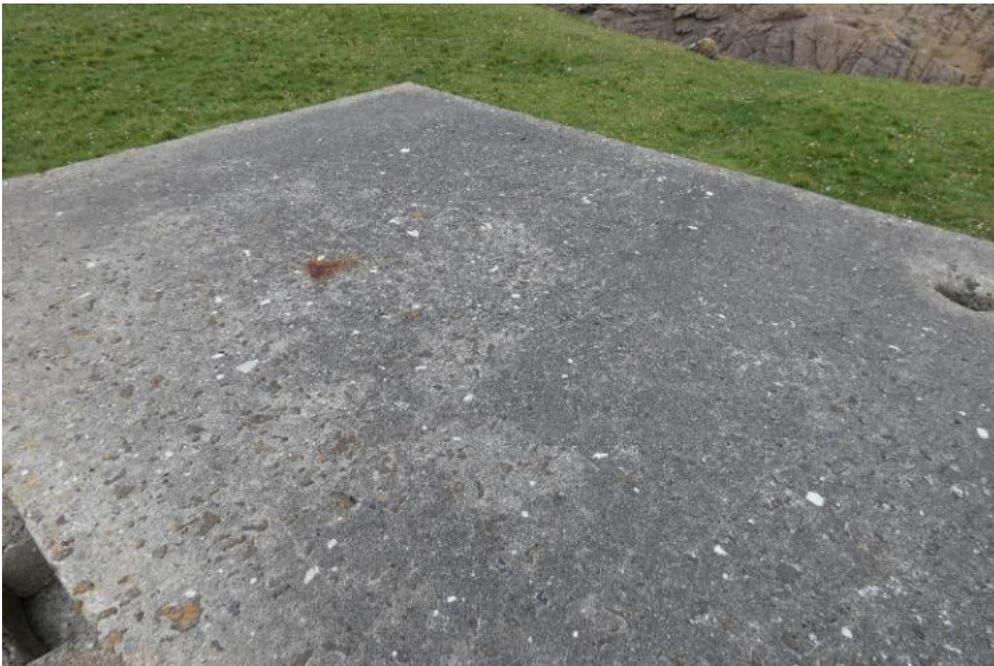
Minor rust staining to the exterior of the roof slab.

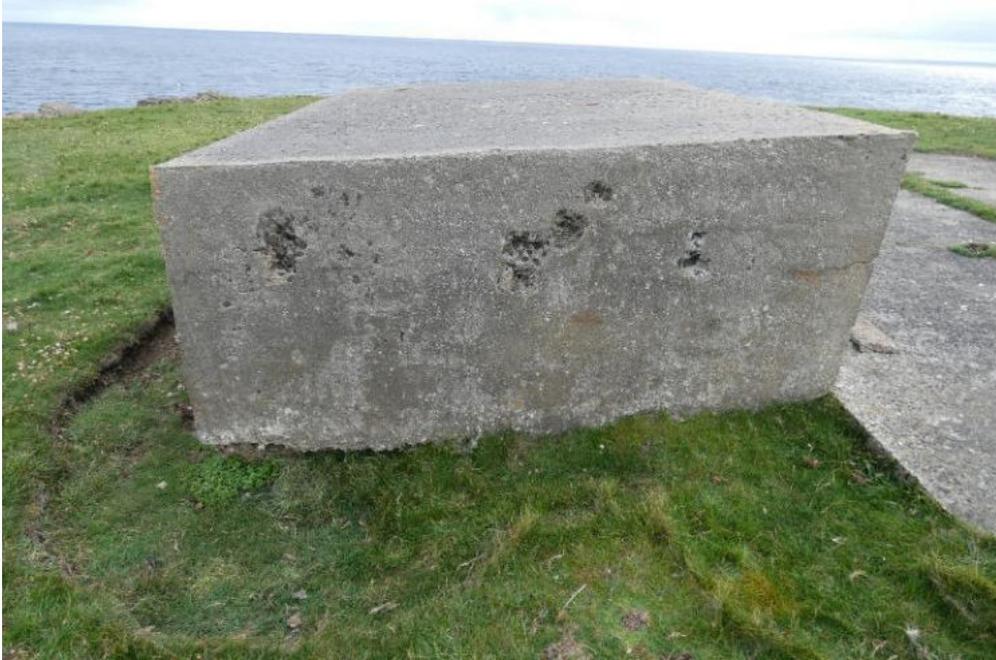
Localised spalling and damage to external walls.

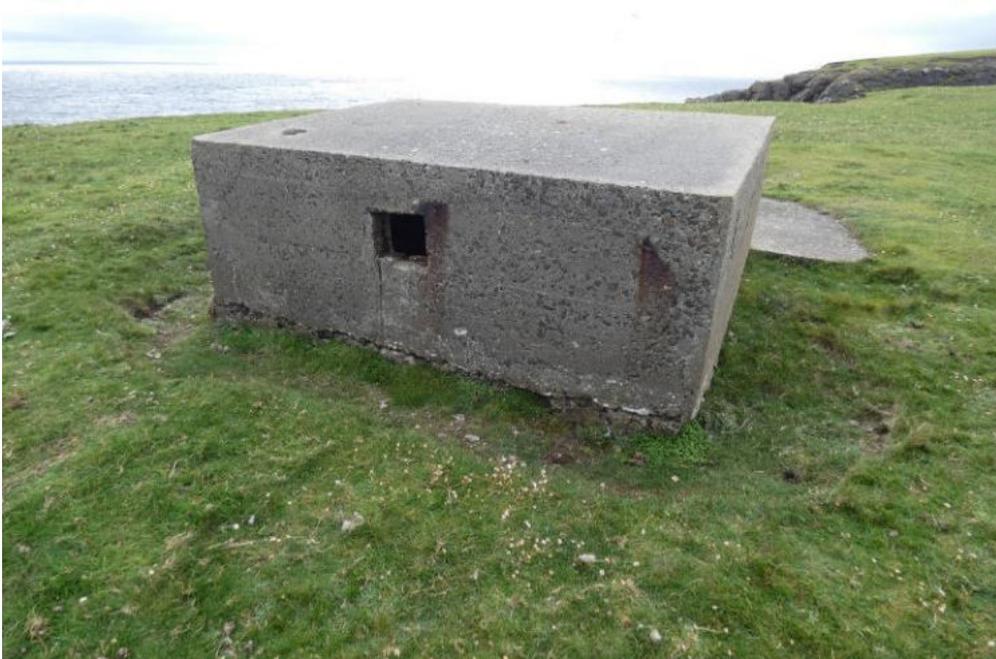
Localised cracking and rust staining.

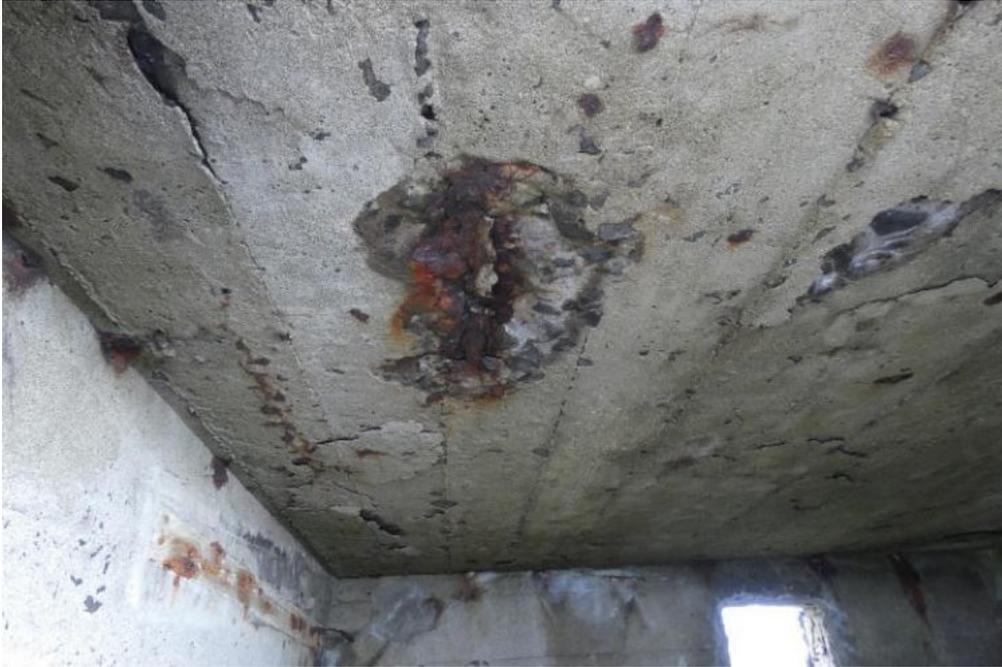
Localised spalling internally exposing corroded reinforcement.

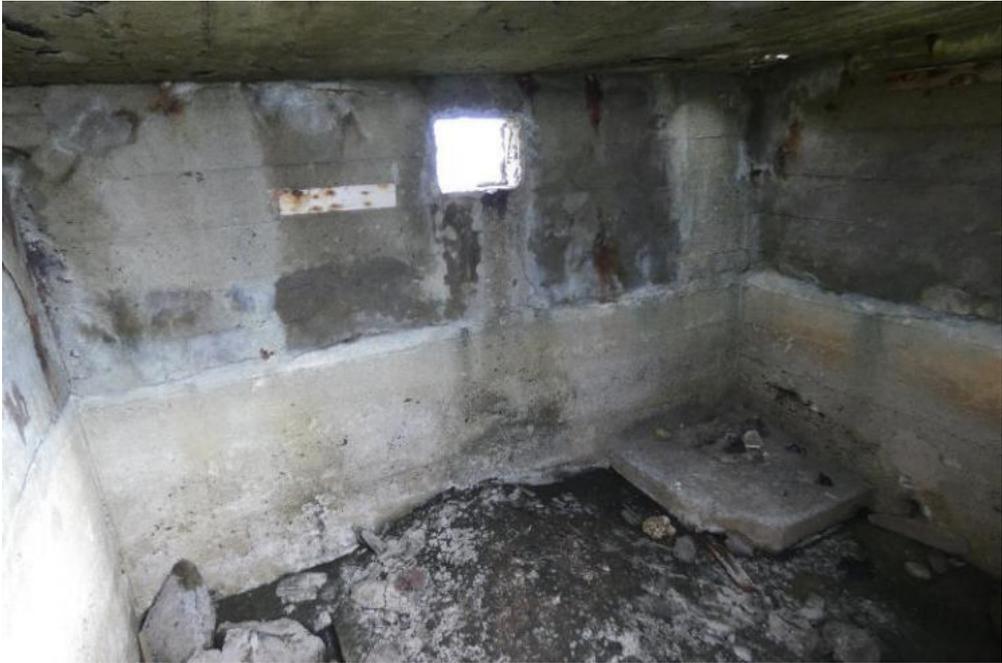
Discoloured and damp stained wall. Floor obscured by accumulated debris.

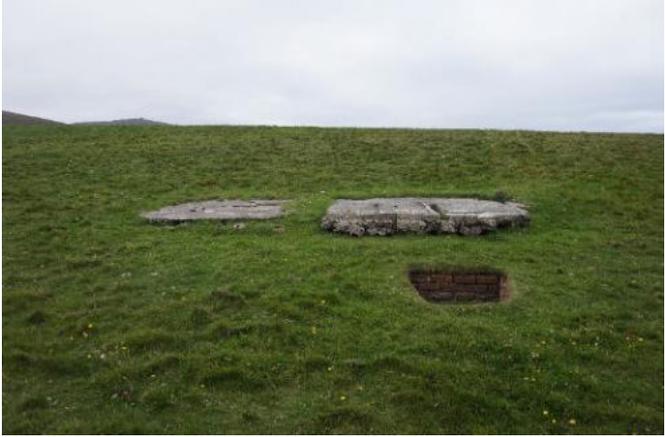
Condition:			
<p>Fair: The upper face and exposed edges of the east concrete base are spalling and the entrance step is misaligned. The west concrete base has subsided, is heavily cracked and exposed edges are disaggregating. The brick chamber has open joints throughout, which loose wallhead brickwork.</p>			
Recommendations:			Priority:

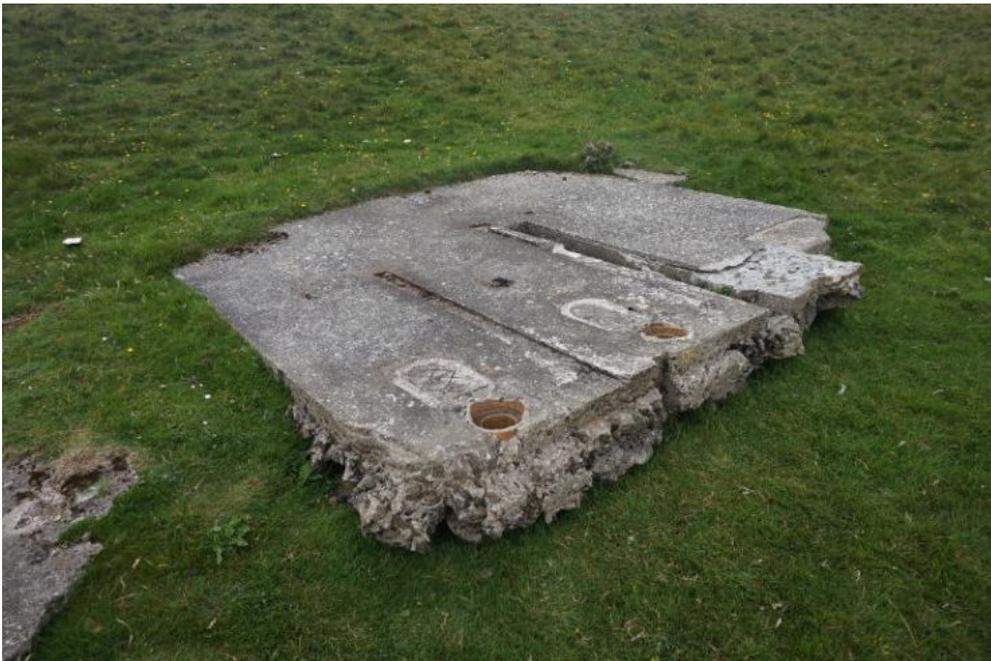
East concrete base with spalling upper face.

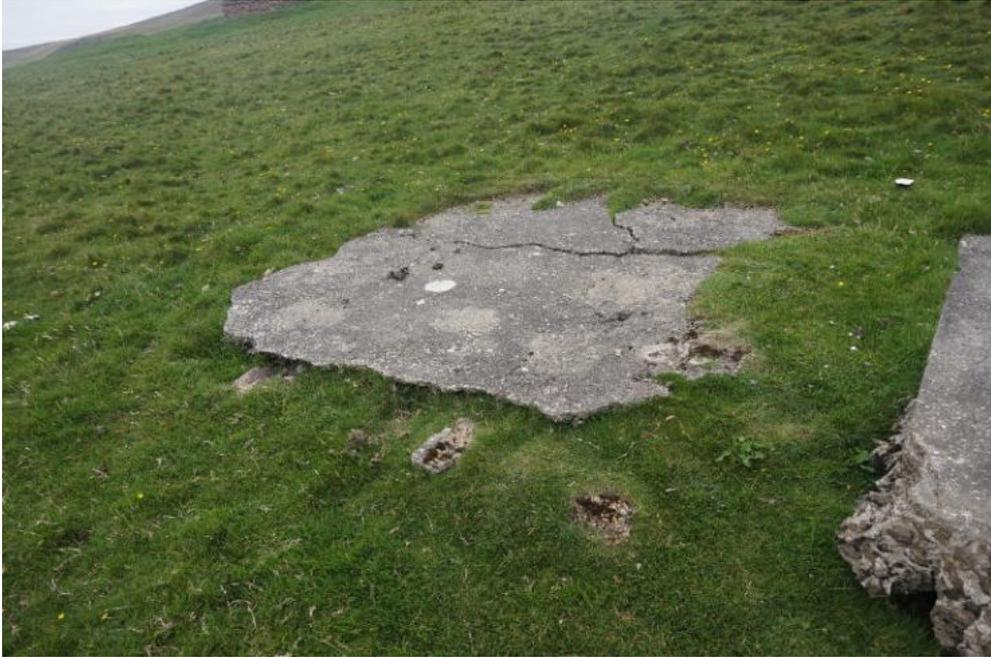
West concrete base has subsided resulting in extensive cracking.

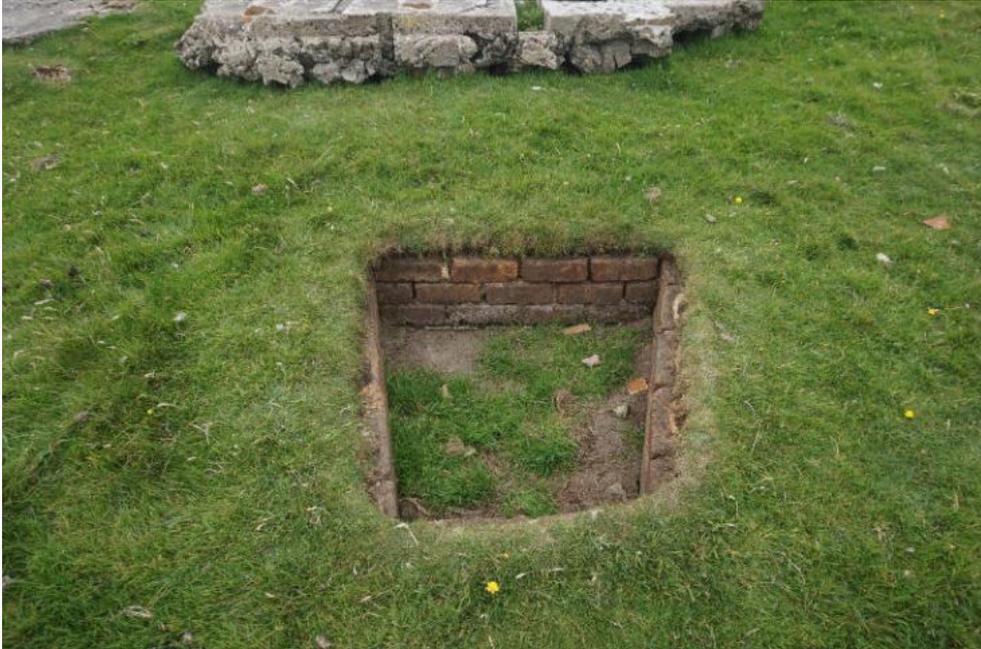
Open joints and loose brickwork to wallheads of brick drainage chamber.
