Appendix 14.10 Conservation Management Plan

Shetland Space Centre Conservation Management Plan

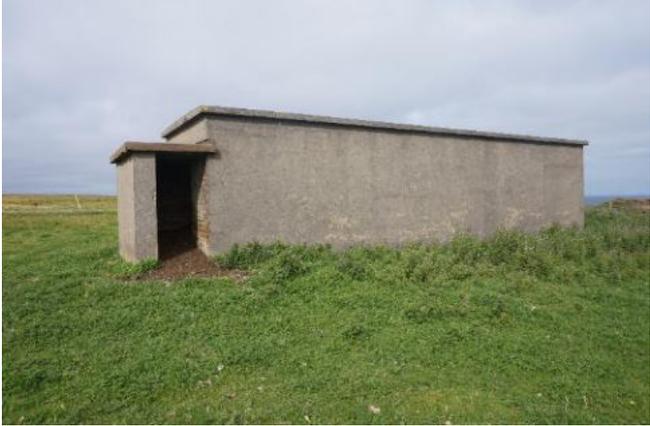
Condition:			
<p>Fair: Only fragments of the asphalt roof finishes survive which has exposed cracking across the exterior of the concrete roof slab. However, despite this the roof structure appears in a relatively good condition, with only minor damp staining, discolouration and localised spalling, exposing reinforcement, visible. Cracked, spalled and bossed rendered finishes externally throughout. Rotten timber frame to east elevation opening and corroded surface mounted servicing. Paint finishes to internal brickwork affected by damp staining and from salts due to large accumulations of animal faeces. Nesting birds.</p>

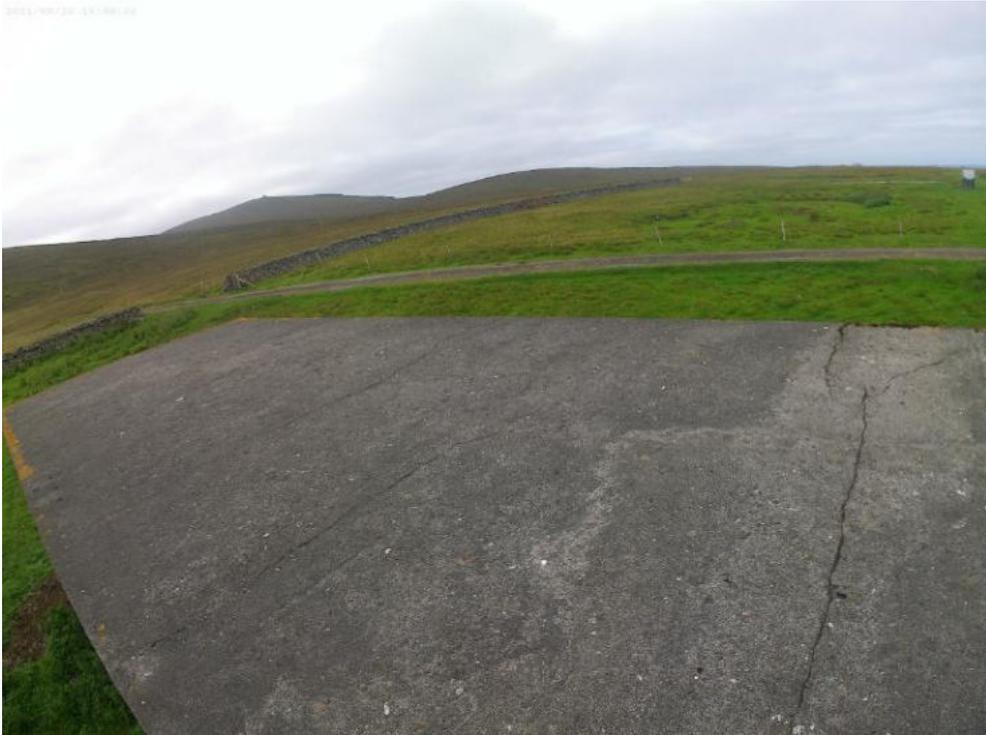
Cracking is visible throughout the exposed concrete roof slab.

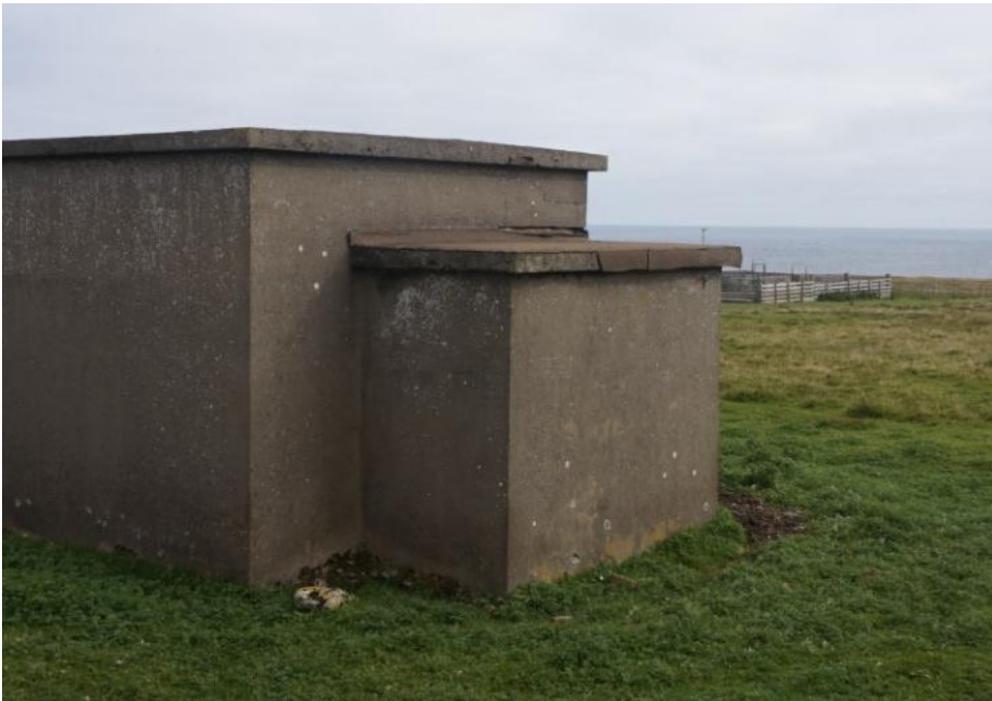
Failing asphalt junction between the west entrance porch and main building. Only fragments survive on the main roof.

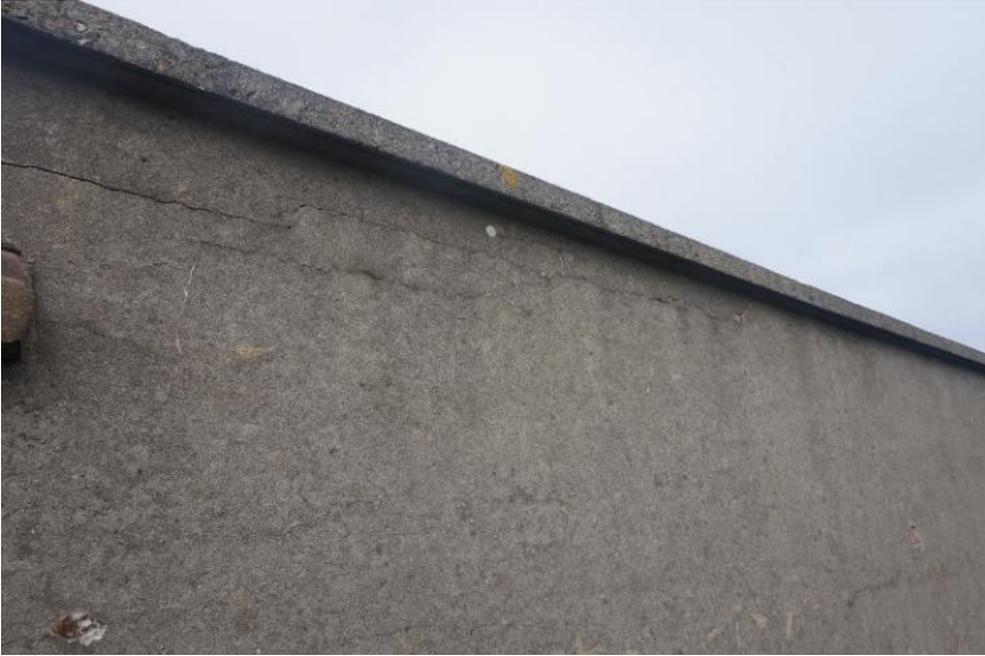
Cracked and bossed render was observed externally on all elevations. Horizontal cracking at top of wall indicative of movement caused by drying shrinkage of roof slab.

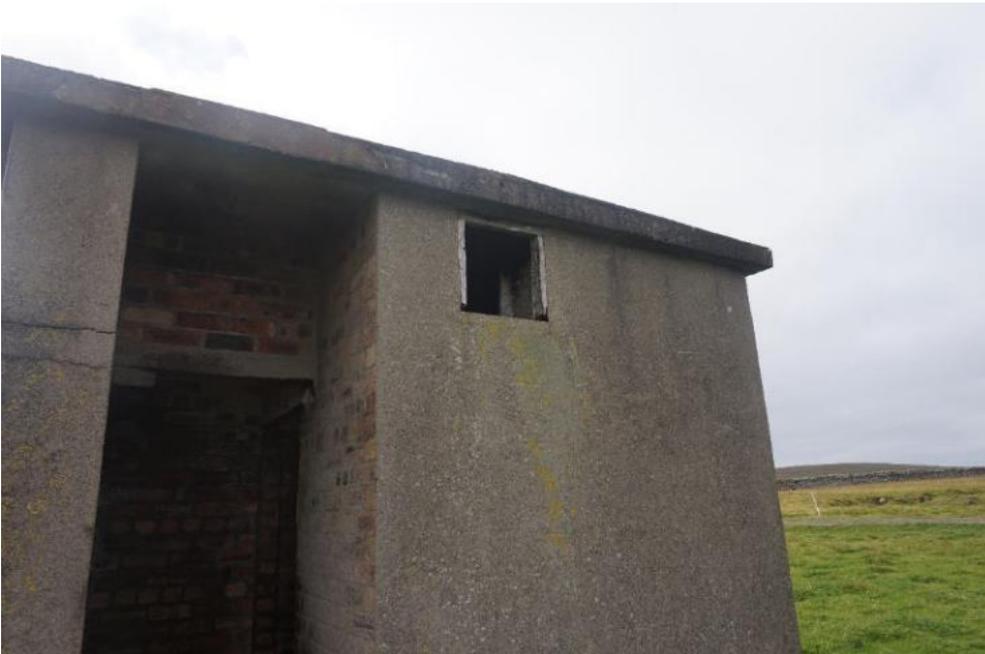
Rotten timber frame to opening on the east elevation. Note loss of concrete from the underside of the RC lintol above the internal opening: removal of surviving, but cracked, concrete from that lintol necessary.

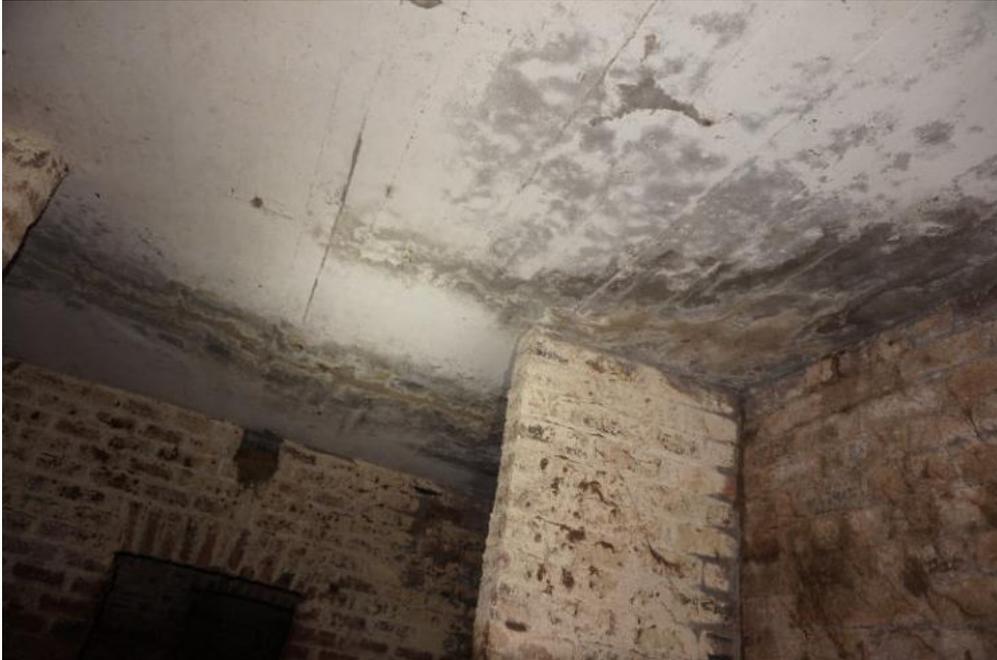
Damp staining and discolouration to underside of concrete roof slab.

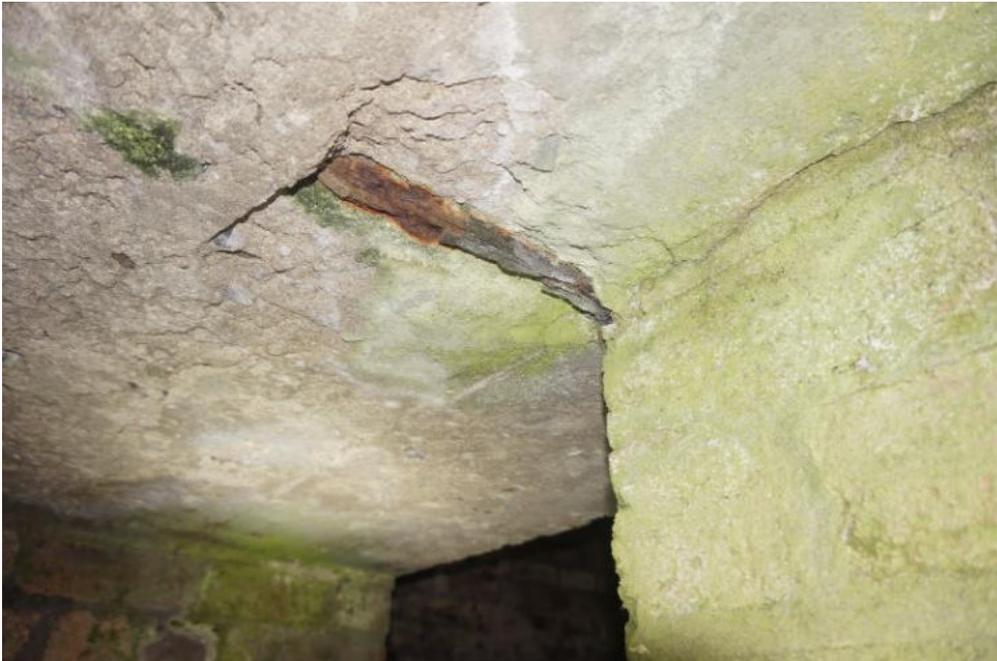
Despite the lack of roof finishes, only minor corrosion of reinforcement was observed.

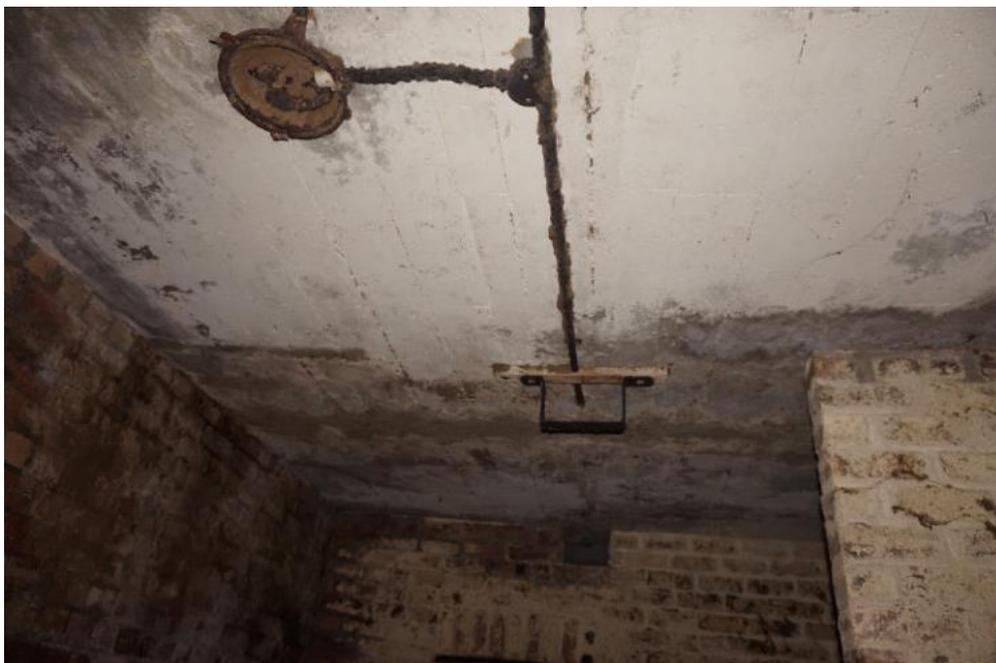
Corroded surface mounted servicing.

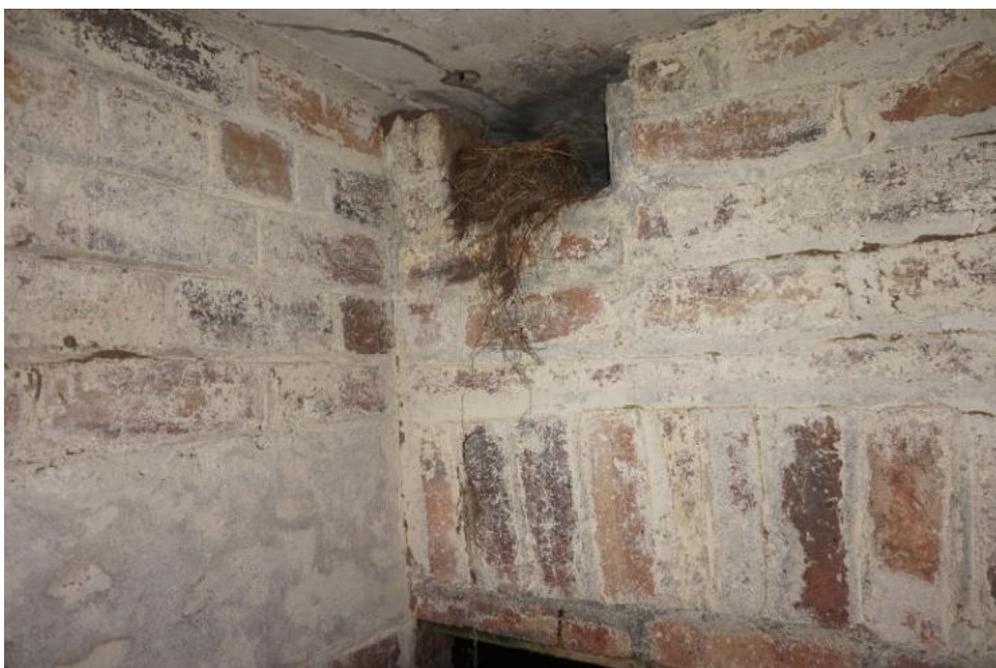
Nesting birds are using the structure.

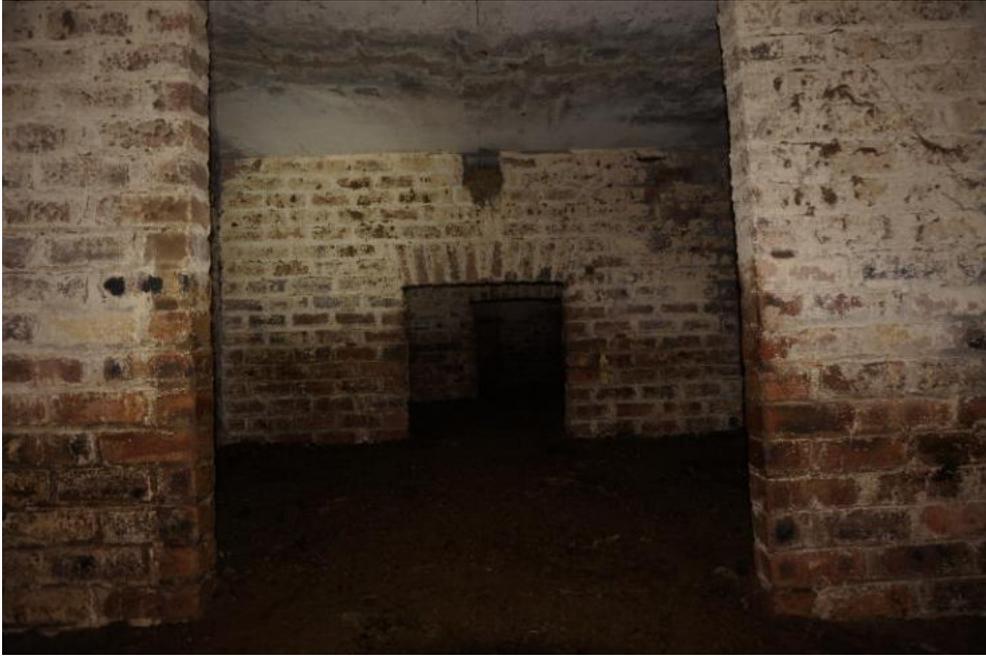
Internal painted surfaces and damp stained and affected by salts from the large accumulations of animal faeces.

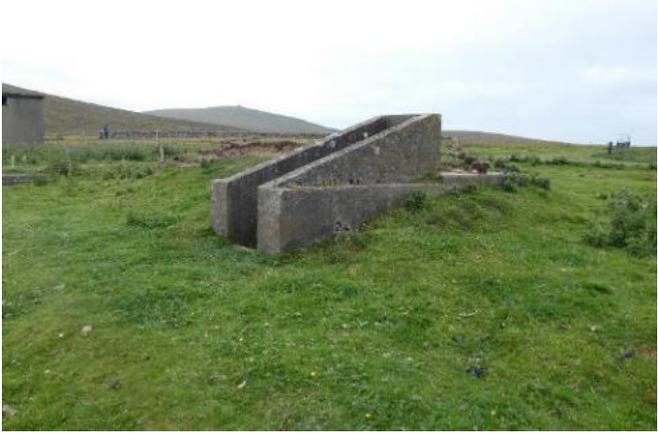
Condition:			
<p>Fair: Minor failing render externally exposing brickwork beneath and supporting vegetation growth. Extensive loss of the earth and turf covering exacerbated by grazing and burrowing.</p> <p>Localised spalling of concrete soffit internally which is exposing reinforcement. Localised loss of internal render.</p>			
Recommendations:			Priority:

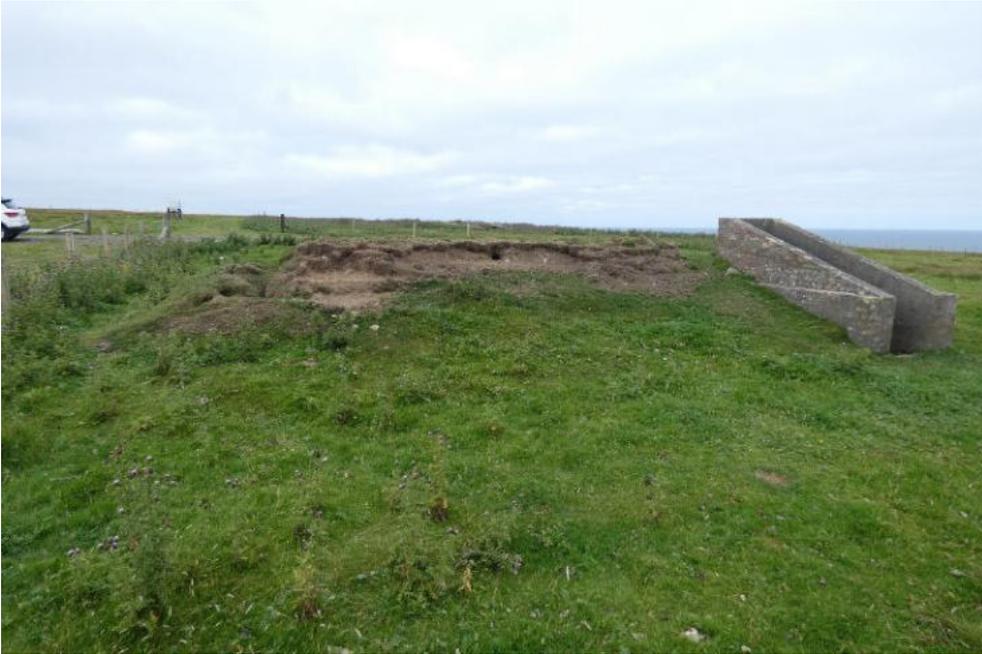
General view from southwest. Note damage caused by grazing and burrowing animals.

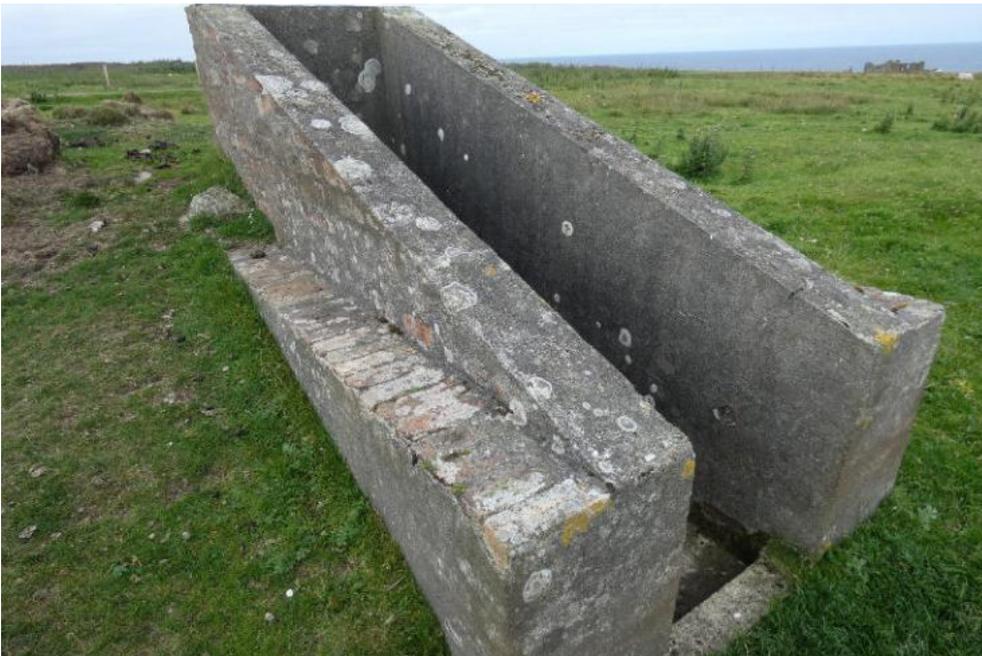
There is only minor damage to the rendered brick tunnel entrance.

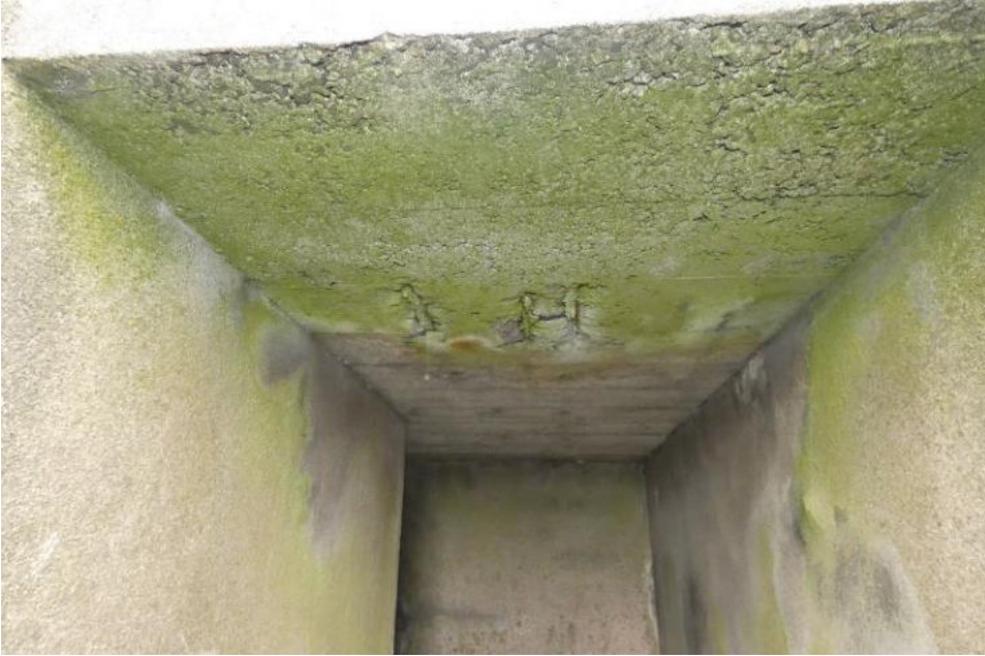
Localised spalling to the soffit of the roof slab exposing reinforcement.

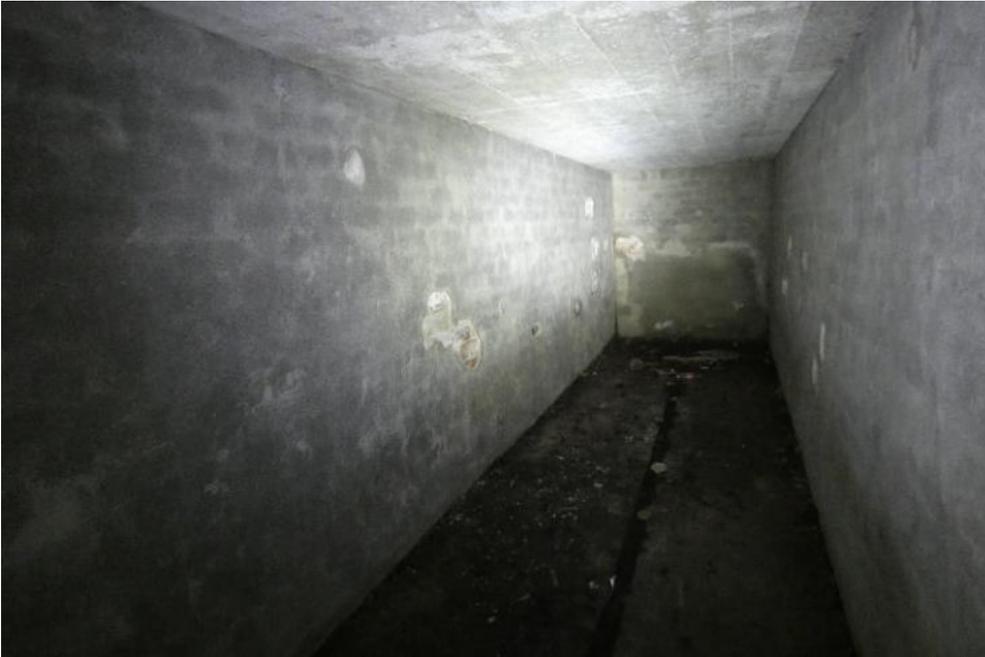
Localised failing render internally.

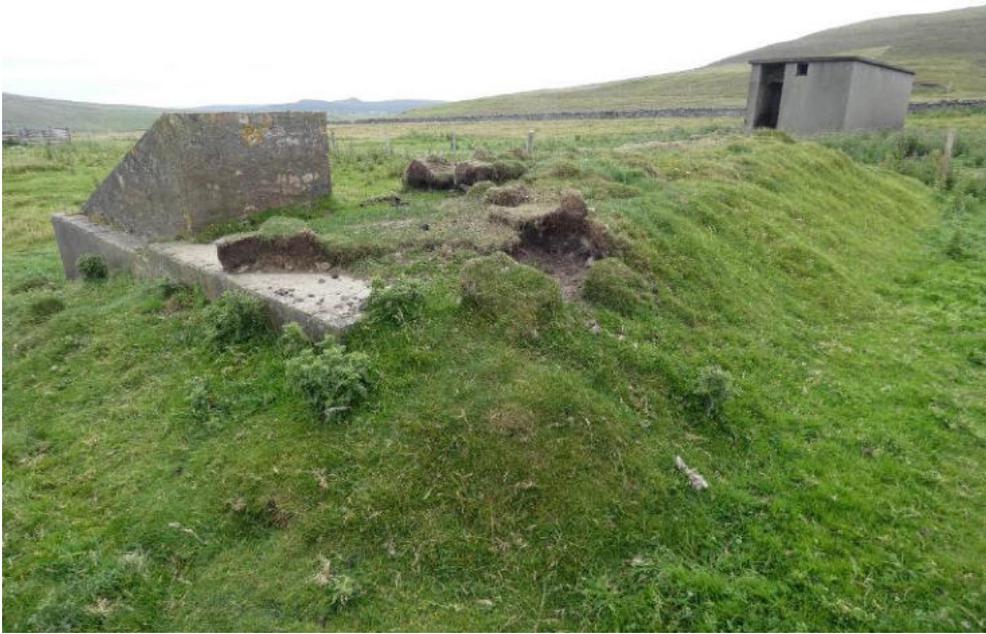
Replacing the missing and damaged earth and turf banking will protect the structure below.

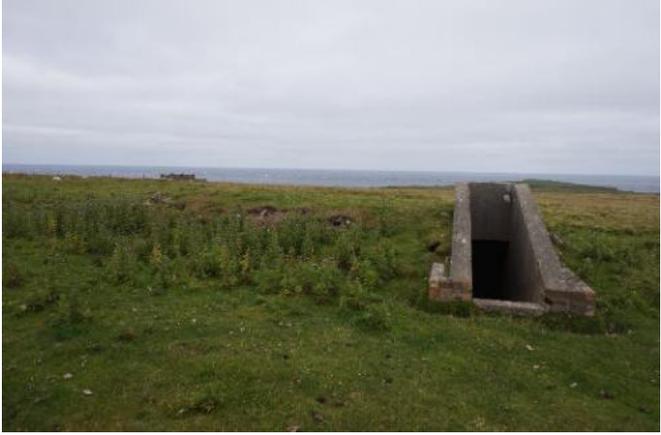
Condition:			
<p>Fair: Minor failing render externally exposing brickwork beneath and supporting vegetation growth. Extensive loss of the earth and turf covering exacerbated by grazing and burrowing.</p> <p>Localised loss of internal render.</p> <p>Internal concrete roof slab and floor in good condition.</p>			
Recommendations:			Priority:

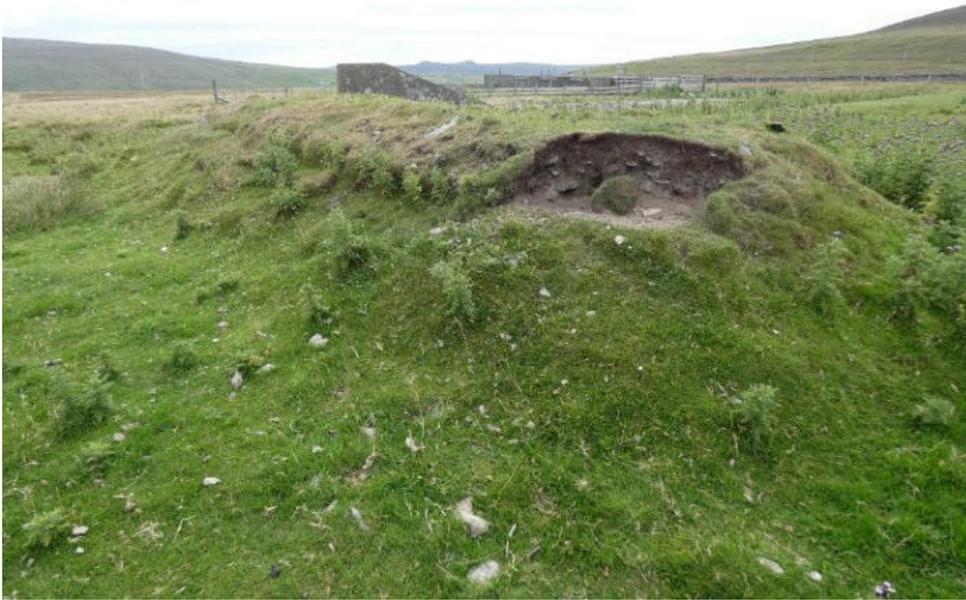
General view from southeast. Note damage caused by grazing and burrowing animals. Replacing the missing and damaged earth and turf banking will protect the structure below.

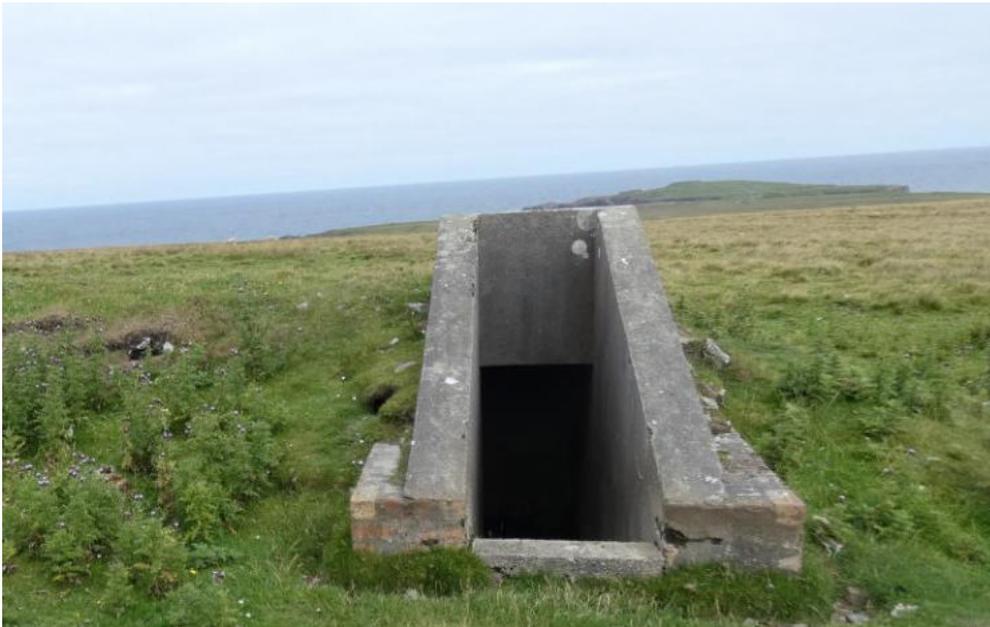
There is only minor damage to the rendered brick tunnel entrance.

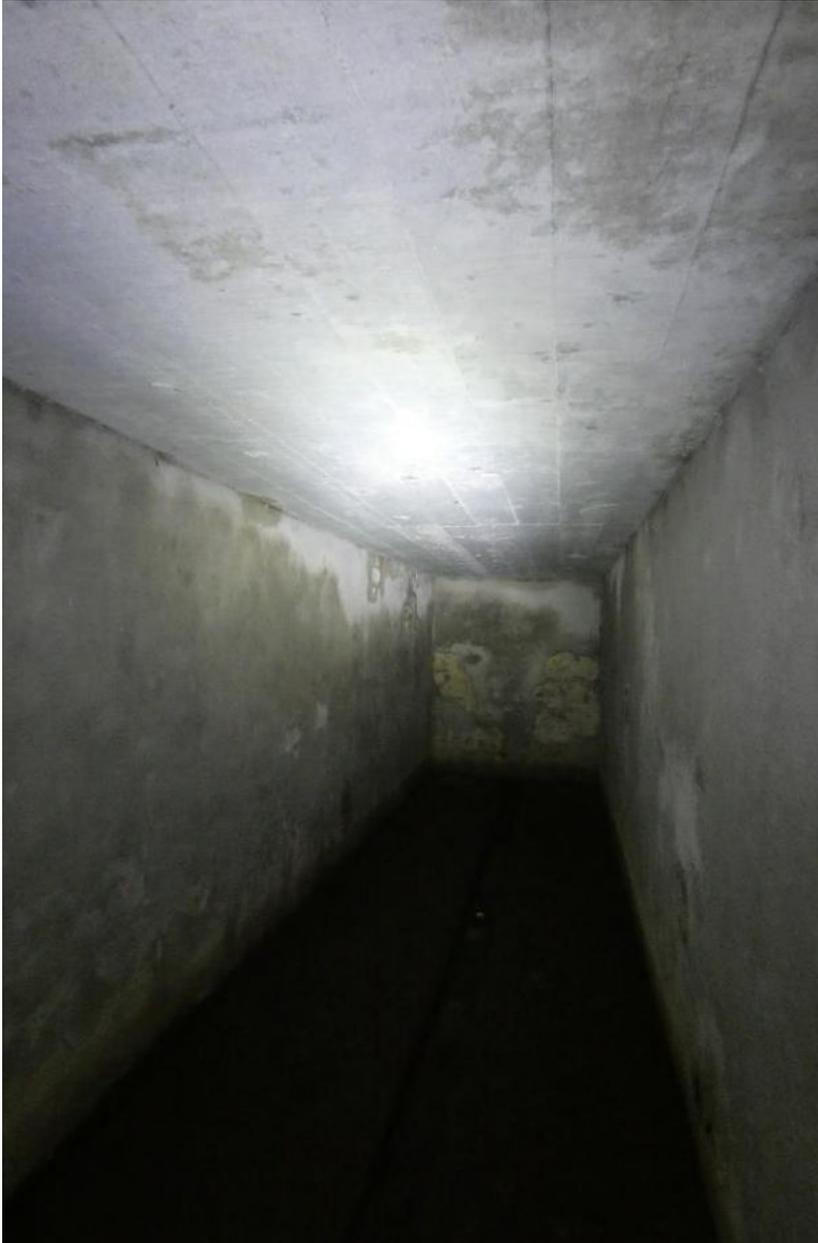
Localised failing render internally.

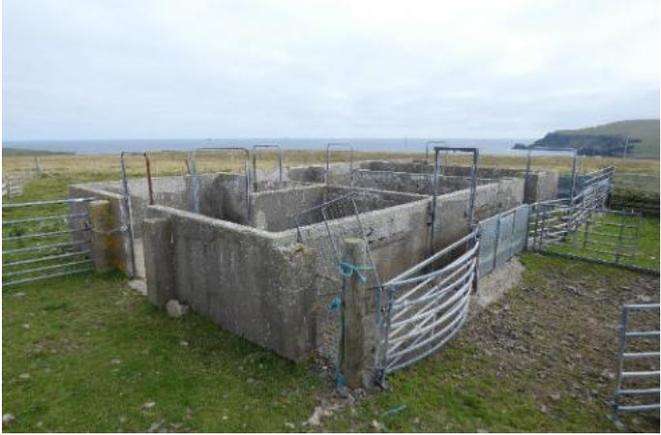
Condition:			
<p>Fair: Extensive crazed, cracked and bossed rendered throughout, with localised vegetation growth. Localised brickwork damage to wallheads. Concrete floor stable, but disaggregation and vegetation growth observed.</p>			
Recommendations:			Priority:

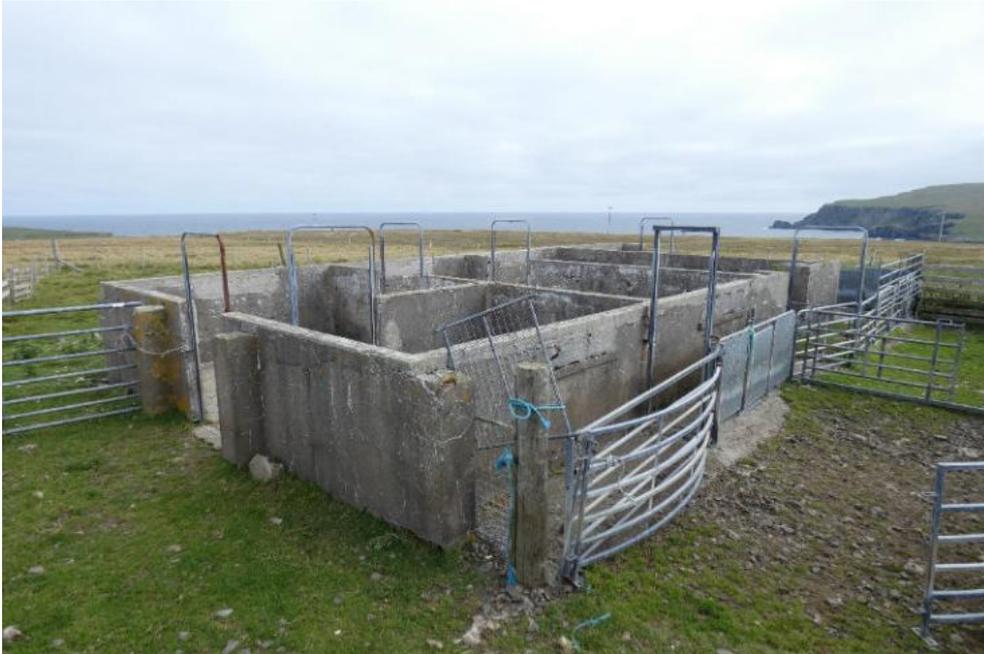
View from northwest. Walls have been lowered, with rendering patch repaired and gates inserted to accommodate agricultural use.

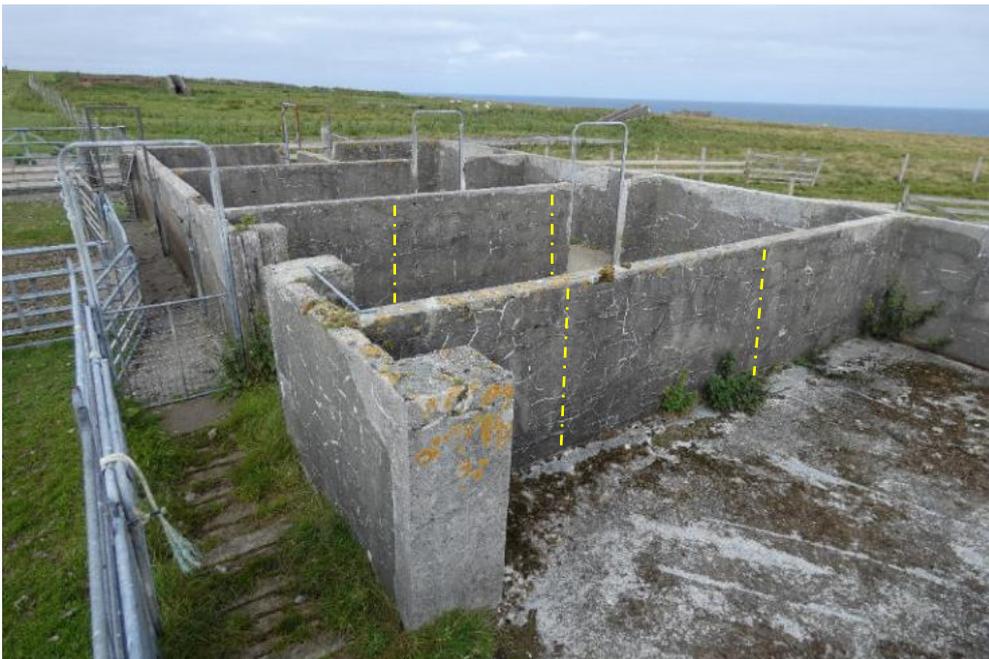
The cement render is extensively cracked and in some areas is supporting vegetation growth. The concrete floor has minor disaggregation and is supporting vegetation growth. The relatively long and slender internal partition walls depend on the integrity of the mortar in their bed joints for their stability. The robustness of these walls can be increased with the introduction of new buttresses at key points (indicated)

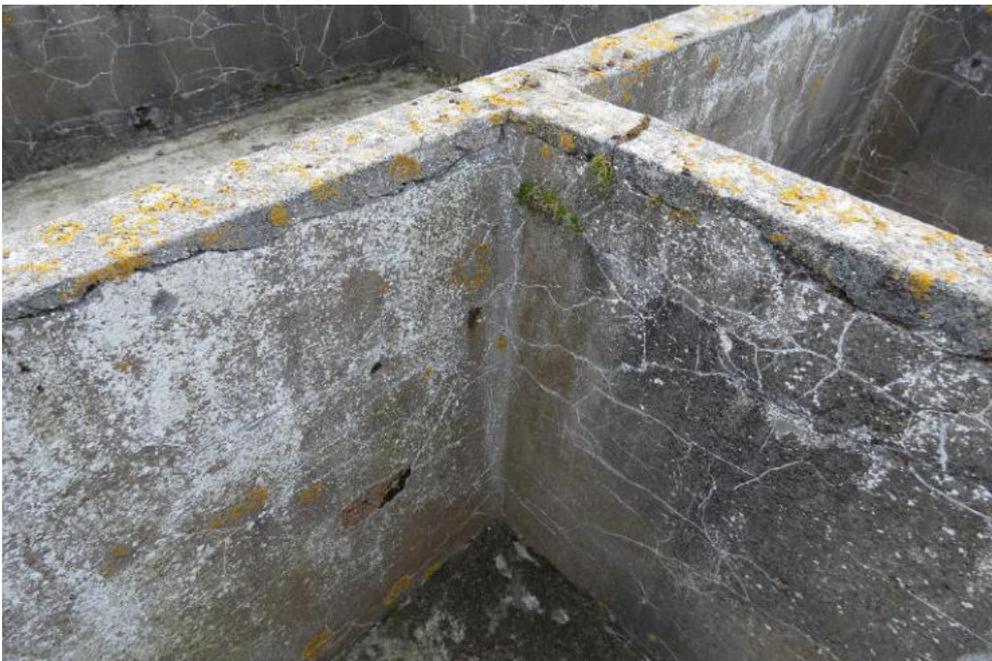
The render was patch repaired when the walls were lowered. All render (original and later) has cracked.

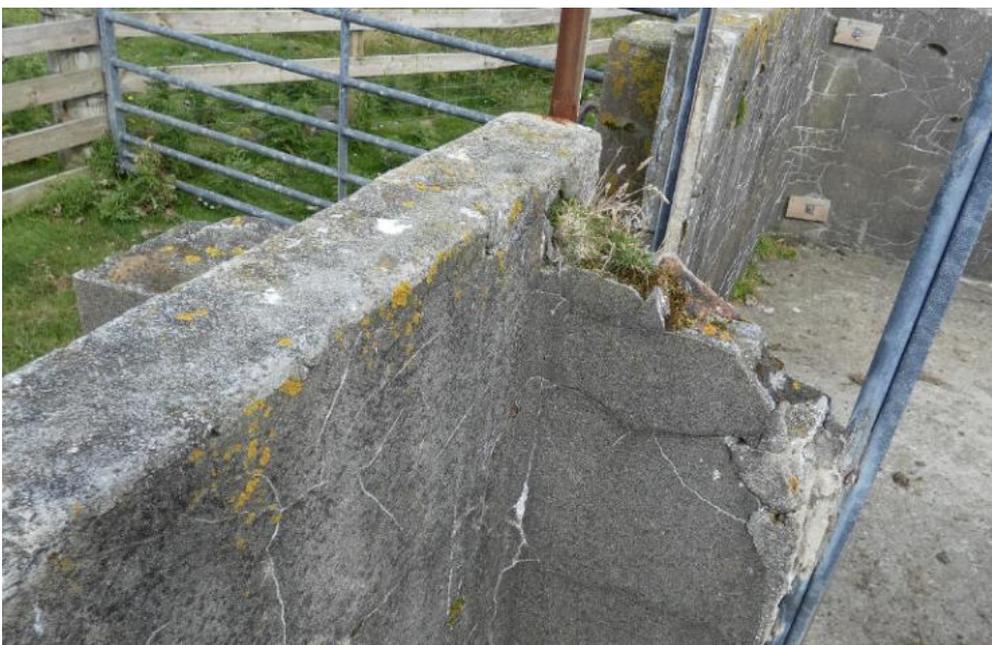
Localised damaged wallhead brickwork.

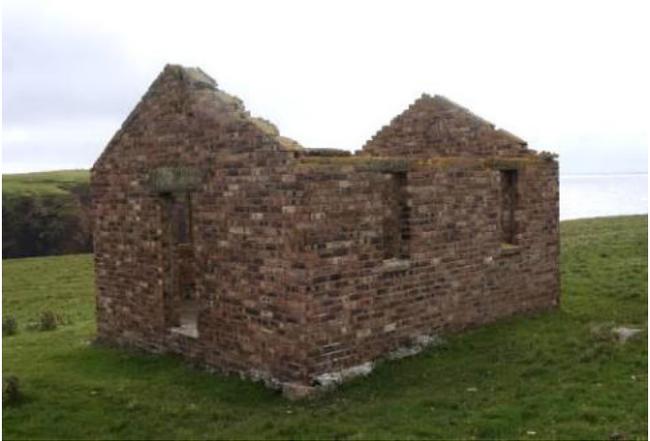
Condition:			
<p>Fair (locally poor): no obvious indications of structural distress within the walls despite appearing to be built with too few wall ties. However vertical cracking of cavity-closing mortar suggests that the leaves are separating. The loss of the roof has exposed the cavity at wallhead level resulting in corroded wall ties. Damaged and missing concrete capping to gable wallheads. Displaced concrete lintol and missing high level brickwork to east elevation. Missing high level brickwork to west elevation. Cracking below east elevation window (south). Eroded cills and lintols. Localised failing mortar joints and mortar with window checks in vicinity of corroding steel window frames. Concrete floor cracked, supporting vegetation growth.</p>

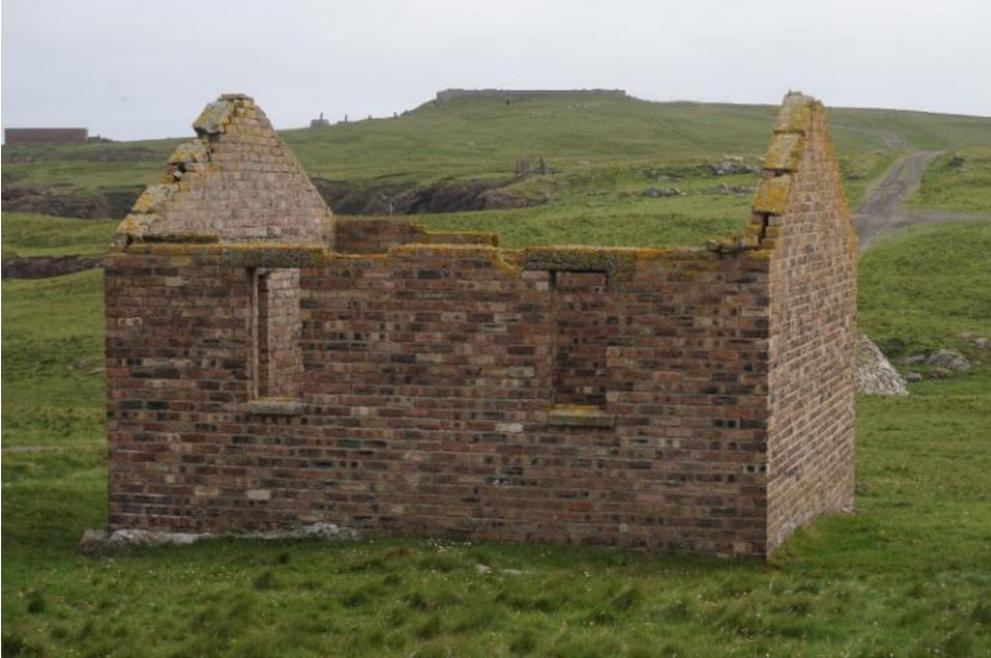
West elevation with missing wallhead brickwork. Note failing cappings to gables.

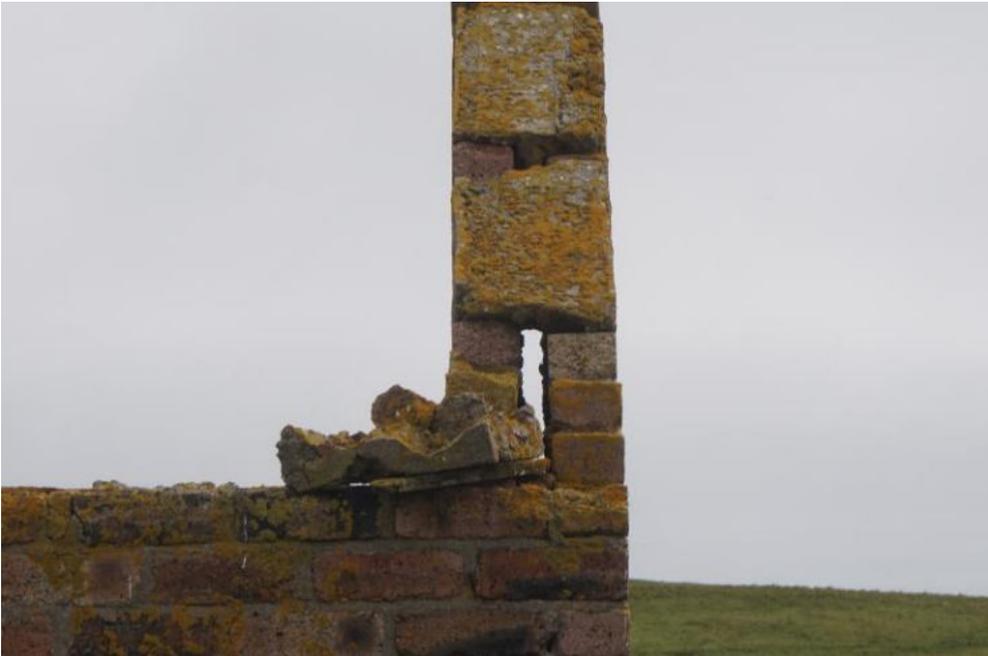
Damaged and dislodged concrete capping to south gable should be removed to reduce health and safety risk. Note that no wall ties are visible within the cavity. Reinstating the wallhead capping will prevent water ingress into the cavity.

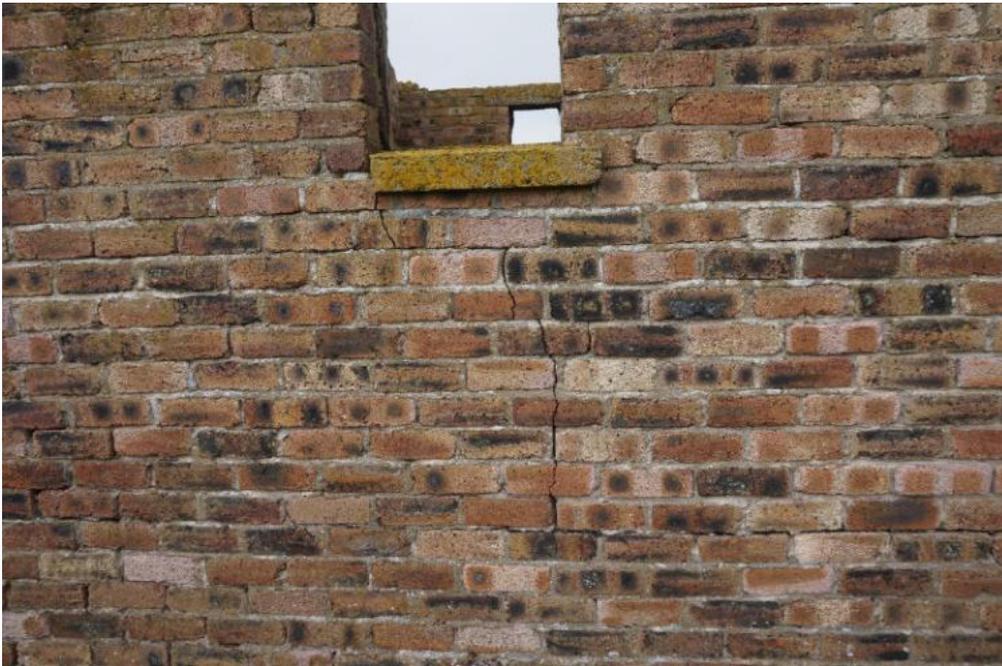
Failing joints should be repointed and the crack below the east elevation window repaired with proprietary bed-joint reinforcement to reinstate continuity within masonry.

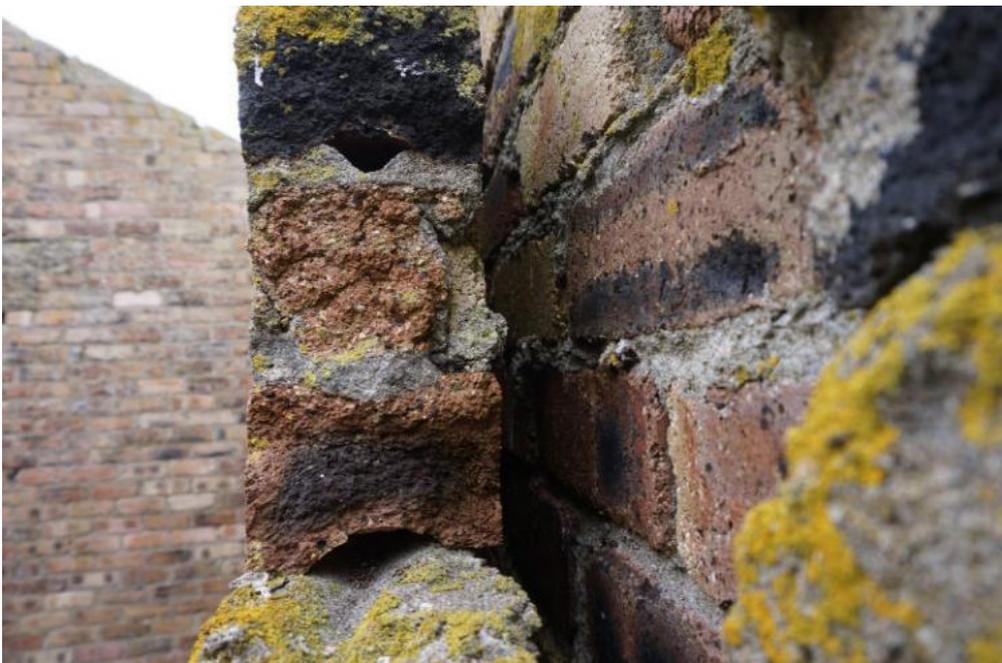
The brickwork is poorly tied. Cavity ties should be retrofitted to ensure future stability.

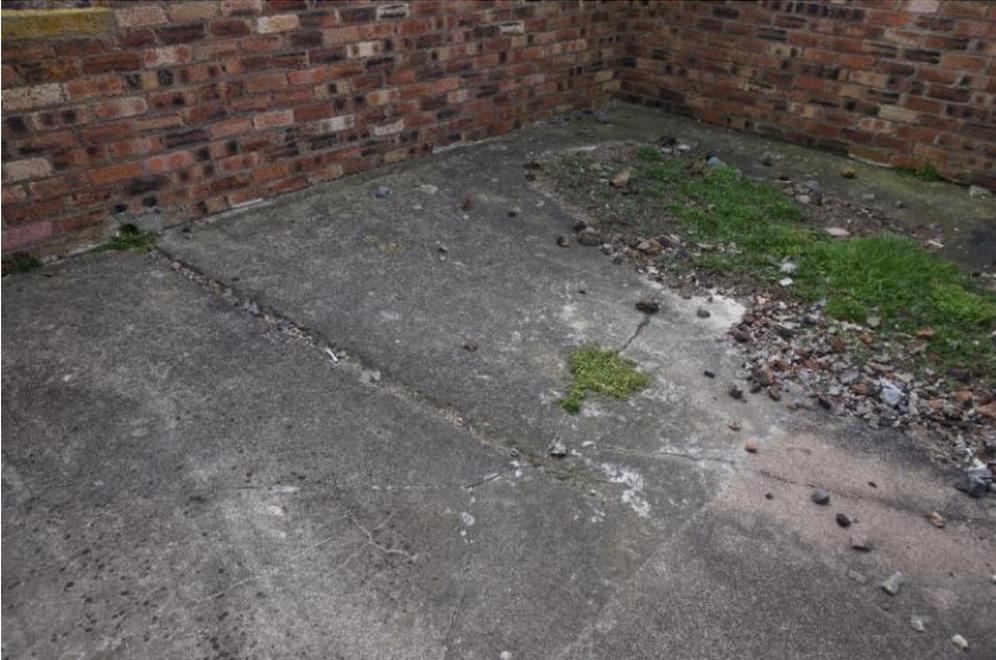
Cracked concrete floor slab supporting vegetation growth.

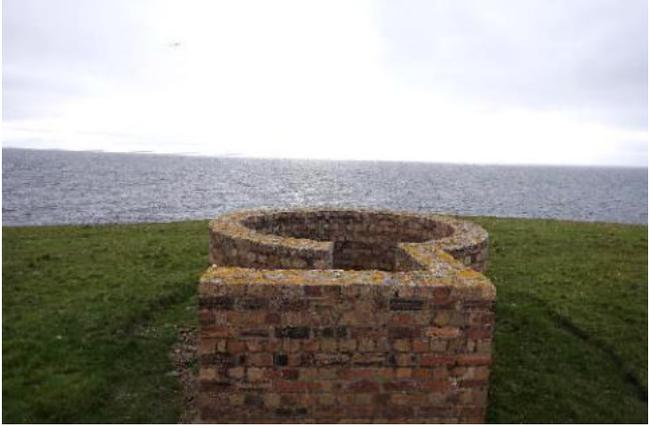
Condition:			
Fair: Minor localised open, cracked and failing mortar joints, including to exposed wallhead which is supporting vegetation growth. Minor localised damaged bricks.			
Recommendations:			Priority:
1.	Repoint open and defective joints, especially skyward facing joints. £200.00		Desirable

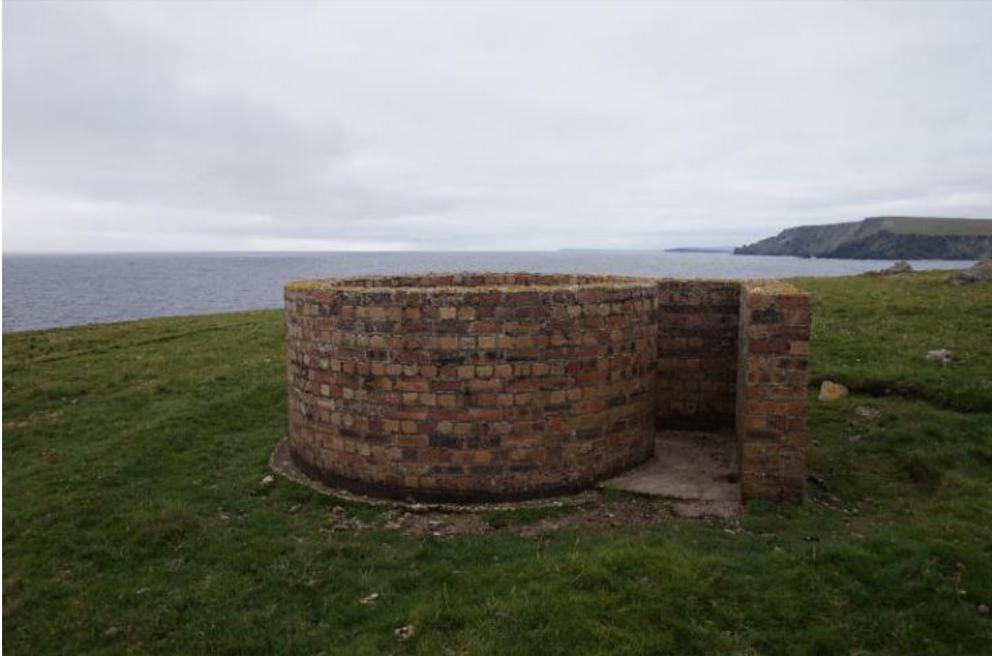
View from east showing concrete strip foundation and concrete floor.

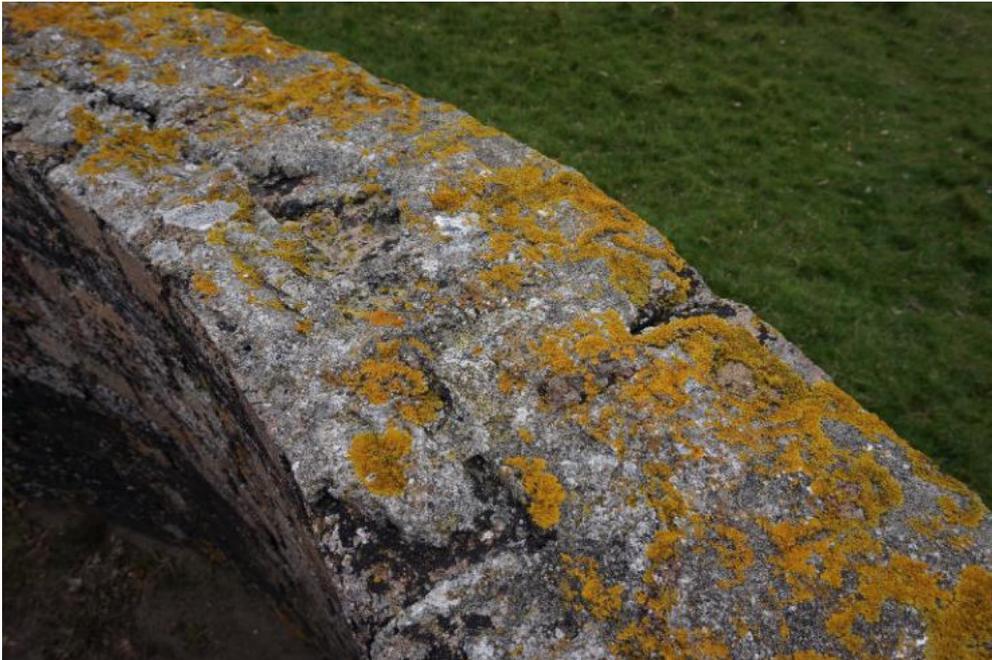
Localised failing skyward facing wallhead joints.

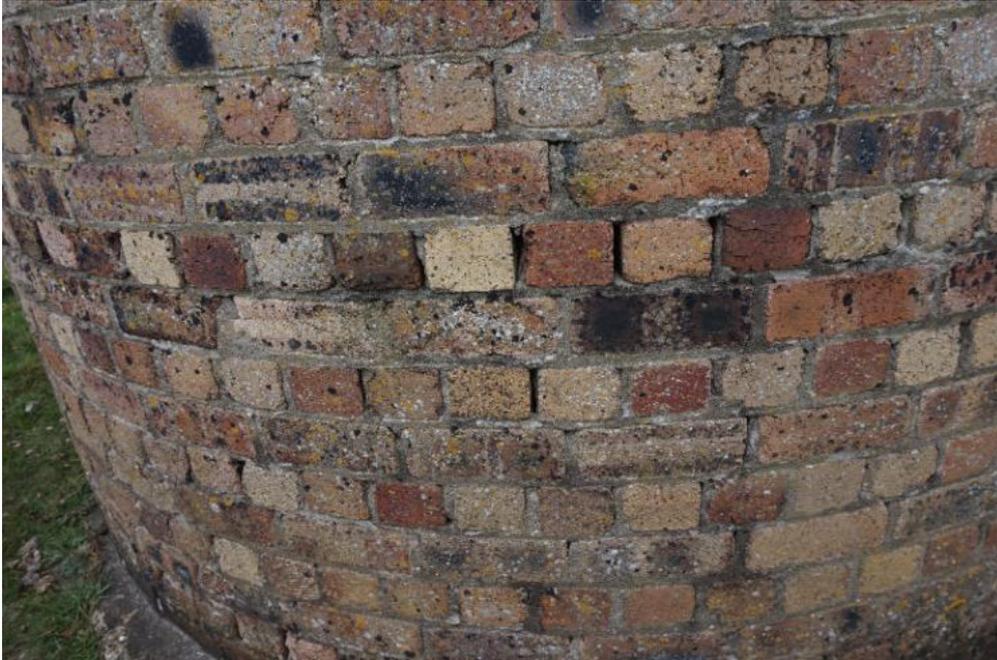
Localised failing wallface joints.

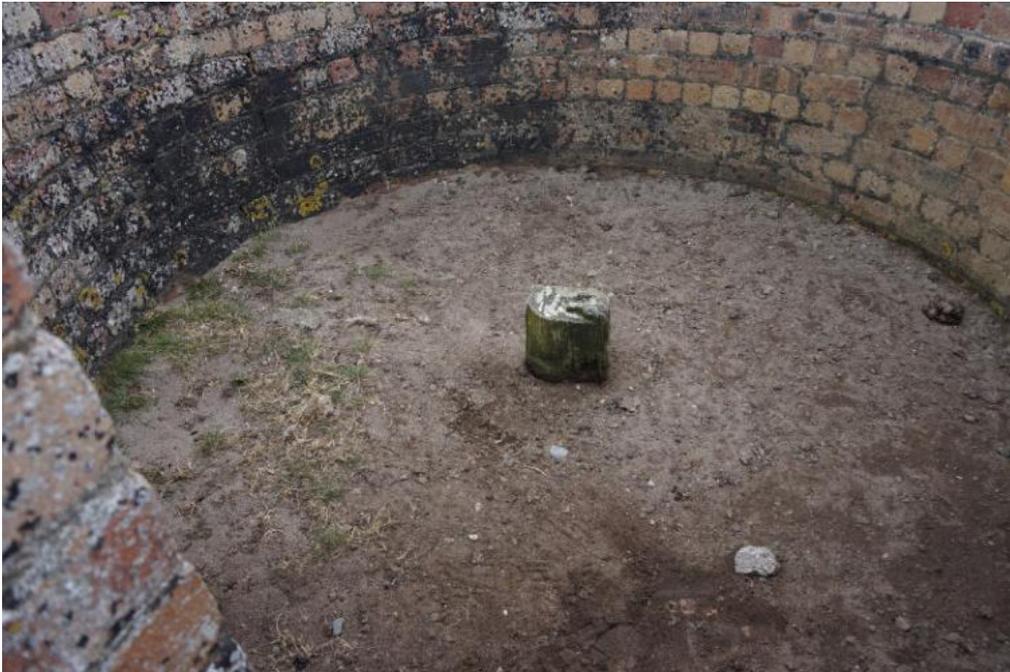
Partly obscured internal floor with central timber post.
