Appendix 14.10 Conservation Management Plan

Shetland Space Centre Conservation Management Plan

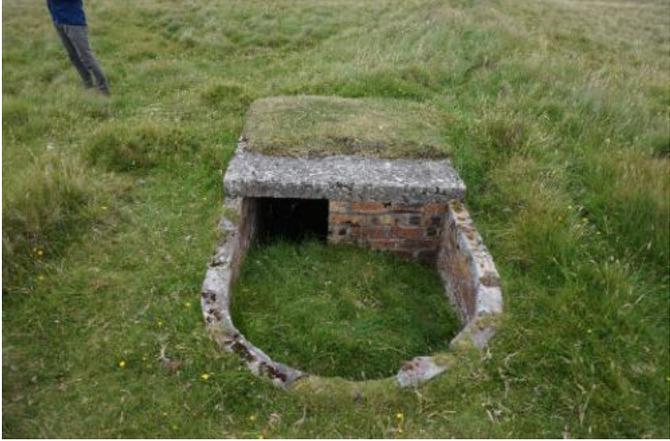
Condition:			
<p>Fair: Cracked brick joints at curved end and locally below roof slab. Localised damaged bricks at curved end. Minor disaggregation of exposed roof slab. Internal walls saturated below covered area.</p> <p>Covered part of the structure is flooded.</p>			
Recommendations:			Priority:

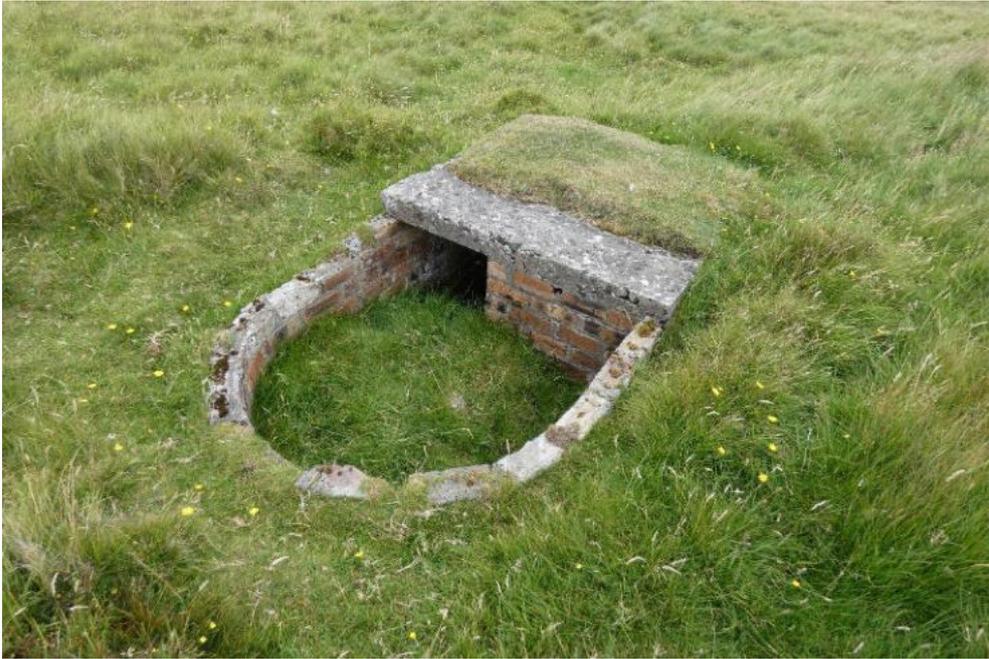
General view. Note damaged wallhead bricks.

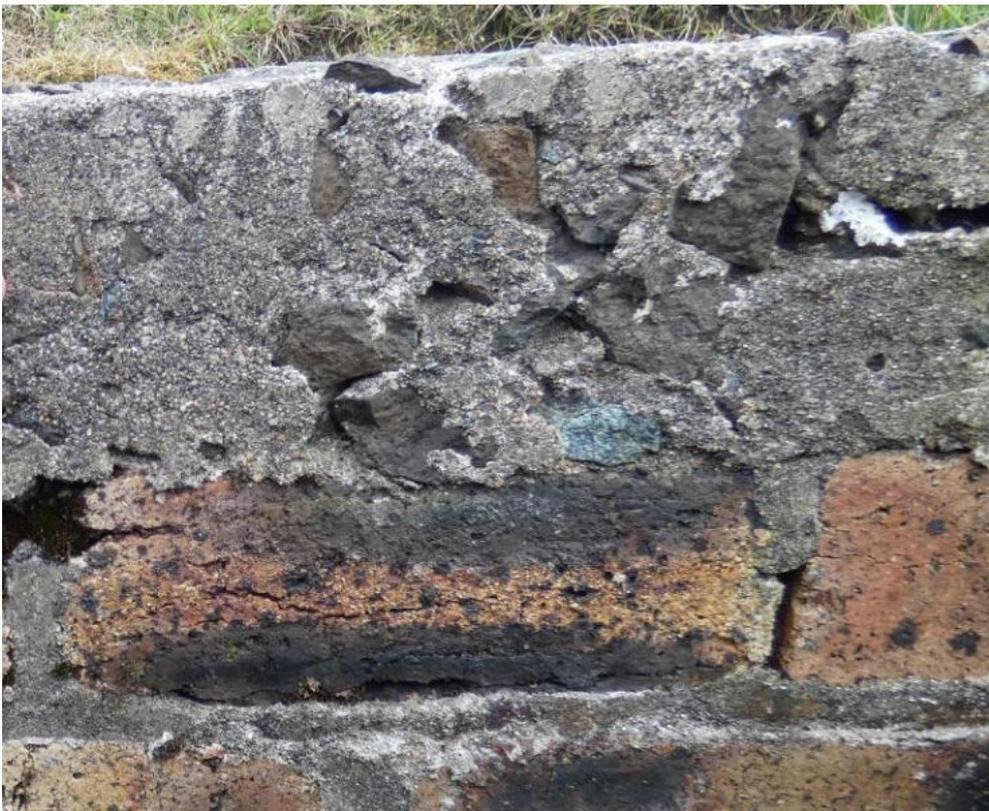
Defective brick joints and exposed aggregate to roof slab.

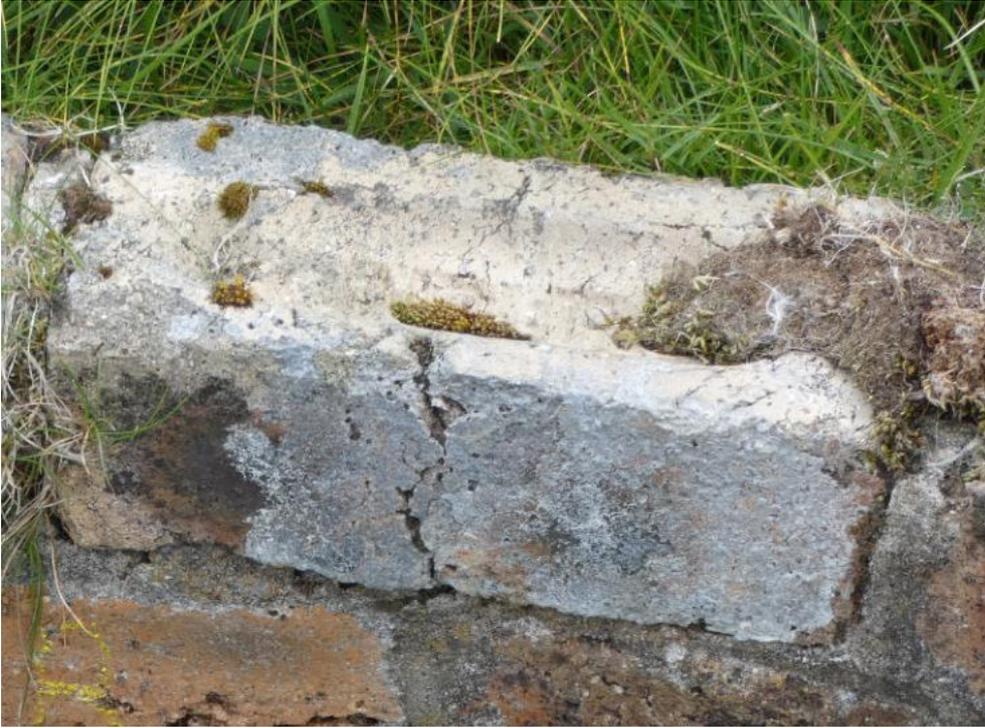
Localised failing joints at curved wallhead.

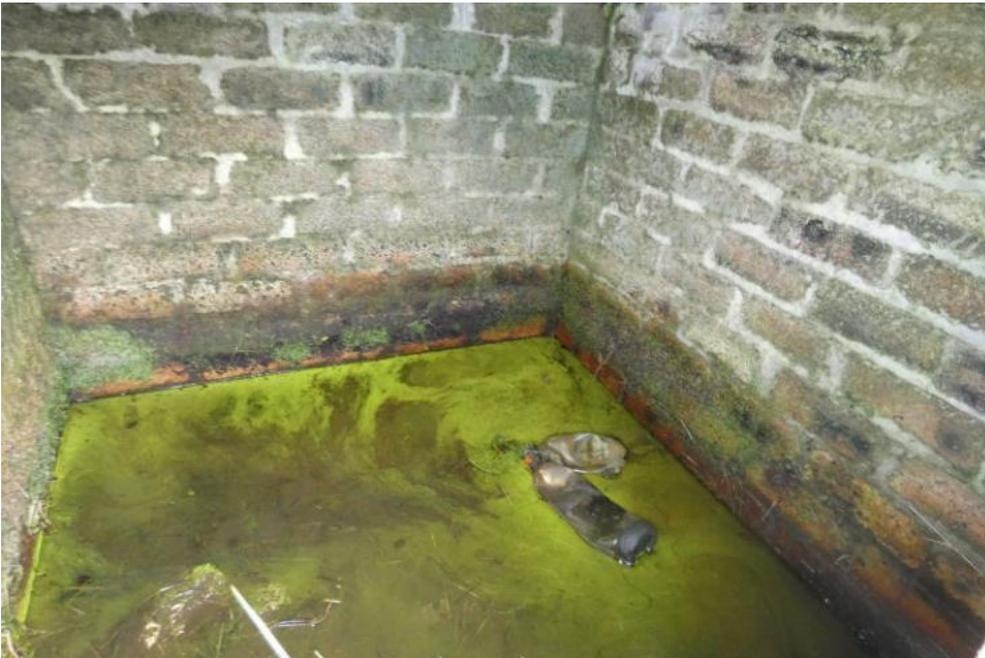
Flooded covered area saturating brickwork above.

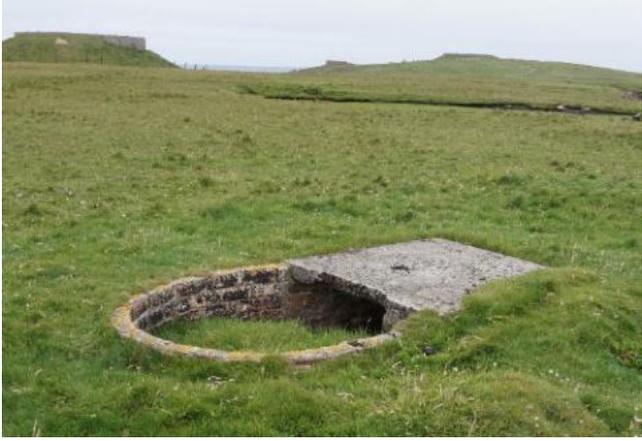
Condition:			
<p>Fair: Cracked joints at curved end. Spalled concrete and exposed corroded reinforcement over entrance to covered end. Internal walls saturated below covered area.</p> <p>Covered part of the structure is flooded.</p>			
Recommendations:			Priority:

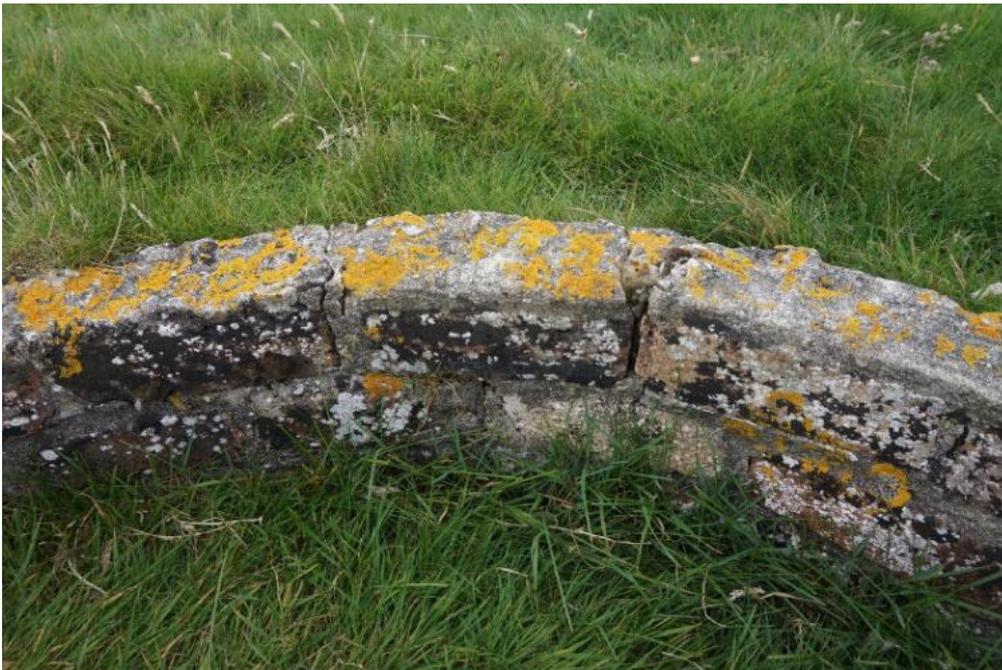
Localised failing joints to wallhead of curved west end.

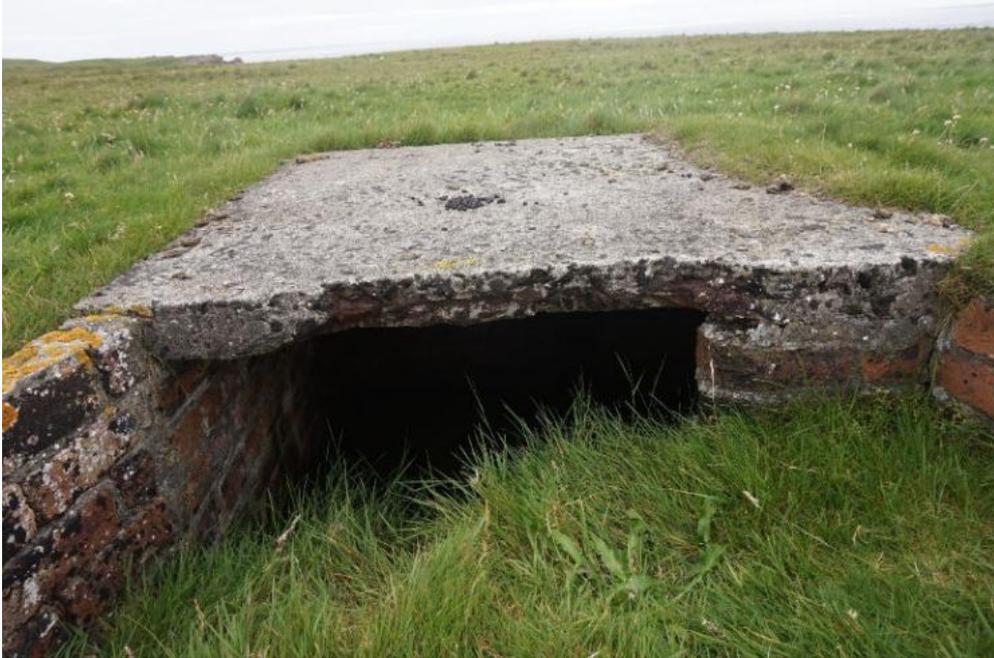
The concrete roof slab is currently stable, however, its condition should be monitored as part of future inspections.

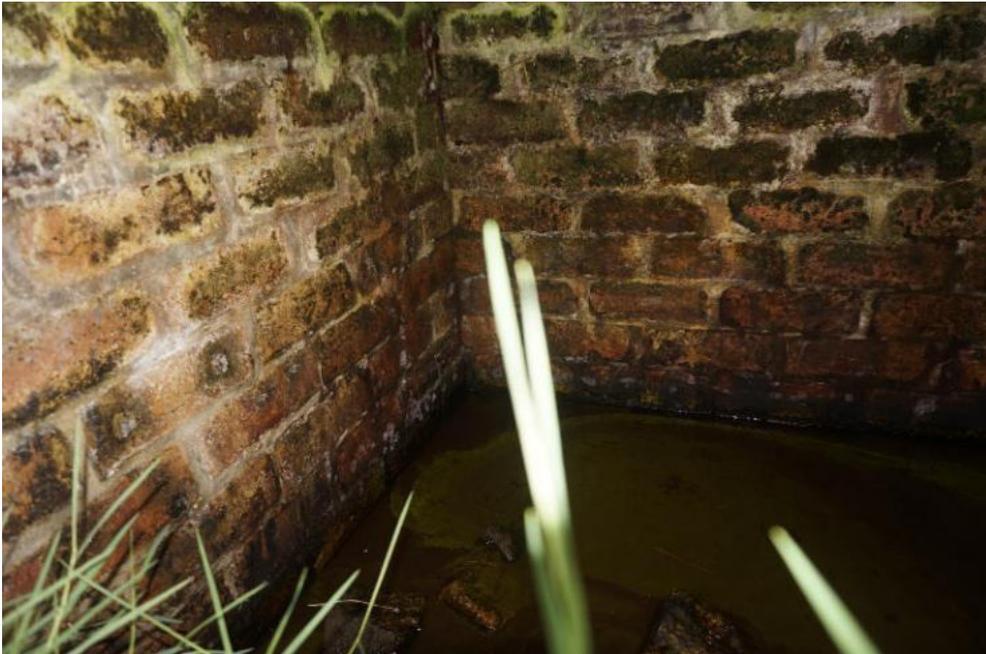
Flooded covered area, with displaced bricks.

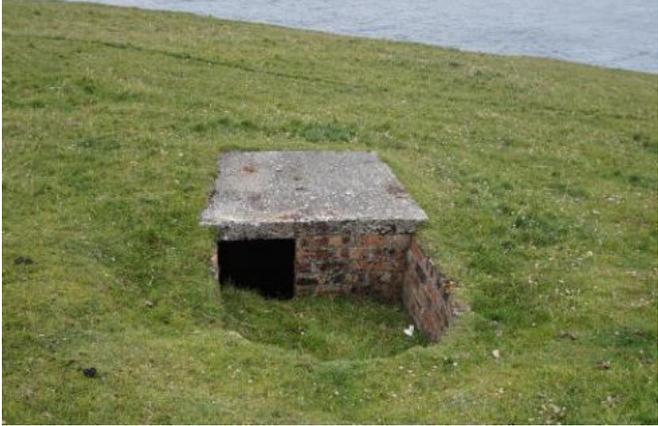
Condition:			
<p>Fair: Wallhead mostly covered with grass to curved north end but failing joints and missing brickwork visible. at curved end. Minor spalled concrete and rust staining to roof slab. Internal walls saturated below covered area.</p>			
Recommendations:			Priority:

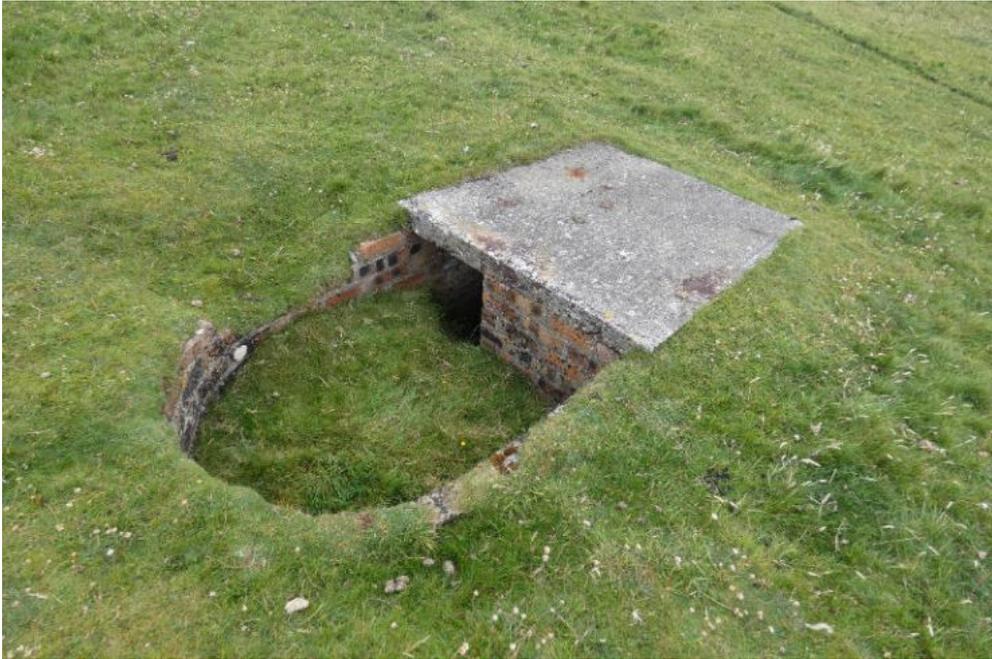
Missing wallhead brick work and defective mortar joints. Minor concrete spalling at slab edge.

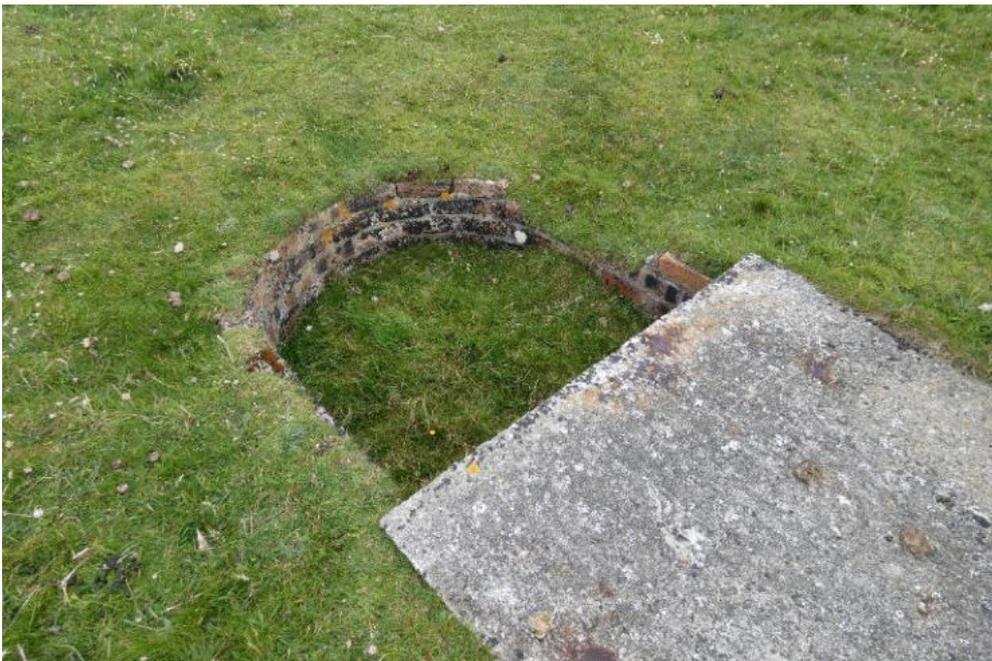
Missing wallhead brick work and defective mortar joints. Localised rust staining to concrete roof slab.

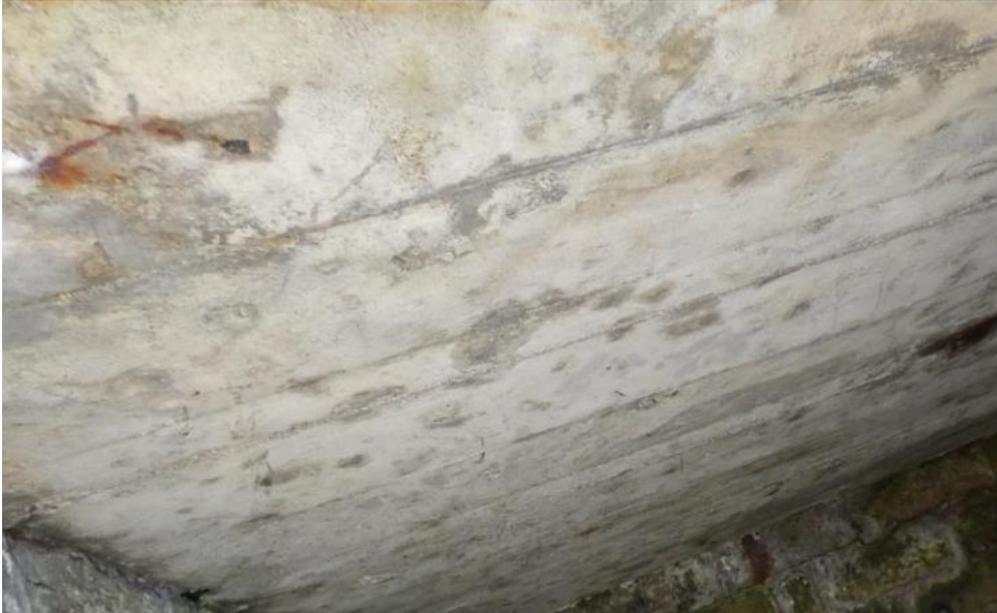
Minor spalling and exposed reinforcement.

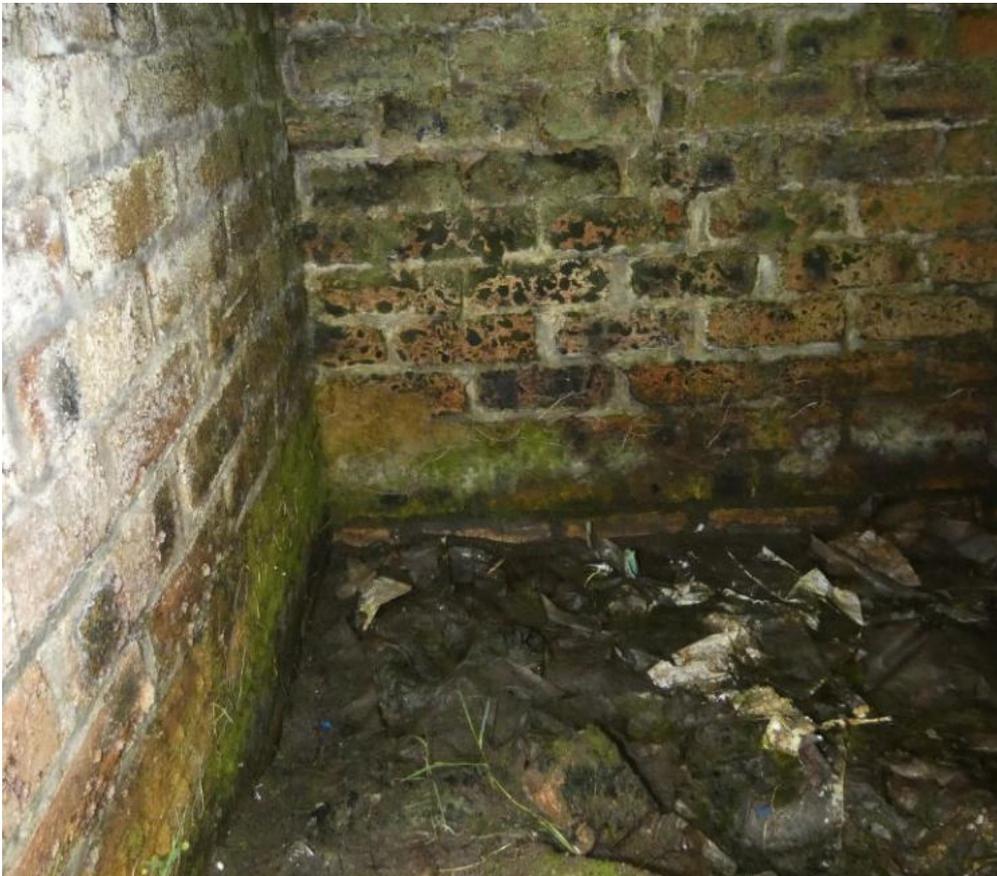
Saturated brickwork below covered area.

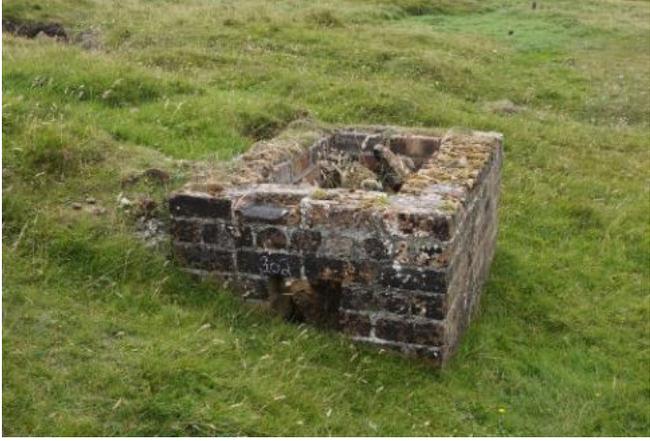
Condition:			
<p>Fair: Minor localised open, cracked and failing mortar joints, including to exposed wallhead which is supporting vegetation growth. Minor localised damaged bricks.</p>			
Recommendations:			Priority:
1.	Repoint open and defective joints, especially skyward facing joints. £50.00		Desirable

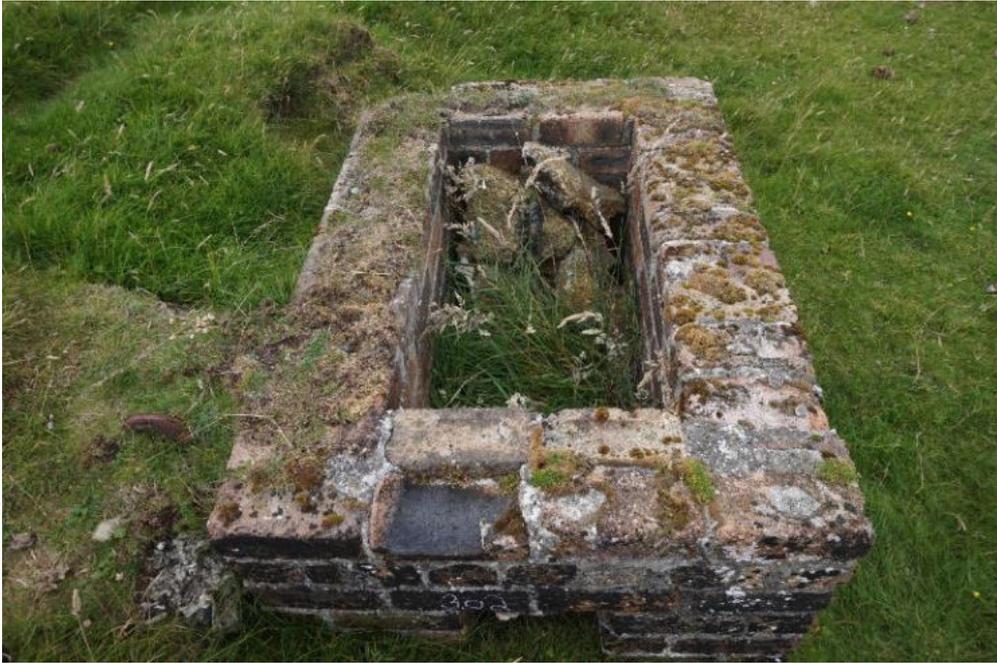
Failing joints to wallhead supporting vegetation growth. Localised damaged bricks.

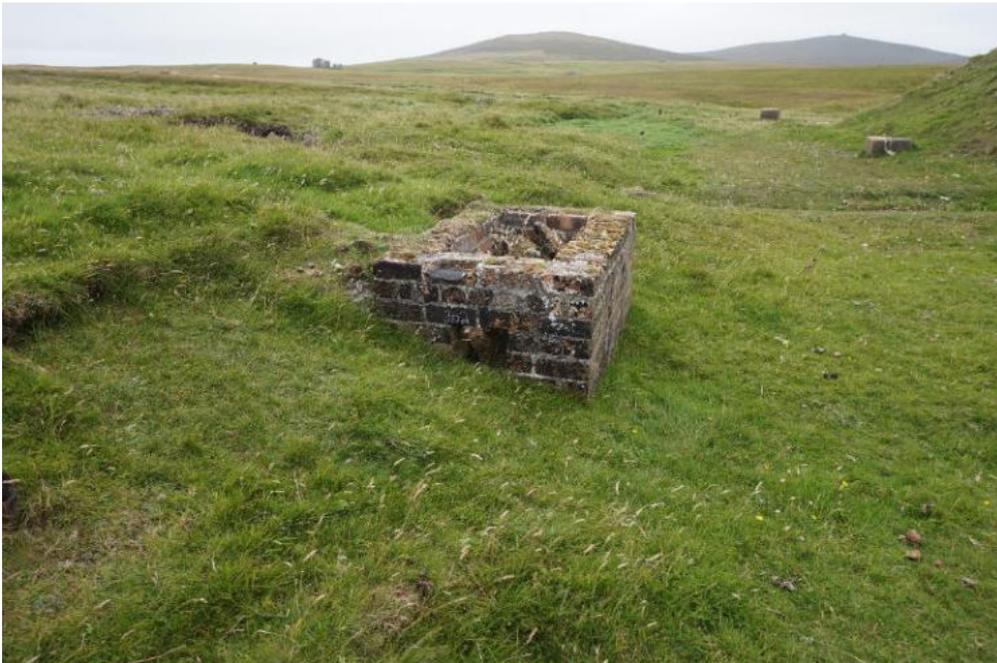
View from east showing small opening at ground level.

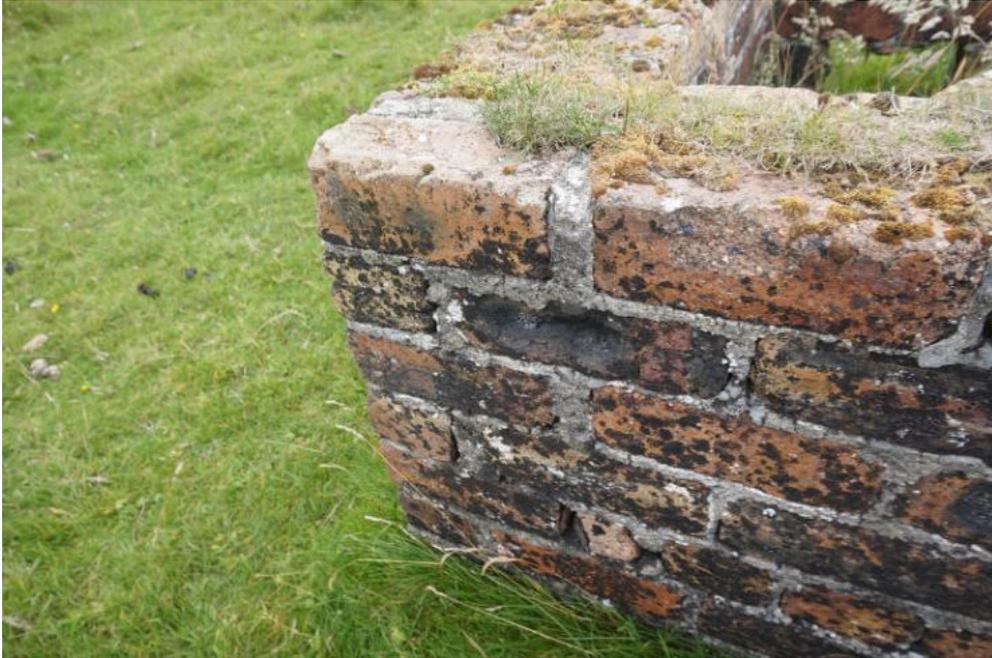
Failing joints to wallhead supporting vegetation growth. Localised damaged bricks and open joints to wall face.

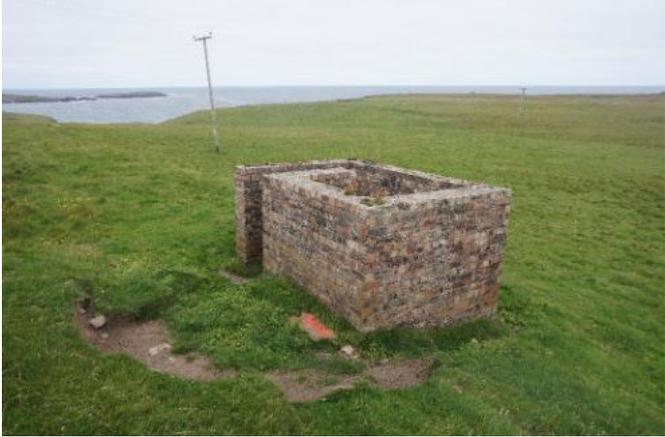
Condition:			
<p>Fair: Minor localised open, cracked and failing mortar joints, including to exposed wallhead which is supporting vegetation growth. Minor localised damaged bricks. Structure is not plumb or level indicating subsidence but appears stable as no structural cracking visible.</p>			
Recommendations:			Priority:
1.	Repoint open and defective joints, especially skyward facing joints. £200.00		Desirable

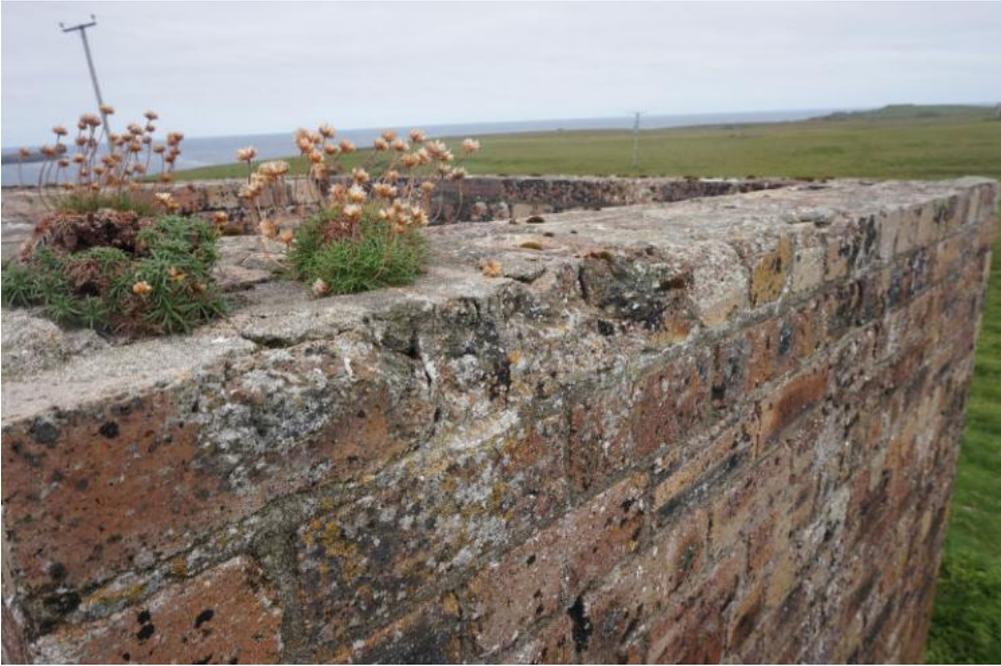
Localised damaged brickwork and defective joints. Vegetation growth at wallhead.

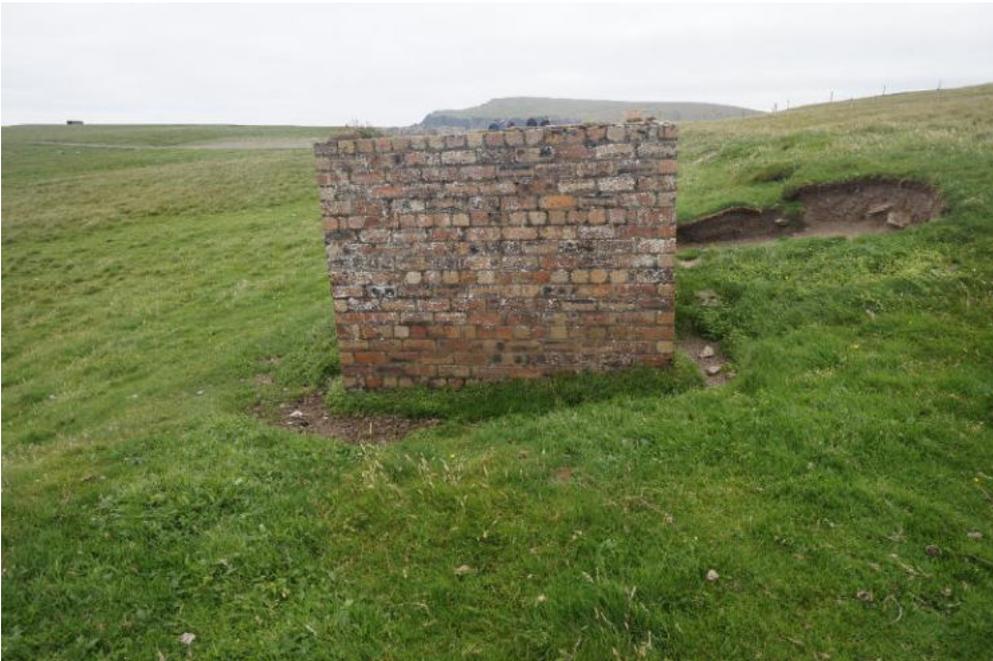
No structural cracking was observed despite the walls not being plumb or level.

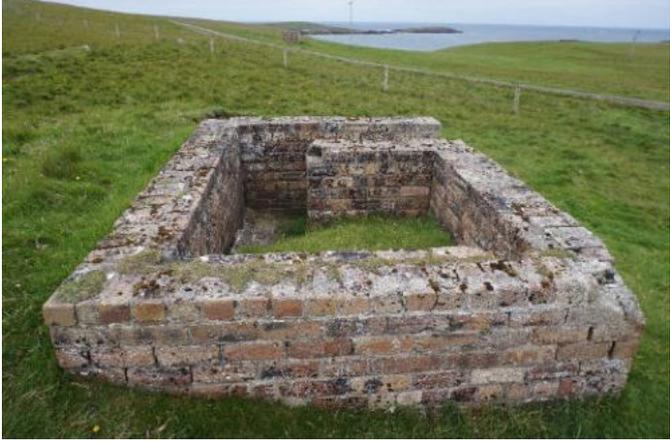
Condition:			
Fair: Localised open, cracked and failing mortar joints throughout, including to exposed wallhead which is supporting vegetation growth. Damaged and missing brickwork to wallhead.			
Recommendations:			Priority:
1.	Repoint open and defective joints, especially skyward facing joints. Consolidate around damaged brickwork in southeast corner to minimise risk of further loss in this area. £400.00		Desirable

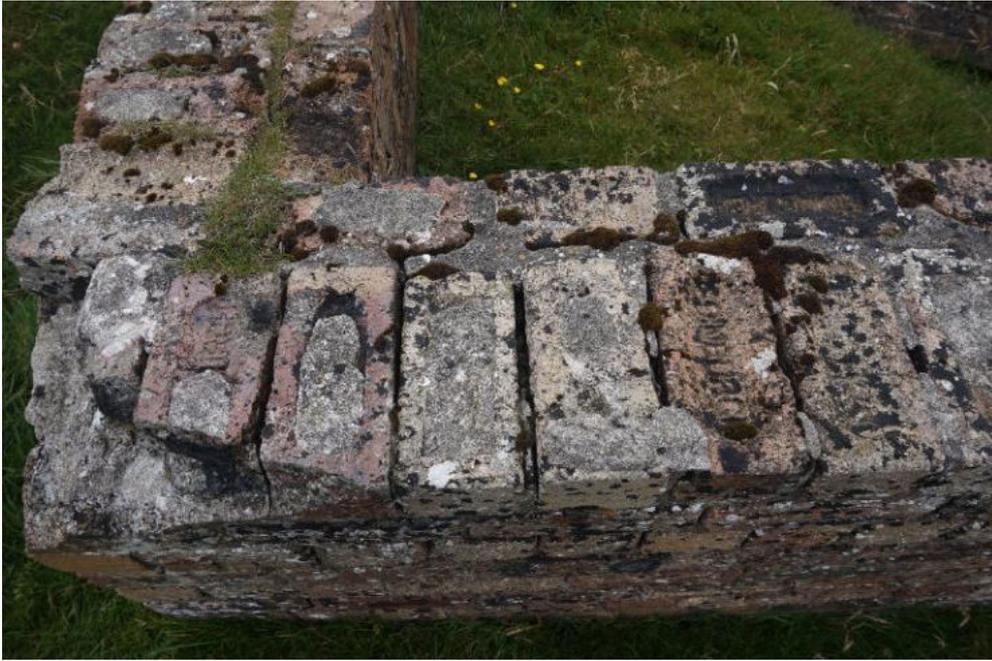
Open and defective wallhead joints and damaged brickwork in southeast corner.

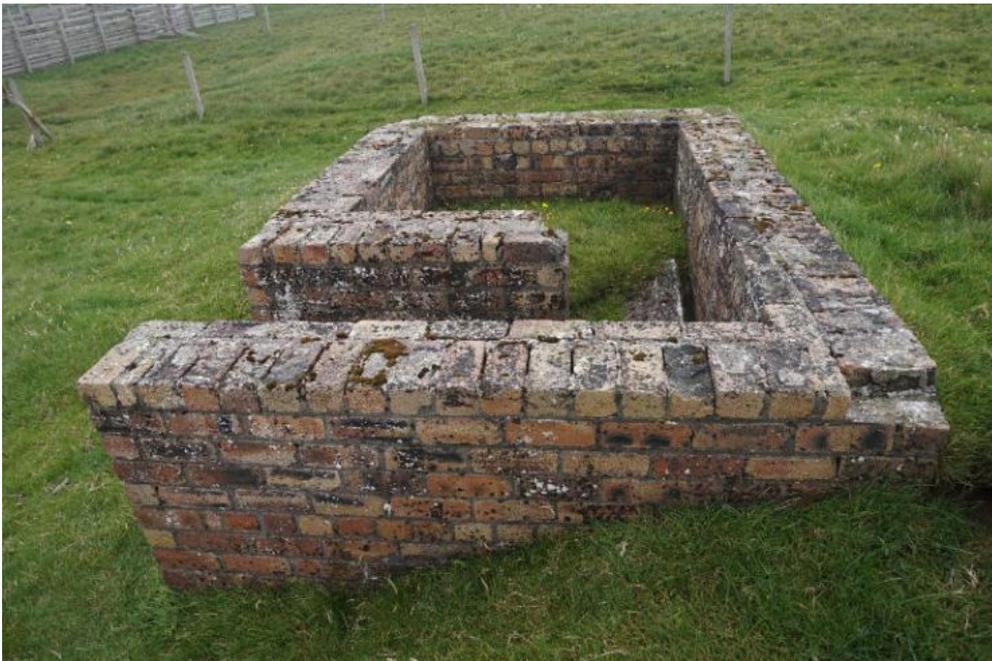
North Elevation: Missing and damaged brickwork and defective mortar joints.

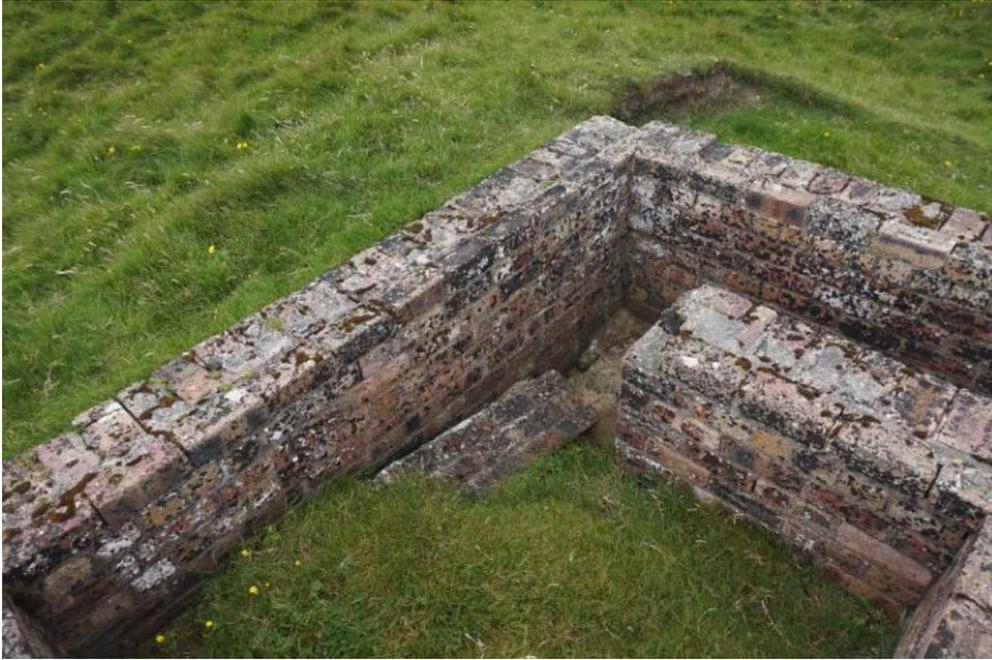
Significant soil and grass accumulations internally and displaced brickwork and concrete.

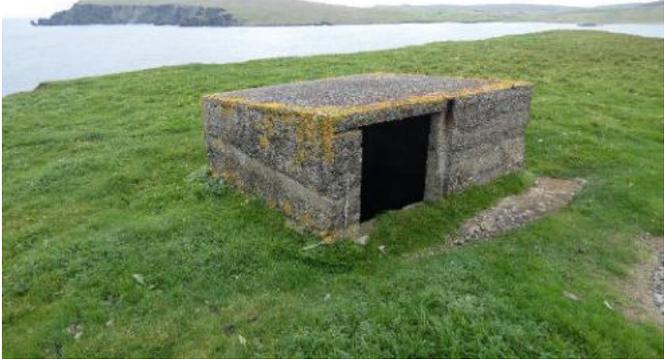
Condition:			
<p>Fair: Constructed with poorly mixed and compacted concrete with cracking visible at lift lines approx. mid point of external walls and at roof junction. Structurally stable. Localised disaggregation and surface loss externally. Poor coverage to reinforcement causing localised spalling and rusting staining to roof structure. Leaching saturation and damp staining internally, exacerbated by the flooded floor. Lichen growth externally.</p>			
Recommendations:			Priority:

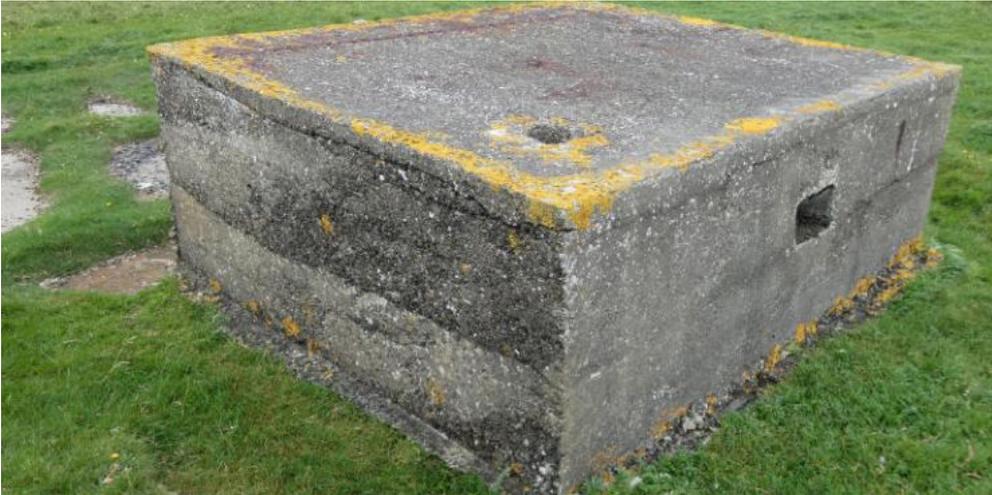
Cracking at lift lines on external walls and at the junction with the roof slab. Poorly mixed and compacted concrete with minor surface disaggregation, cracking and spalling. Lichen growth on all faces.

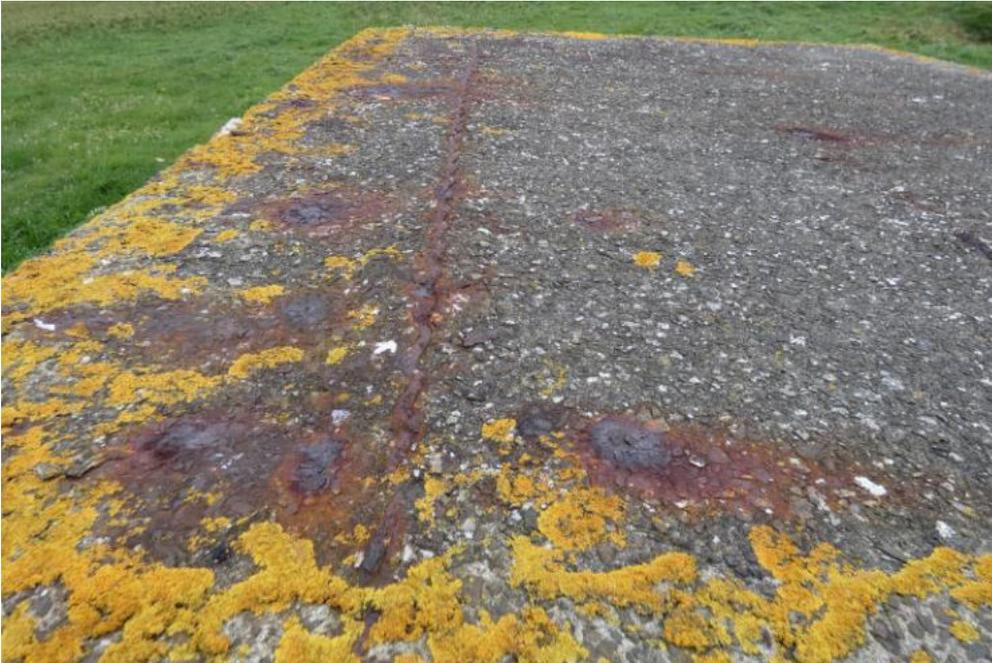
Poor coverage has exposed reinforcement externally on the roof slab.

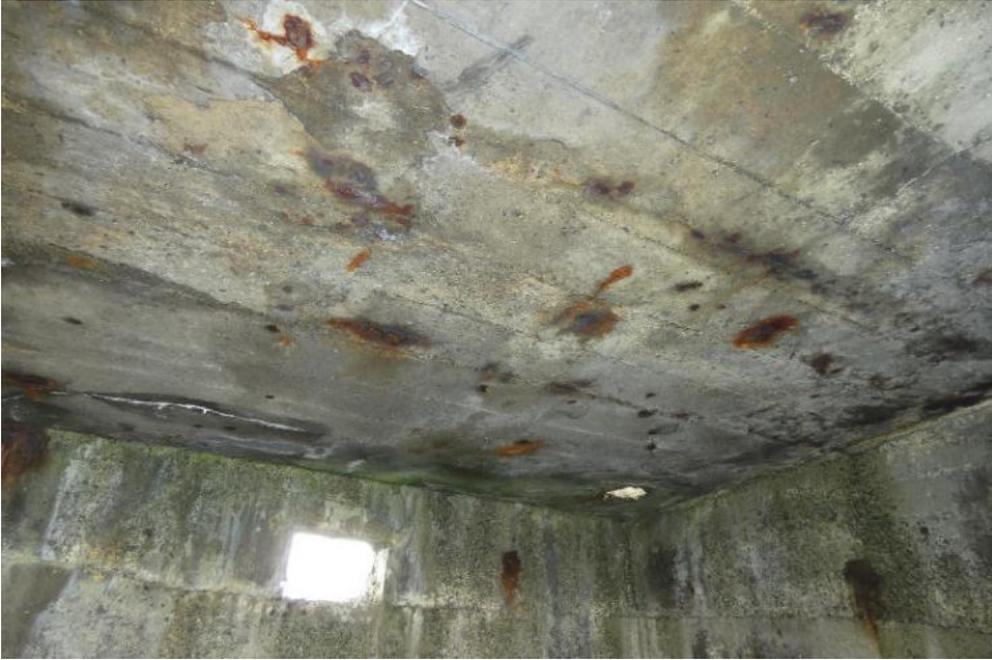
Hairline cracking, rust staining, leaching and discolouration to the soffit of the roof structure.

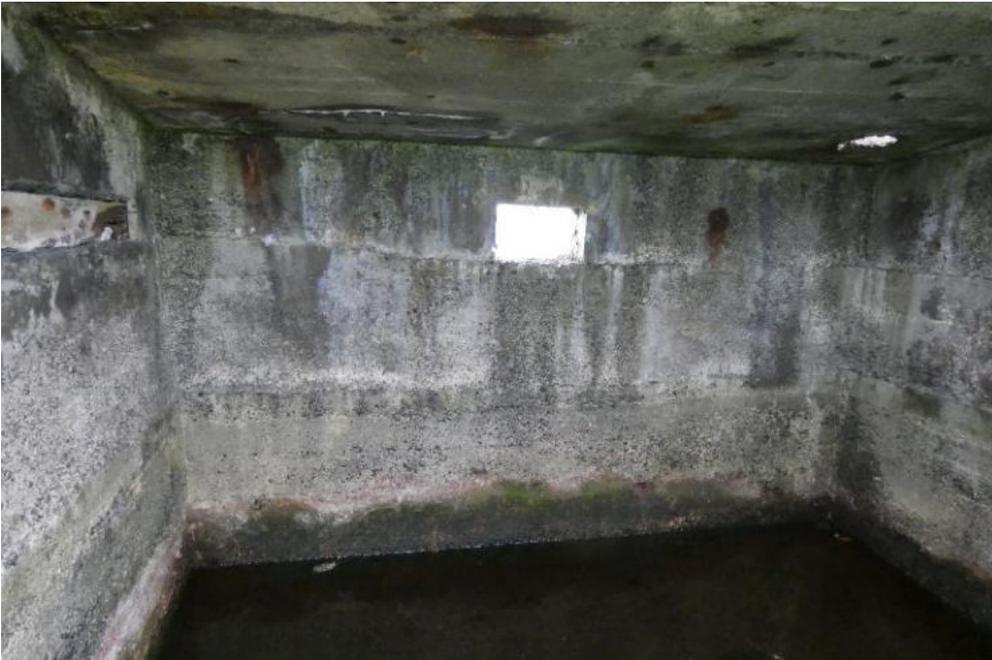
Hairline cracking, rust staining, leaching and discolouration to the walls exacerbated by flooding internally.

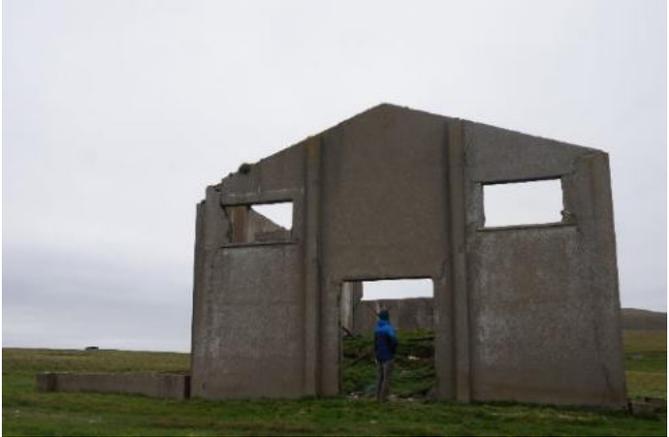
Site No.	77	Site Name:	Power House
Description:		General Photograph:	
<p>Cement rendered one-brick-thick brick-masonry walls with external and internal piers, the latter appear to have been built to support steelwork carrying an unknown intermediate structure, now removed or buried under collapse debris. The roof structure has collapsed but can be seen to have comprised steel Fink-type trusses spanning onto the external walls. Rendered lean-to extension to east elevation and three concrete bases with rendered brick perimeter footing to the south. Precast reinforced concrete window cills and lintels. North facing and lean-to windows have been infilled with concrete blocks. Evidence for steel framed windows in openings. Internal floor obscured by accumulations of soil, animal faeces, grass and the collapsed steel roof structure and asbestos cement roof finish.</p>

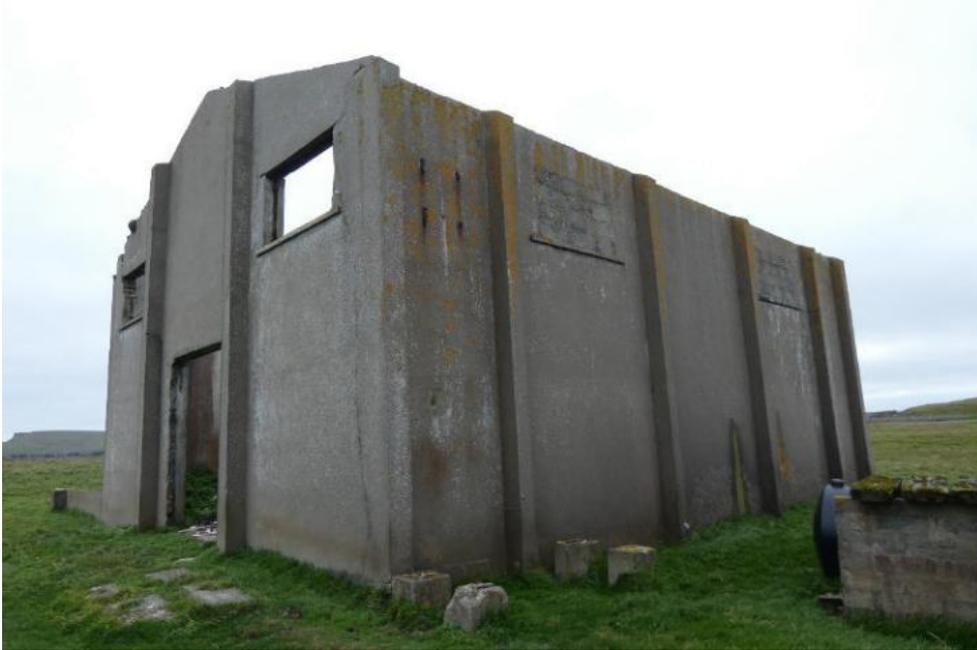
The northeast corner of the building. Note the vertical crack in the east elevation at the corner: there is no continuity between the west or south walls – they are free-standing elements.

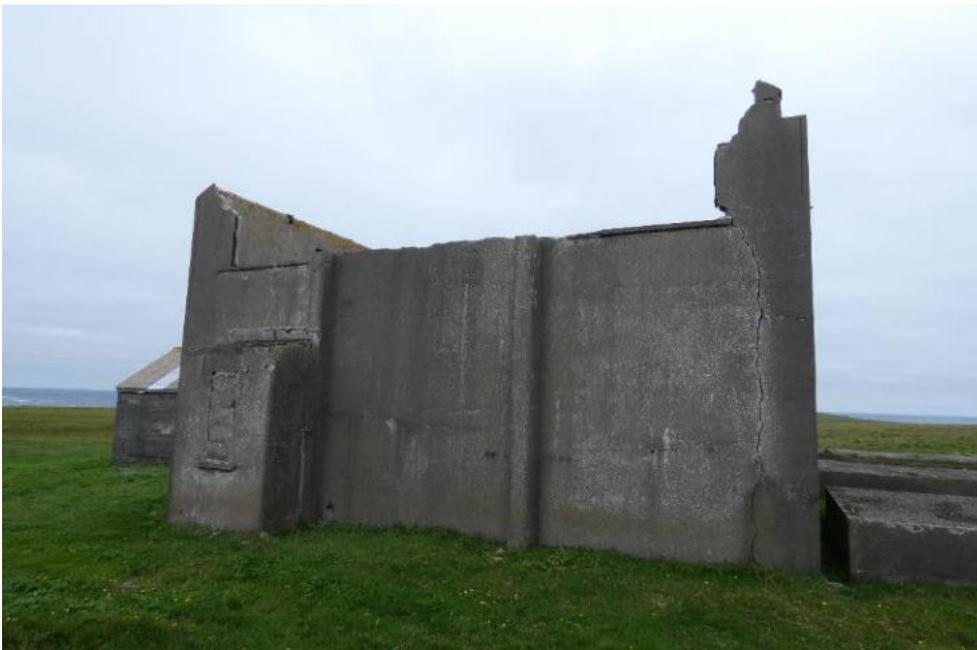
West elevation. The triangular gable has collapsed, falling inwards. Note the full-height crack to the south corner: there is no continuity between the west or south walls – they are free-standing elements.

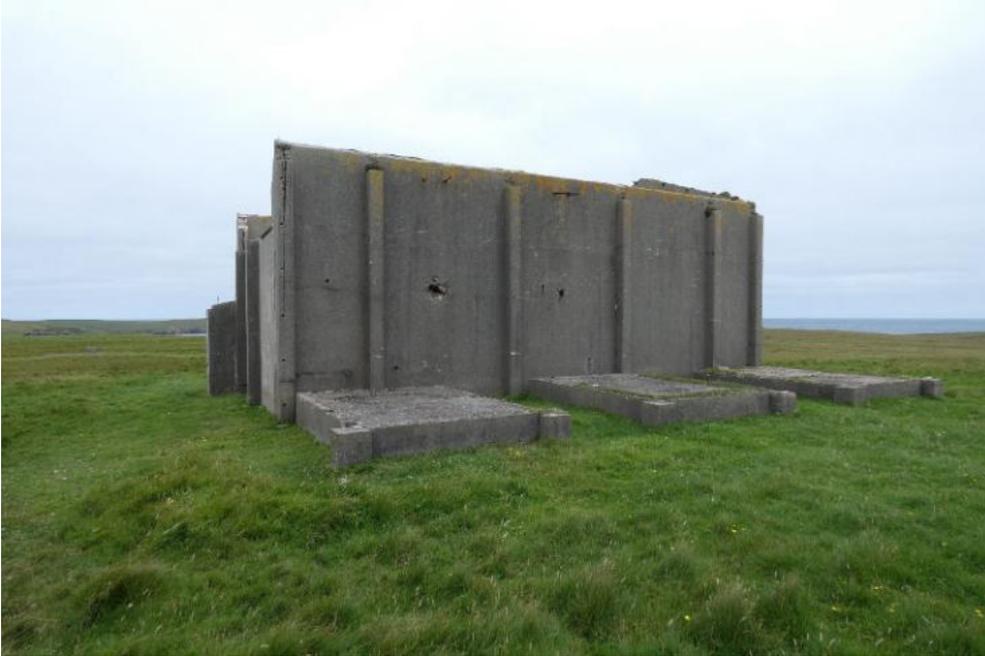
South elevation. See photos 2 and 4. This wall is a tall, thin, free-standing element.

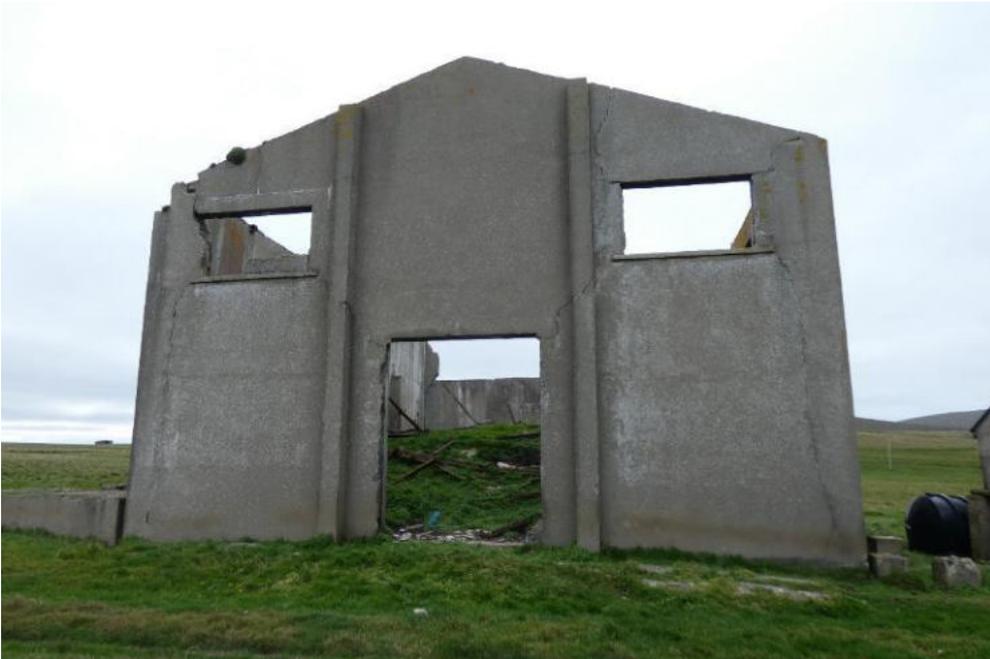
East elevation. Note the vertical cracking at each corner. Note the diagonal cracking between the entrance opening and both window openings and how this cracking continues up to wallhead: this elevation is a stack of independent, thin, tall, wall panels sitting atop each other.

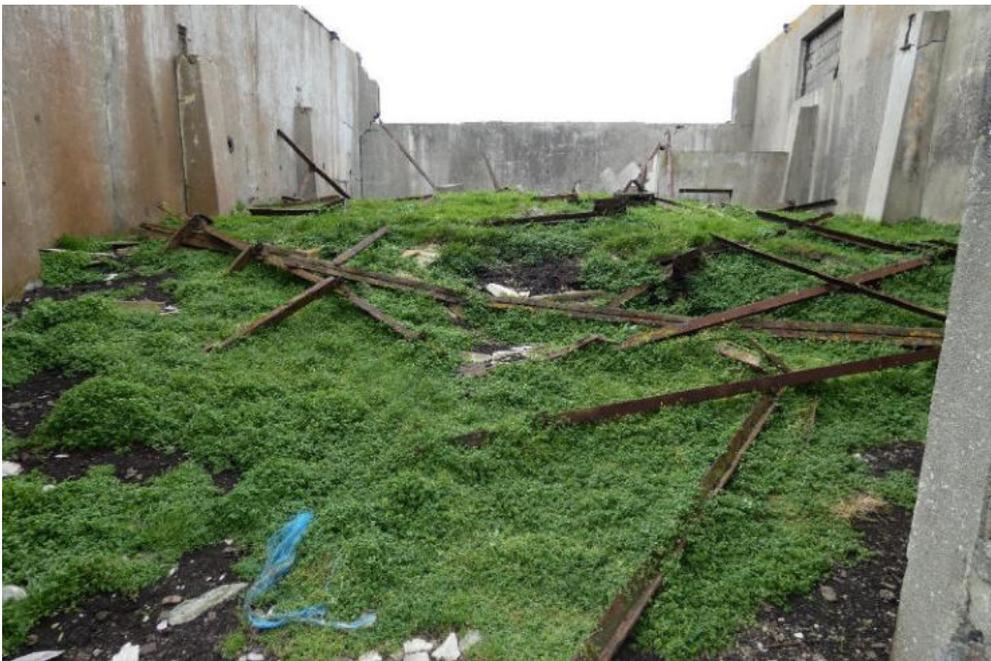
Inside the building. Note remains of the roof structure and asbestos roof tiles.

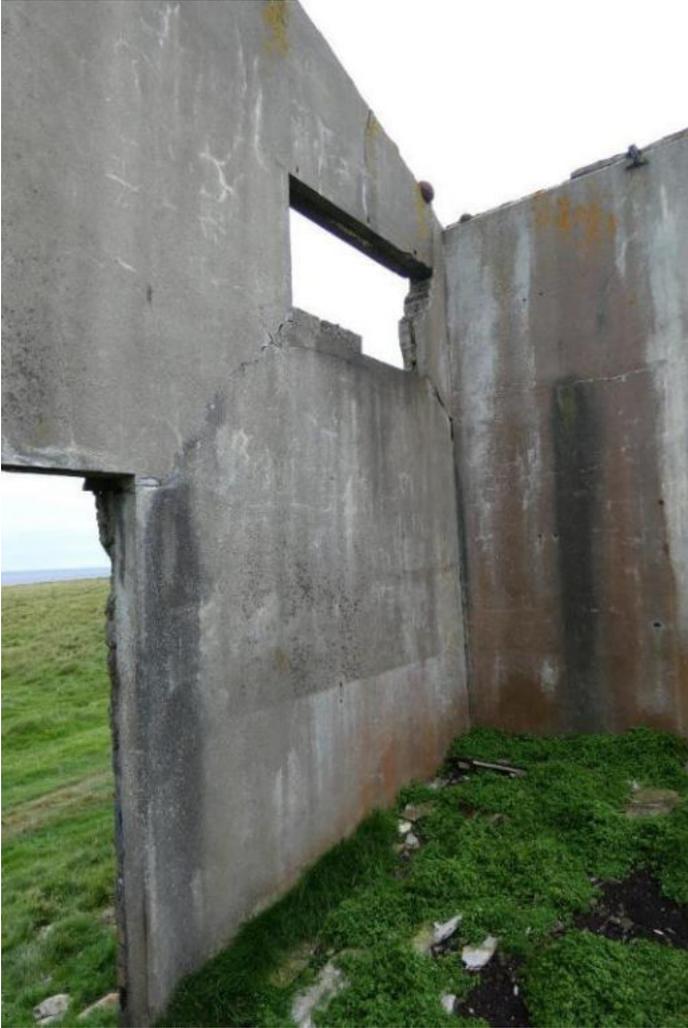
Internal view of east gable. Note how the cracking is right through the masonry.
