Appendix 14.10 Conservation Management Plan

Shetland Space Centre Conservation Management Plan

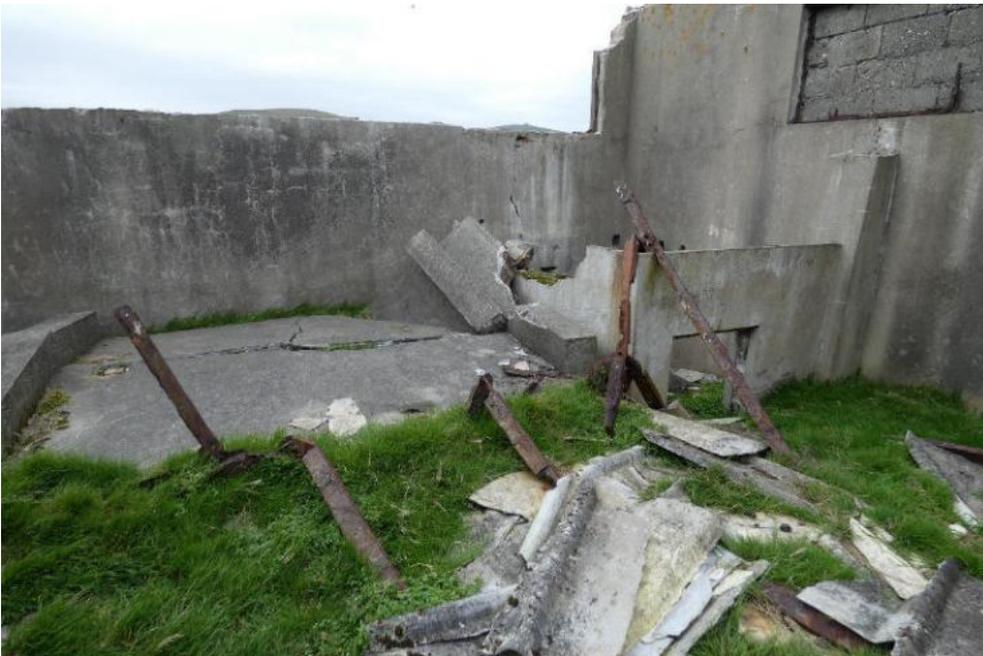
Inside of the west gable. The collapsed upper section can be seen on the floor.

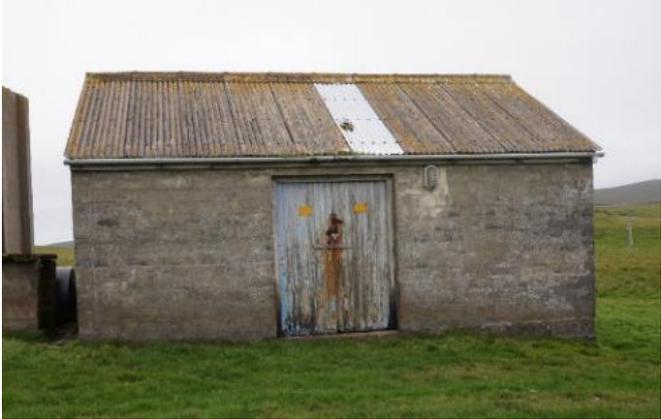
Condition:				
<p>Fair (locally poor): roof coverings appear weather tight. Blocked gutter to east, damaged to west. Missing downpipes. Concrete block walls in good condition. Cracking to lintol over north window. External joinery in poor decorative condition. Rotten boards to north window and localised rot to doors and frame.</p>				
Recommendations:				Priority:

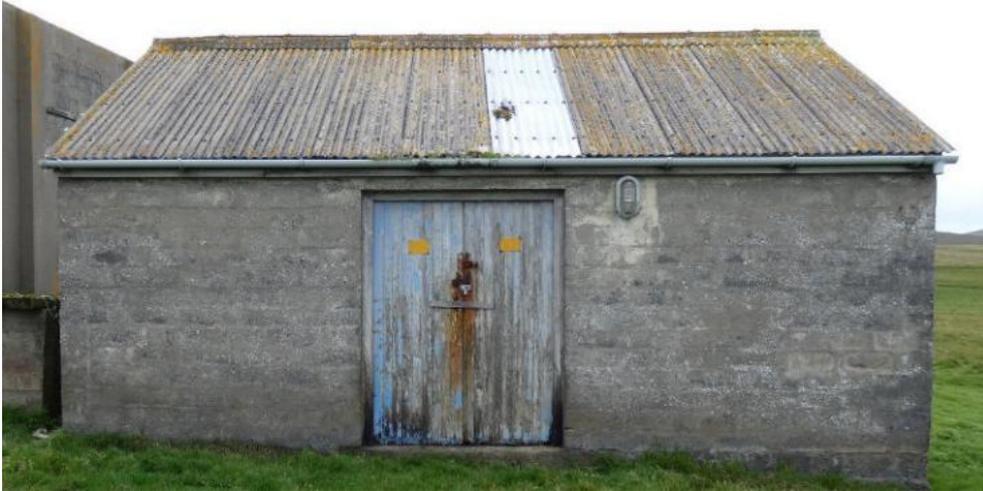
East elevation: Replace rainwater goods. Joinery repairs to doors prior to full joinery redecoration.

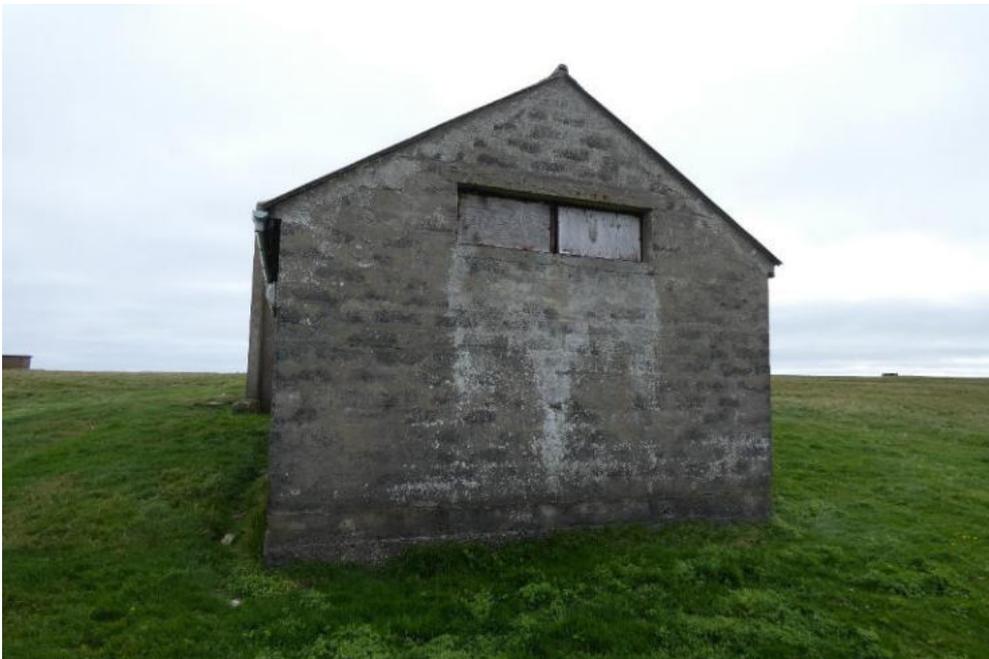
North elevation: Repoint cracked lintol and monitor. Replace boards to window and decorate.

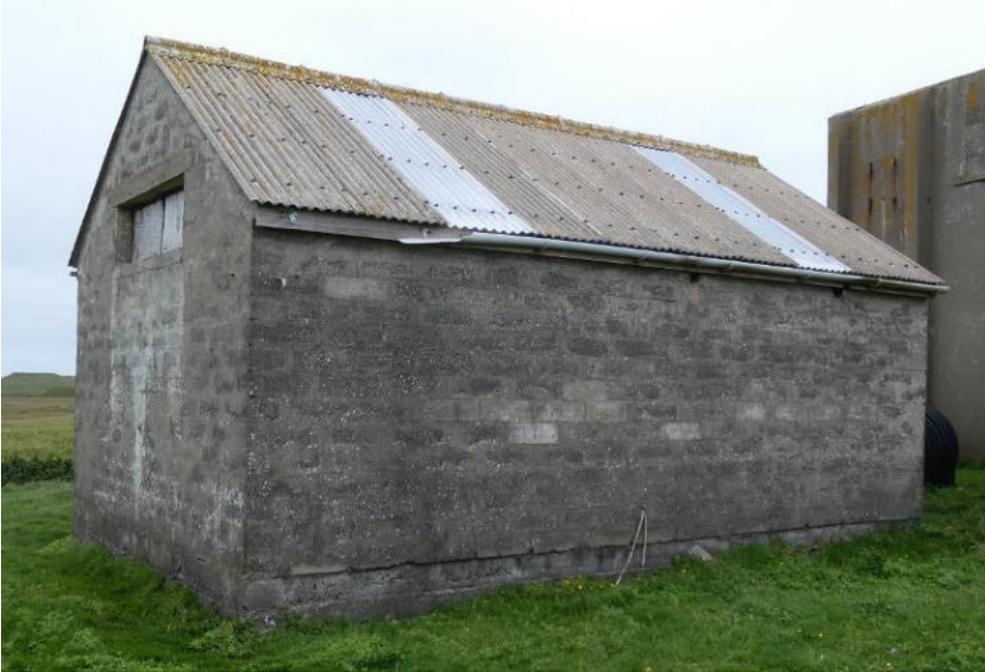
West elevation: Replace rainwater goods. Decorate facia.

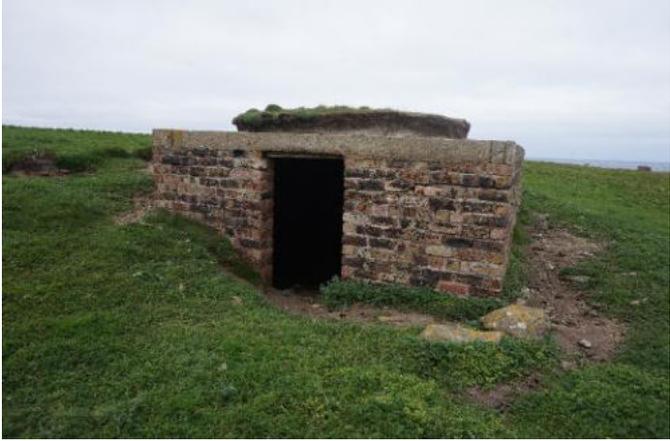
Condition:			
<p>Fair: Localised open, cracked and failing mortar joints throughout, especially immediately below roof slab on external faces where cracked and locally spalling brickwork was also observed. Internal brickwork damp and stained from saturated ground conditions, supporting moss and algal growth. Localised leaching on brickwork internally below roof slab. Rust staining to underside of roof slab, but structurally stable; no spalling concrete. Minor cracking to concrete externally immediately above junction with brickwork. Vent pipe blocked by soft capping</p>

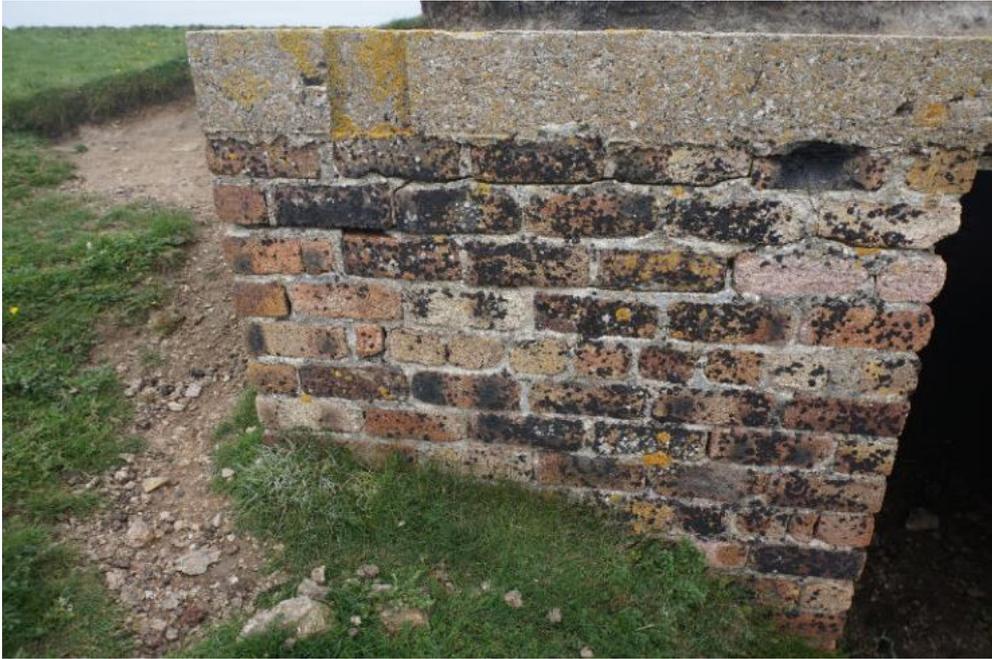
Cracked and failing mortar joints, and localised damaged brickwork.

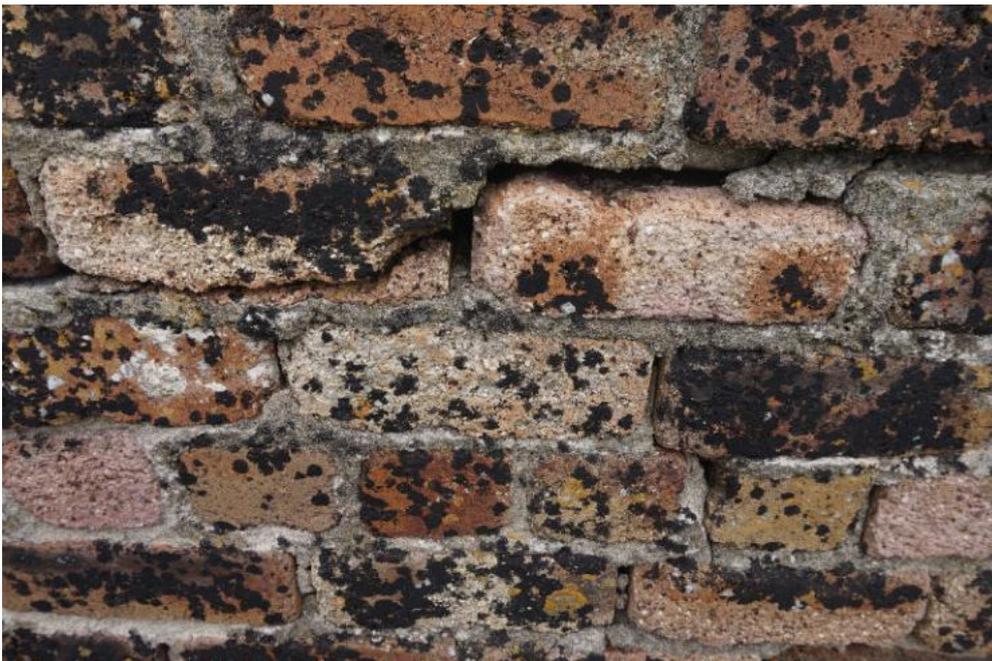
Damaged areas should be repointed to minimise further damage from water ingress and freeze/thaw.

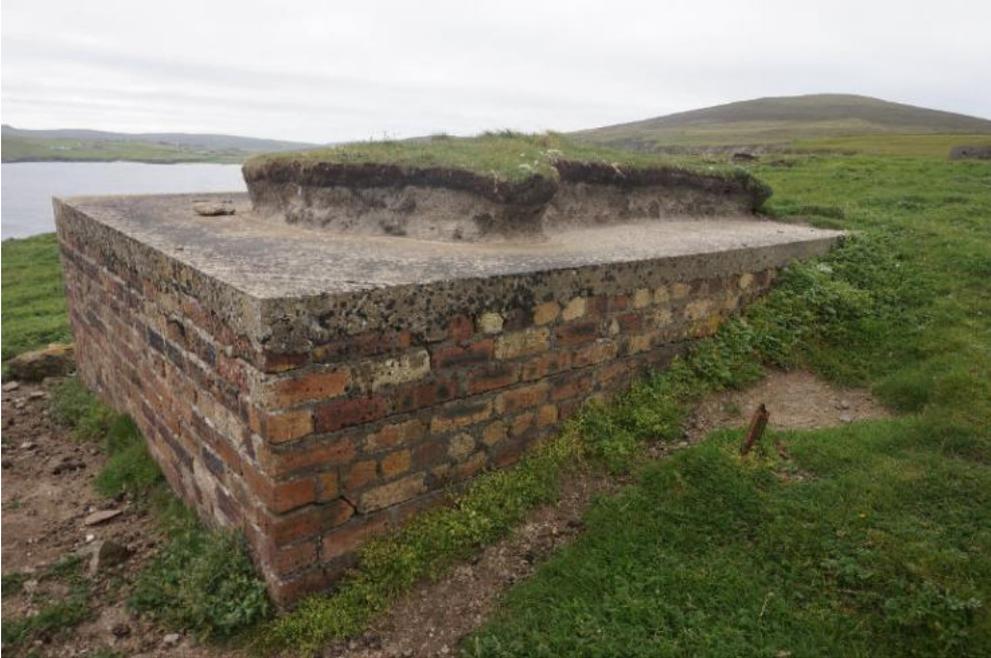
The worse affected areas are immediately below roof slab level, although repairs are required locally elsewhere. Cracked / open bed joints to the upper parts of the masonry are indicative of movement induced by drying shrinkage of roof slab.

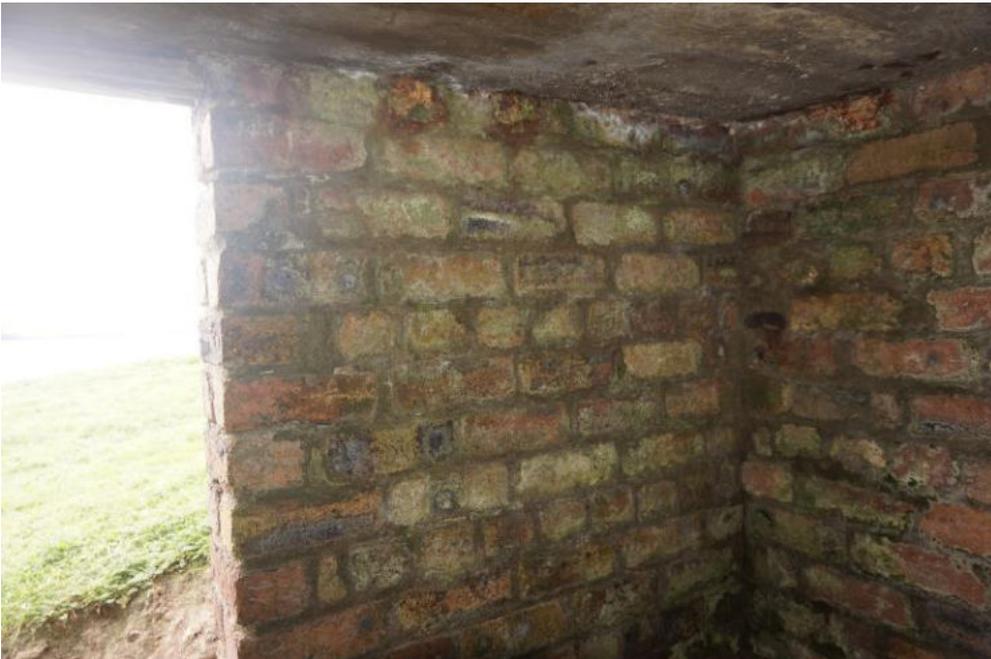
Localised leaching internally below the roof slab.

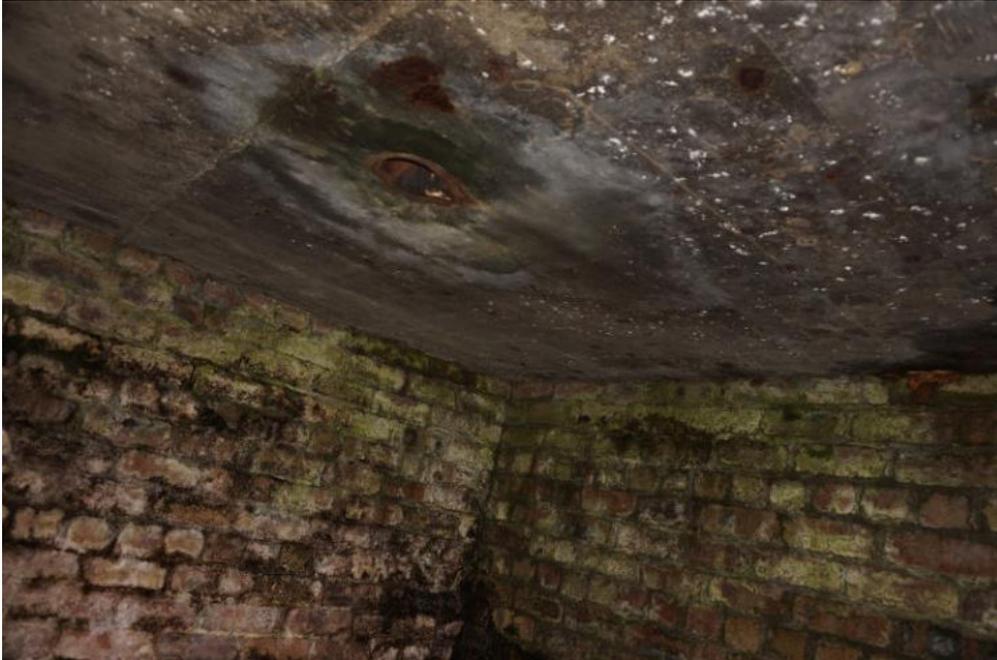
The vent pipe is blocked from above by soil and grass. Localised rust staining was observed on the soffit of the roof slab. No obvious spalling of the concrete.

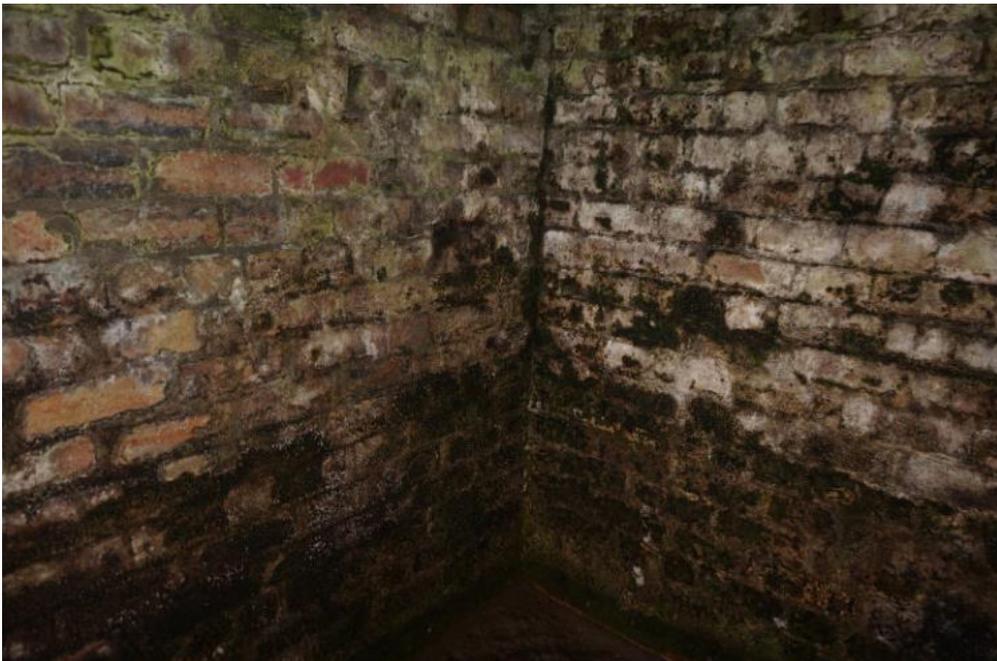
Damp stained brickwork internally from saturated ground conditions.

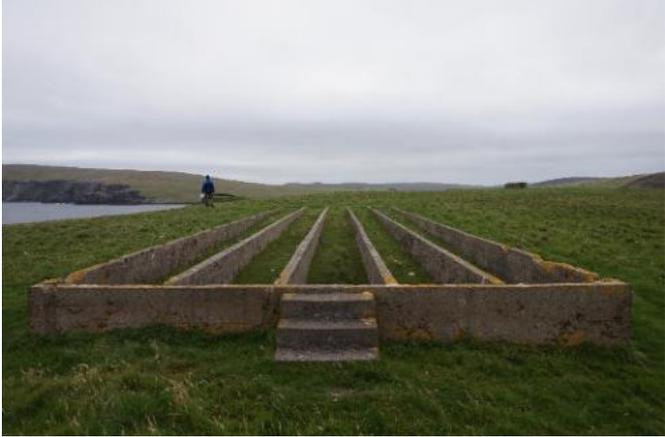
Condition:			
<p>Fair (locally poor): Despite cracking and localised spalling in the vicinity of surviving corroding wallplate fixings, and damaged/missing areas being visible throughout, the concrete walls remain stable. As much of the damage is limited to the perimeter footings, it suggests it was caused during demolition of the superstructure and removal of the wallplate fixings, or a result of later corrosion and spalling.</p>			
Recommendations:			Priority:

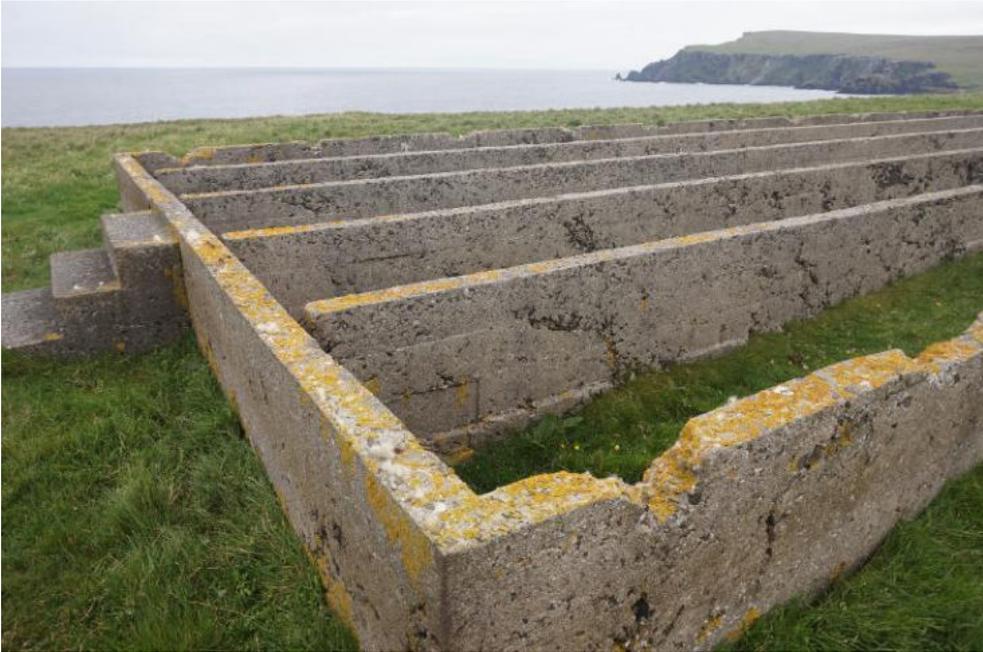
Damaged concrete is limited to the perimeter walls, suggesting it was caused during demolition works and removal of the wallplate fixings or when the fixings corroded at a later date causing localised spalling. Note poorly mixed and compacted concrete.

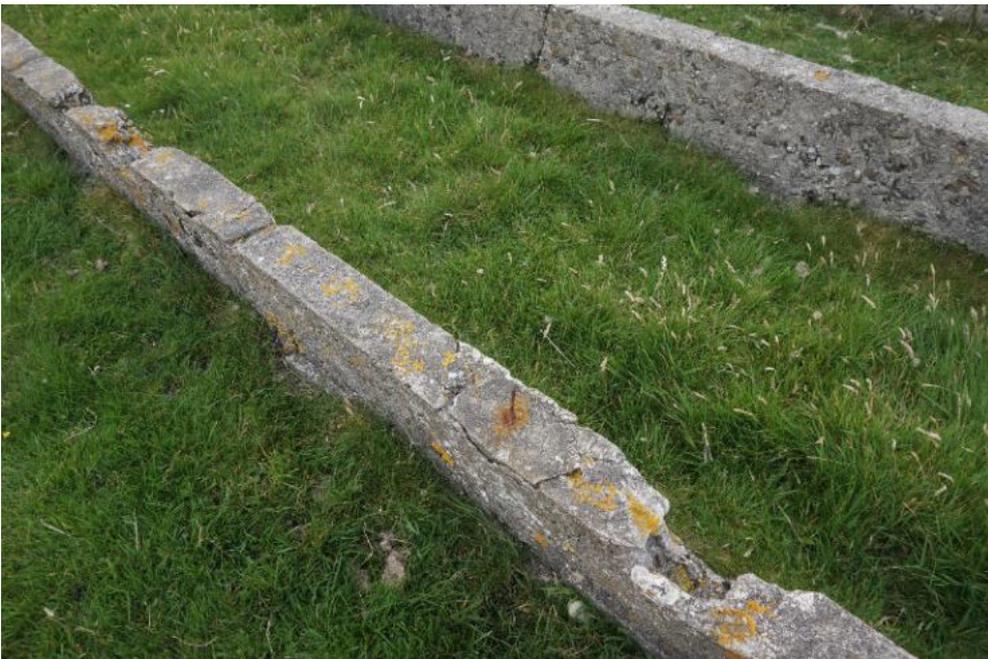
Localised spalling where corroded wallplate fixings survive.

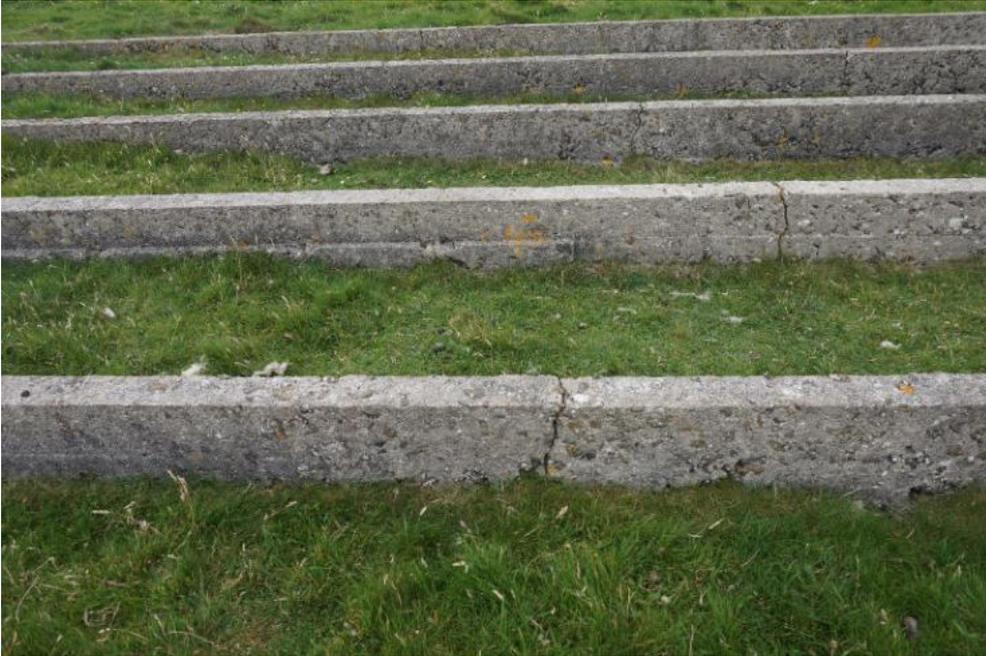
Despite the cracking which was observed throughout, the stability of the concrete walls appears unaffected.

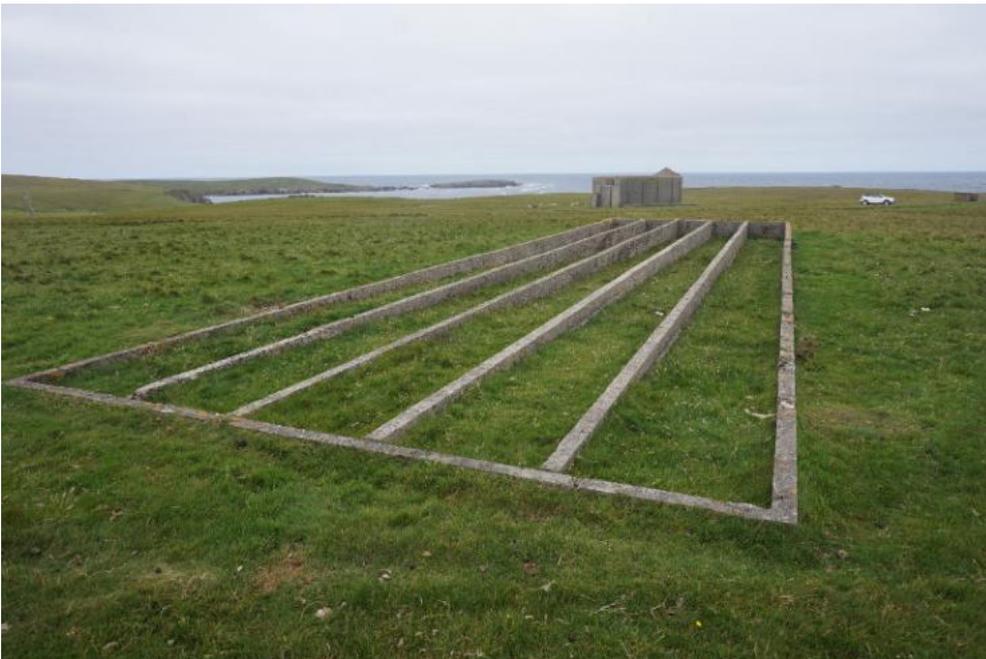
The greatest potential future risk to the concrete footings is from increased numbers visiting the site. Any future repairs to make good cracks or spalled areas should be informed by regular inspections to assess if their condition worsens. The option of burying the remains should be considered. This will not only protect the structure but will also reduce health and safety risk to visitors.

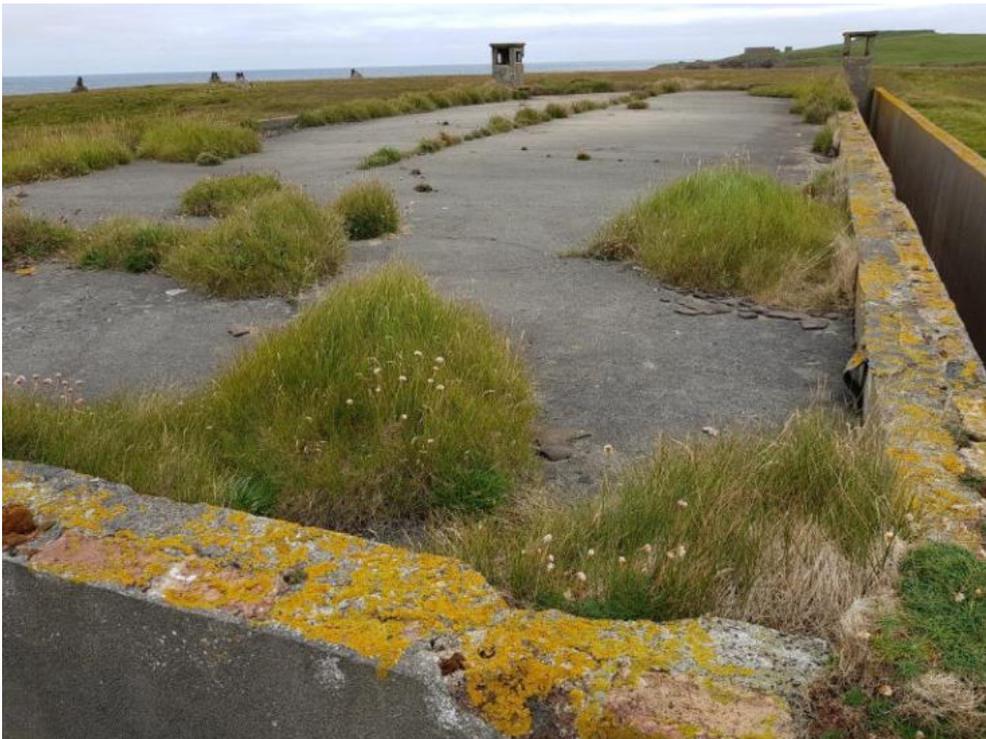
Looking across the roofscape. Note cracked asphalt, vegetation and missing concrete copes from wallheads.

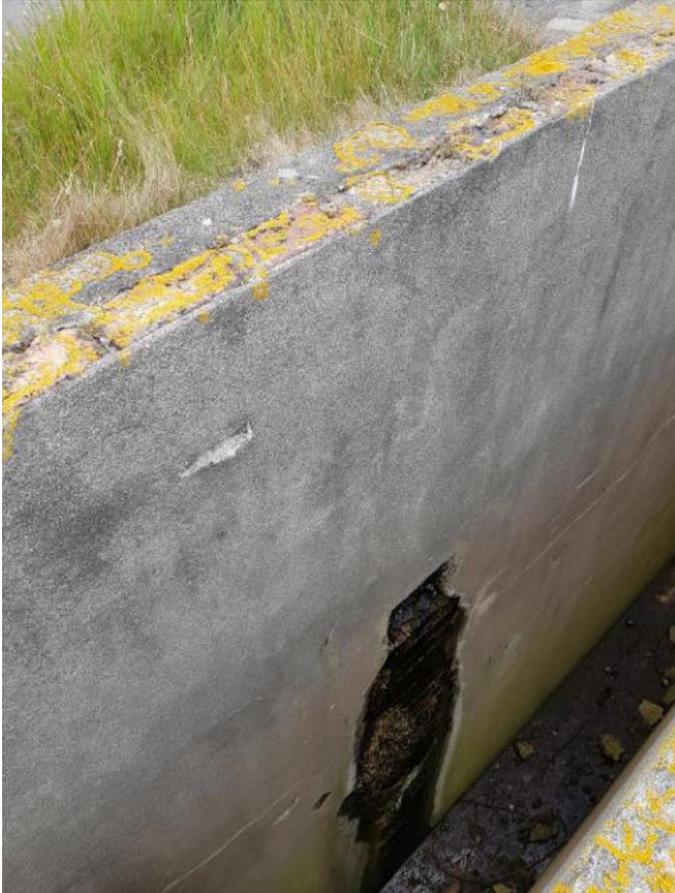
The outlet from the roof runs down into the wall and discharges part-way up it. Outlet is blocked by vegetation. Not loss of render from below the discharge point.

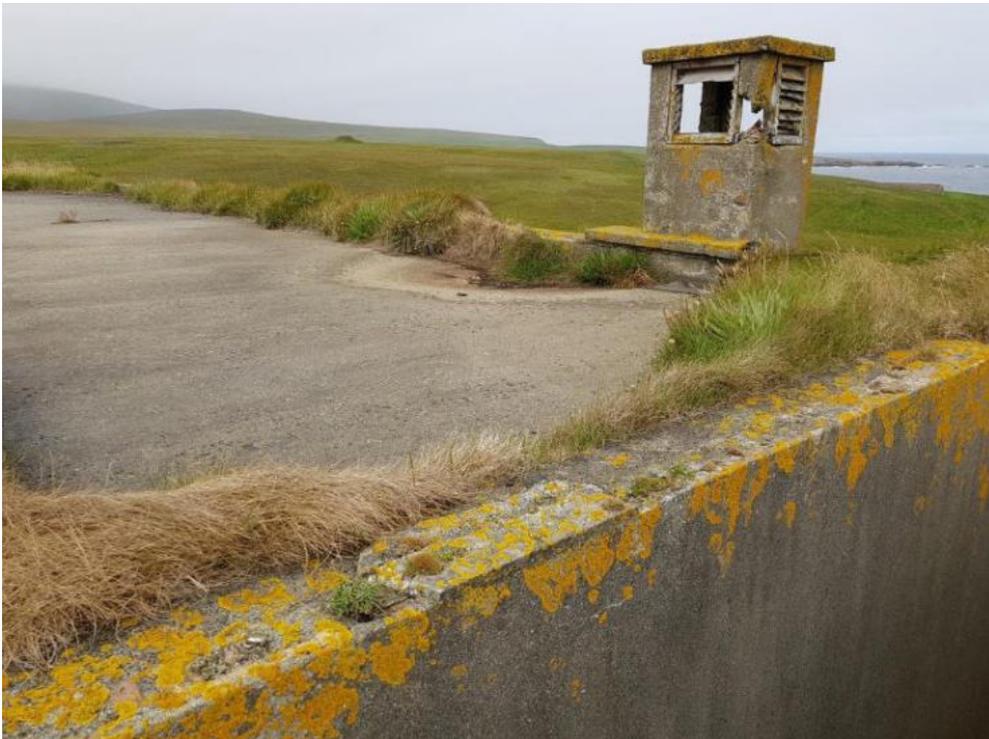
As 6. Note broken leg of RC cap to chimney – see next photo.

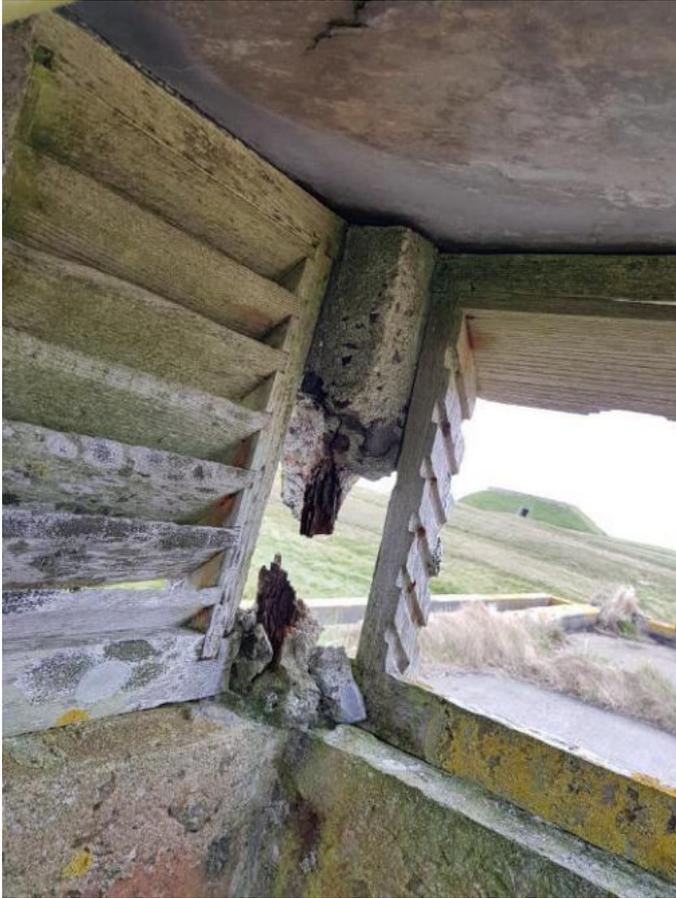
From previous, inside chimney. Chimney is generally of brick construction with an RC base and cap. This leg of the cap is broken as a result of expansive corrosion of its reinforcement. As long as the roof slab is securely fixed to the surviving legs then no further action need be taken at this time.

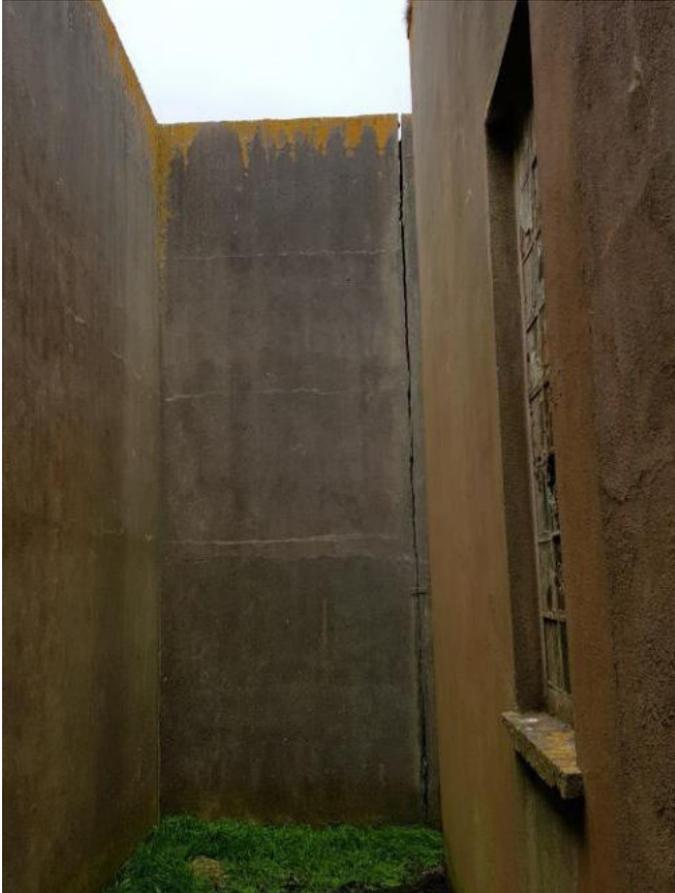
Looking along the external perimeter. The crack in the blast wall seen in the distance may actually be a deliberate joint – possibly true for other similar apparent cracks. Uncracked cement ‘tell tales’ placed across these cracks suggest there has been no recent movement (tell tales are dated 1942)

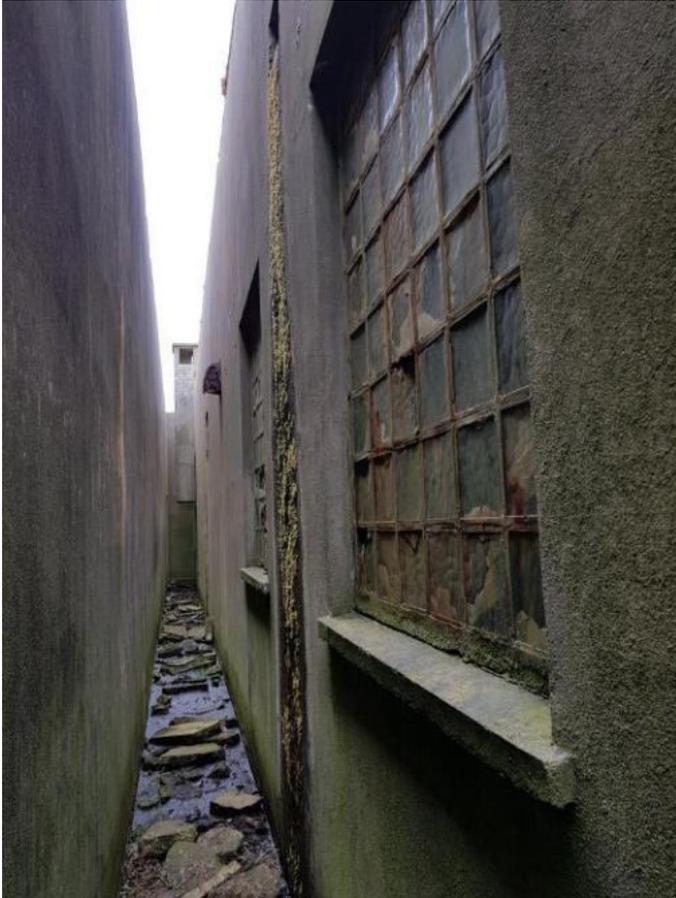
Note debris and build up of water in external perimeter.

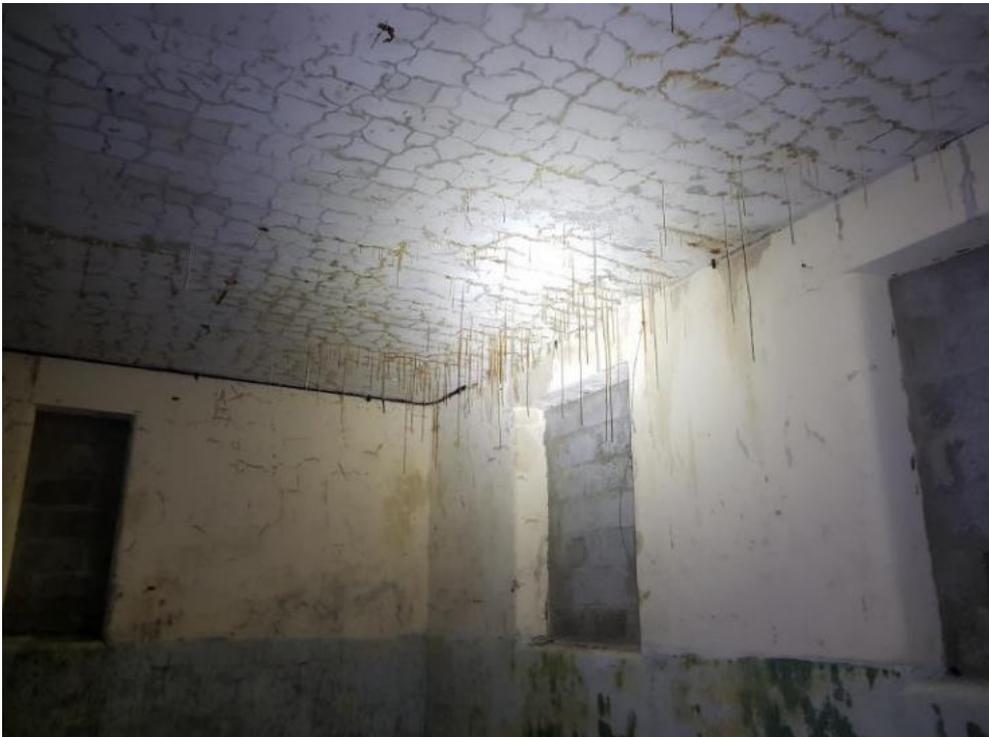
Water ingress through the roof slab obvious, indicated by the stalactites from the roof and cracking of the plaster.

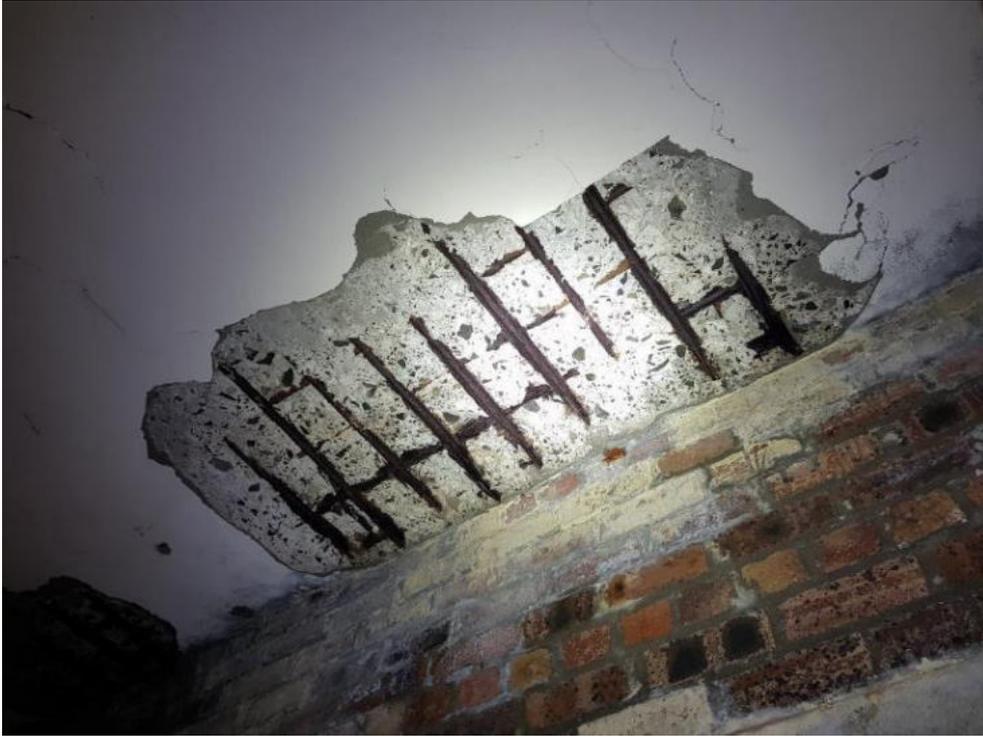
Spalling concrete caused by expansive corrosion of reinforcement.

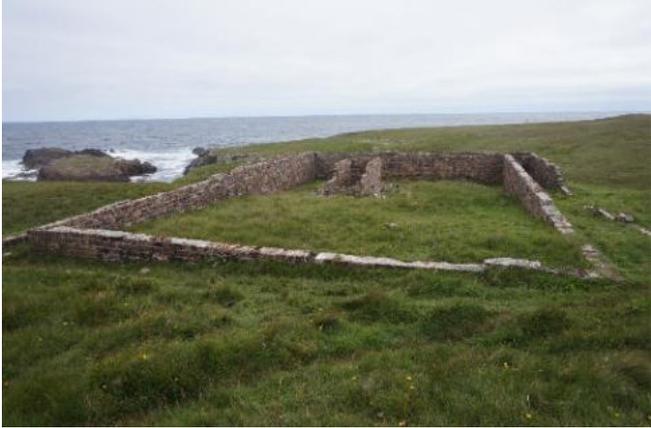
Condition:			
<p>Poor:</p> <p>General – open and defective skyward facing joints supporting vegetation growth throughout, locally elsewhere to wall faces. Localised loose brickwork, spalling and damaged brickwork prevalent to exposed wallheads. Fallen/displaced brickwork throughout, but most noticeable within the void between the east inner and outer skins, and around the central feature.</p> <p>Outer skin – recent area of collapse at the north end of the east wall adjacent to structural cracking and a pronounced leaning section of the adjoining north wall, an indication of subsidence and general instability, possibly exacerbated by demolition activities, at the northeast corner.</p> <p>Inner skin – vertical cracks to east and west walls.</p> <p>Central feature – spalling, damaged and loose brickwork to exposed wallheads</p>

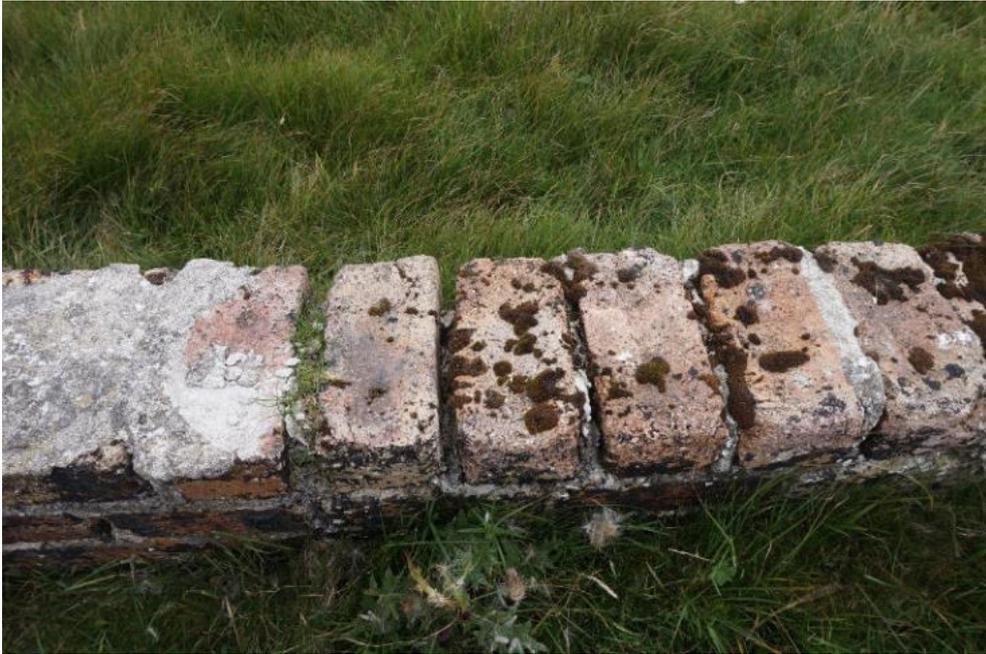
Open and defective wallhead joints were observed throughout. Several localised loose bricks were found on all walls.

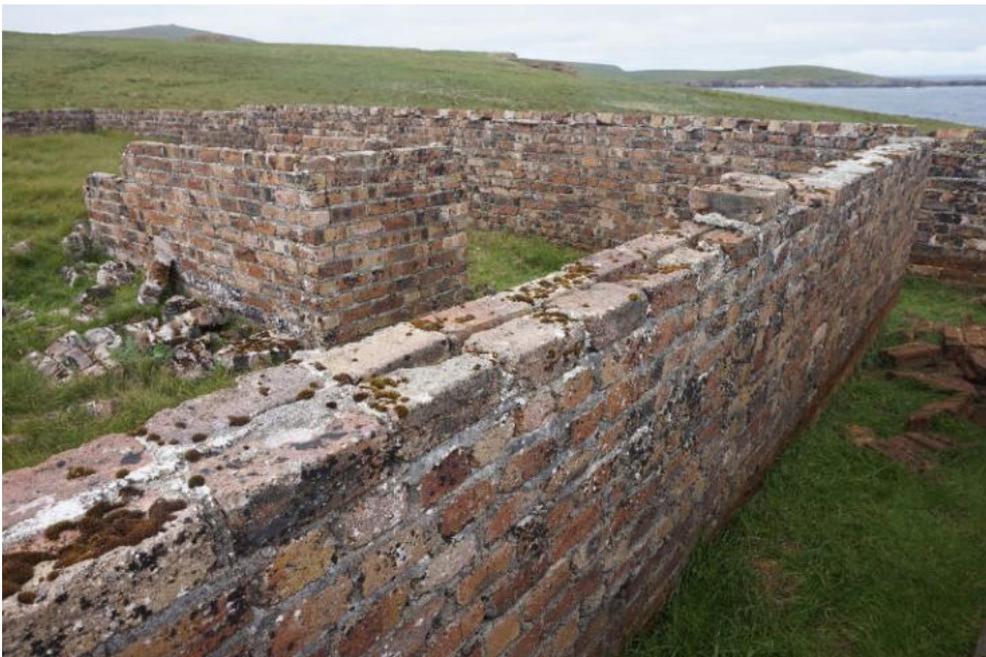
Failing wallhead joints should be repointed and loose bricks rebedded.

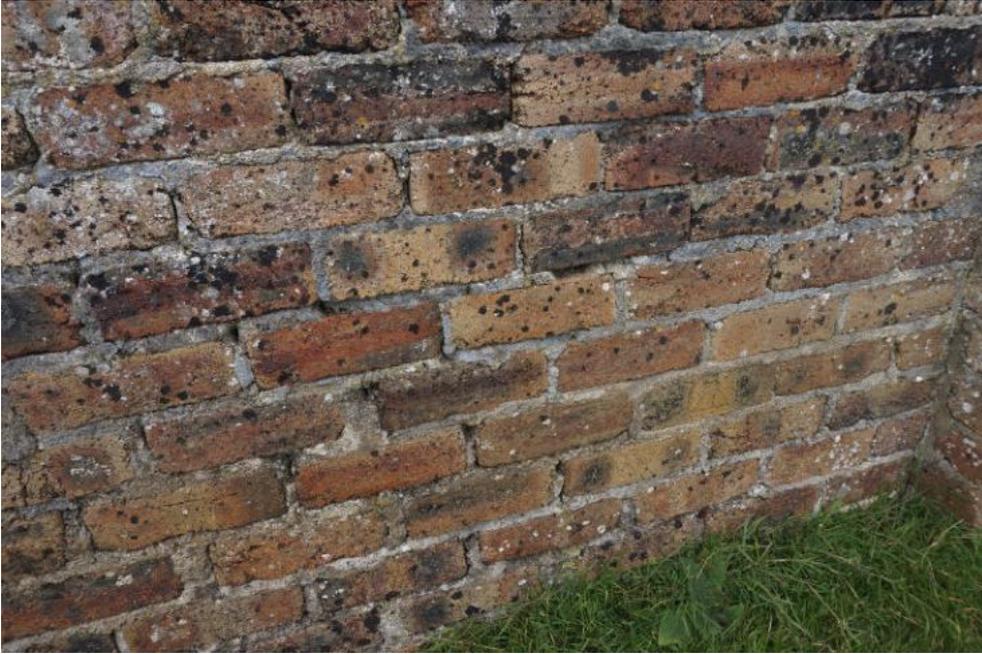
Localised open and failing joints visible on all wall faces.

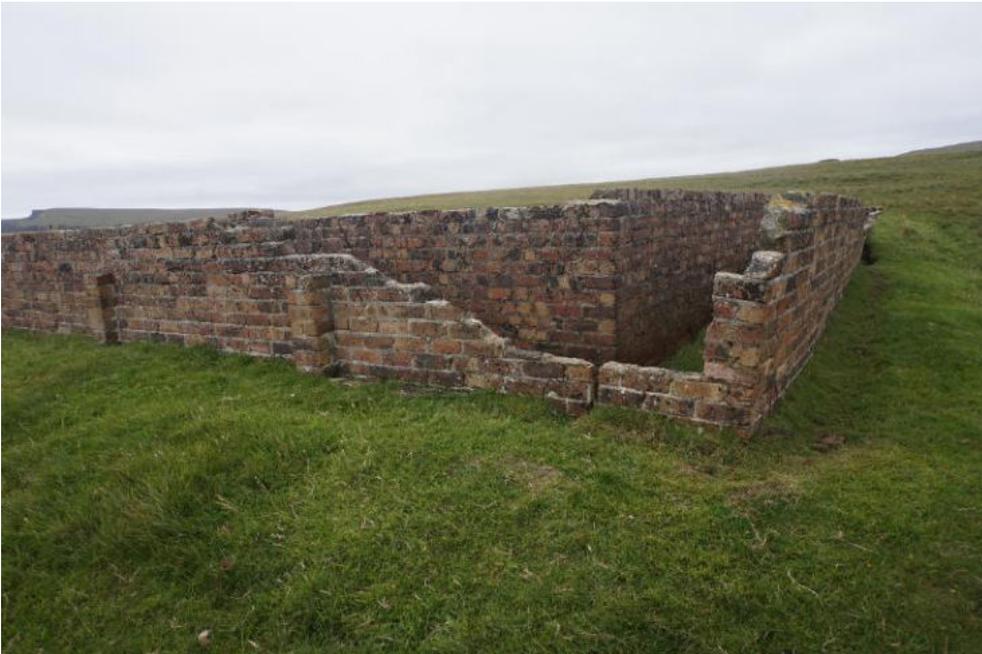
Structural issues in the northeast corner. Vertical cracks on the east elevation of the inner and out skins and a pronounced lean to the north wall of the outer skin. Cracks should be repointed and monitored to assess ongoing movement. The leaning outer skin should either be made safe by extending the earth banking eastwards to prevent further outward rotation or taken down to a safe height. The external wall generally does not have inherent stability generally. This issue should be addressed if increased footfall is expected.

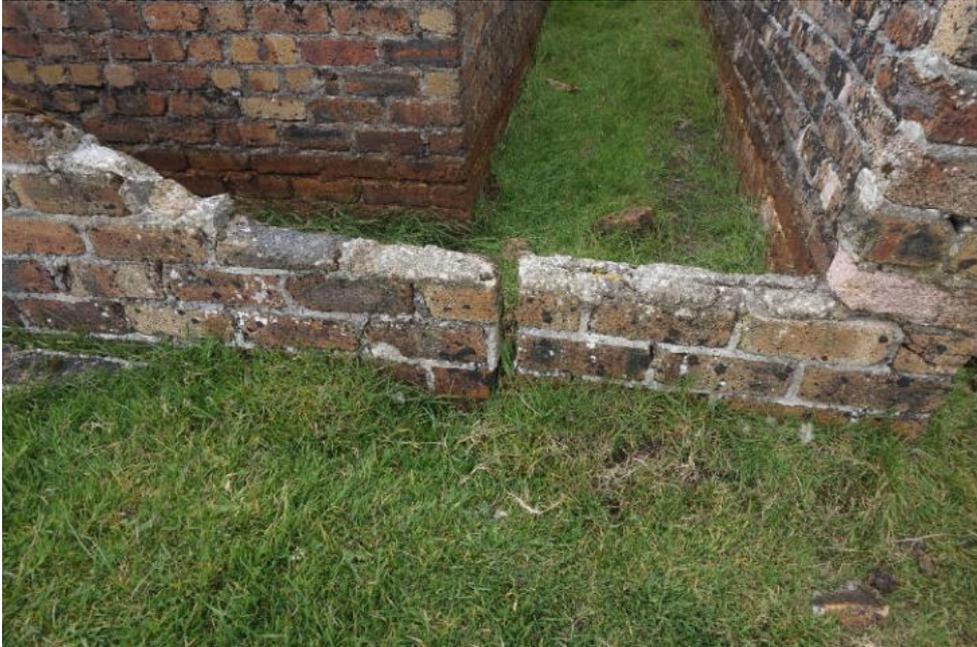
Cracked brickwork to the east facing half brick thick outer skin adjacent to the leaning north wall.

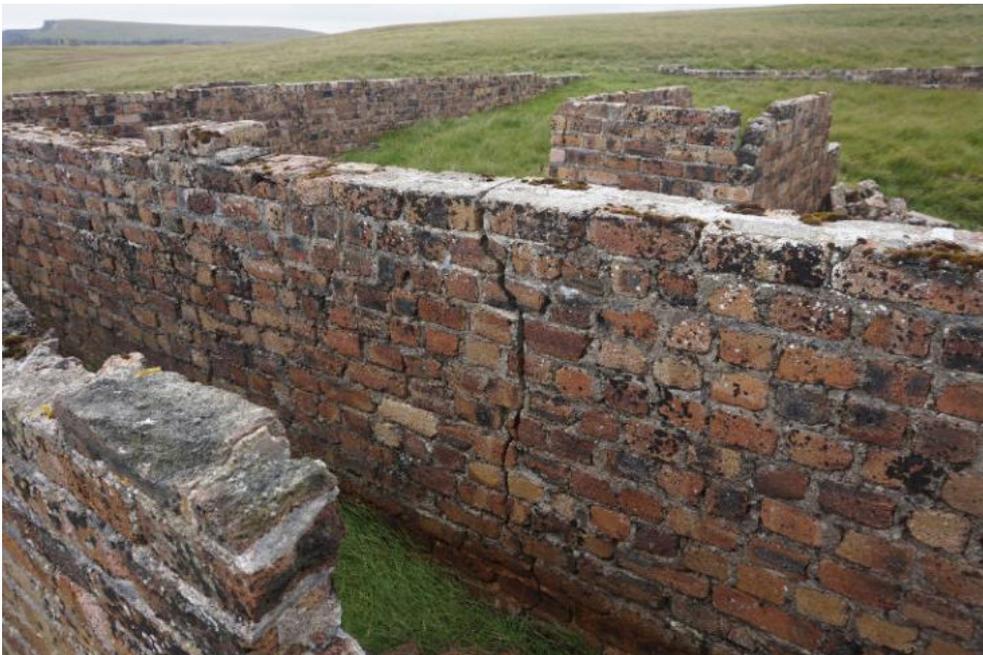
Cracked brickwork to the single brick thick east facing inner skin. Cracks should be repointed to allow future monitoring.

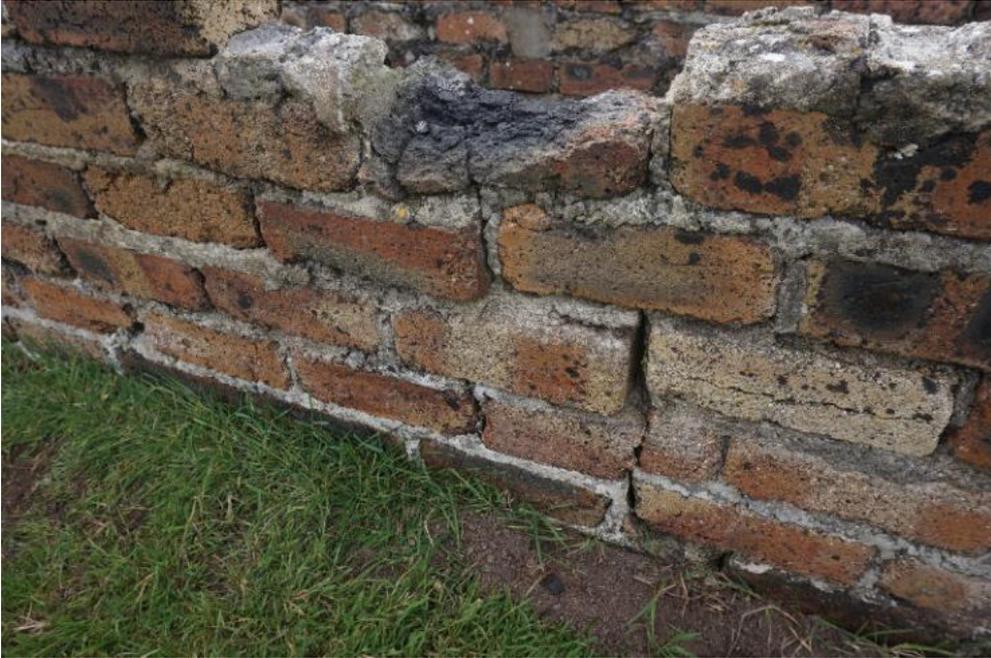
Ideally, damaged wallhead brickwork should be retained, with failing surrounding joints repointed and consolidated to minimise future loss. However, localised removal and replacement of badly damaged bricks should be anticipated.

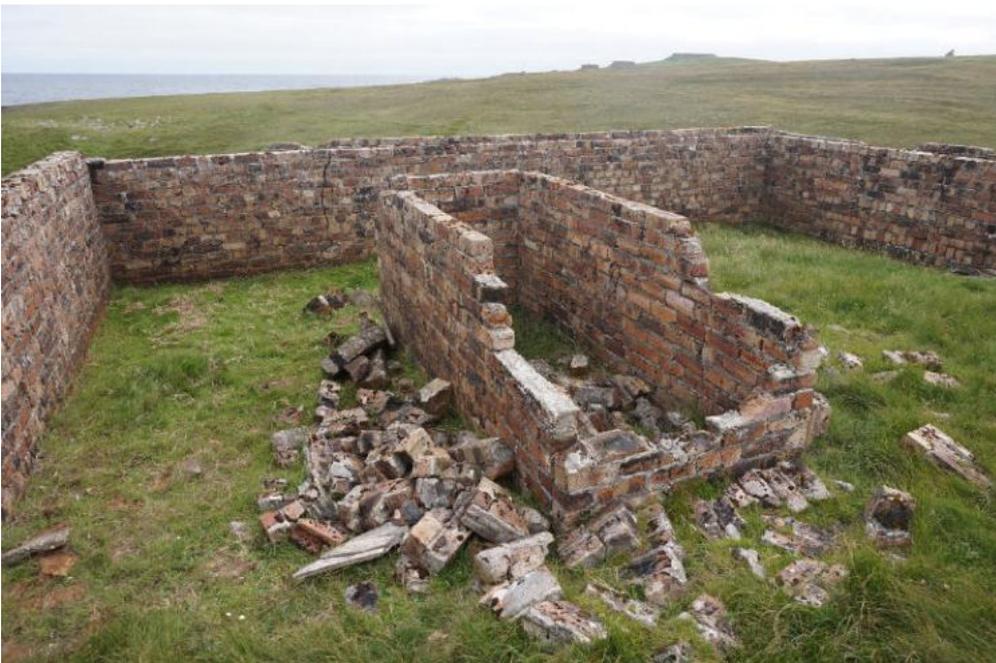
After a full recording exercise, fallen and displaced brickwork should be removed to reduce health and safety risk if increased footfall to the site is anticipated in future. As with the other walls, intervention is required to make good defective joints and loose brickwork, especially to wallheads. The long walls do not have inherent stability generally. This issue should be addressed if increased footfall is expected.

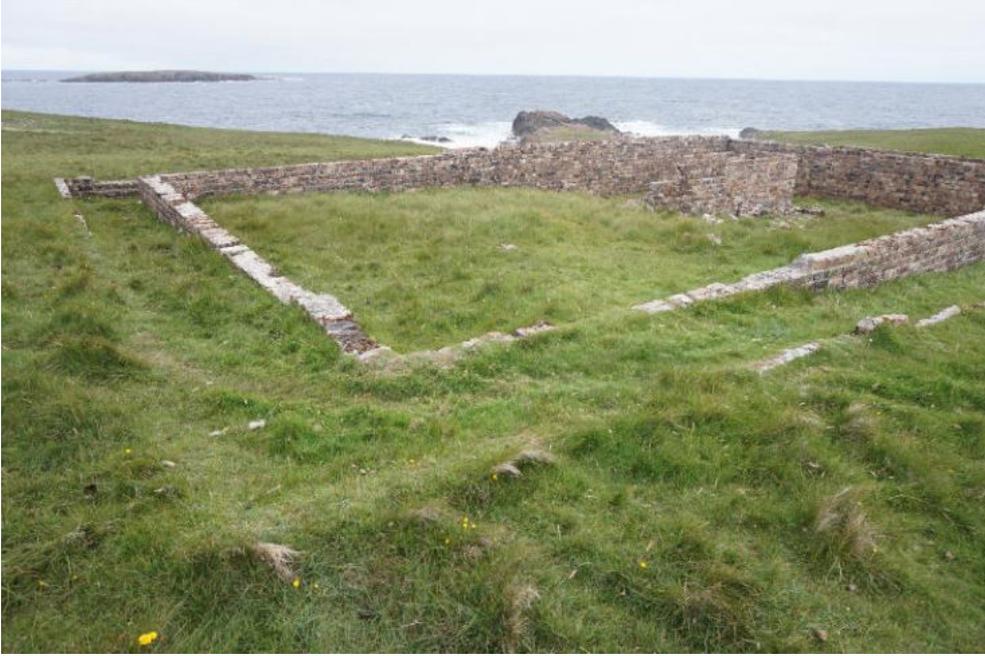
Buried sections of brickwork should not be disturbed.
