Appendix 14.10 Conservation Management Plan

Shetland Space Centre Conservation Management Plan

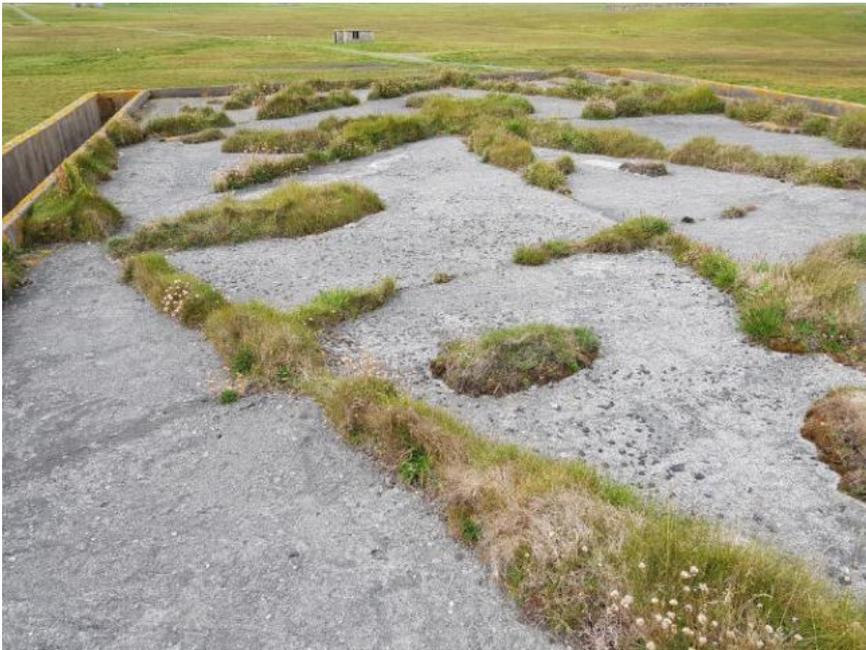
General view across the roof. The roof is laid to falls. The original asphalt protective covering remains but in poor condition. The growth pattern in the vegetation is indicative of where the finishes are cracked and allowing greatest concentration of water ingress into the roof slab.

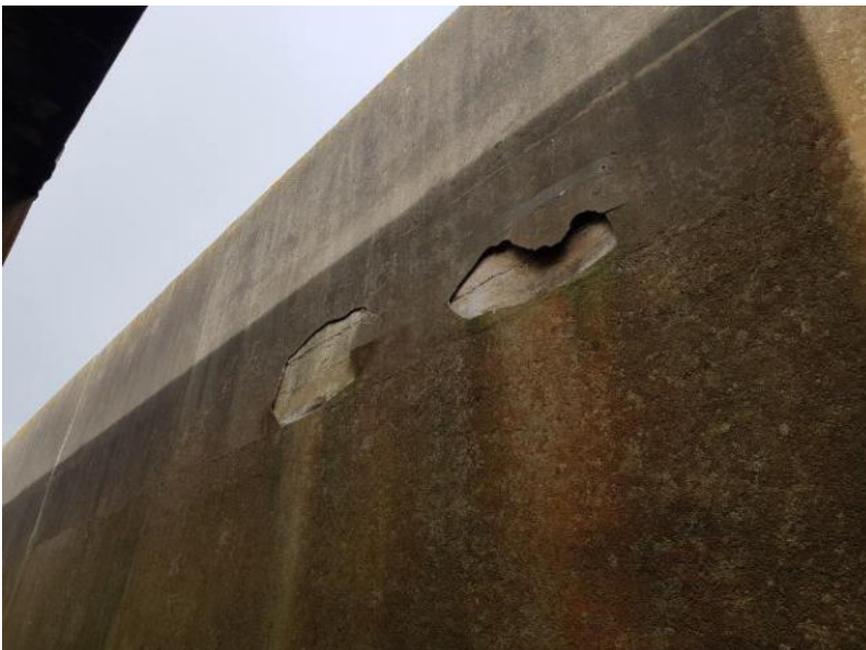
Failing render from the faces of the RC blast walls. note the smooth surface of the exposed substrate, with no obvious formed key to receive the render.

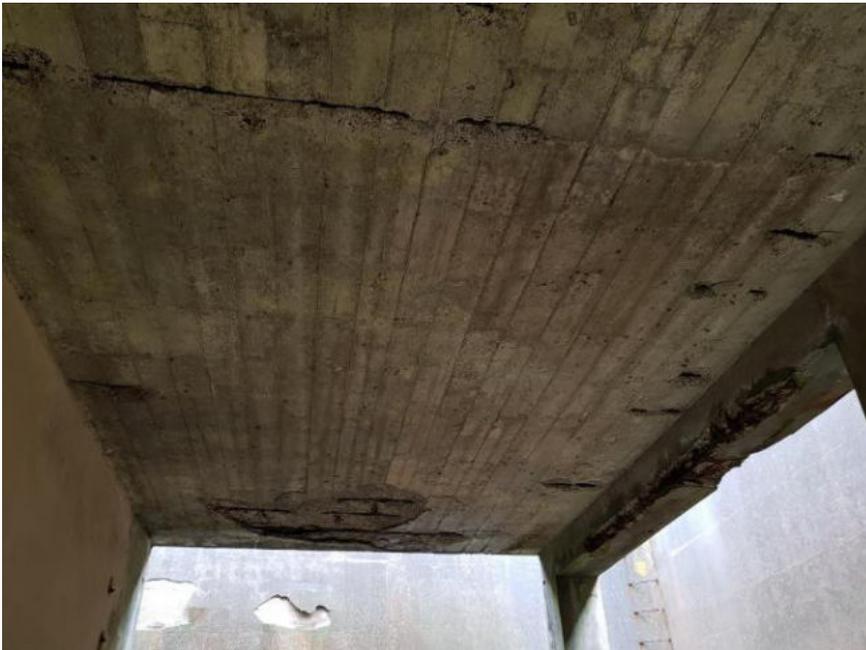
Underside of the porch roof showing areas of spalling concrete to the roof generally, concentrated at the downstand RC beams. This loss of concrete is attributable to expansive corrosion of the embedded reinforcement owing to uncontrolled water ingress throughout the concrete.

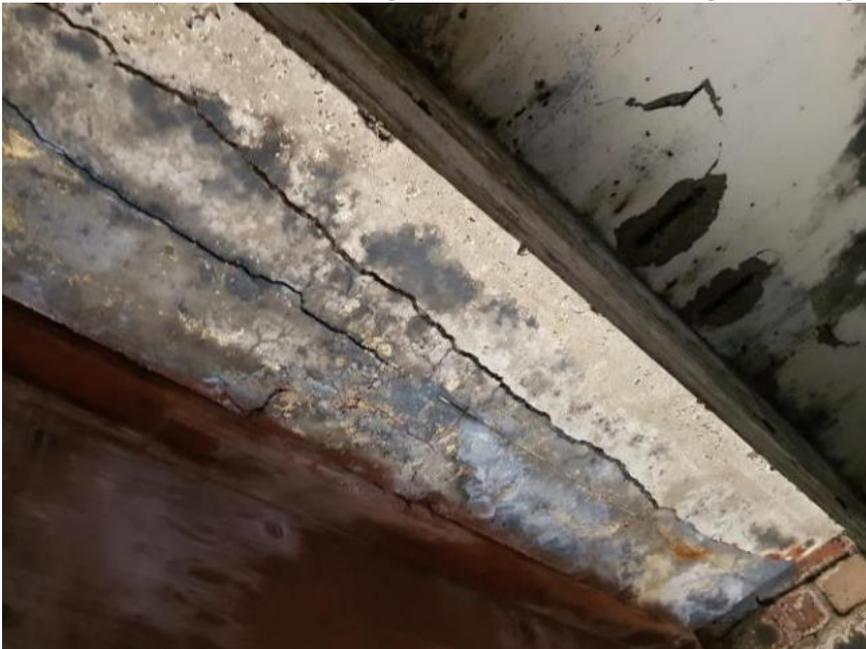
As previous – an RC lintel to the main entrance.

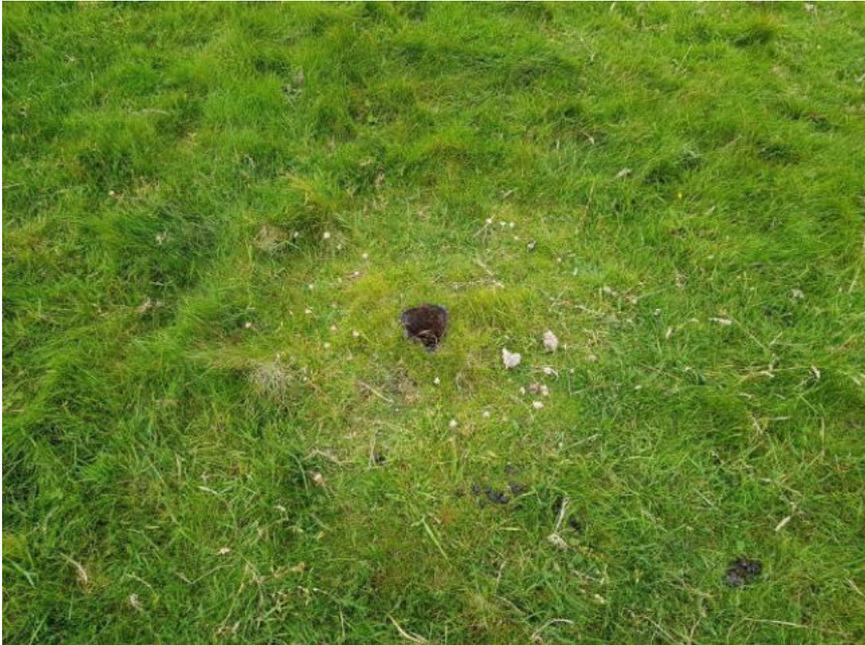
Projecting remains of a former camouflage netting support post. The posts are severely corroded with sharp jagged ends.

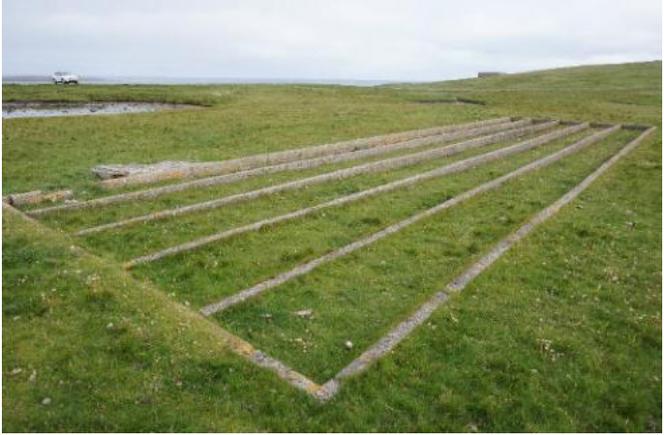
Condition:			
<p>Fair (locally poor): Cracking visible throughout, however the stability of the walls appears unaffected. Localised cracking and spalling in the vicinity of embedded ferrous fixings. Localised damaged and displaced concrete at western end of north footing adjacent to the entrance platt. Localised spalling and disaggregation at the eastern end of one of the centre footings. The entrance platt is misaligned, with localised cracking, spalling and disaggregation, but stable.</p>			
Recommendations:			Priority:

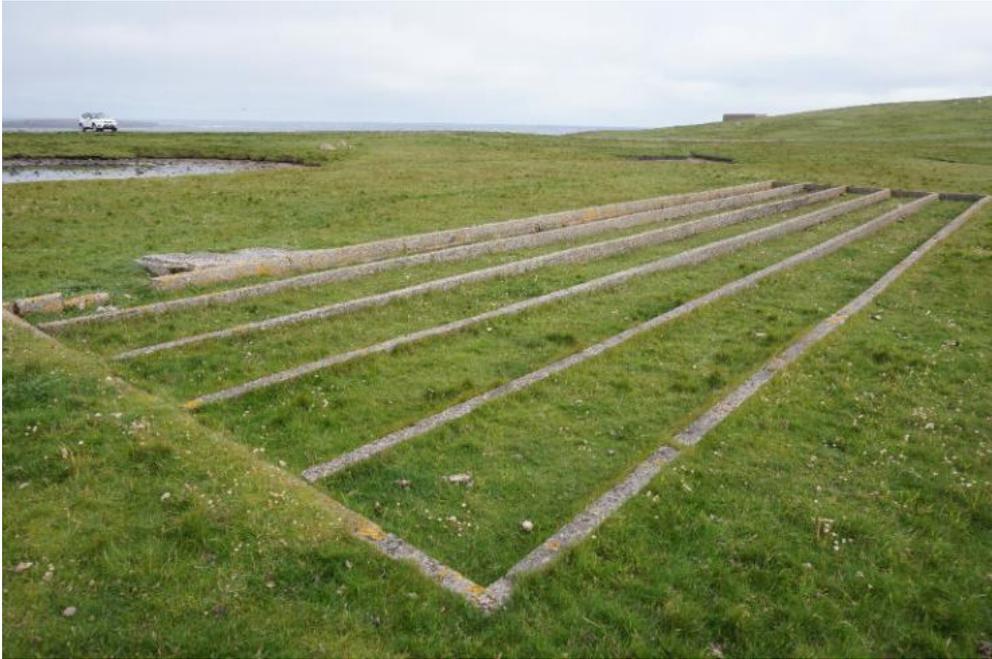
Sections of concrete at the eastern end of the structure are partially buried. The structure is generally stable, however, if increased footfall is anticipated, localised repairs and/or wholesale burying should be considered to protect the concrete and to reduce health and safety risk.

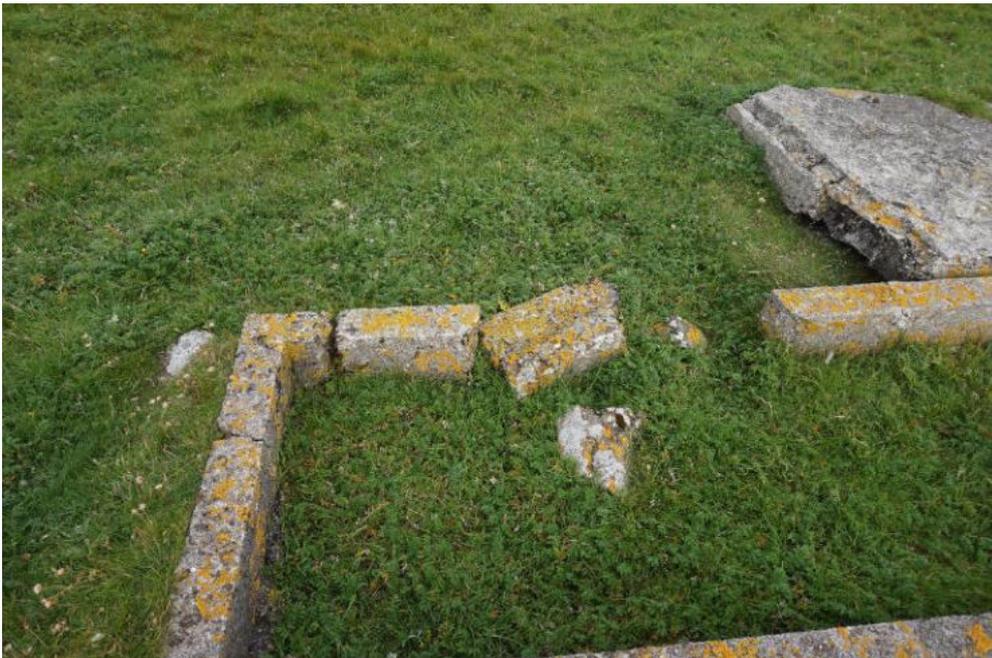
Localised damage and displacement of the western end of the north perimeter sleeper wall.

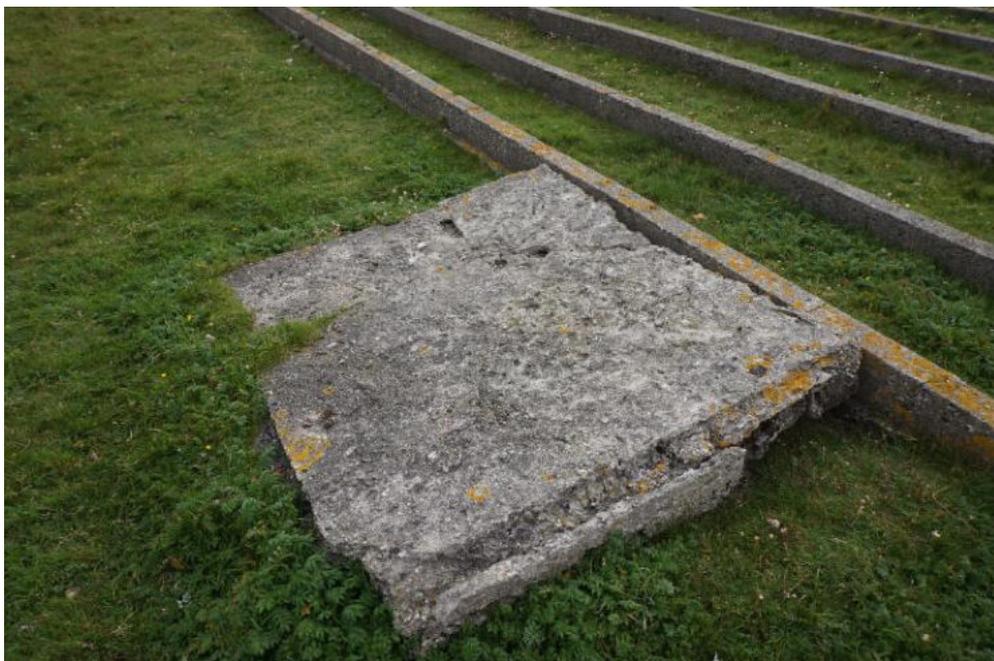
The entrance platt remains stable despite misalignment and localised cracking, spalling and disaggregation.

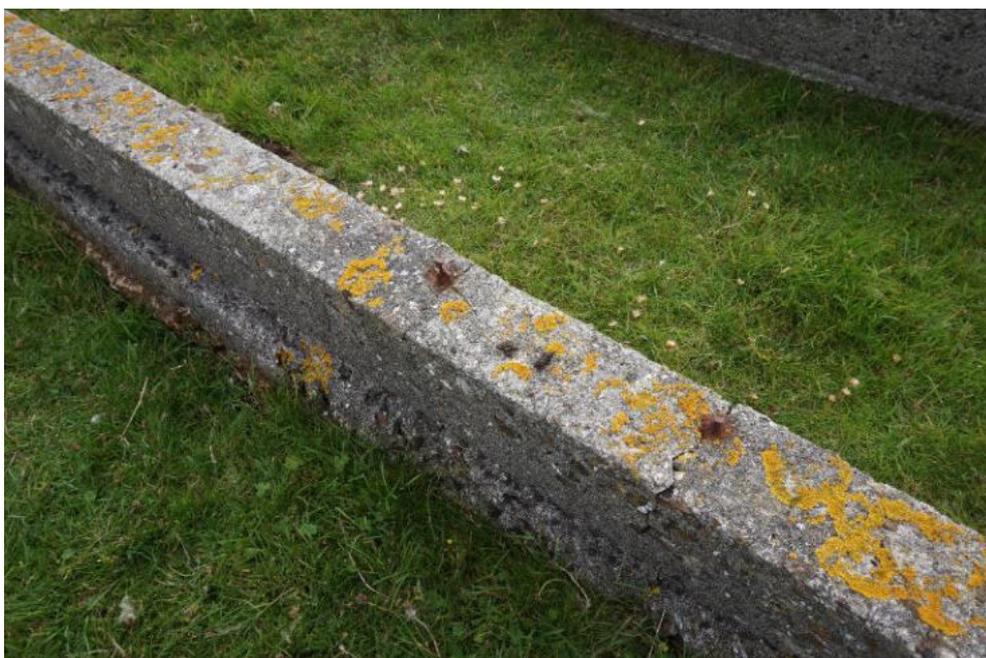
Cracking and spalling in the vicinity of embedded ferrous fixings which would have been used to secure timber wallplates.

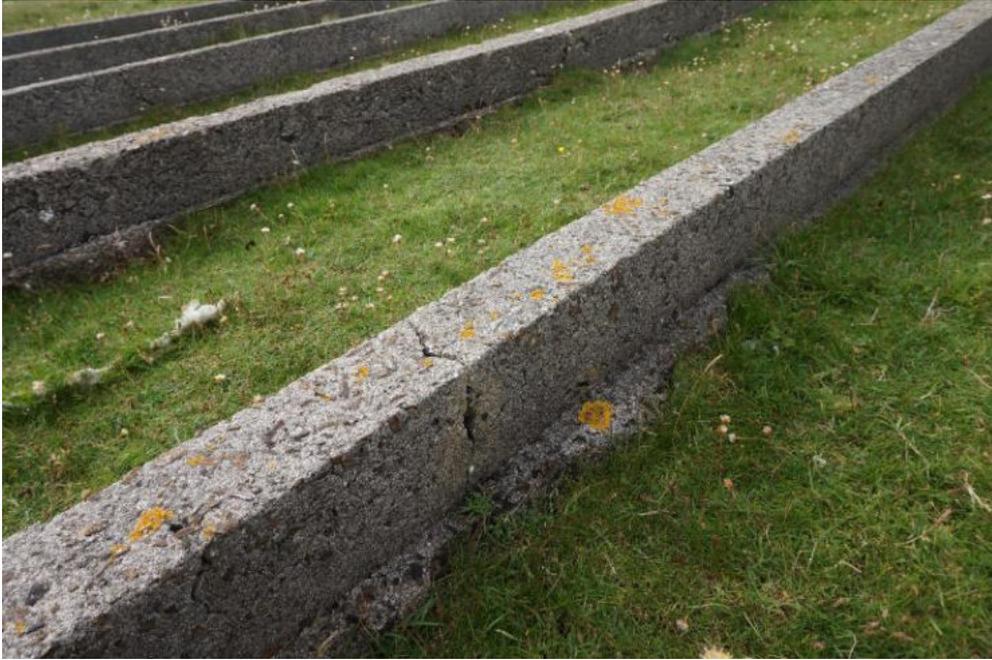
Despite widespread cracking, the walls remain stable.

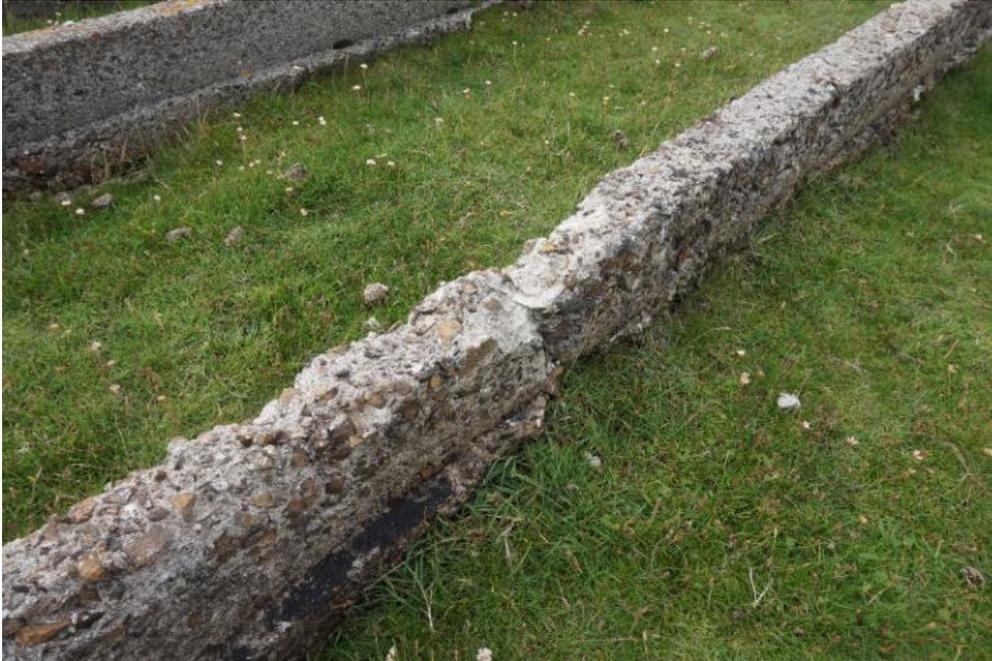
Localised spalling and disaggregation at the eastern end of one of the centre sleeper walls.

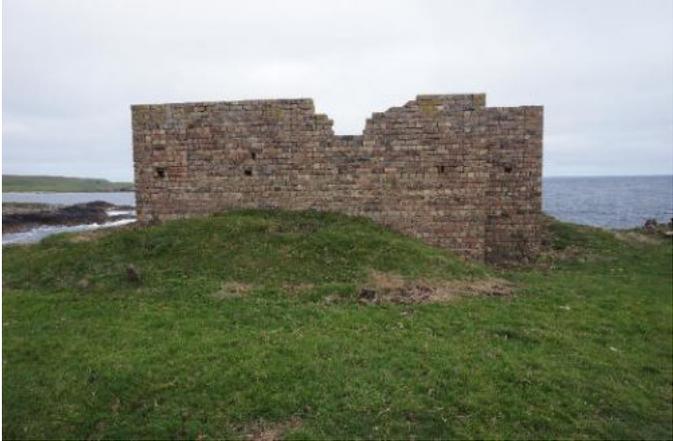
Condition:			
<p>Fair: with localised issues of instability arising from either low-quality of original construction. Open and failing skyward facing joints to wall head and locally elsewhere on wall faces.</p> <p>Vertical cracking on all faces, most visible at upper level where the single brick thick brickwork panels are poorly tied to the 1.5 brick thick piers, and locally at lower levels, including centrally on the north, east and west elevations. There is significant cracking at the northeast corner where the north and east walls are poorly tied, with similar cracking at the southeast corner, both areas potentially affected by poor ground conditions affecting the foundations.</p> <p>Internally, the small rectangular brick structure and concrete base are in a stable condition</p>			
Recommendations:			Priority:

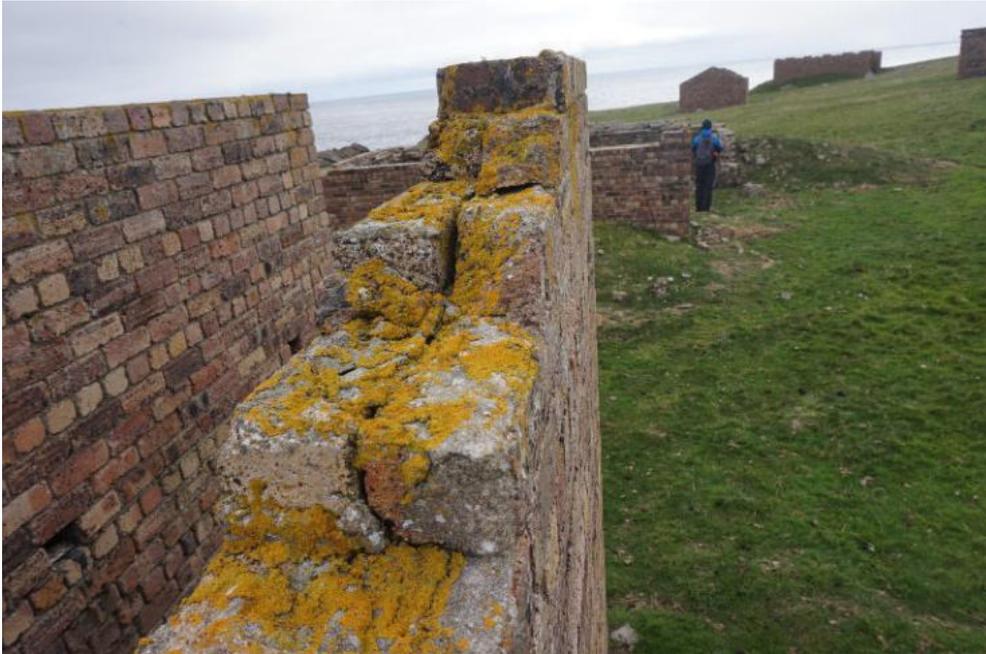
Failing skyward facing joints should be repointed.

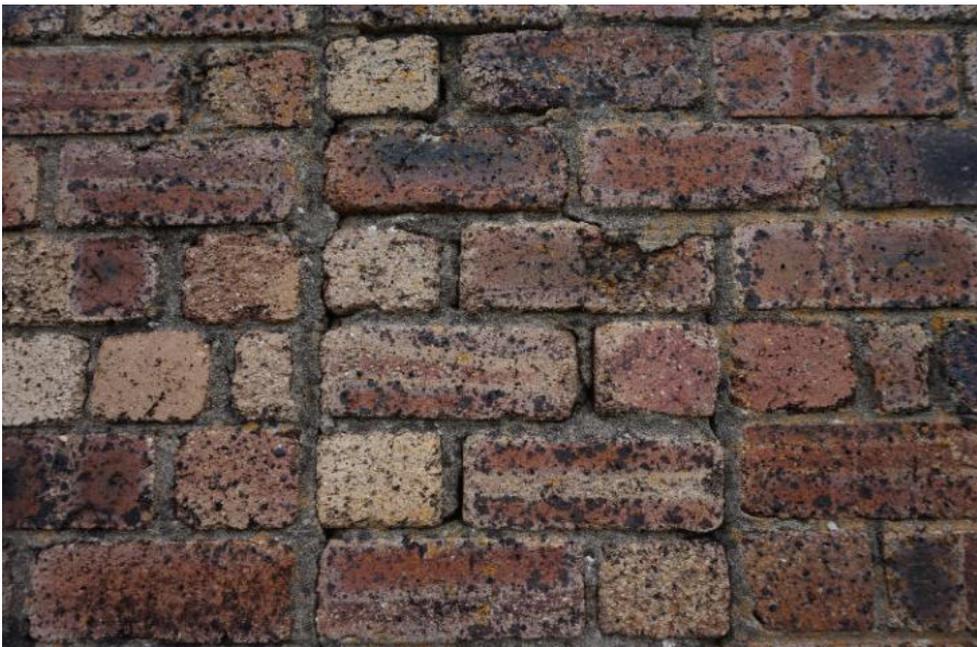
Localised failing wall face joints and minor cracking should be repointed. Note poor continuity between pier (middle of photo) and adjacent panels – see also photos 5 and 6.

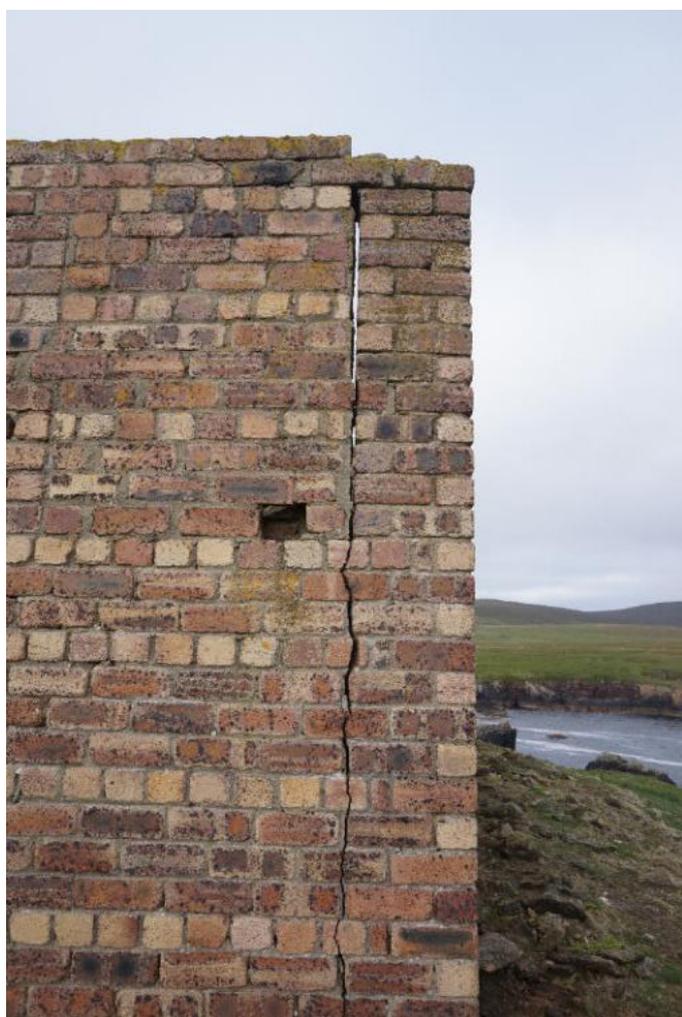
Cracks at the northeast (lower image) and southeast corners where brickwork is poorly tied and are likely to be exacerbated by poor ground conditions affecting the foundations. Stitching across these cracks is recommended.

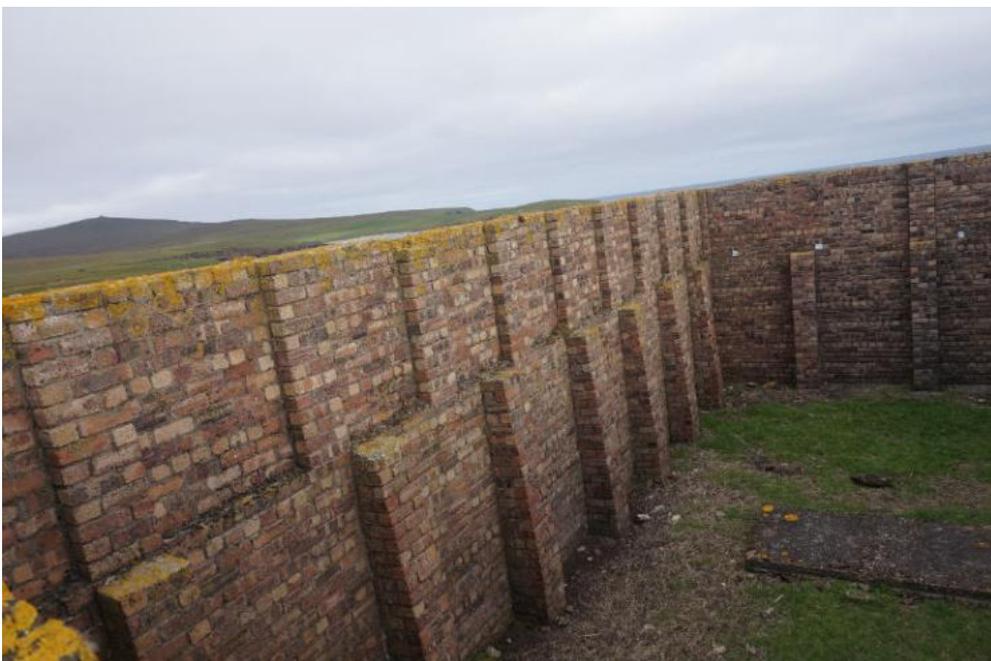
Cracks at higher levels are aligned with the upper piers which are poorly tied to the adjacent thinner single brick thick infilled brickwork. See also Photo 2

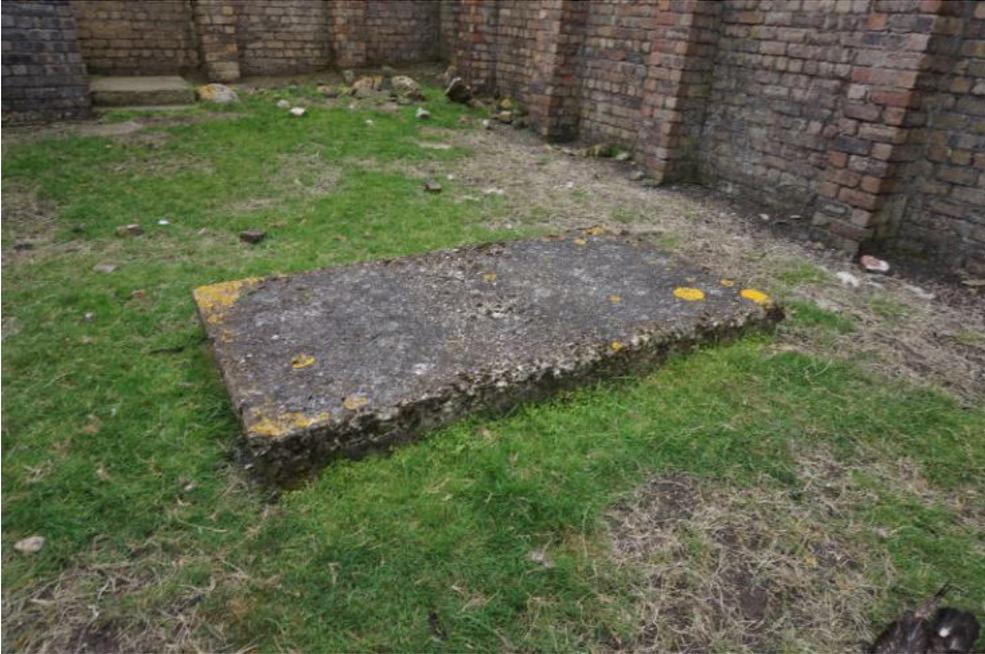
The concrete base internally is in good condition.

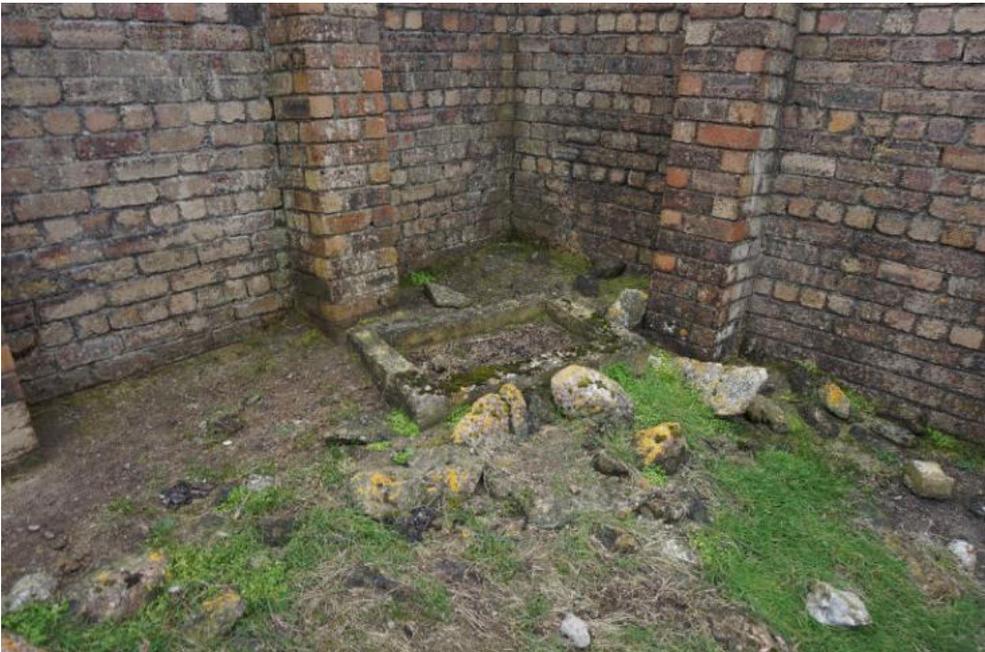
The small rectangle brick structure internally is in good condition. There are loose stones and bricks throughout the grass covered floor internally.

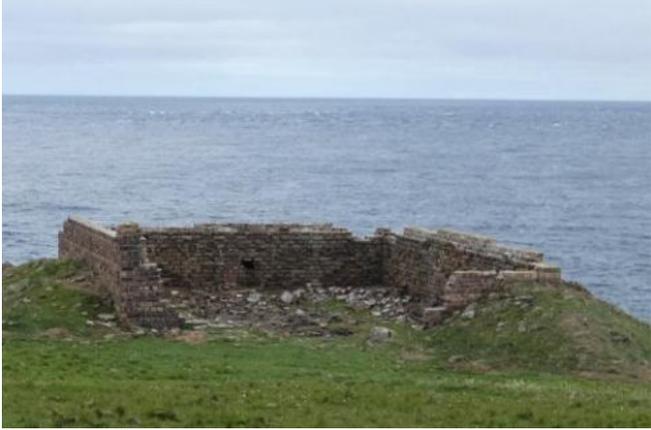
Condition:			
<p>Poor: Badly fire damaged having previously been used by the local fire service for training drills. Upper sections of walls have collapsed with loose brickwork lying in close proximity of the structure. Surviving lower brickwork is fire damaged, with internal faces vitrified, many becoming detached from the masonry, and all joints friable. Externally, there is loose bricks to wallheads and around the south facing opening, and localised cracking, failing joints and cracks elsewhere.</p>

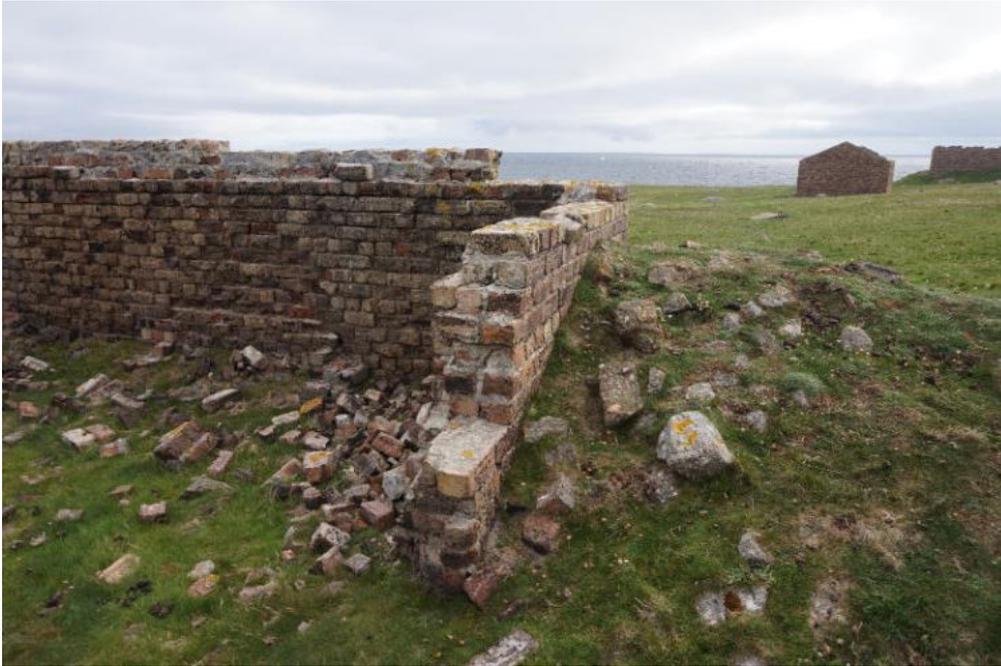
Fallen brickwork should be removed to allow safe access to carry out repairs and to minimise health and safety risk if increased footfall is anticipated. Upon completion of the brick repairs, consider reinstating the earth banking to increase the stability of the fire damaged walls.

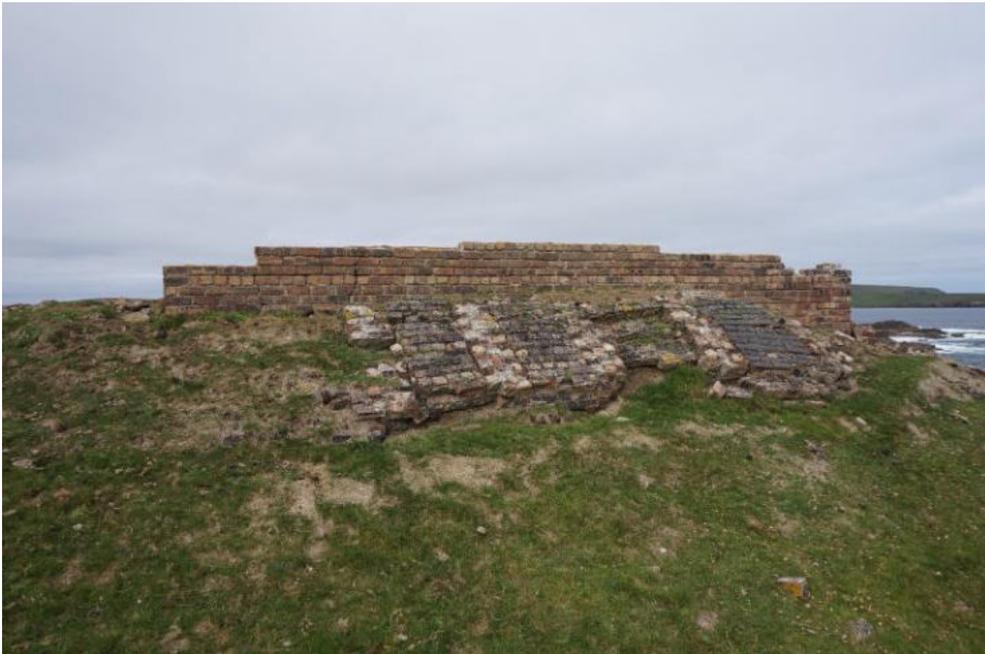
The collapsed brickwork from the east elevation, which appears to have fallen in one large intact section, could potentially be left or buried.

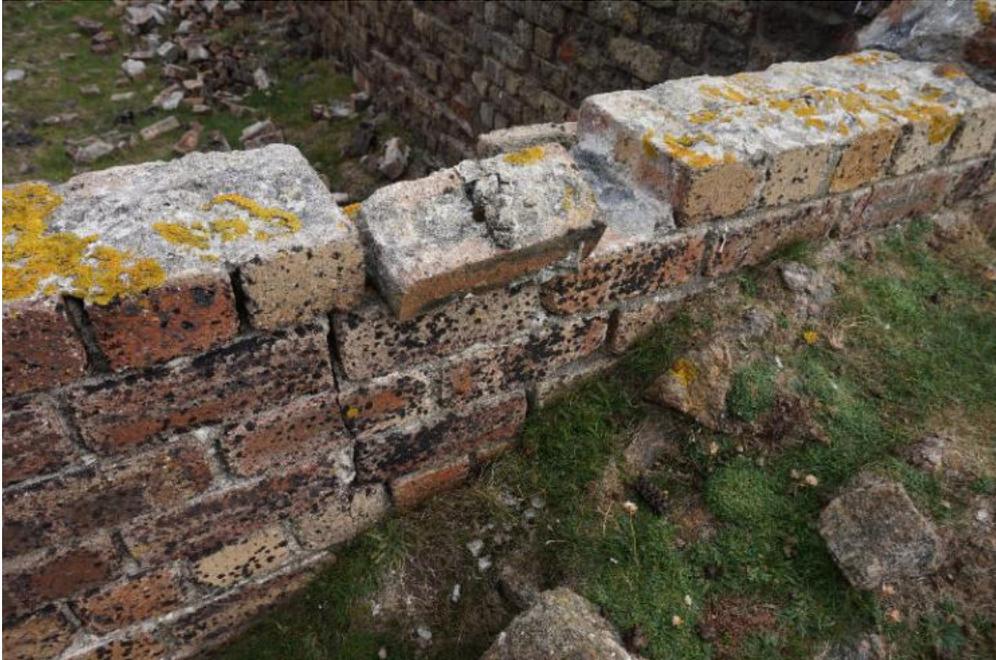
Defective skyward facing joints should be repointed, with allowance for resetting loose brickwork.

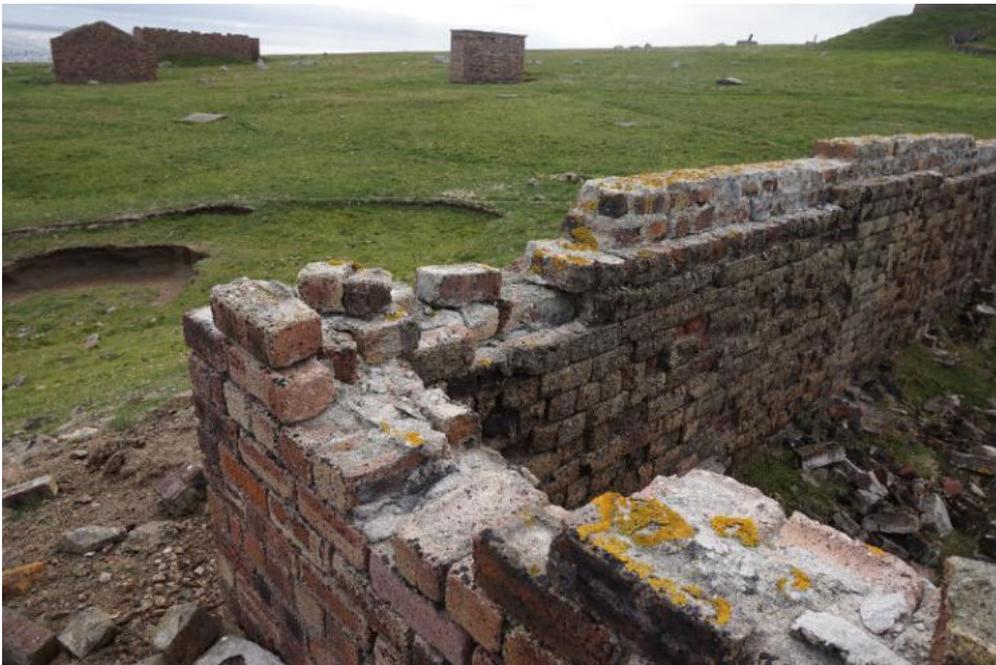
Loose wallhead brickwork and failing joints.

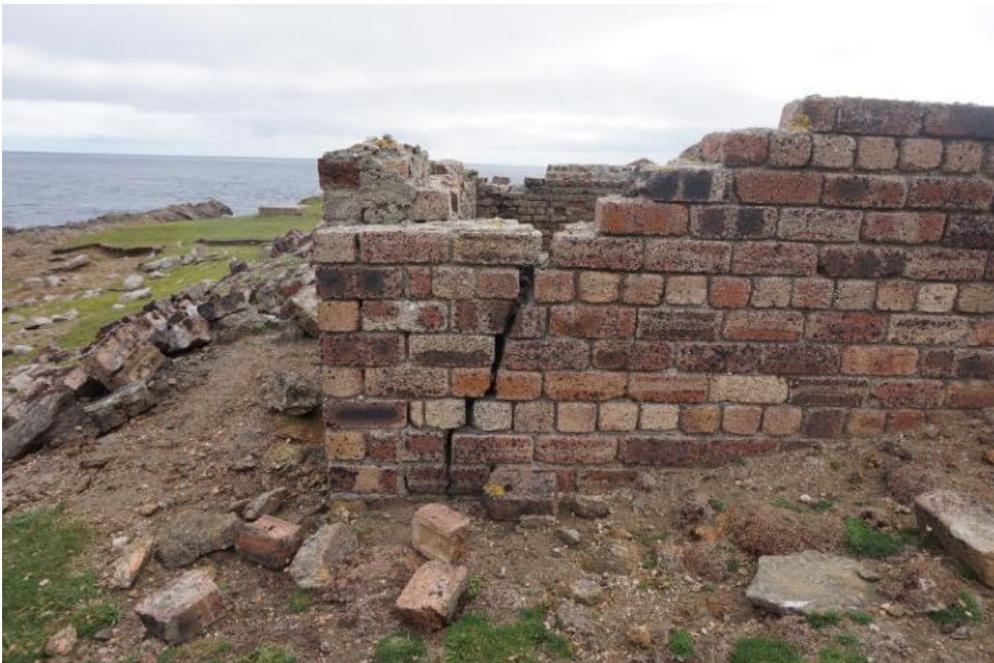
Repoint failing joints and cracks on external faces. Consider reinstating / increasing the height of the earth banking to provide additional support to the fire damaged walls.

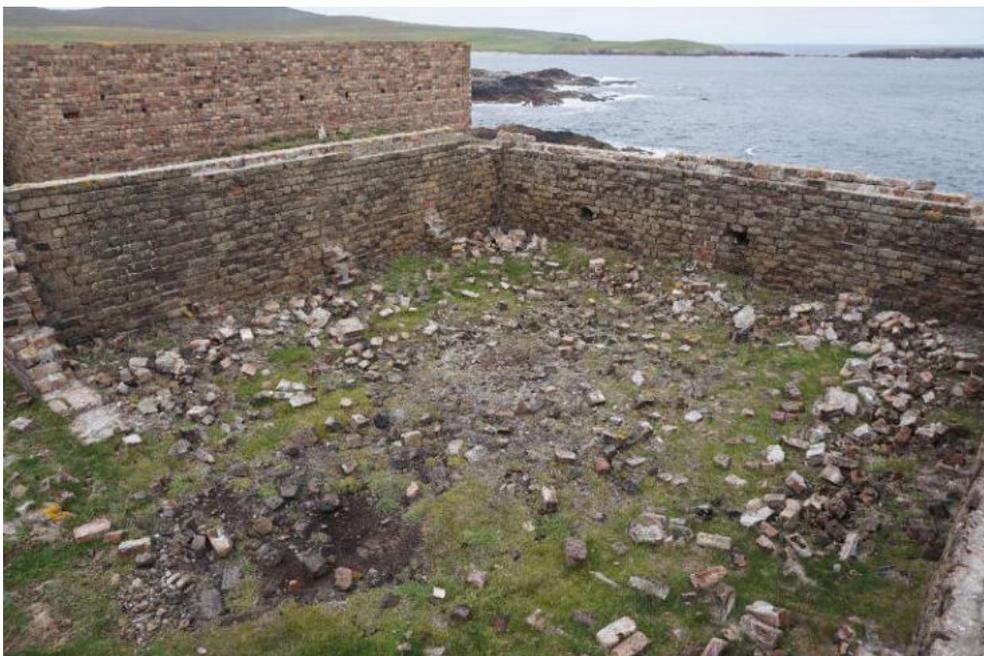
General view internally.

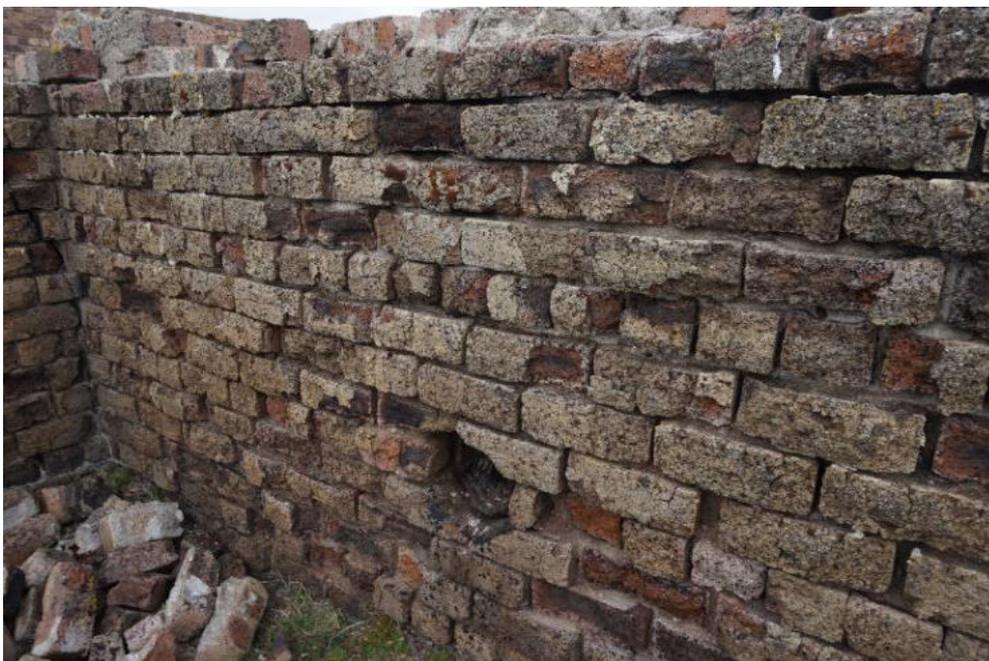
The internal faces are badly fire damaged, requiring extensive consolidation including repointing, resetting loose bricks and replacing badly damaged bricks.

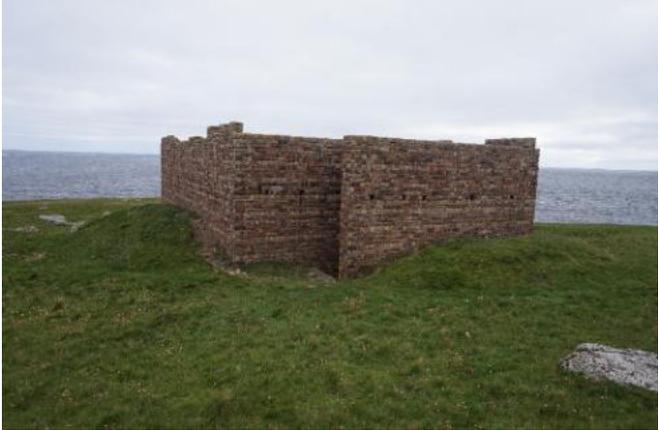
Condition:			
<p>Fair: Open and failing skyward facing joints to wall head and locally elsewhere on wall faces.</p> <p>Missing section of brickwork c.0.5m² (built up with dry bedded stonework) on east elevation above internal ground level with crack above extending vertically following line of poorly bonded bricks. Cracking elsewhere at upper level where the single brick thick brickwork is poorly tied to the 1.5 brick thick piers, and locally at lower levels.</p>

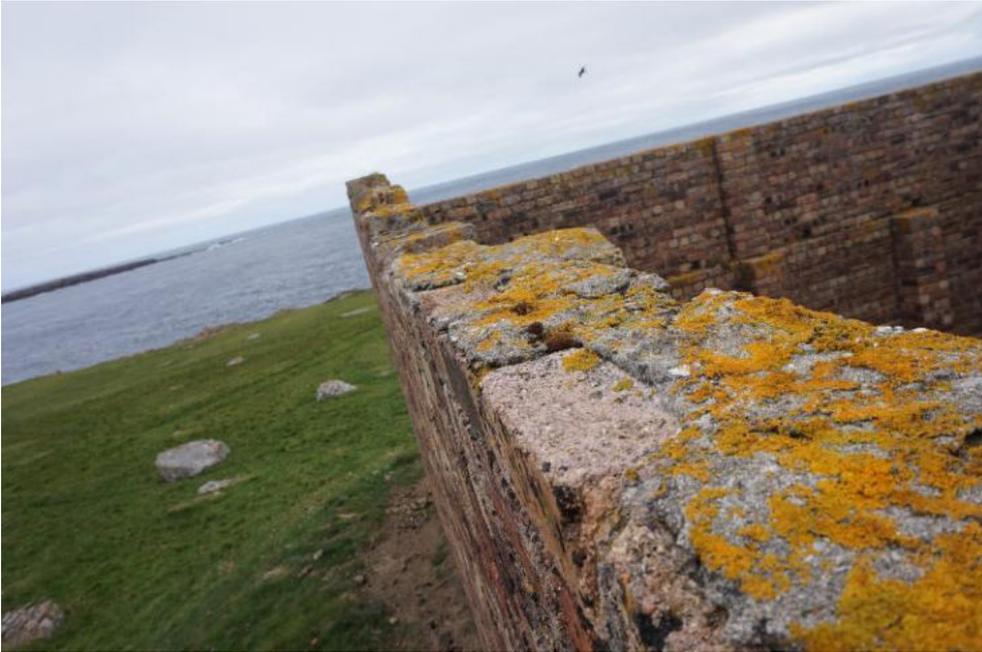
Failing skyward facing joints should be repointed, with allowance for rebedding loose bricks.

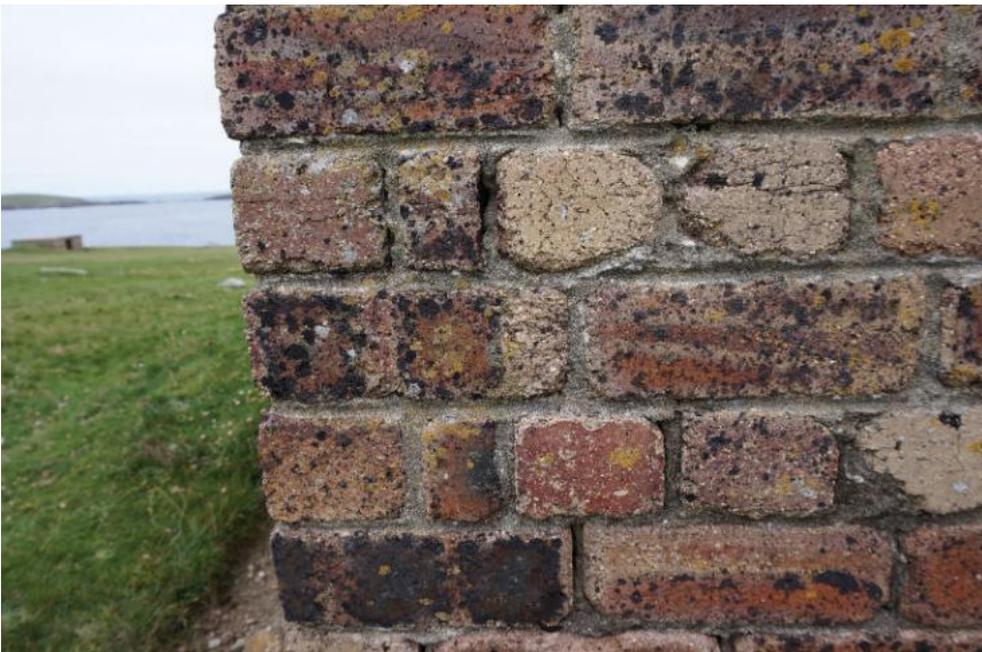
Localised filling wall face joints and minor cracking should be repointed.

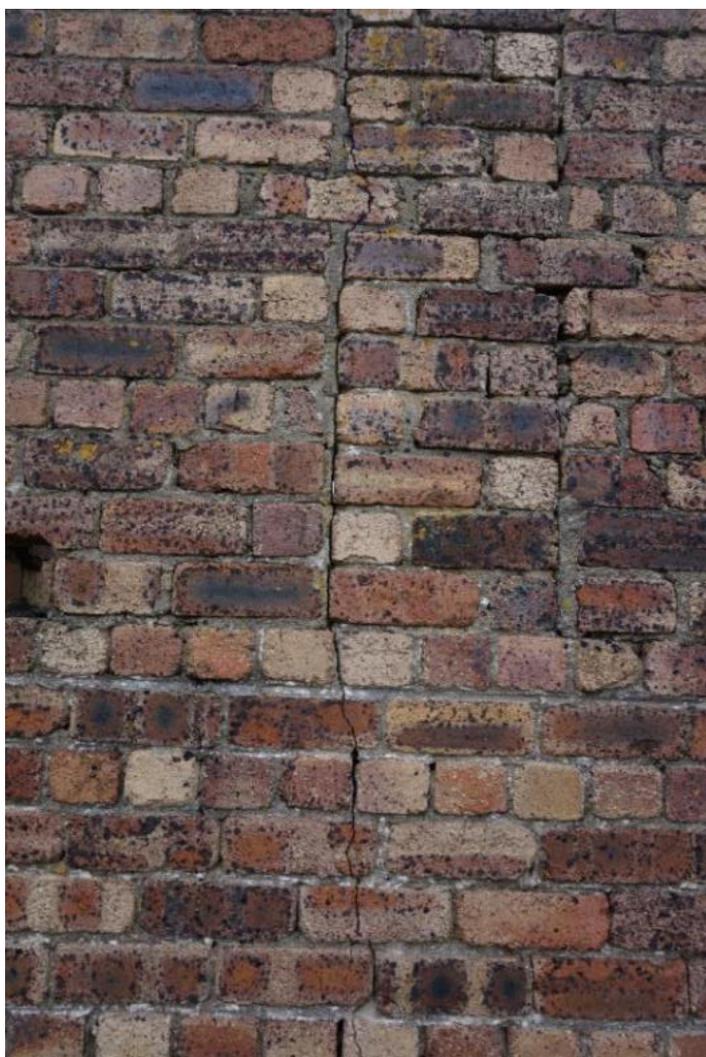
A vertical crack extends from a section of missing brickwork at ground level internally on the east wall. The brickwork panels either side of the pier (seen just off-centre) are poorly tied across the pier.

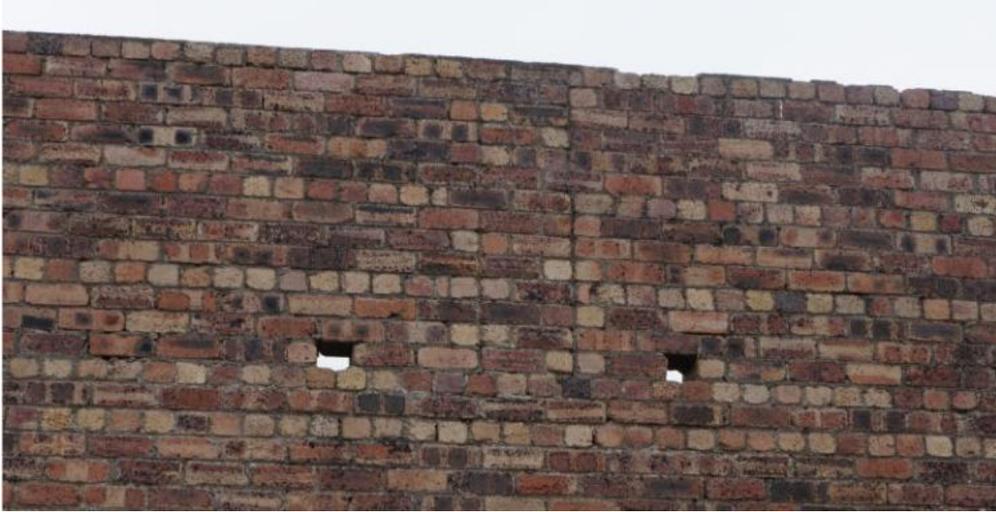
Cracks at higher levels are aligned with the upper piers which are poorly tied to the adjacent thinner single brick thick infilled brickwork.

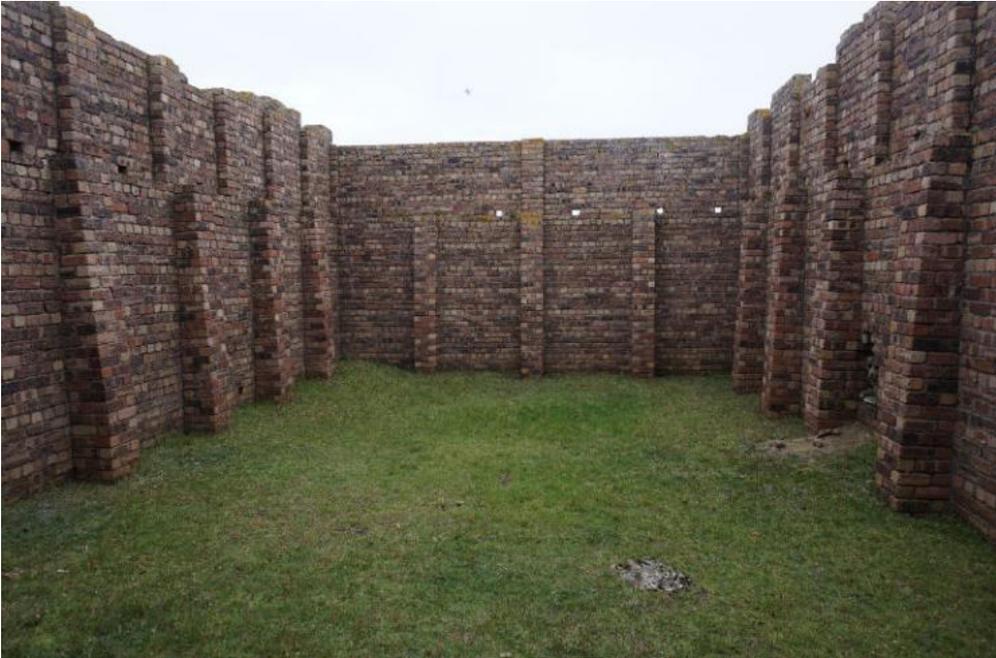
Internal general view.

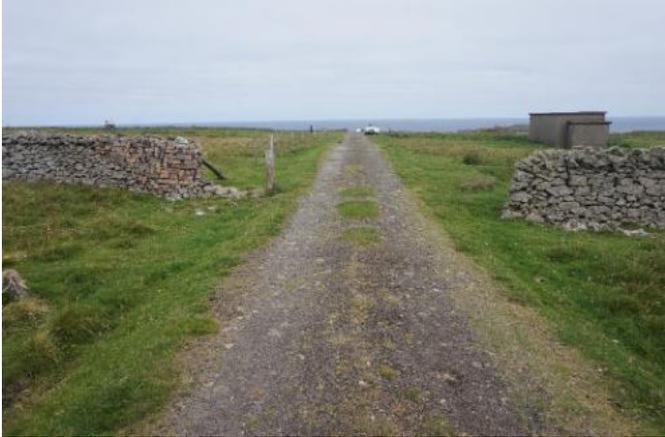
Condition:			
<p>Good: Localised missing coping stones to the north section of wall. Bulging section c.10m² at c.30m north of the access road. Timber post is rotten.</p>			
Recommendations:			Priority:

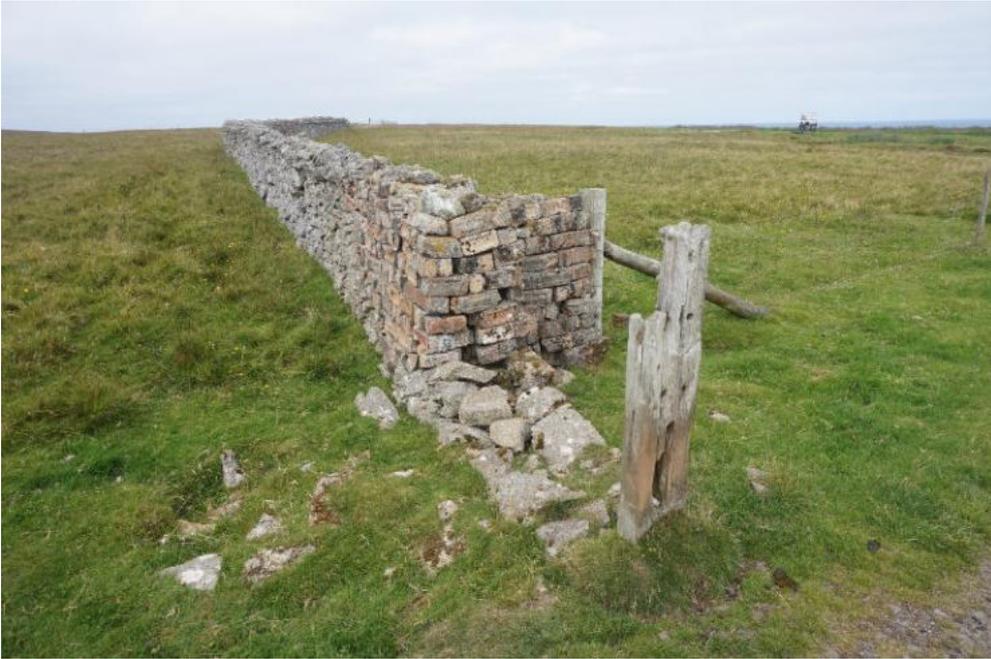
General view north: Brick repairs immediately north of the access road. The repairs remain functional. Rotten timber gate post.

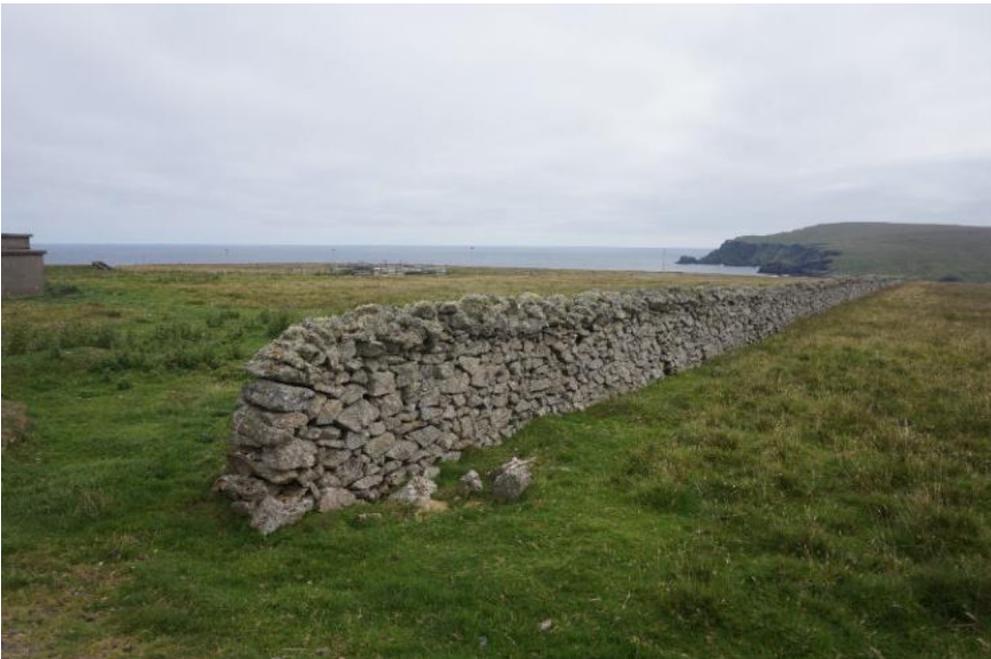
General view south: Copes should be regularly check and loose/displaced stones reset.
