Appendix 14.10 Conservation Management Plan

Shetland Space Centre Conservation Management Plan

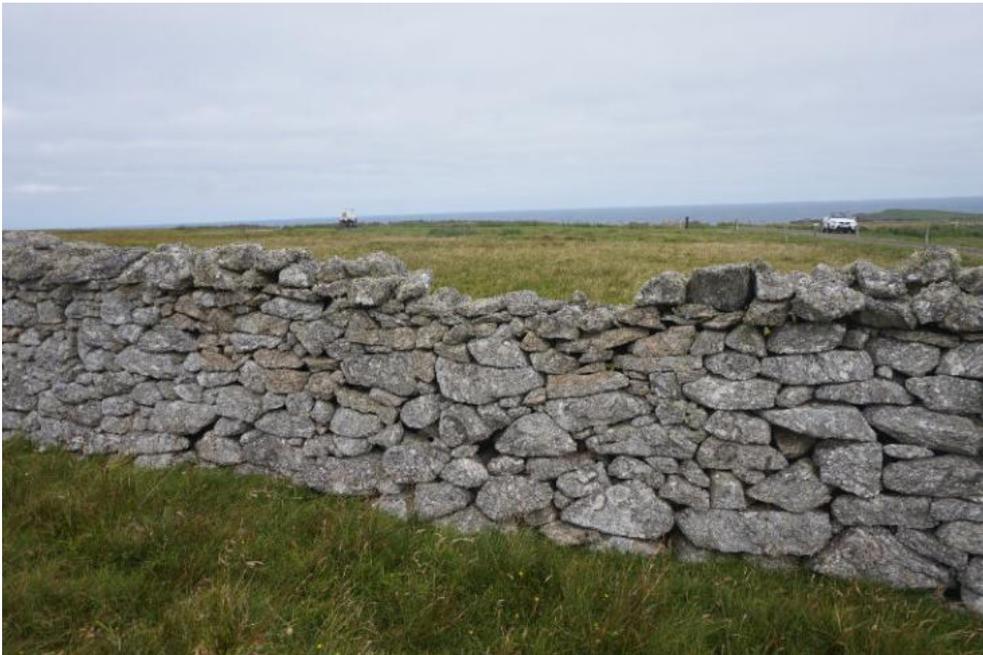
Displaced cope stones should be reinstated.

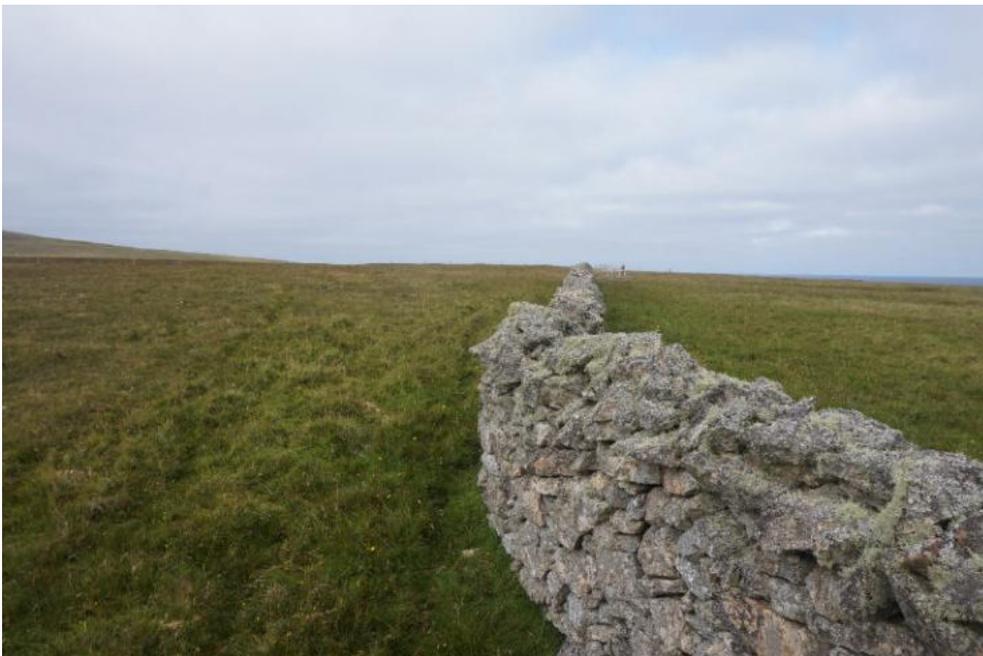
Monitor the bulged section and allow repairs/rebuilding if its condition worsens.

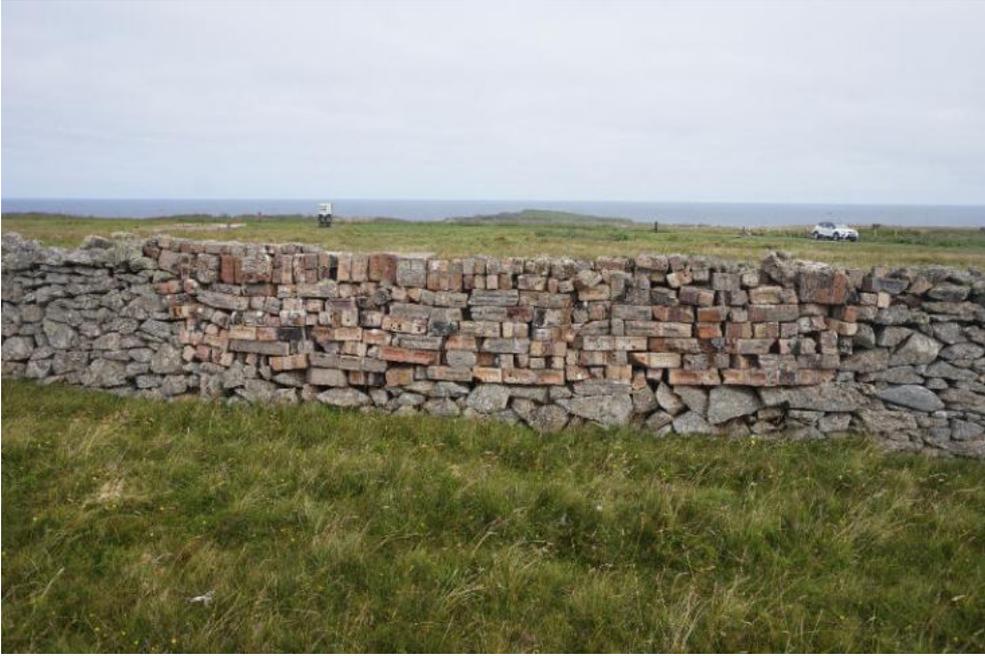
The repair using salvaged bricks c.40m north of the access road remains in good condition.

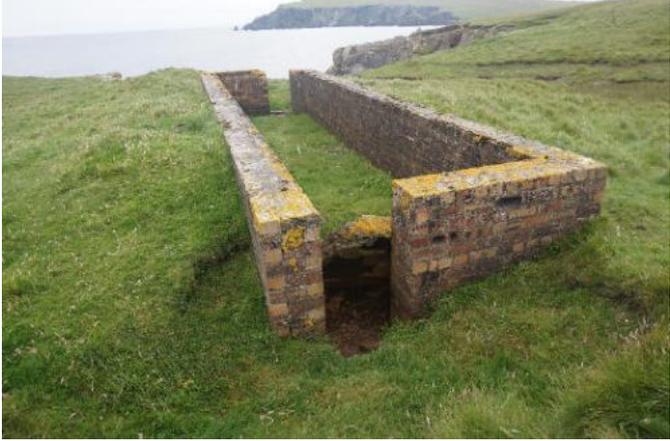
Condition:			
<p>Fair: Localised open, cracked and failing mortar joints throughout, including to exposed wallhead which is supporting vegetation growth. Damaged and missing brickwork to wallhead and at south opening.</p>			
Recommendations:			Priority:
1.	<p>Record and monitor future condition, with provision for localised repointing of open and defective joints, especially skyward facing joints. £100.00</p>		Desirable

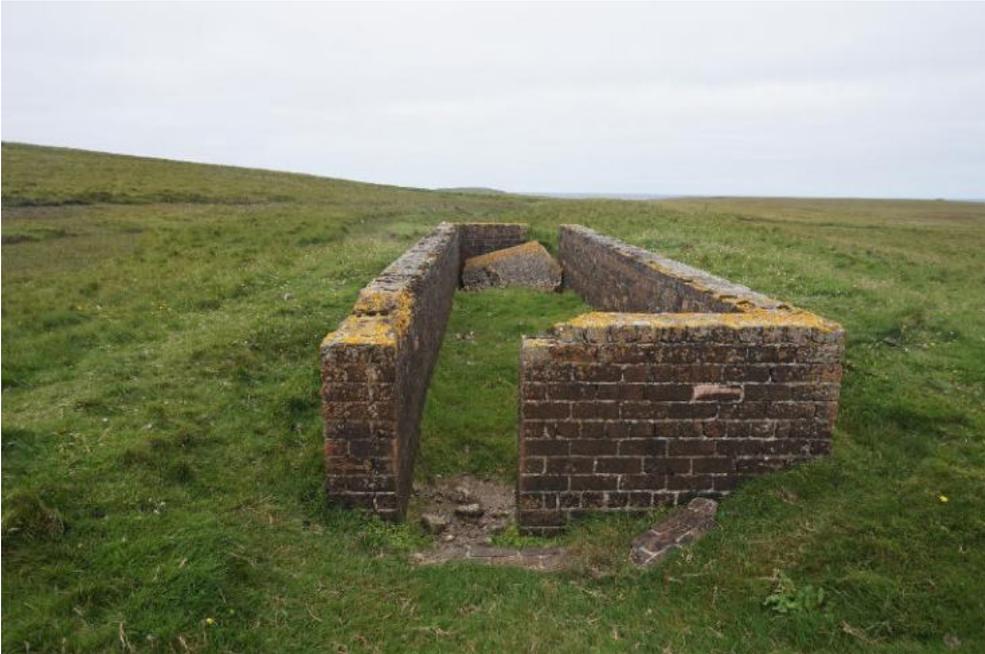
View from south showing missing wallhead brickwork, and displaced bricks and concrete roof slab.

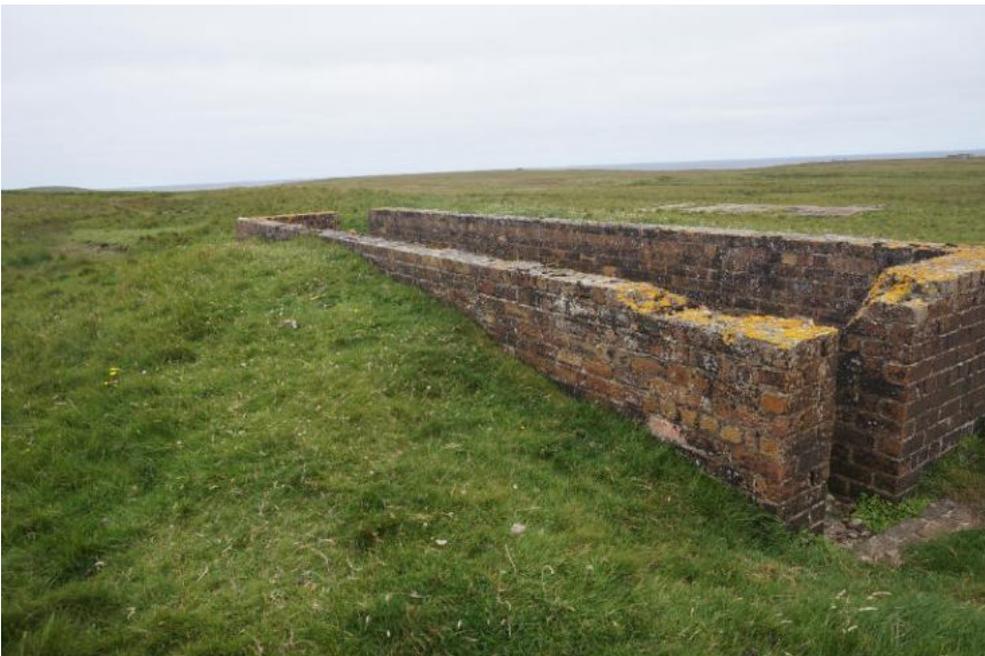
Despite localised failing mortar joints, and damaged and missing brickwork, the structure is in a stable condition.

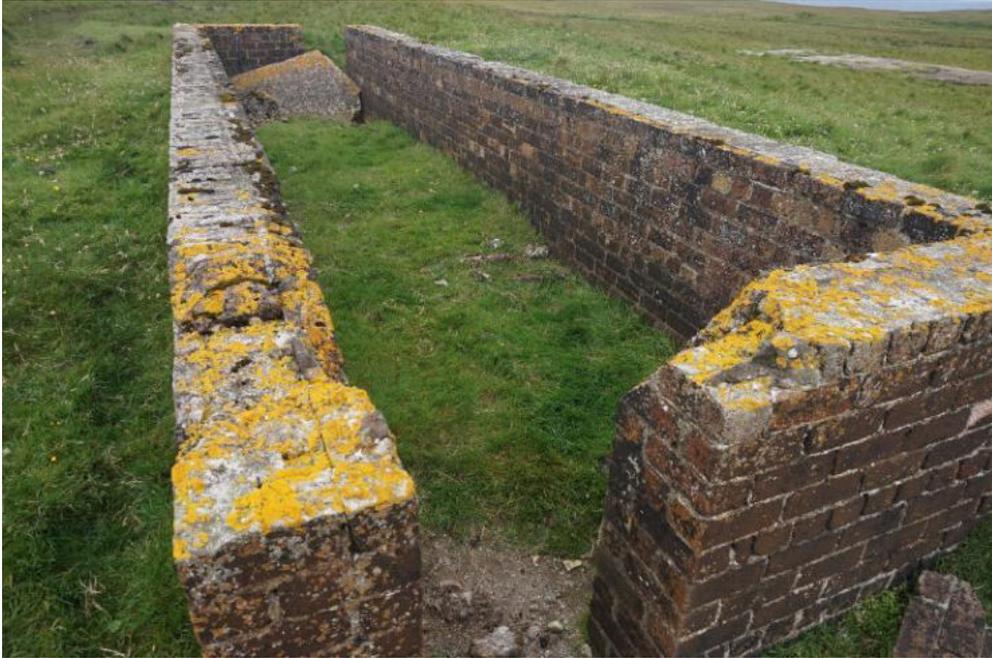
General internal view from south.

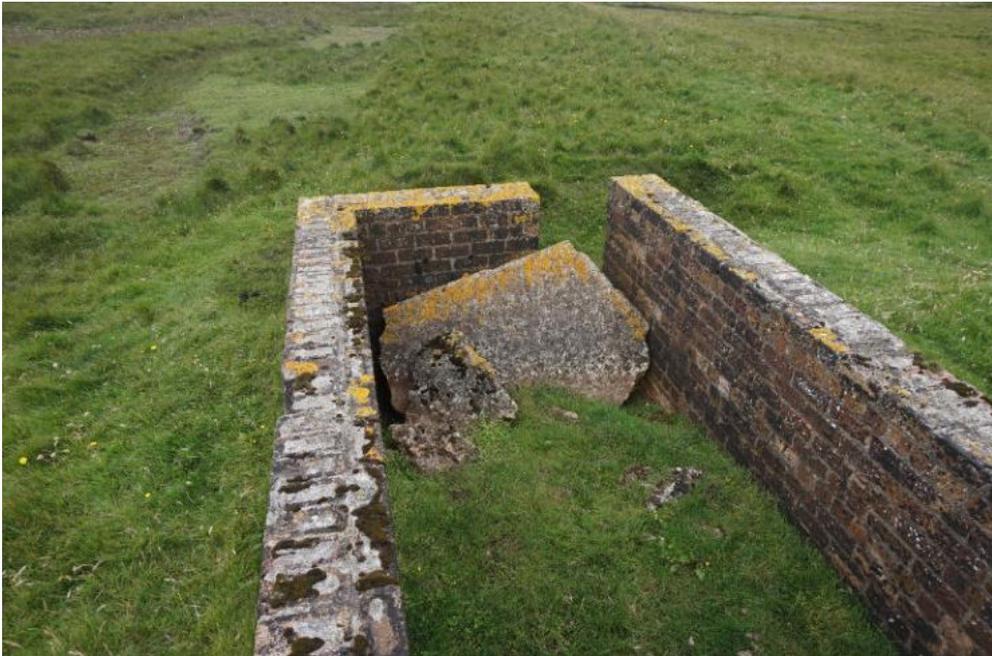
Internal ground levels have increased due to accumulations of soil, and fallen brickwork and concrete.

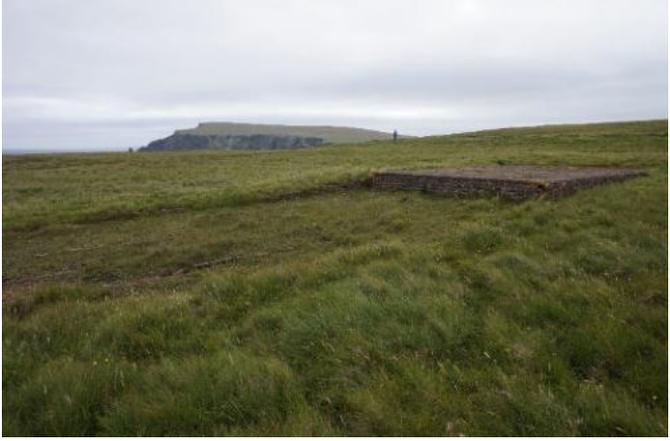
Condition:			
Poor: Loose and displaced brickwork throughout east portion, with failing mortar joints throughout. Cracked and disaggregated concrete floor slab supporting vegetation growth, and localised missing/damaged wallhead brickwork and failing joints to the west portion.			
Recommendations:			Priority:
1.	Record as existing and consider burying to protect footings and concrete from further damage from exposure and increased footfall. £5000.00 – Provisional cost		Necessary

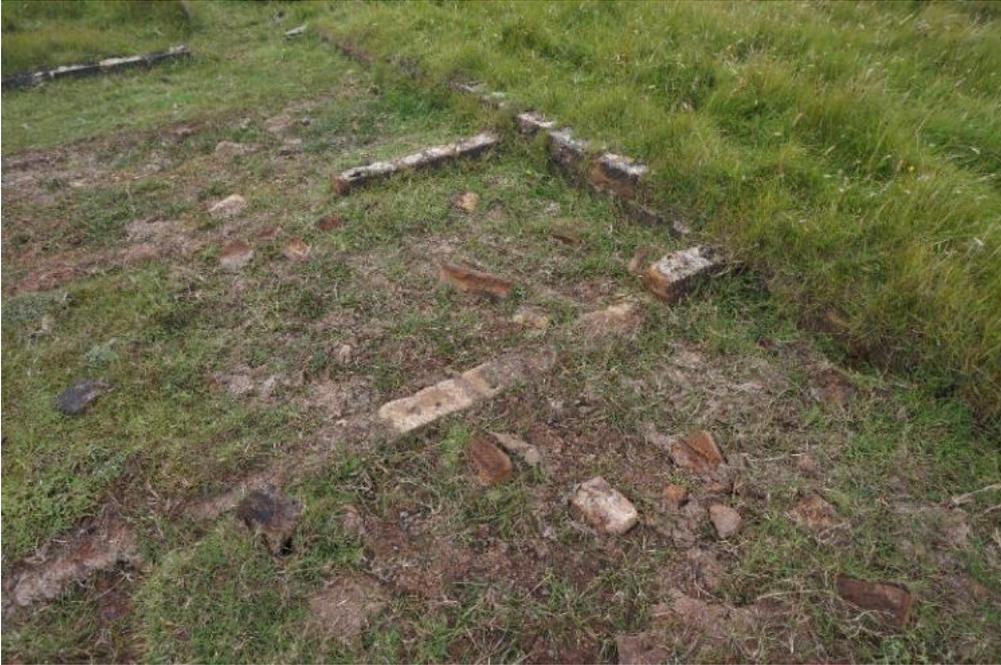
There is loose and displaced brickwork throughout the east portion. Consideration should be given to burying them to protect them from exposure to weathering and from the impact of increased footfall to the site.

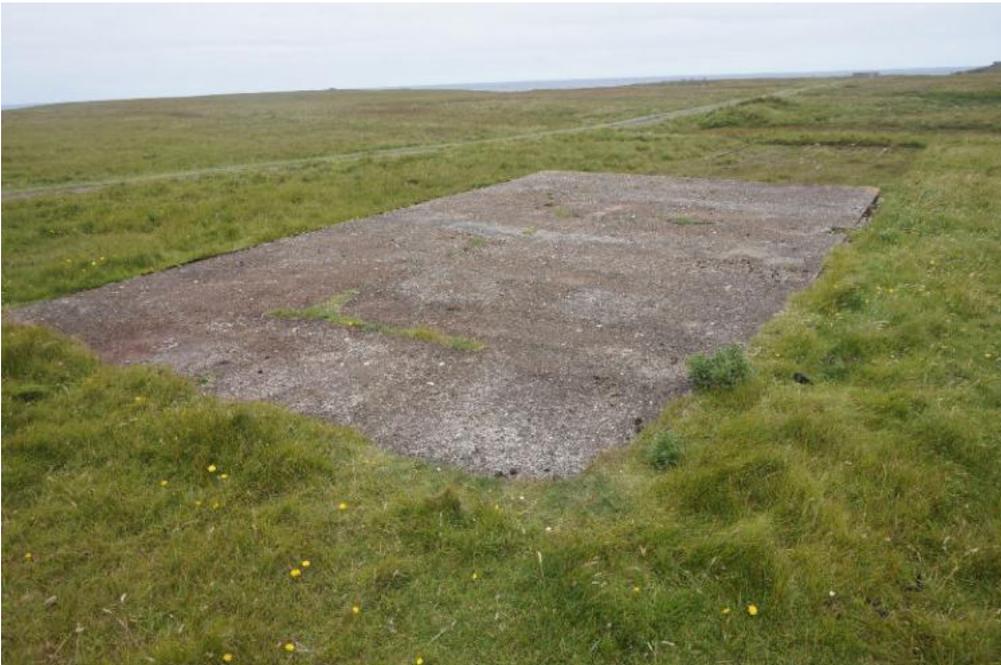
General view from southwest of west portion comprising concrete floor slab surrounded by part buried brick footings.

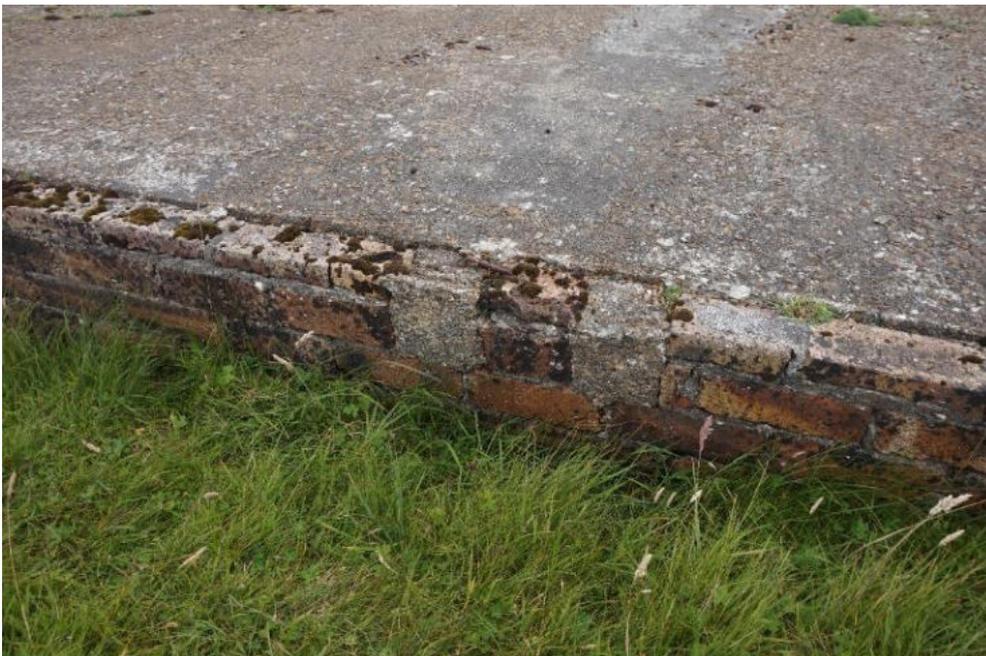
Stumps of reinforced concrete superstructure visible on the footings of the north and south elevations. Note cracked and failing mortar joints.

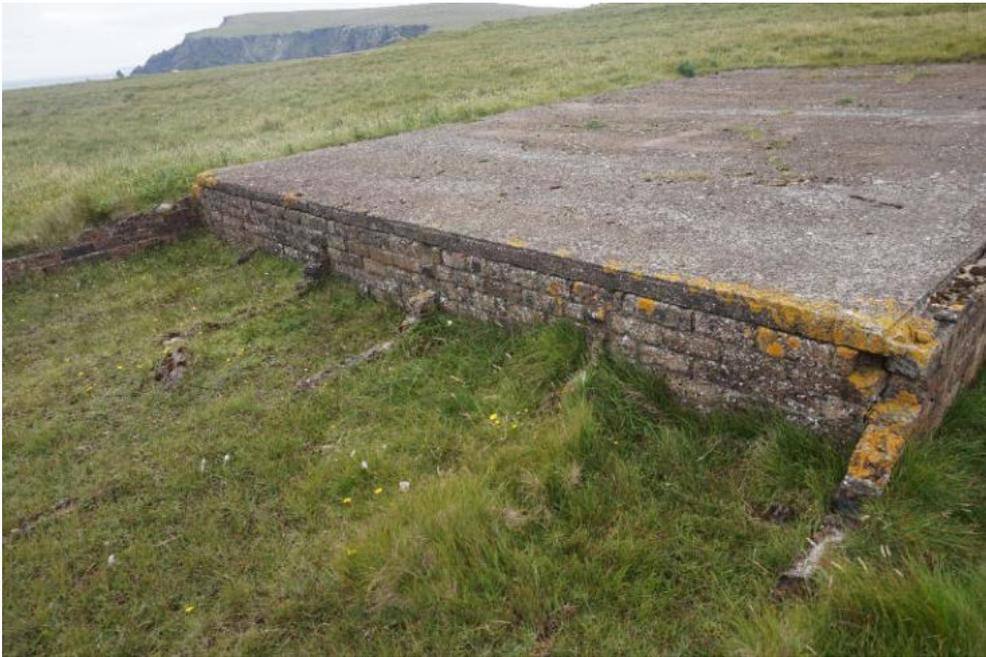
East face of west portion with failing joints and damaged brickwork.

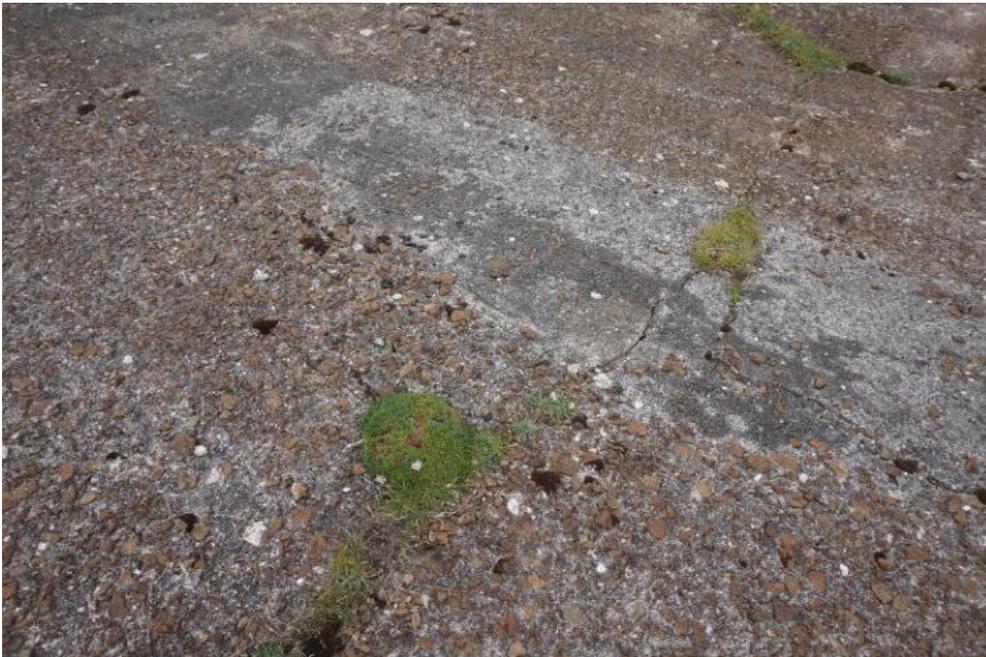
Cracked and disaggregated floor slab supporting vegetation growth.

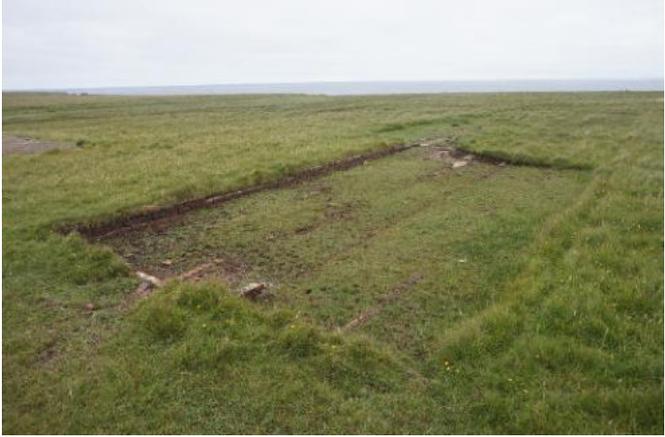
Condition:			
Poor: Loose and displaced brickwork in all areas, with failing mortar joints throughout. Exposed concrete strip foundations are disaggregating. Displaced bricks, timber and metal work lying between footings at south end of the site.			
Recommendations:			Priority:
1.	Record as existing and consider burying to protect footings and concrete from further damage from exposure and increased footfall. £5000.00 – Provisional cost.

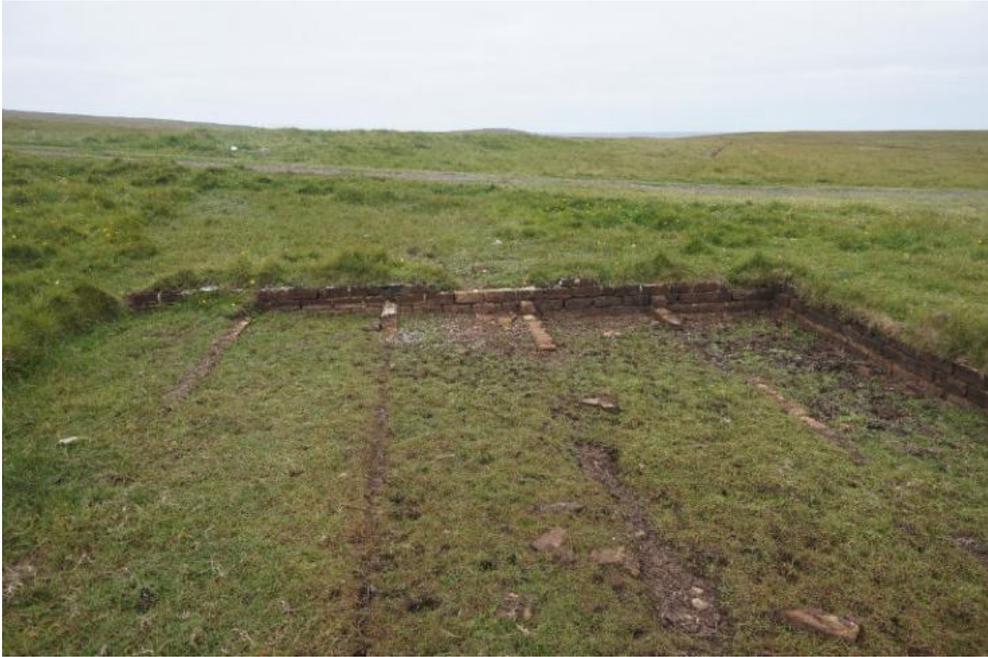
Internal view showing part buried footings with loose bricks and failing mortar joints. Note displaced brickwork. Consideration should be given to burying them to protect them from exposure to weathering and from the impact of increased footfall to the site.

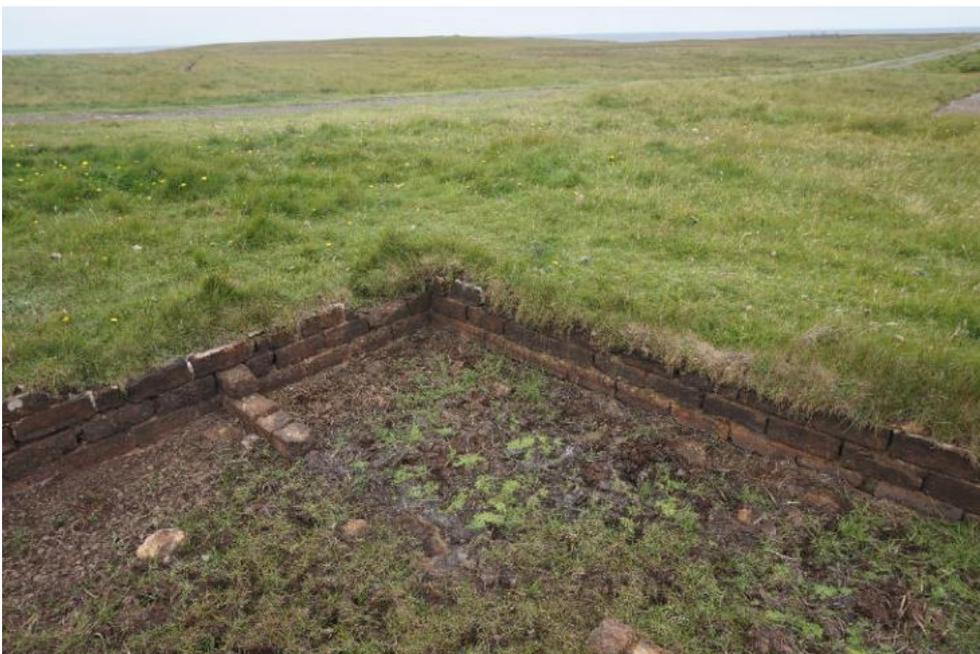
Part buried footings with loose bricks and failing mortar joints in northeast corner.

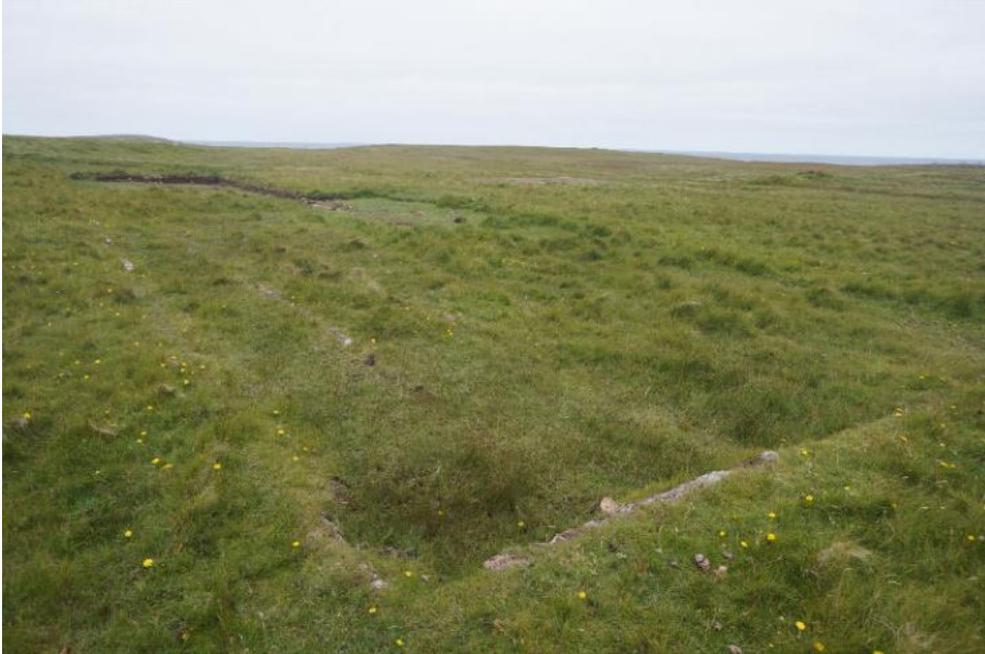
General view from south showing mostly buried footings and foundations.

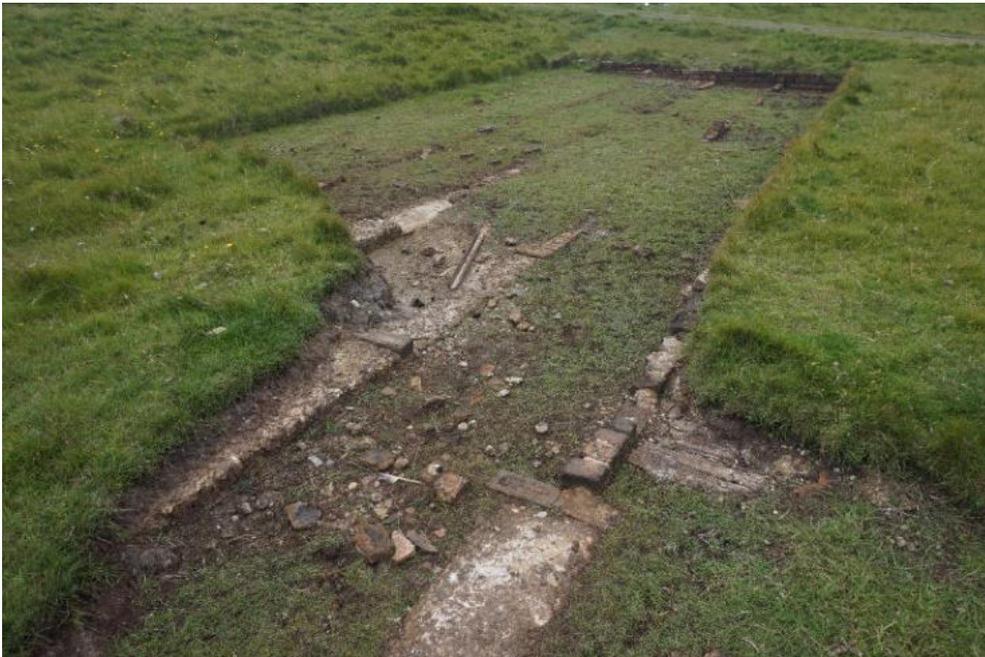
Loose brick footings, disaggregated concrete strip foundations and displaced bricks, timber and metal work at southern portion of the structure.

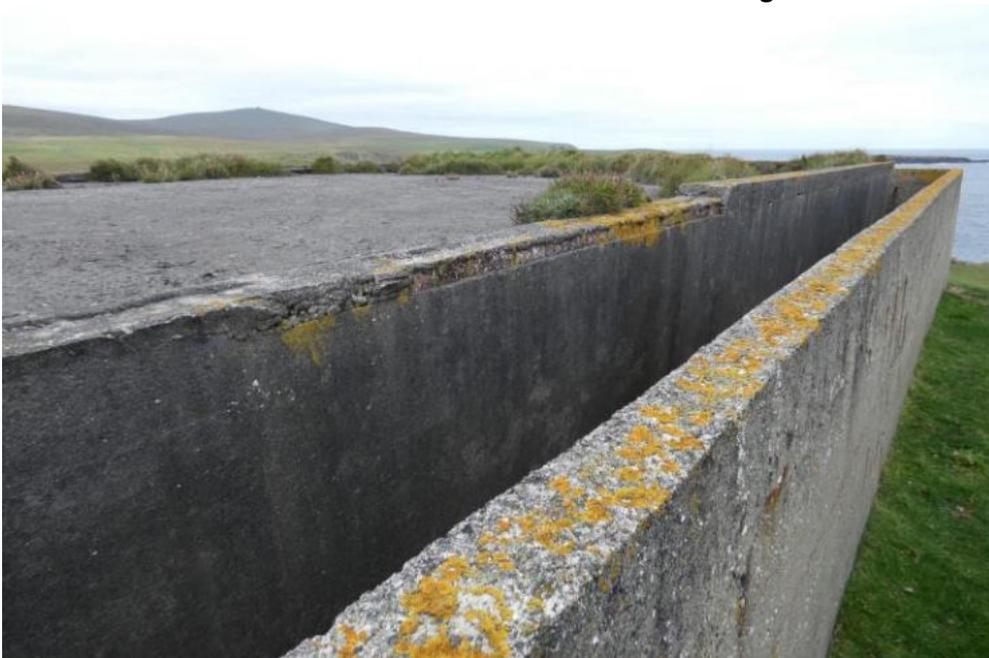
Looking across the surface of the roof. Note missing parapet copes and vegetation growing on roof.

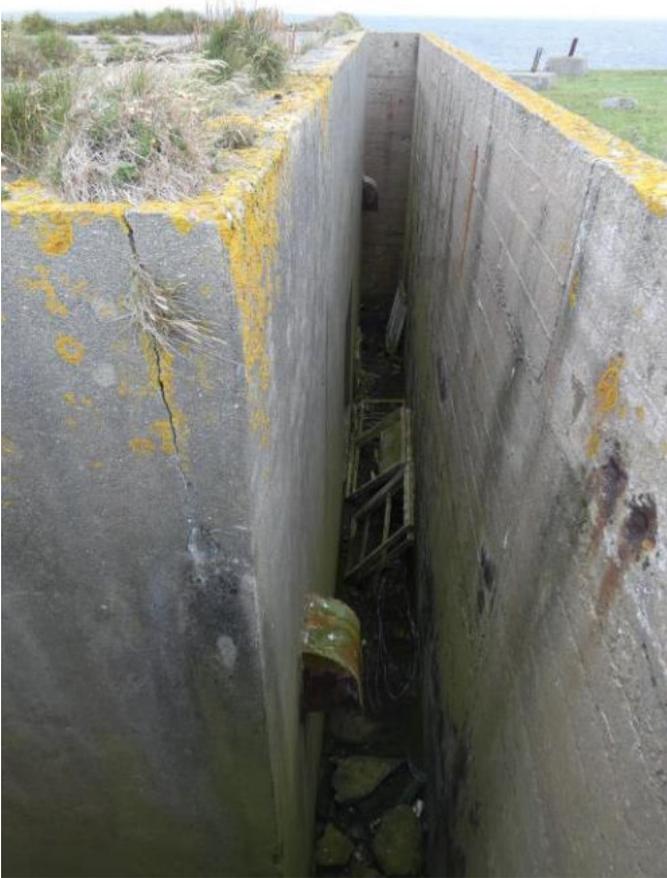
Note the debris across the floor of the perimeter lightwell. Note crack in the render of the building.

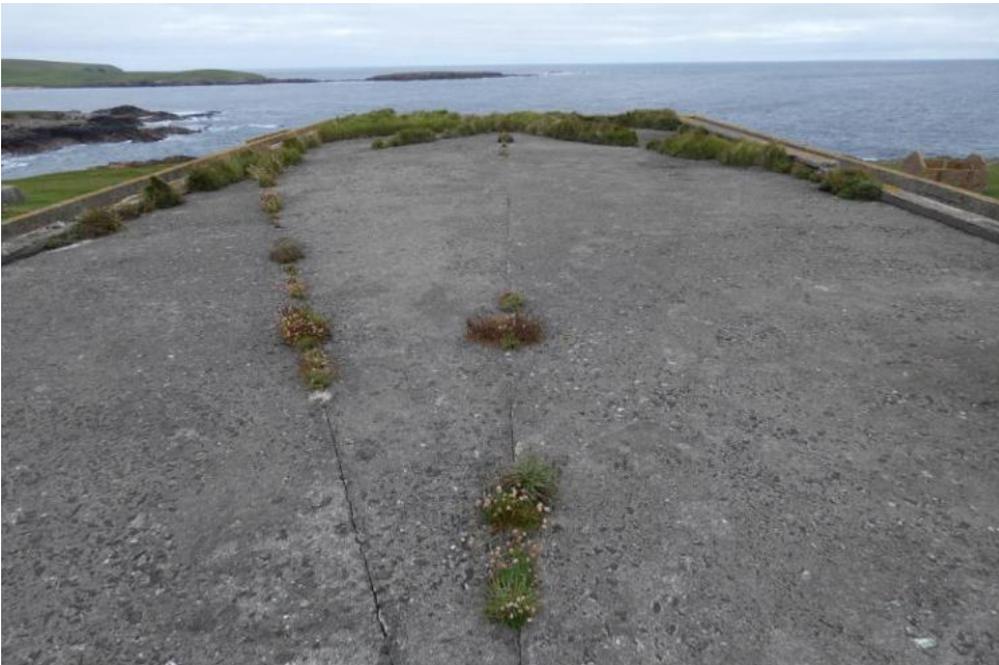
General view across the roof. Note cracking of the asphalt and vegetation growing from those cracks.

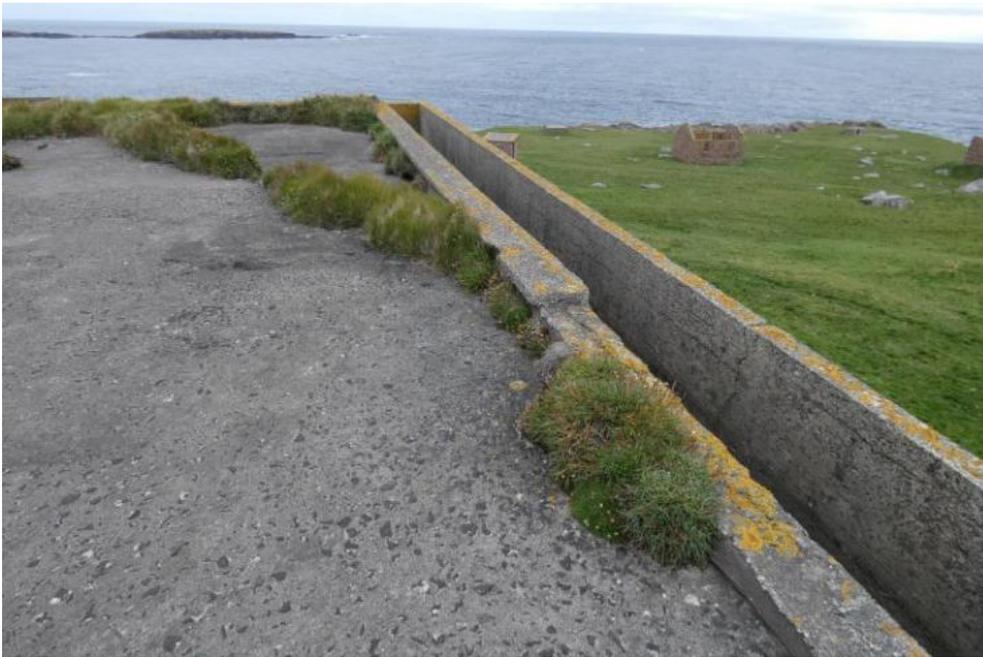
The roofscape. Note missing copes from parapet.

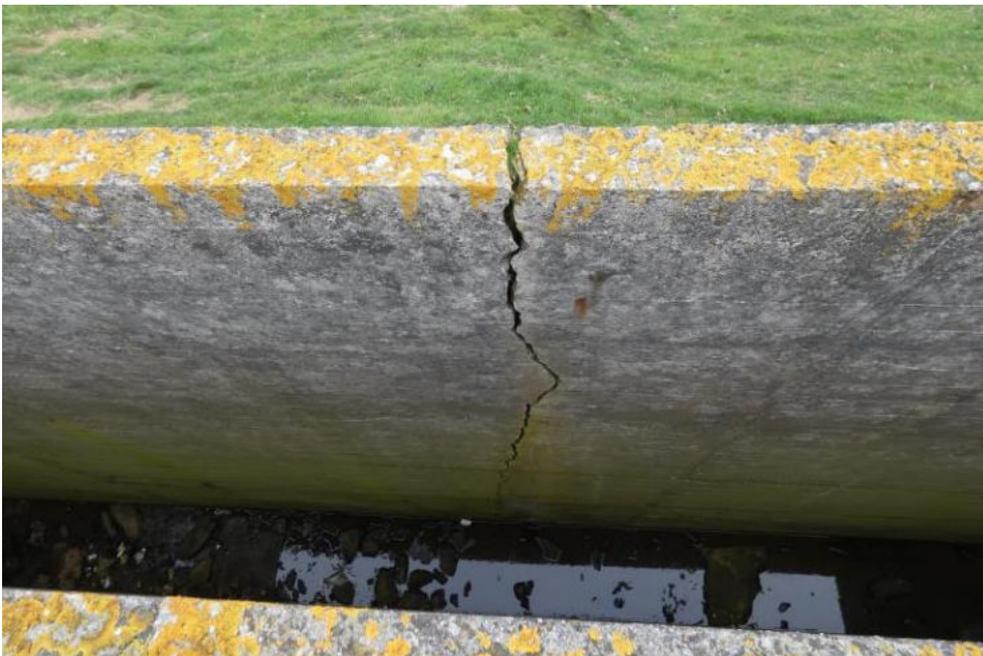
Vertical cracks in the blast walls are wider at the top of the wall than the bottom, indicating foundation movement. the provision of horizontal reinforcing bars appeared to be small.

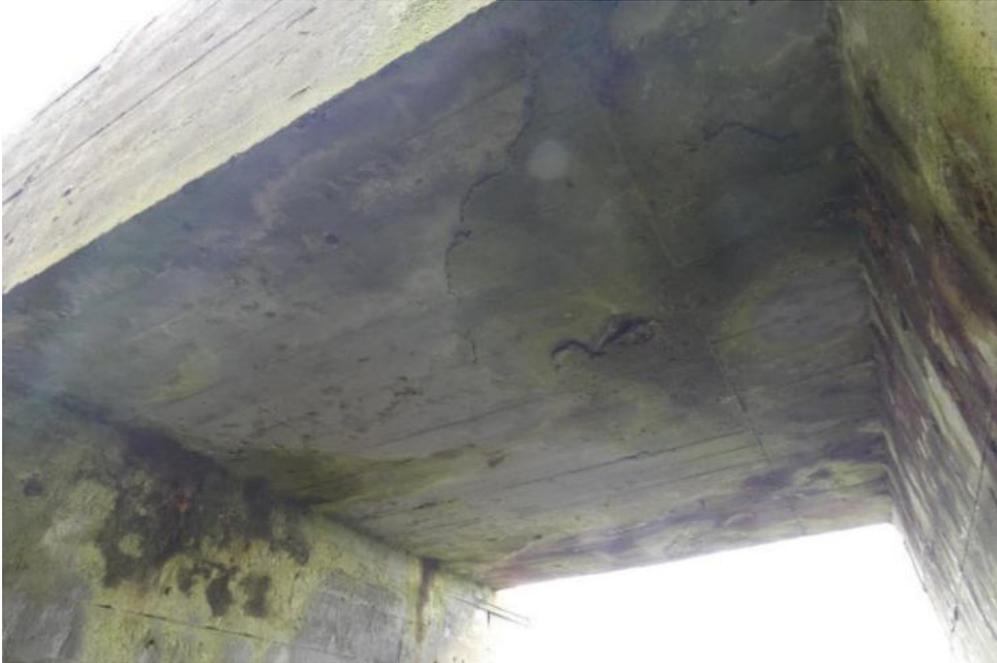
Spalling concrete and render finishes from the soffit of an access tunnel roof.

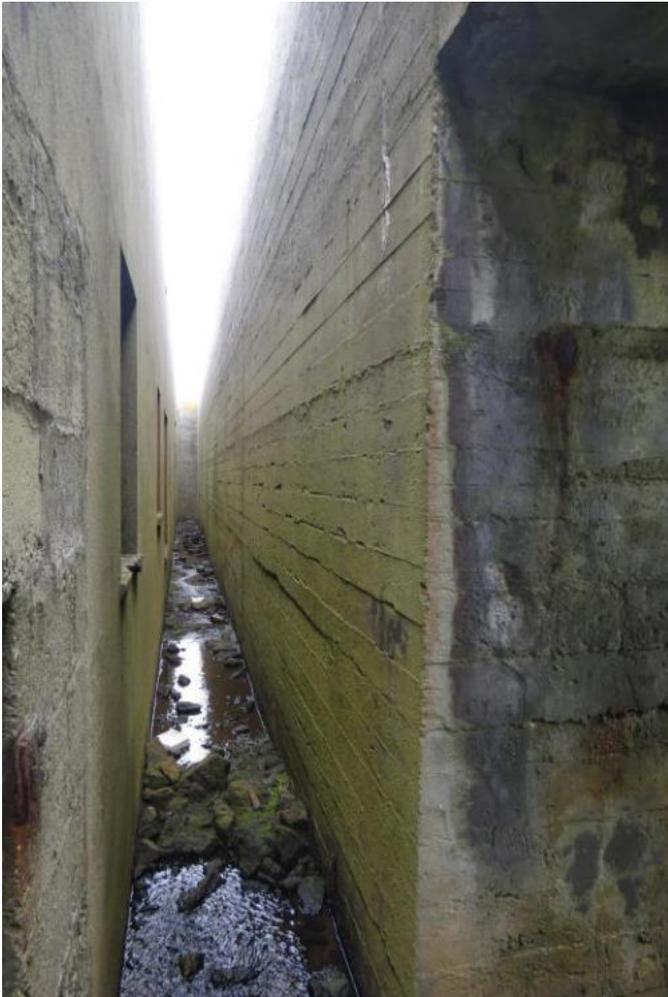
Looking between the blast walls and building proper. Note build up of debris and water.

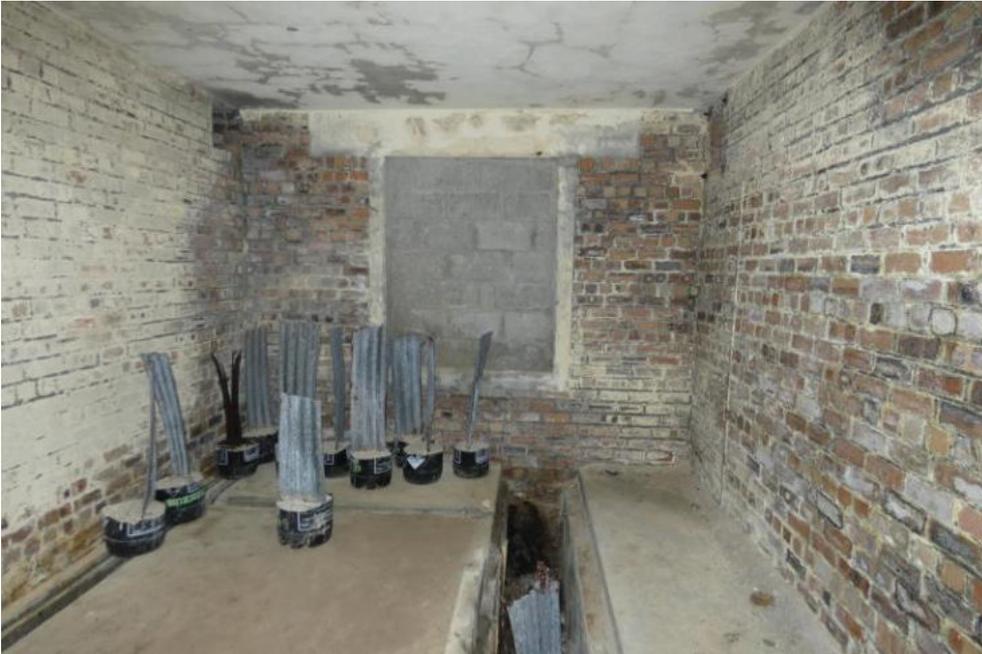
As 10. Note cracked ceiling plaster and indications of general dampness in the brick masonry.

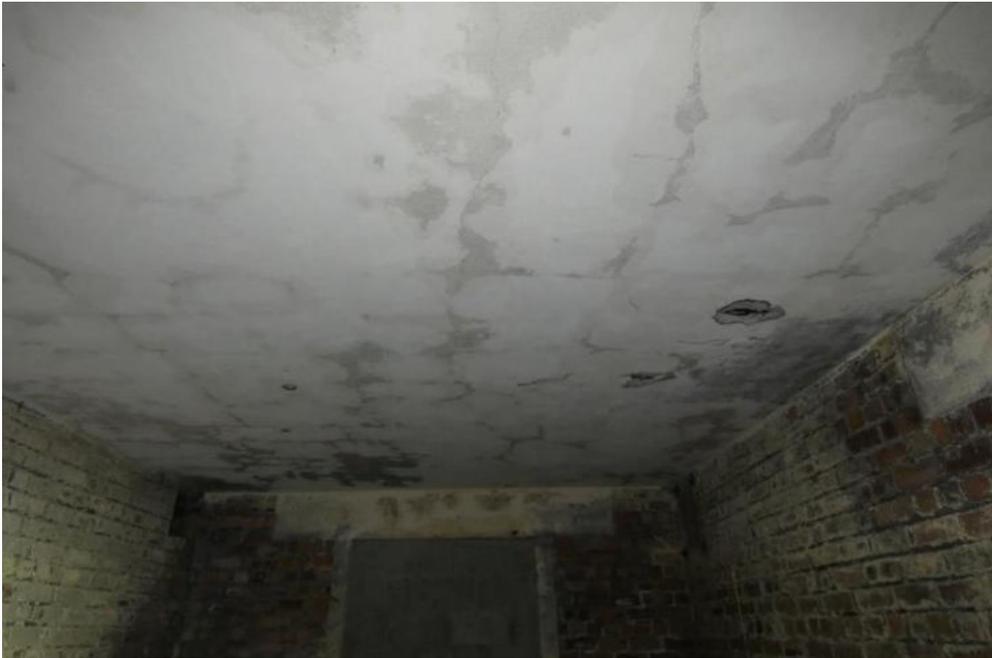
Note cracking of ceiling plaster.

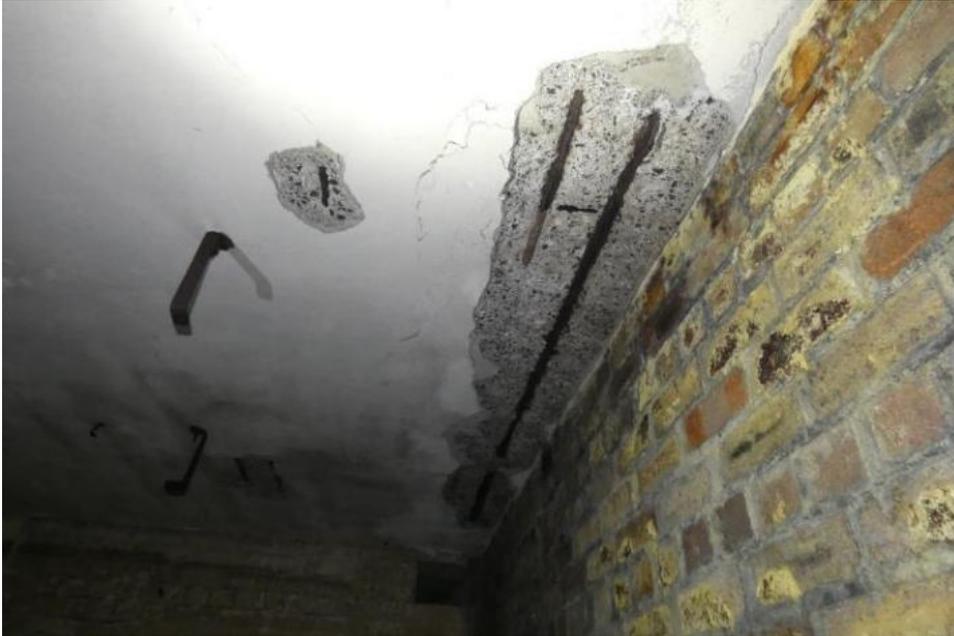
In places, expansive corrosion of reinforcement is causing spalling of concrete from roof soffit.

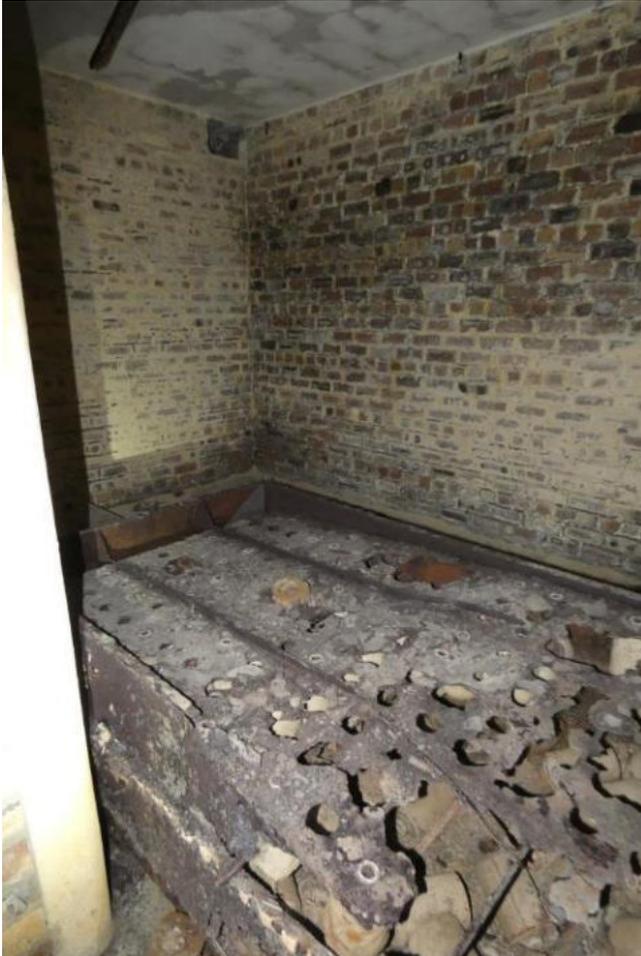
Remnants of equipment survive in places.

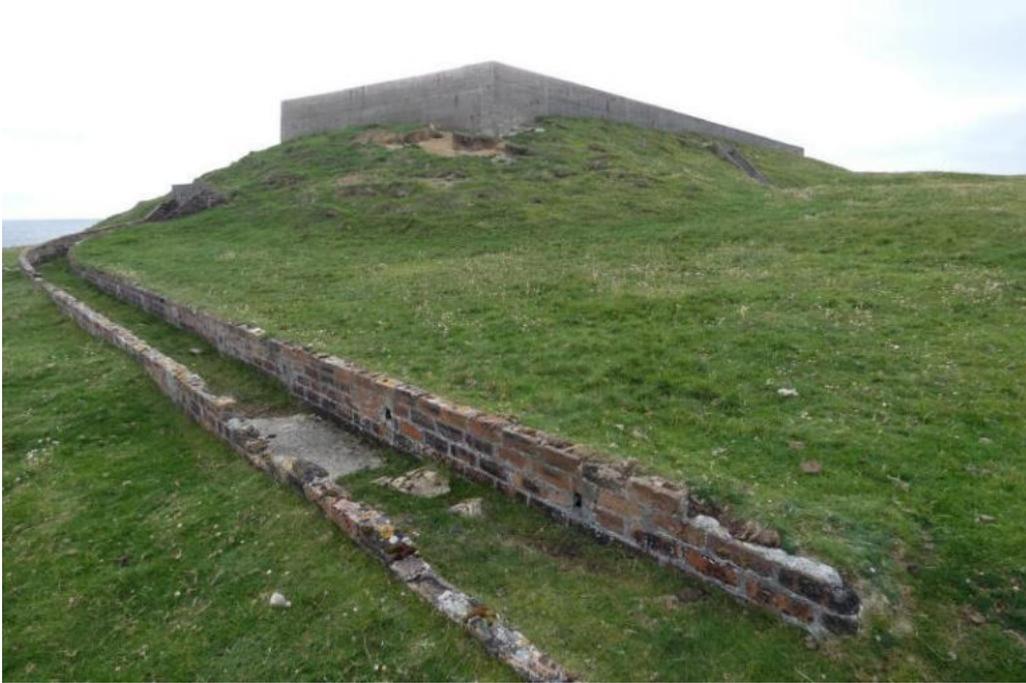
The external brick service trench. Note general deterioration of top courses of its masonry. Note also the loss of material from the embankment about the blast walls.

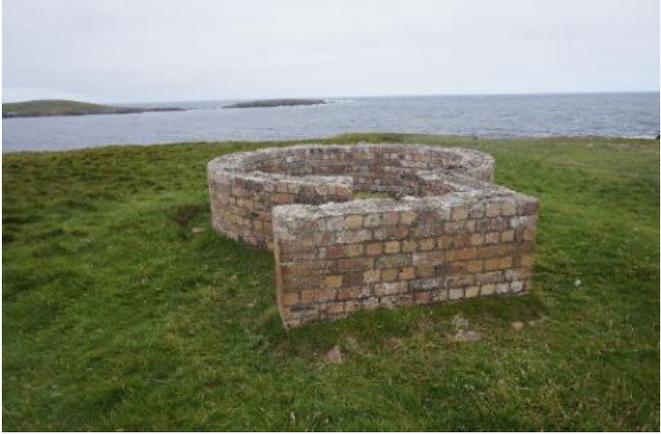
Condition:			
Fair: Localised open, cracked and failing mortar joints, including to exposed wallhead which is supporting vegetation growth. Minor damaged brickwork to wallhead.			
Recommendations:			Priority:
1.	Record and monitor future condition, with provision for localised repointing of open and defective joints, especially skyward facing joints. £100.00		Necessary

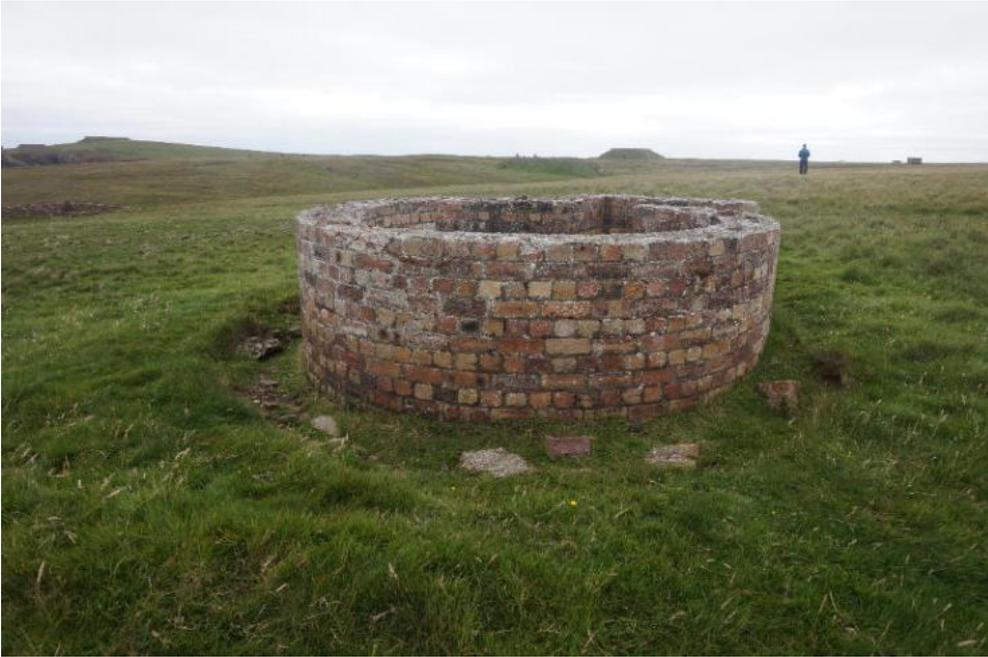
General view from south showing damaged wallhead brickwork and localised failing joints to wall face. Displaced bricks around base of wall.

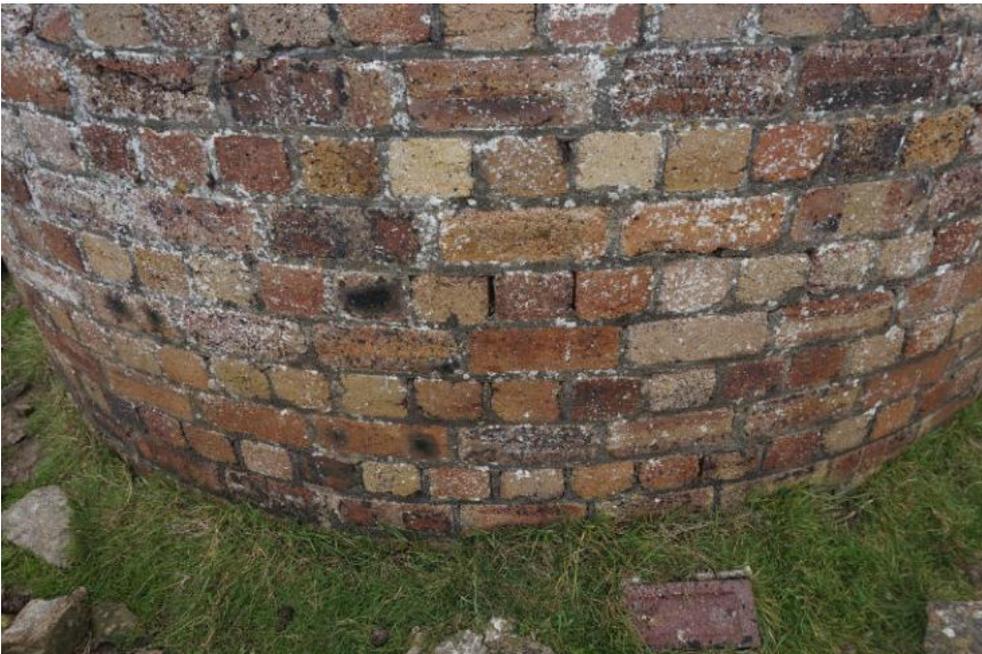
Localised failing joints to wall face.

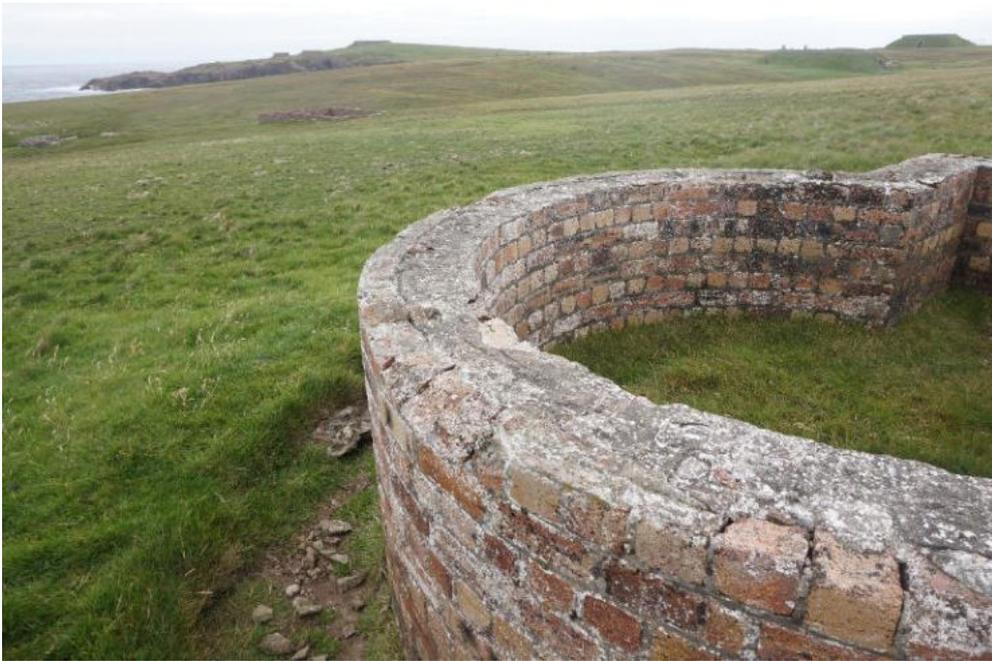
Localised open joints and damaged brickwork to wallhead.

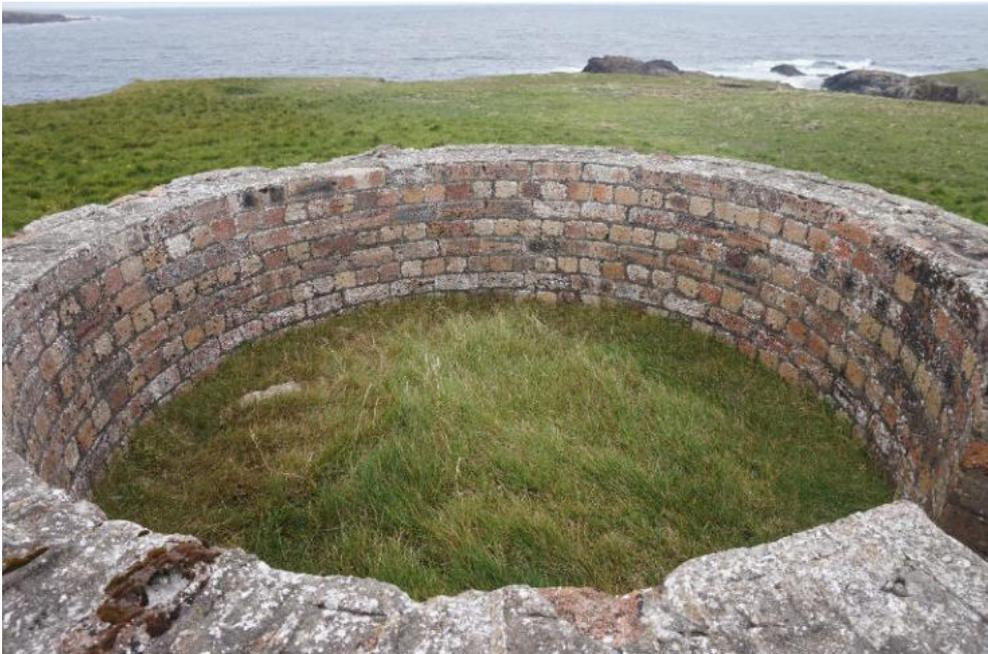
General internal view.
