Appendix 14.10 Conservation Management Plan

Shetland Space Centre Conservation Management Plan

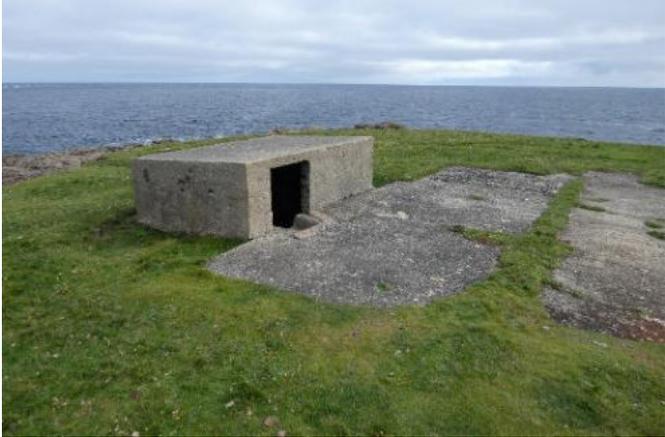
Condition:			
<p>Fair: Constructed with poorly mixed and compacted concrete. No structural distress evident. Localised minor cracking, disaggregation, spalling and surface loss externally. Poor coverage to reinforcement causing localised spalling and/or rusting staining to the external north wall, and roof structure externally and internally. Discolouration and damp staining internally. Hardstanding cracked supporting vegetation growth.</p>			
Recommendations:			Priority:

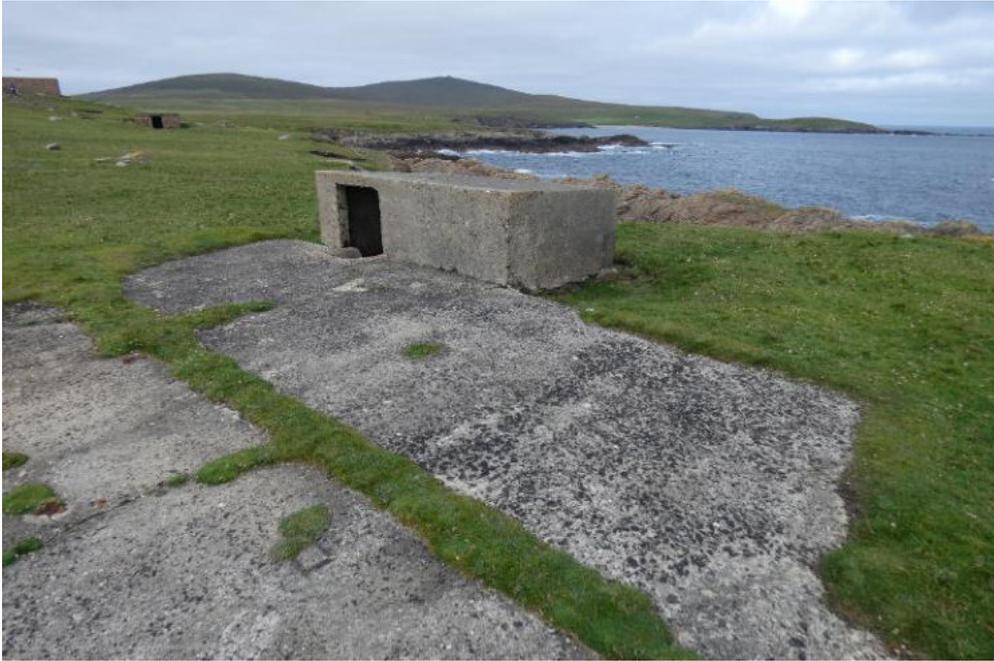
General view showing cracked hardstanding which is supporting vegetation growth.

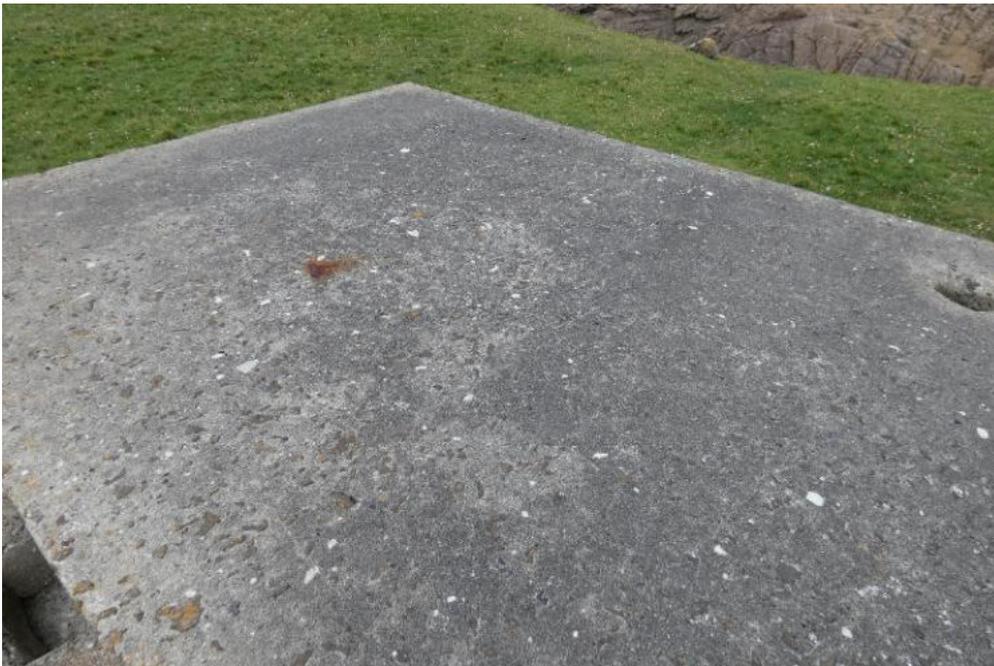
Minor rust staining to the exterior of the roof slab.

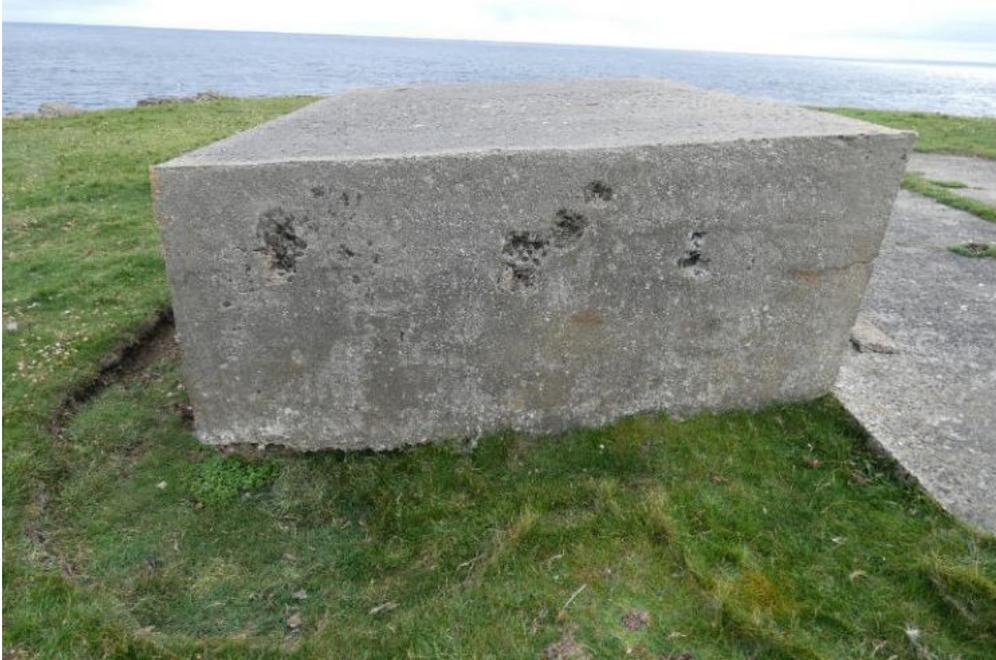
Localised spalling and damage to external walls.

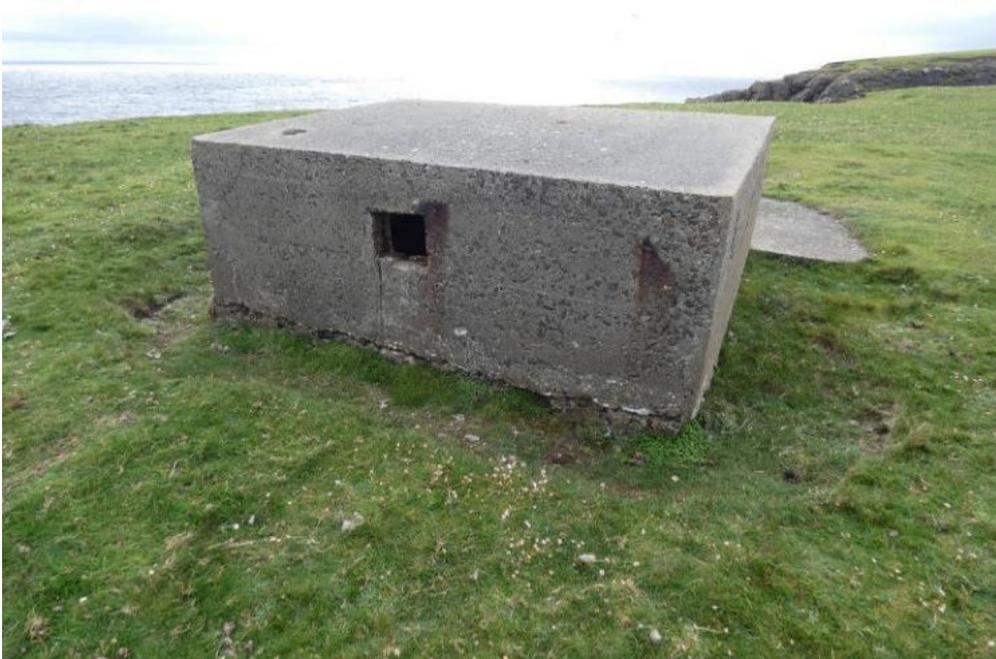
Localised cracking and rust staining.

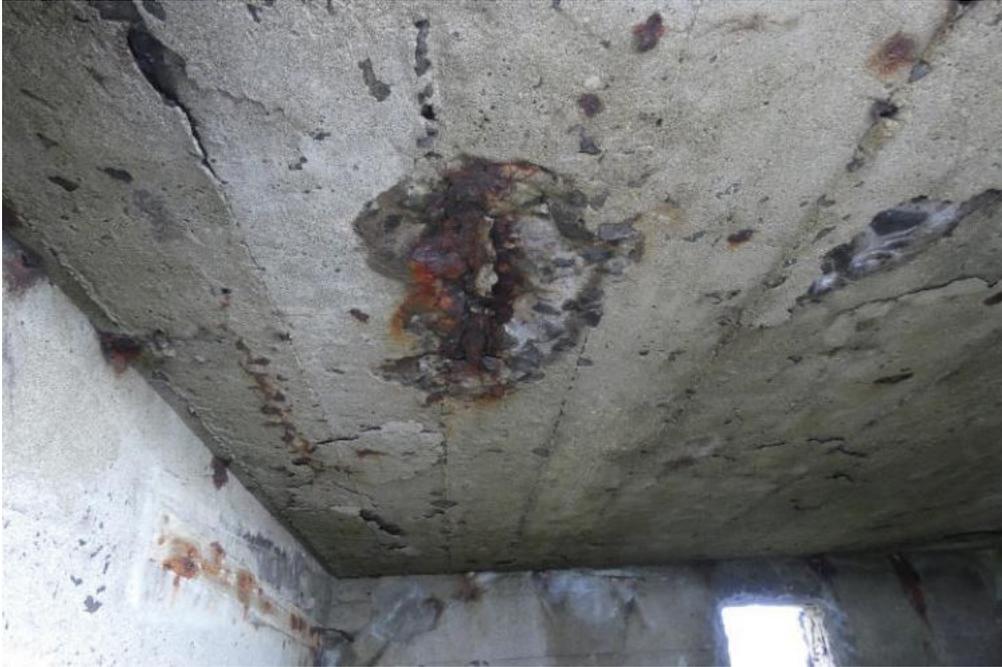
Localised spalling internally exposing corroded reinforcement.

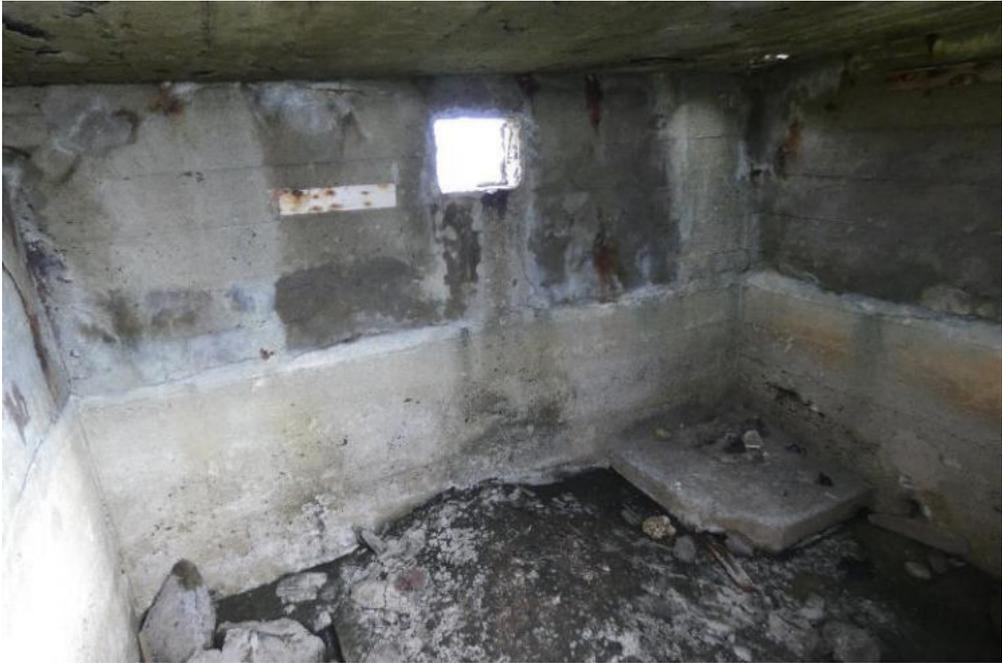
Discoloured and damp stained wall. Floor obscured by accumulated debris.

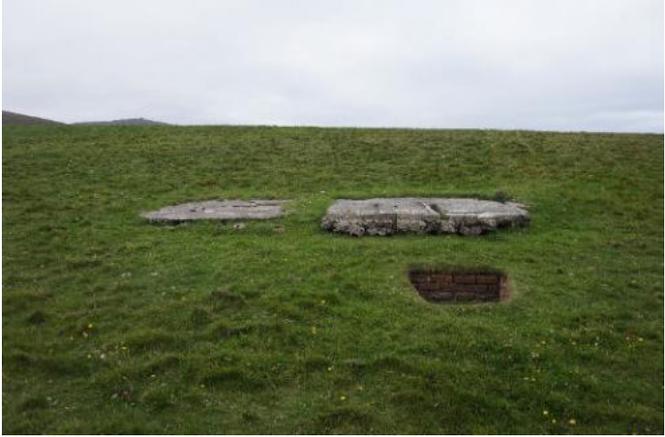
Condition:			
<p>Fair: The upper face and exposed edges of the east concrete base are spalling and the entrance step is misaligned. The west concrete base has subsided, is heavily cracked and exposed edges are disaggregating. The brick chamber has open joints throughout, which loose wallhead brickwork.</p>			
Recommendations:			Priority:

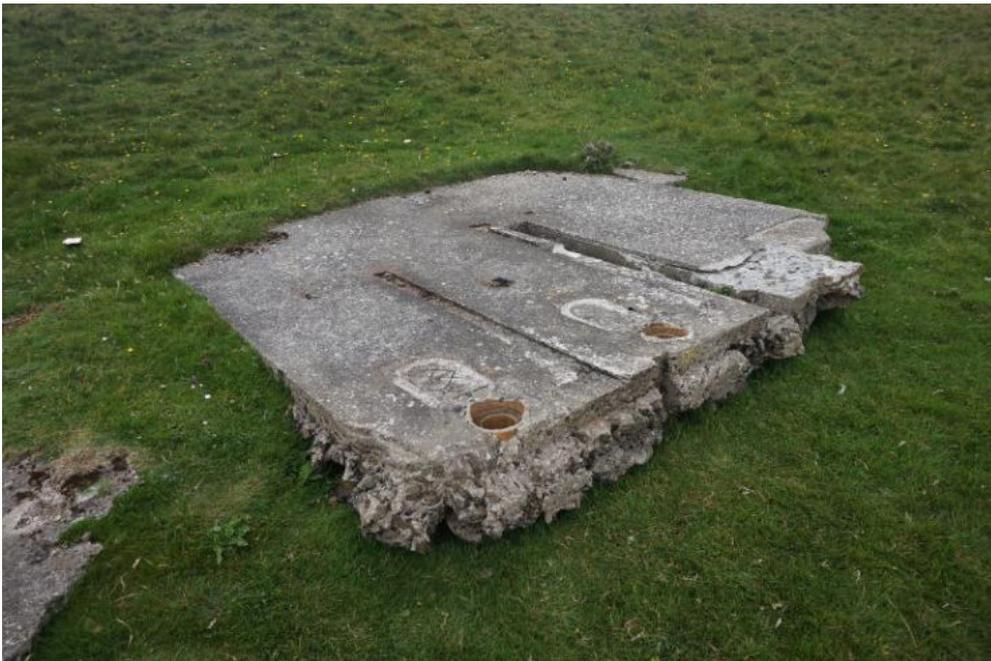
East concrete base with spalling upper face.

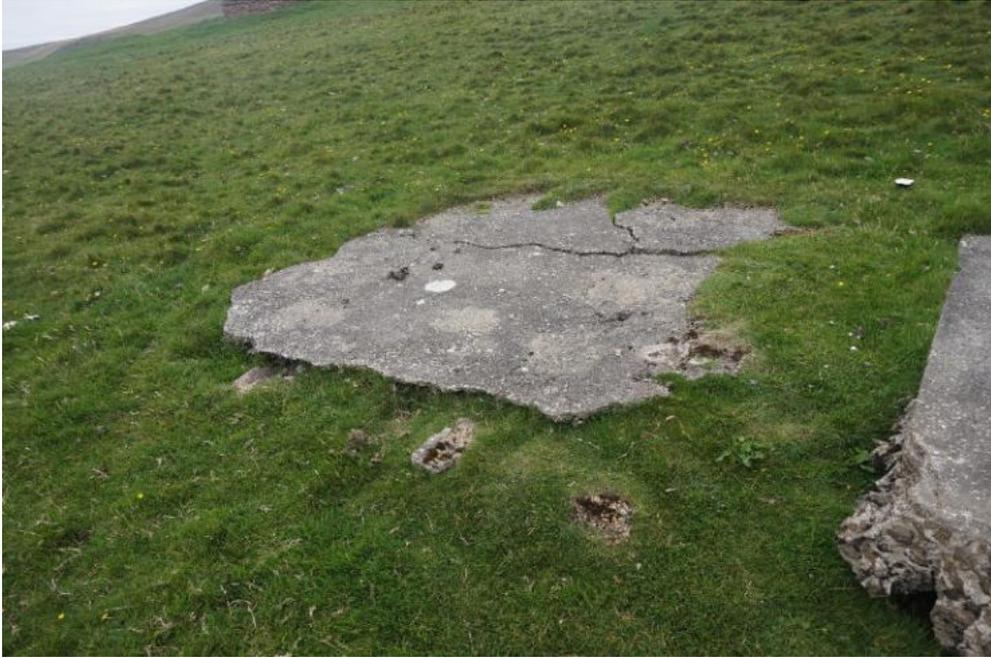
West concrete base has subsided resulting in extensive cracking.

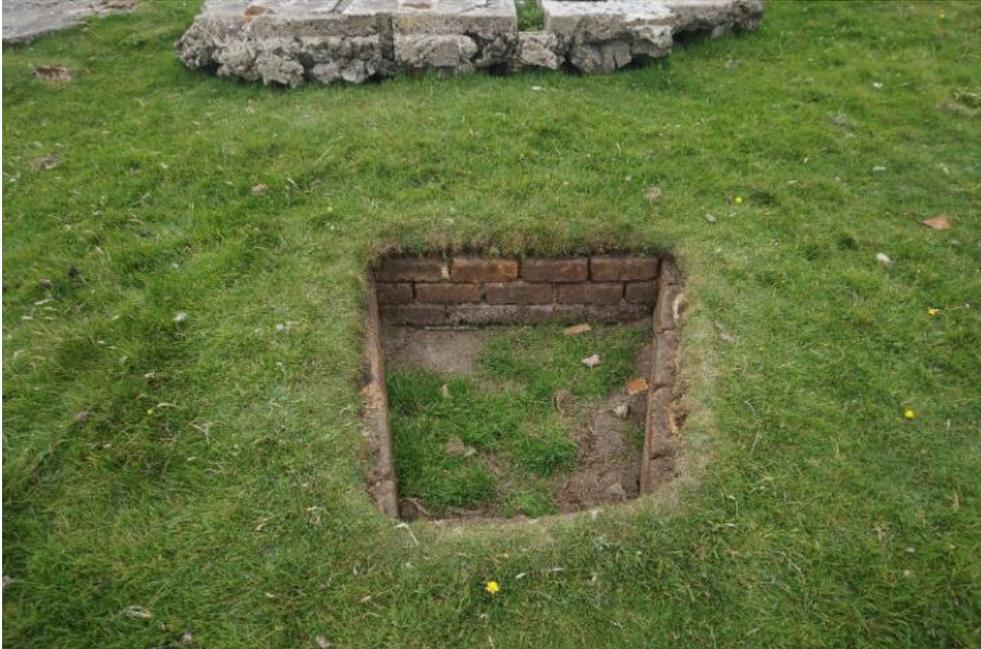
Open joints and loose brickwork to wallheads of brick drainage chamber.

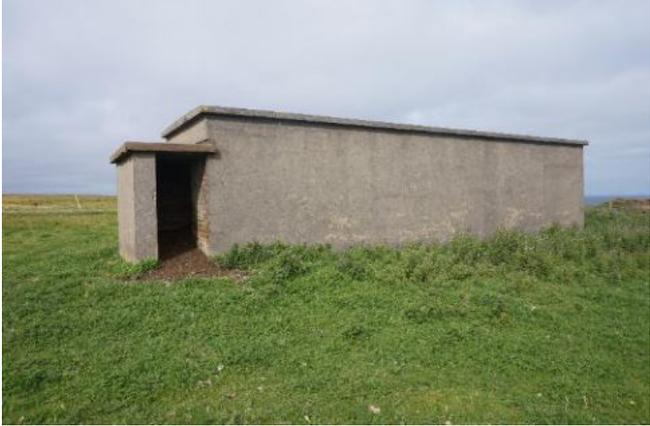
Condition:			
<p>Fair: Only fragments of the asphalt roof finishes survive which has exposed cracking across the exterior of the concrete roof slab. However, despite this the roof structure appears in a relatively good condition, with only minor damp staining, discolouration and localised spalling, exposing reinforcement, visible. Cracked, spalled and bossed rendered finishes externally throughout. Rotten timber frame to east elevation opening and corroded surface mounted servicing. Paint finishes to internal brickwork affected by damp staining and from salts due to large accumulations of animal faeces. Nesting birds.</p>

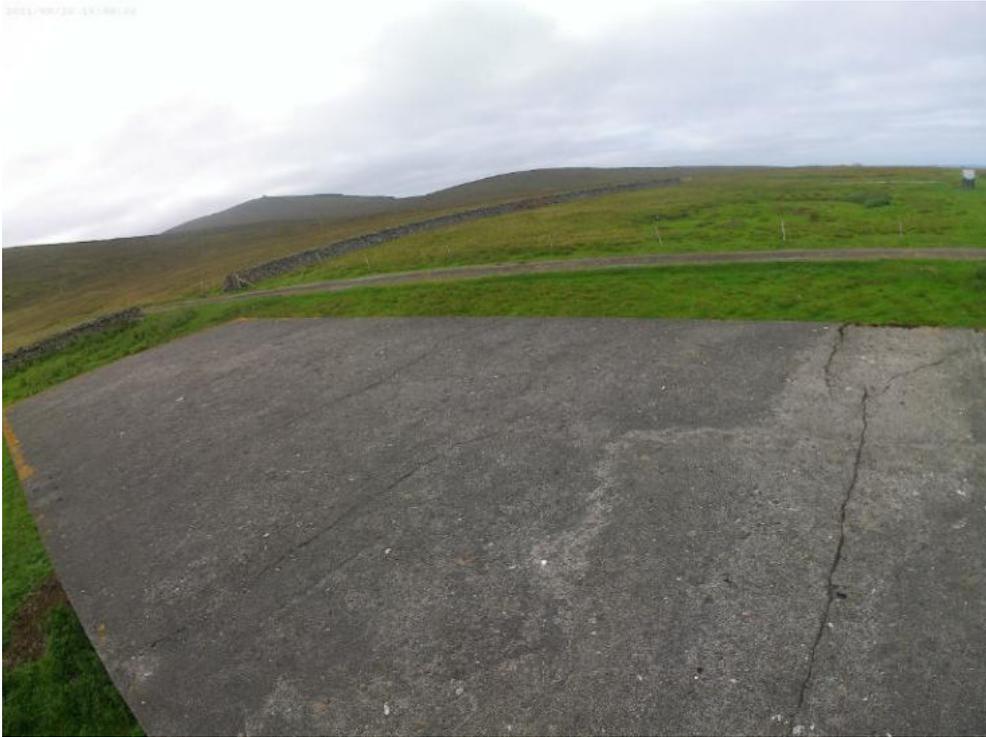
Cracking is visible throughout the exposed concrete roof slab.

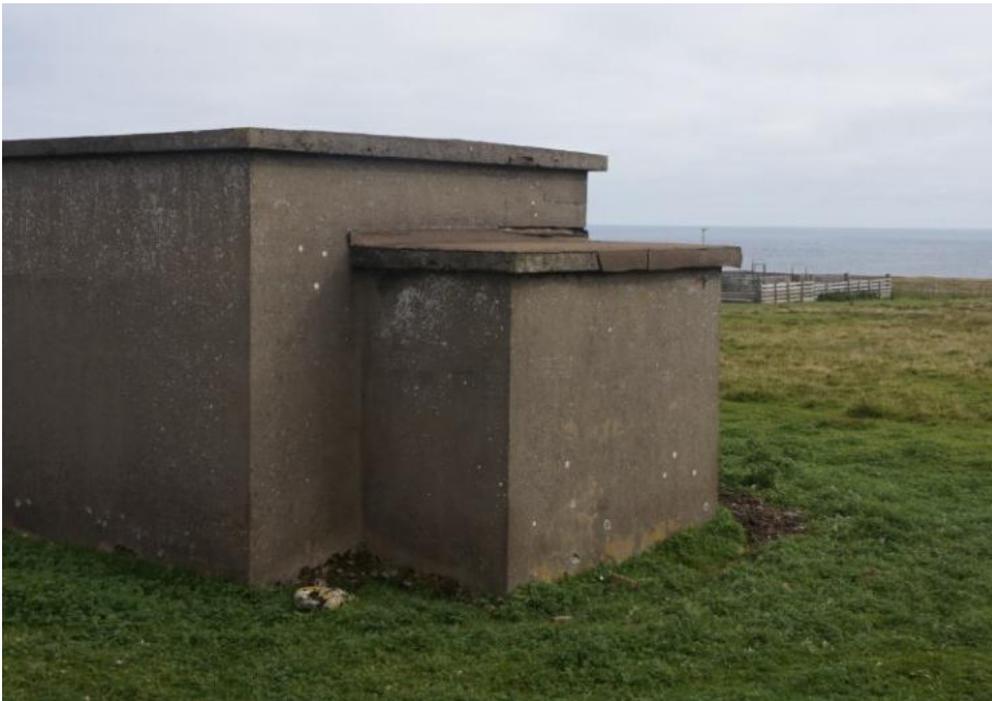
Failing asphalt junction between the west entrance porch and main building. Only fragments survive on the main roof.

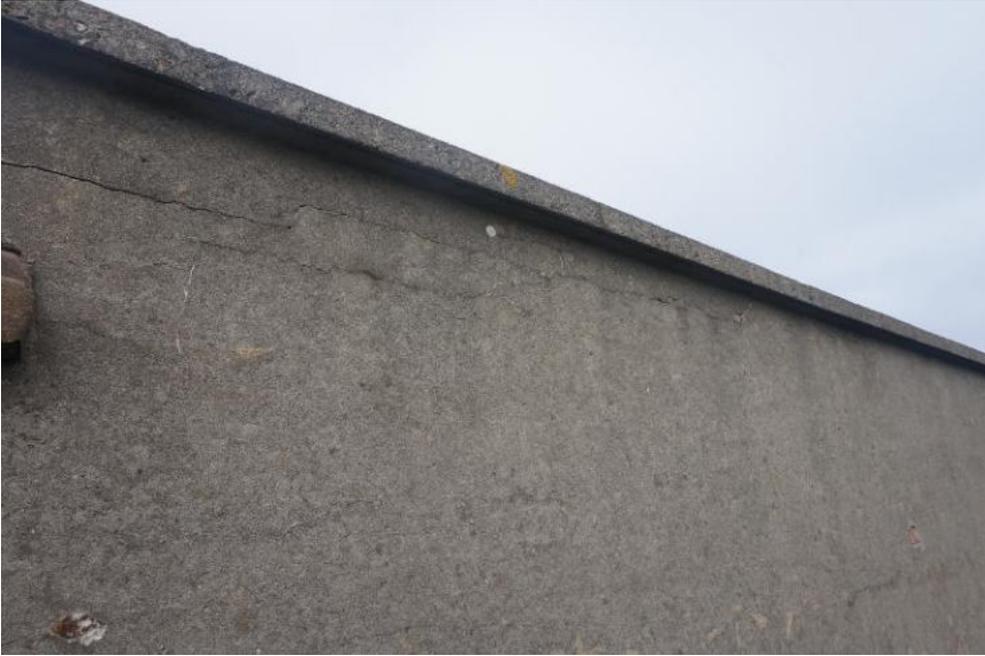
Cracked and bossed render was observed externally on all elevations. Horizontal cracking at top of wall indicative of movement caused by drying shrinkage of roof slab.

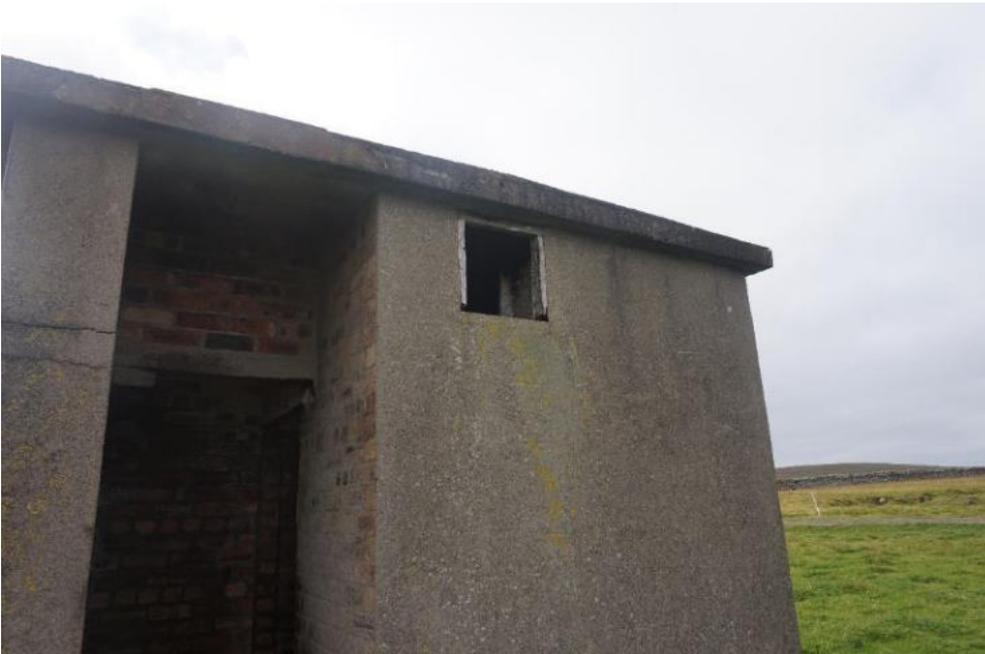
Rotten timber frame to opening on the east elevation. Note loss of concrete from the underside of the RC lintol above the internal opening: removal of surviving, but cracked, concrete from that lintol necessary.

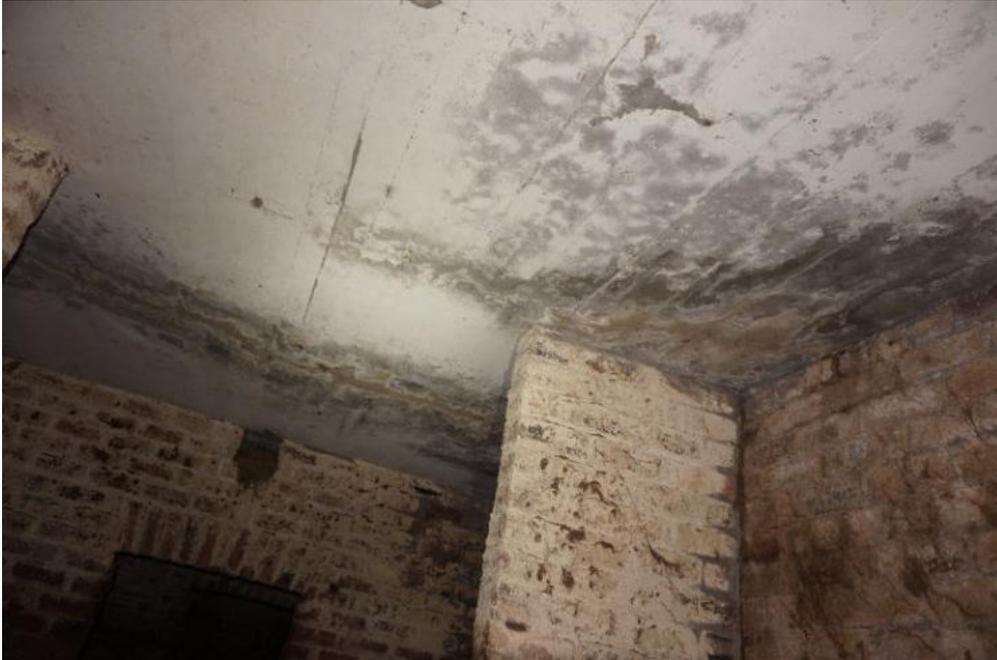
Damp staining and discolouration to underside of concrete roof slab.

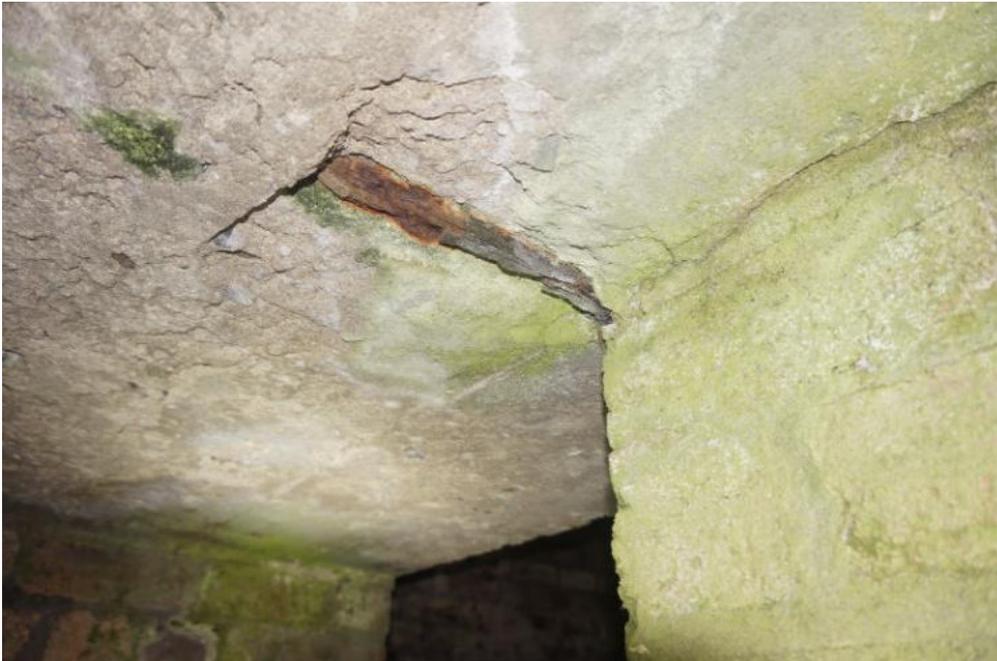
Despite the lack of roof finishes, only minor corrosion of reinforcement was observed.

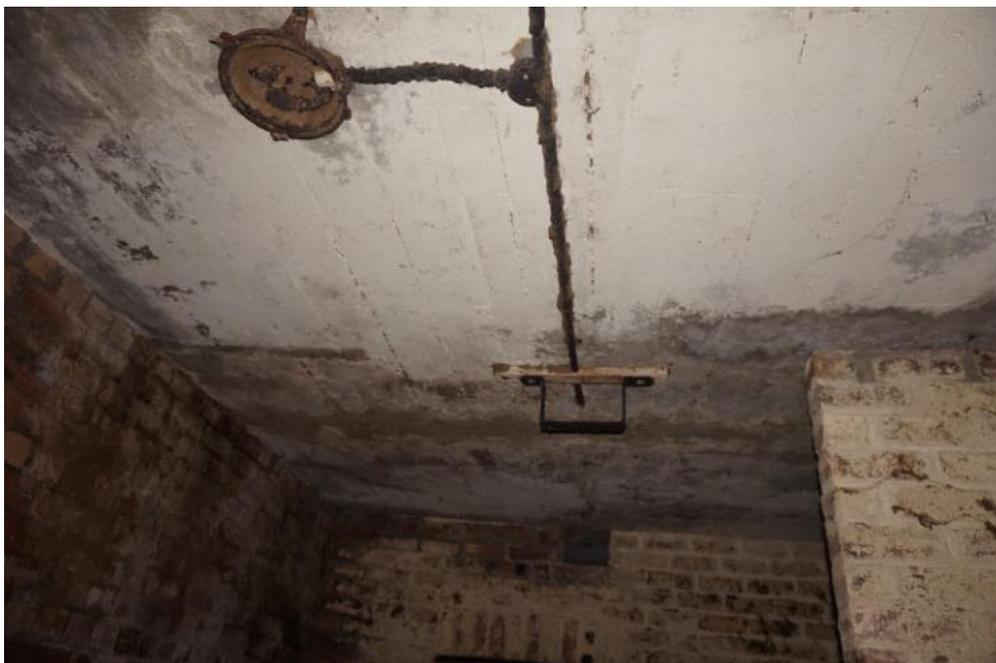
Corroded surface mounted servicing.

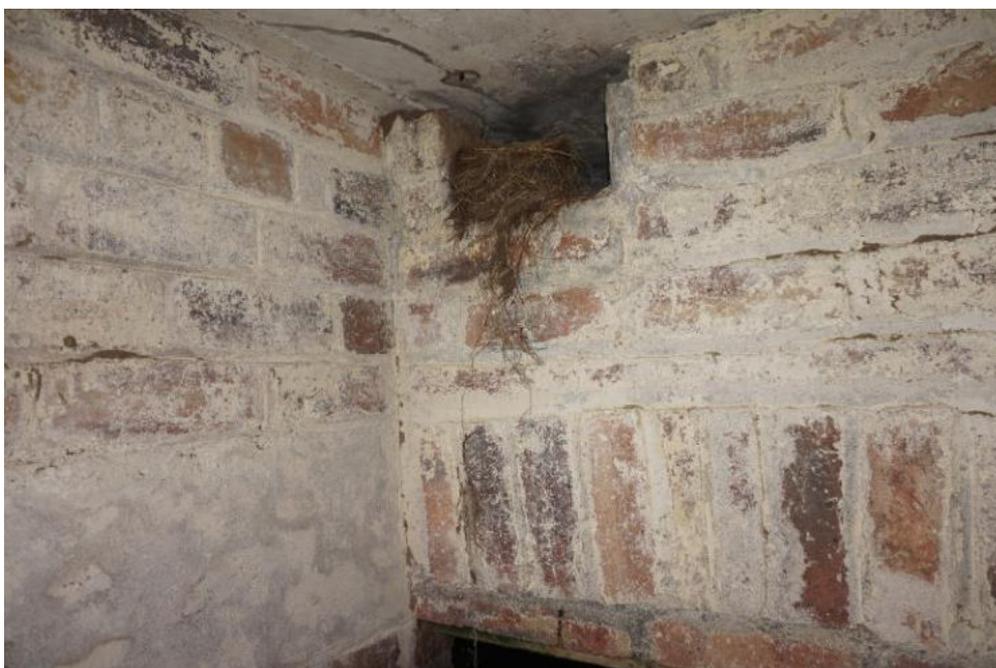
Nesting birds are using the structure.

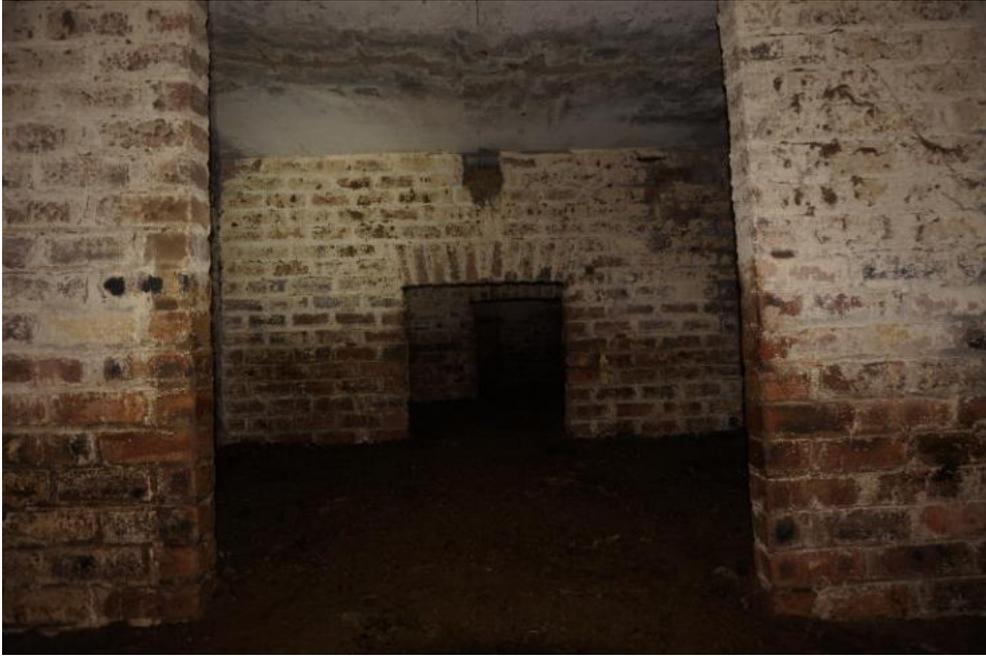
Internal painted surfaces and damp stained and affected by salts from the large accumulations of animal faeces.

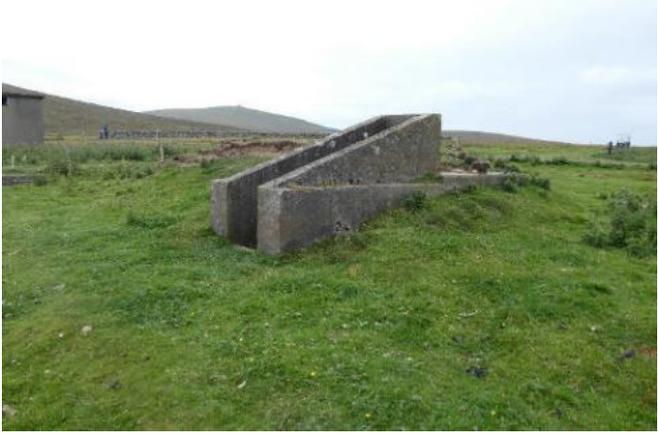
Condition:			
<p>Fair: Minor failing render externally exposing brickwork beneath and supporting vegetation growth. Extensive loss of the earth and turf covering exacerbated by grazing and burrowing.</p> <p>Localised spalling of concrete soffit internally which is exposing reinforcement. Localised loss of internal render.</p>			
Recommendations:			Priority:

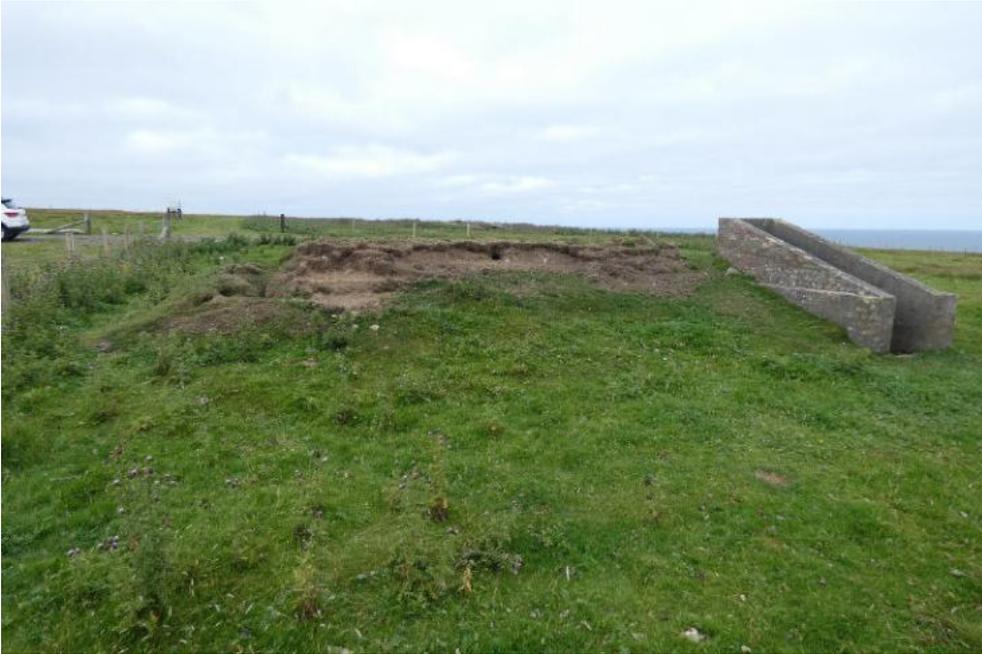
General view from southwest. Note damage caused by grazing and burrowing animals.

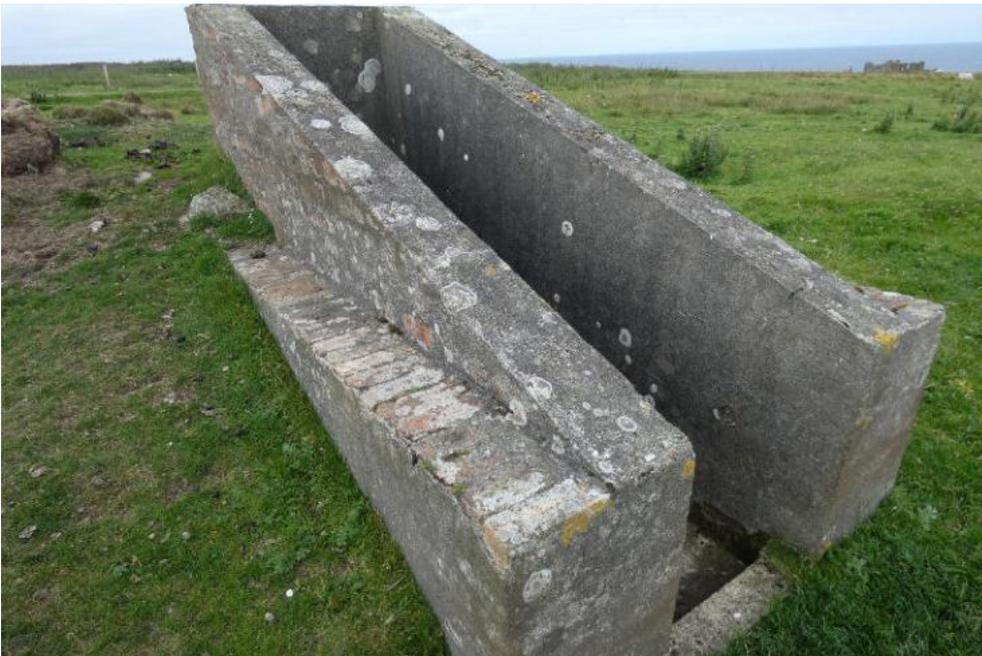
There is only minor damage to the rendered brick tunnel entrance.

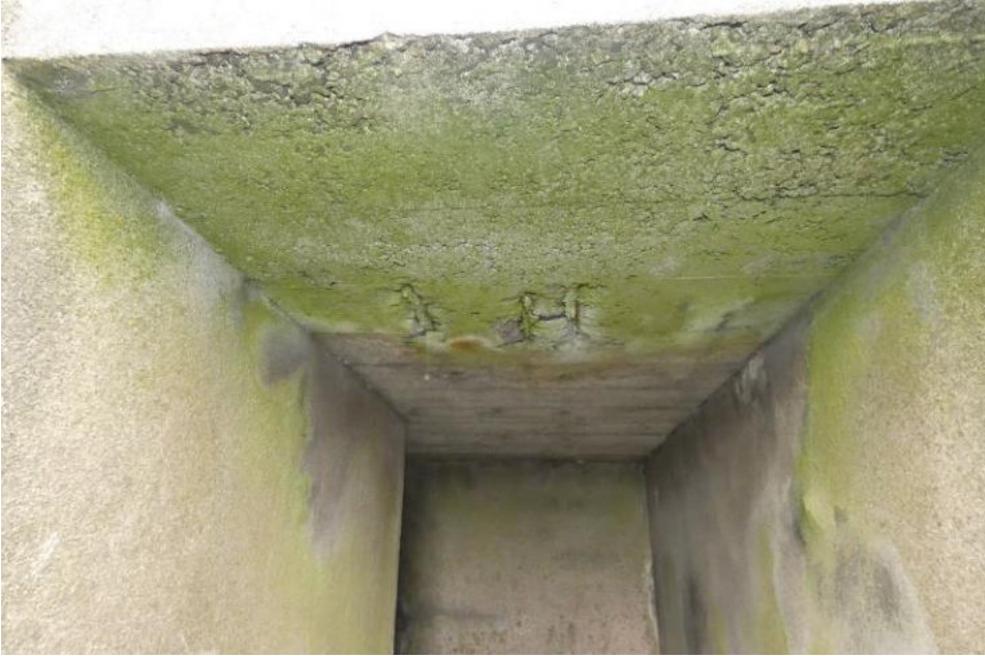
Localised spalling to the soffit of the roof slab exposing reinforcement.

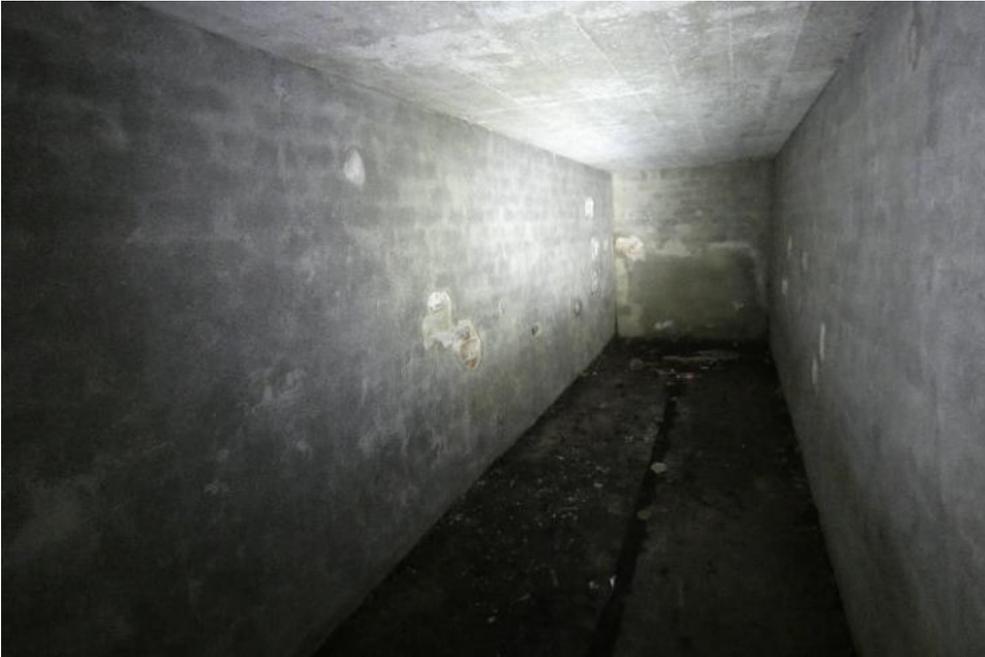
Localised failing render internally.

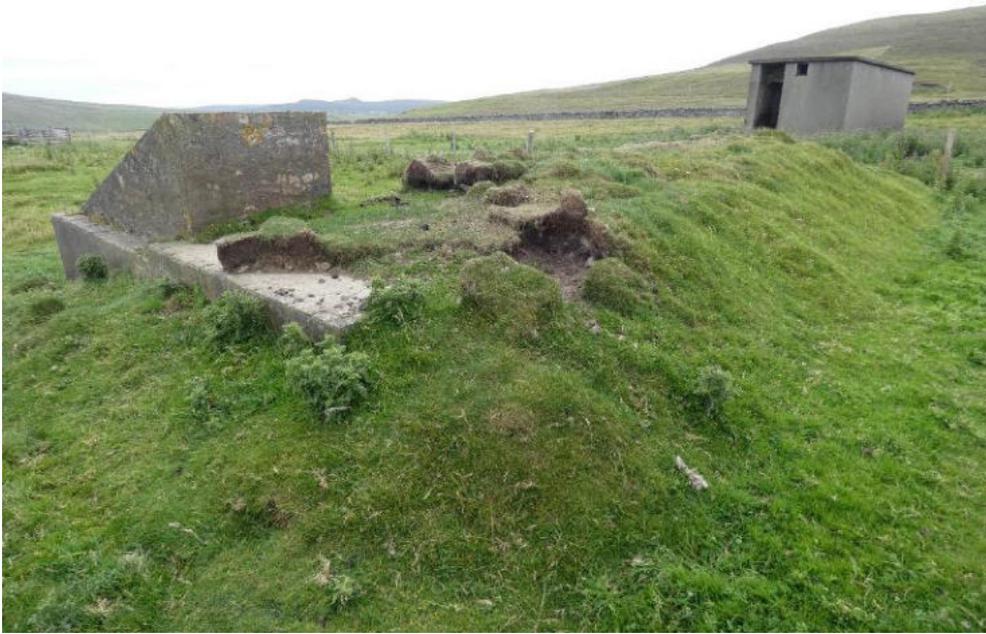
Replacing the missing and damaged earth and turf banking will protect the structure below.

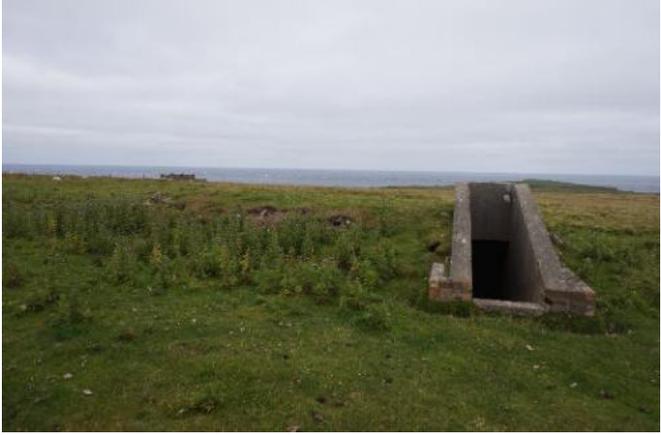
Condition:			
<p>Fair: Minor failing render externally exposing brickwork beneath and supporting vegetation growth. Extensive loss of the earth and turf covering exacerbated by grazing and burrowing.</p> <p>Localised loss of internal render.</p> <p>Internal concrete roof slab and floor in good condition.</p>			
Recommendations:			Priority:

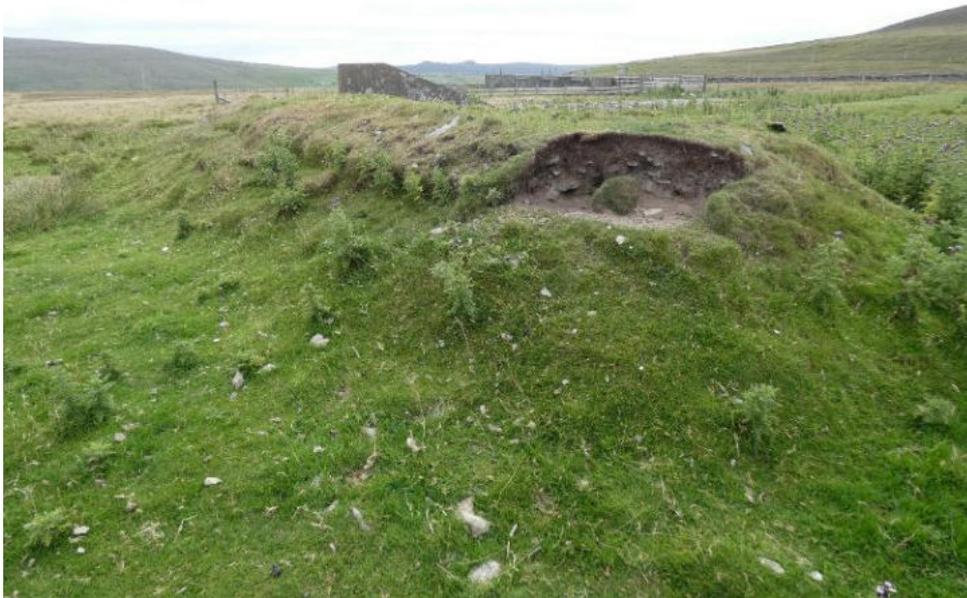
General view from southeast. Note damage caused by grazing and burrowing animals. Replacing the missing and damaged earth and turf banking will protect the structure below.

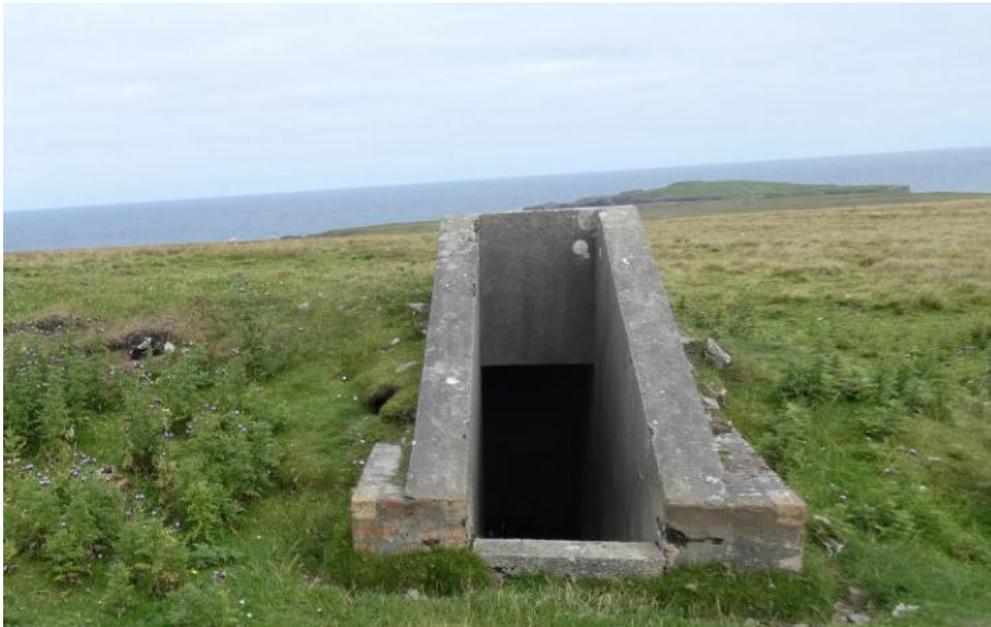
There is only minor damage to the rendered brick tunnel entrance.

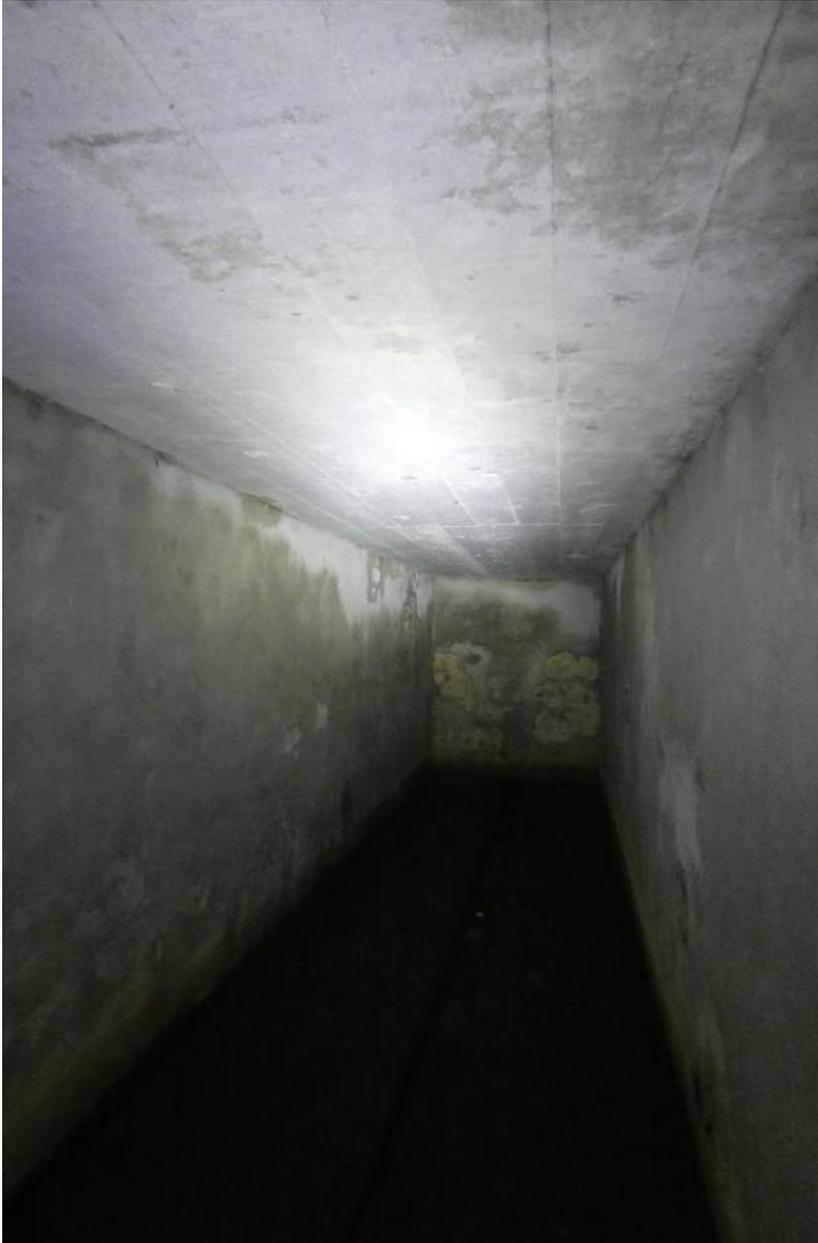
Localised failing render internally.

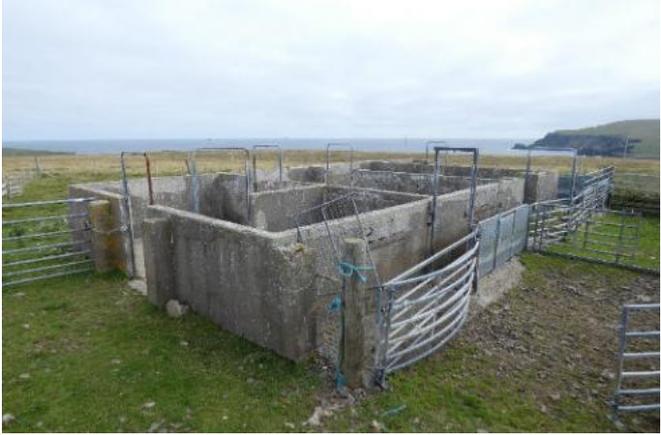
Condition:			
<p>Fair: Extensive crazed, cracked and bossed rendered throughout, with localised vegetation growth. Localised brickwork damage to wallheads. Concrete floor stable, but disaggregation and vegetation growth observed.</p>			
Recommendations:			Priority:

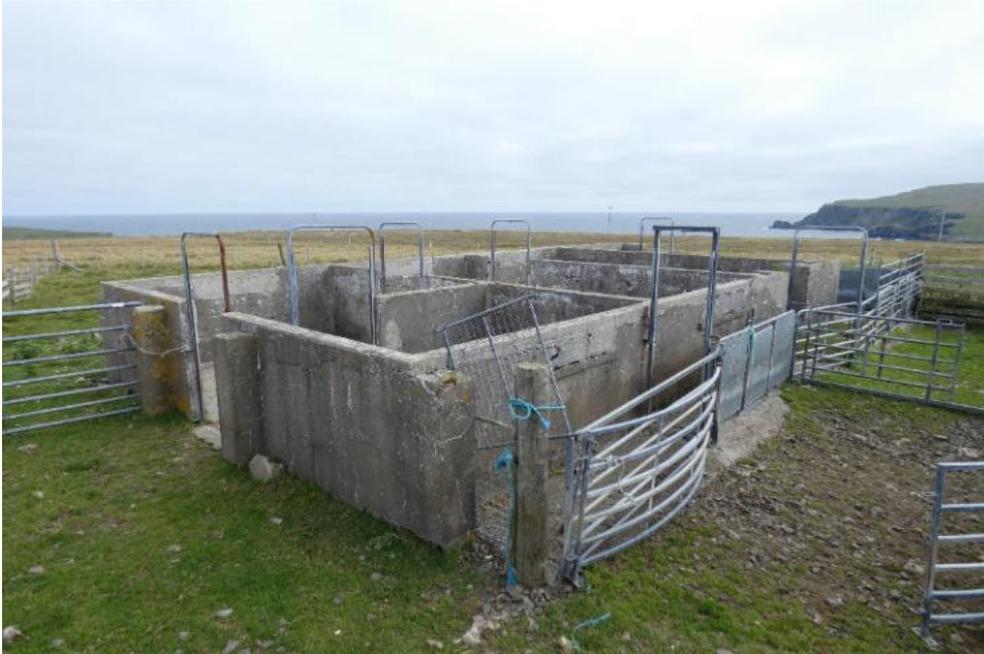
View from northwest. Walls have been lowered, with rendering patch repaired and gates inserted to accommodate agricultural use.

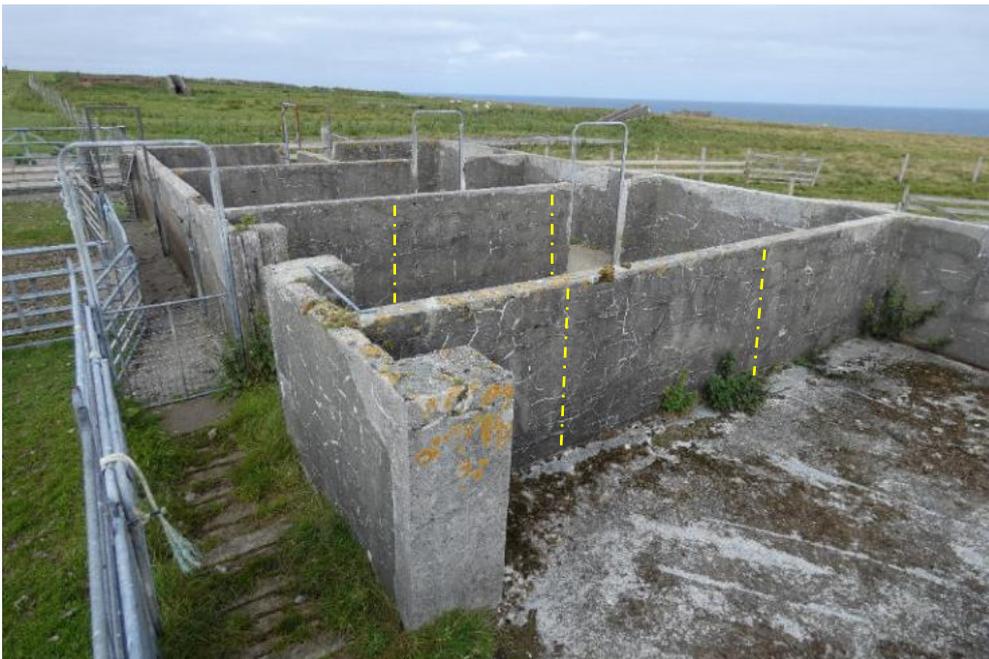
The cement render is extensively cracked and in some areas is supporting vegetation growth. The concrete floor has minor disaggregation and is supporting vegetation growth. The relatively long and slender internal partition walls depend on the integrity of the mortar in their bed joints for their stability. The robustness of these walls can be increased with the introduction of new buttresses at key points (indicated)

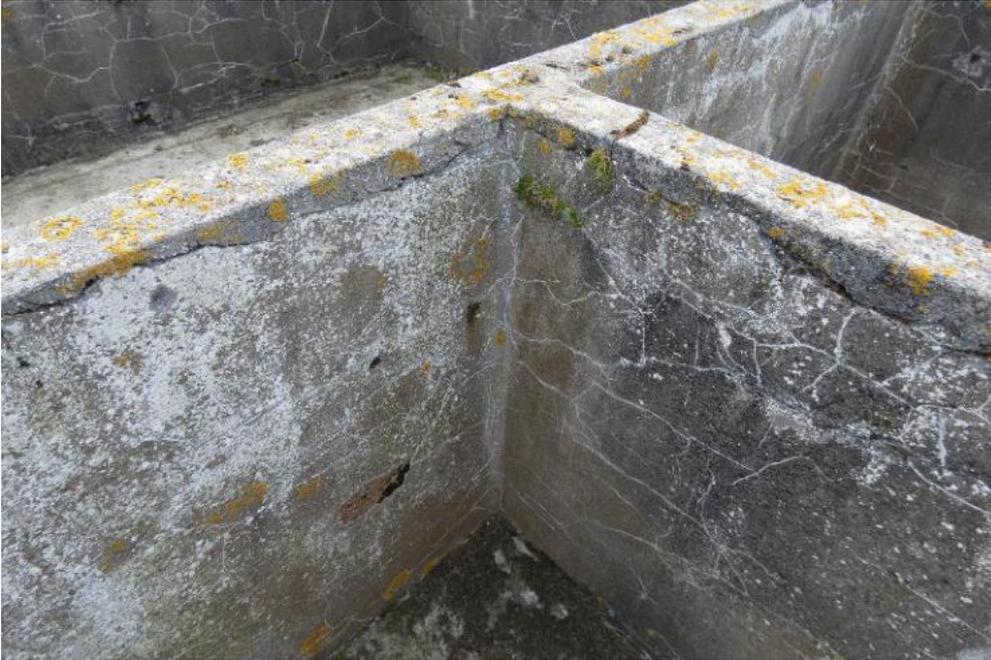
The render was patch repaired when the walls were lowered. All render (original and later) has cracked.

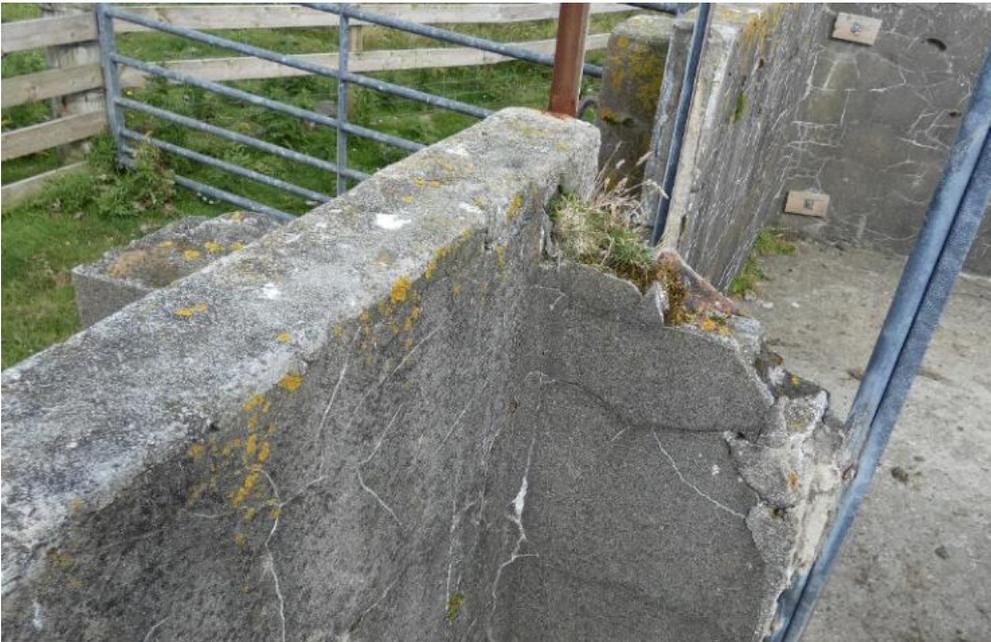
Localised damaged wallhead brickwork.
