Appendix 14.10 Conservation Management Plan

Shetland Space Centre Conservation Management Plan

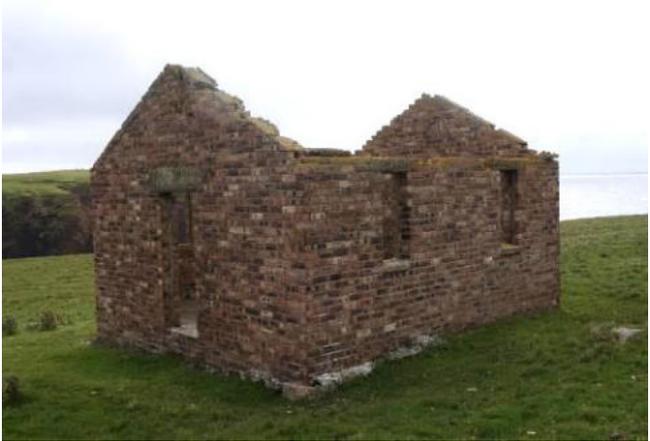
Condition:			
<p>Fair (locally poor): no obvious indications of structural distress within the walls despite appearing to be built with too few wall ties. However vertical cracking of cavity-closing mortar suggests that the leaves are separating. The loss of the roof has exposed the cavity at wallhead level resulting in corroded wall ties. Damaged and missing concrete capping to gable wallheads. Displaced concrete lintol and missing high level brickwork to east elevation. Missing high level brickwork to west elevation. Cracking below east elevation window (south). Eroded cills and lintols. Localised failing mortar joints and mortar with window checks in vicinity of corroding steel window frames. Concrete floor cracked, supporting vegetation growth.</p>

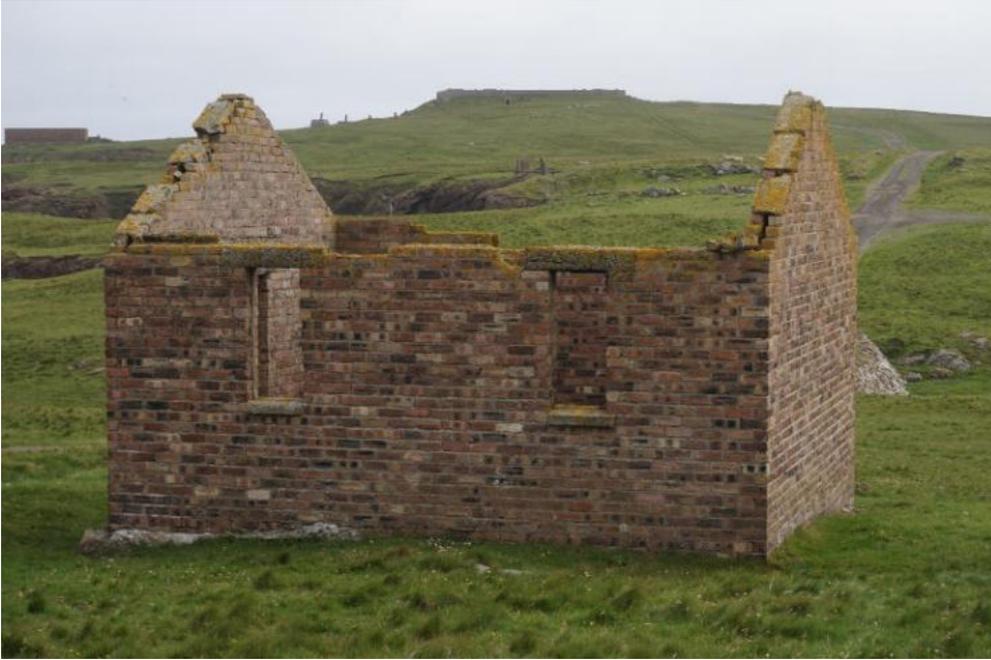
West elevation with missing wallhead brickwork. Note failing cappings to gables.

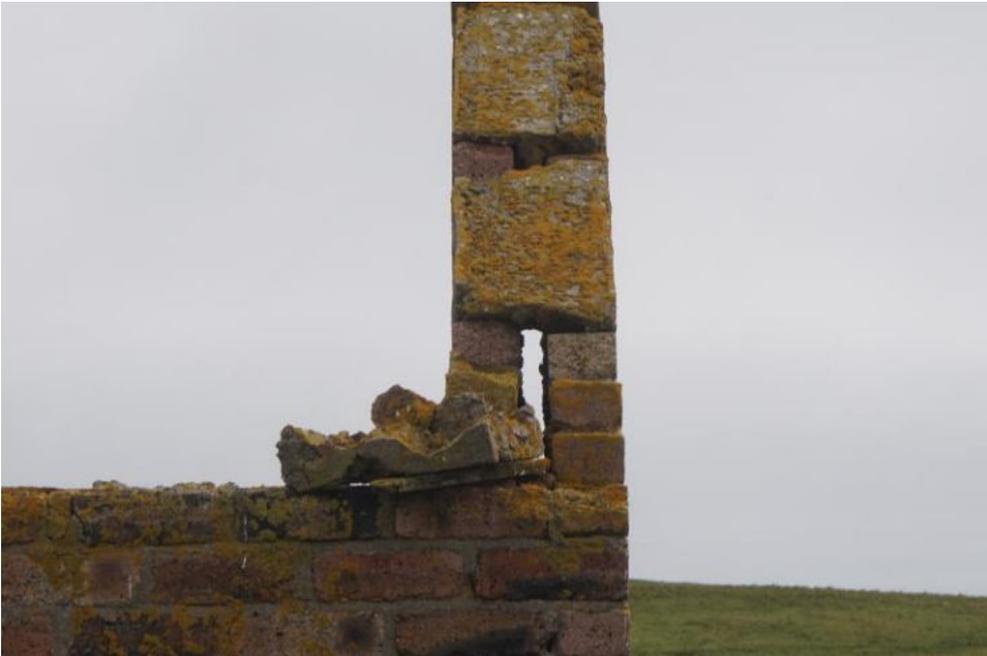
Damaged and dislodged concrete capping to south gable should be removed to reduce health and safety risk. Note that no wall ties are visible within the cavity. Reinstating the wallhead capping will prevent water ingress into the cavity.

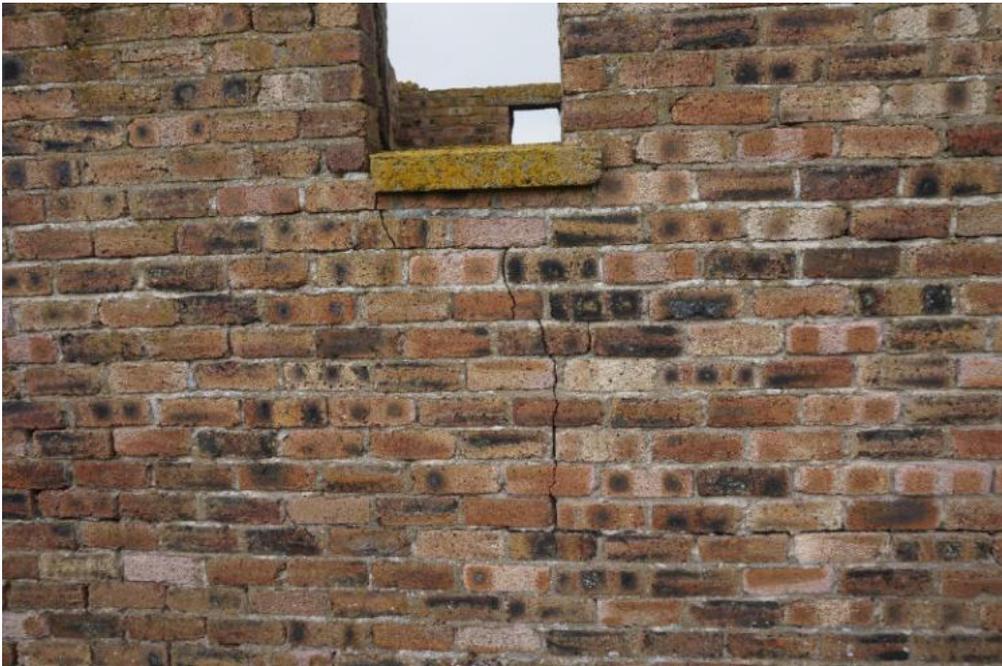
Failing joints should be repointed and the crack below the east elevation window repaired with proprietary bed-joint reinforcement to reinstate continuity within masonry.

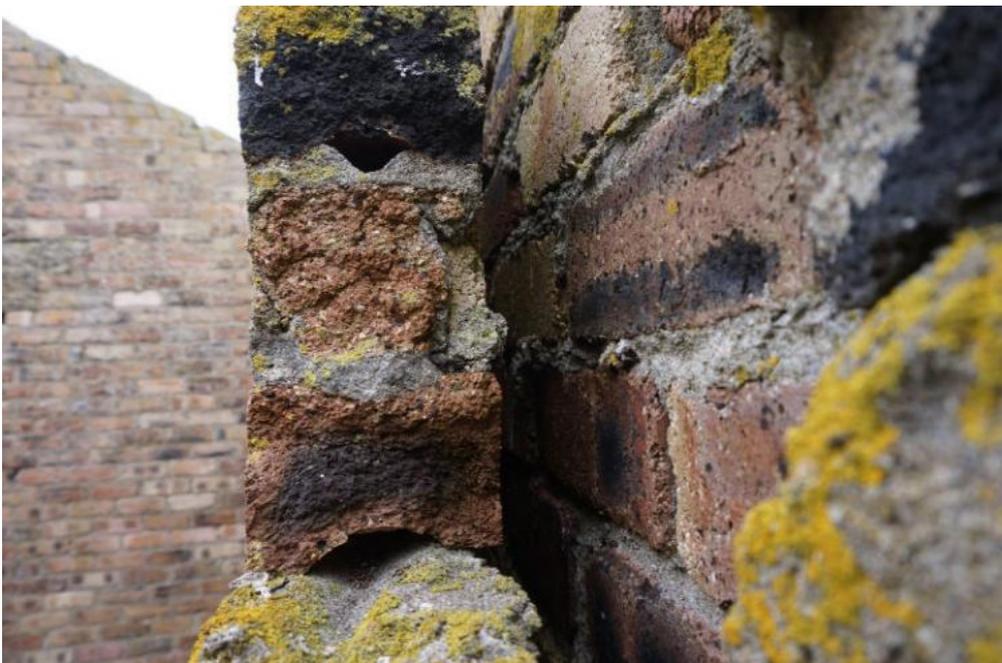
The brickwork is poorly tied. Cavity ties should be retrofitted to ensure future stability.

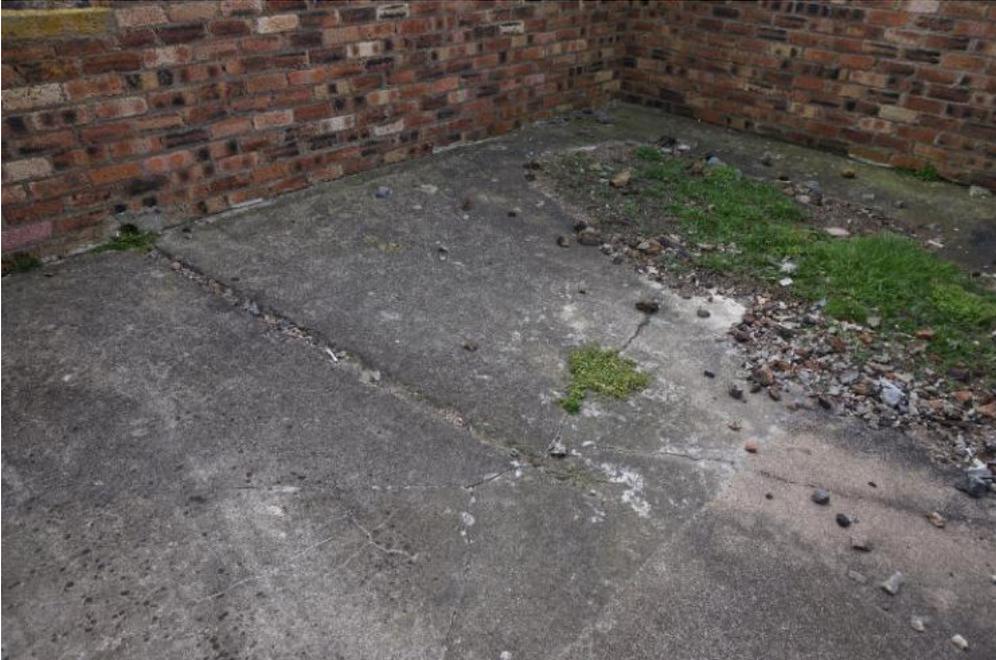
Cracked concrete floor slab supporting vegetation growth.

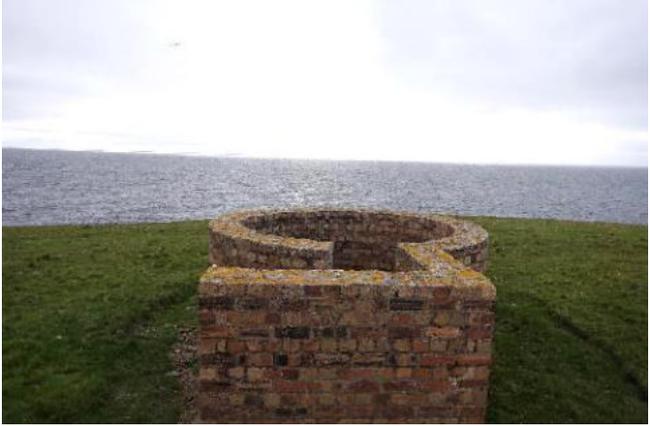
Condition:			
Fair: Minor localised open, cracked and failing mortar joints, including to exposed wallhead which is supporting vegetation growth. Minor localised damaged bricks.			
Recommendations:			Priority:
1.	Repoint open and defective joints, especially skyward facing joints. £200.00		Desirable

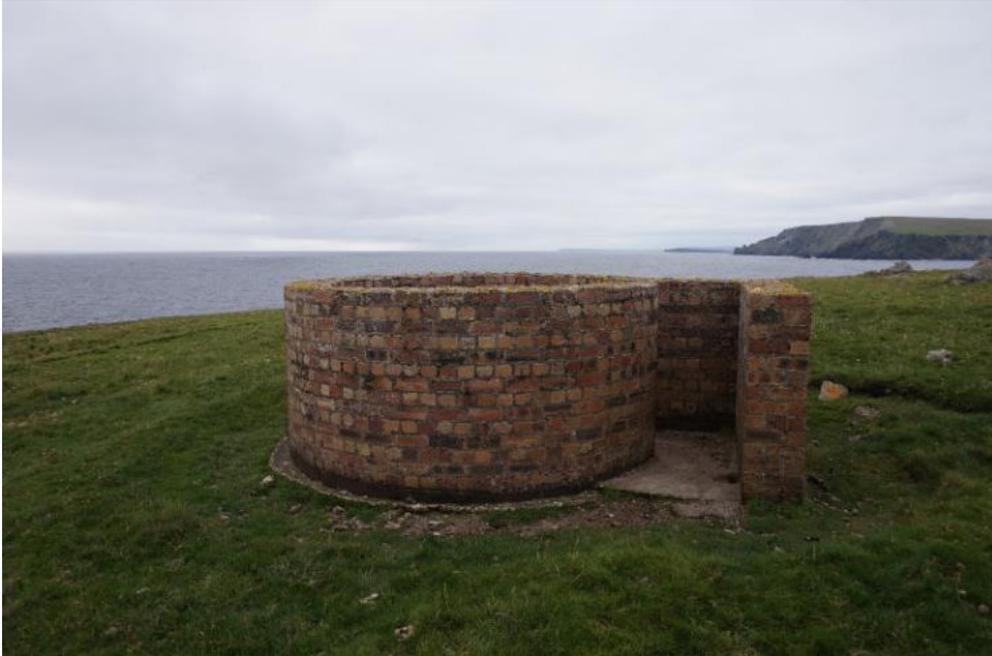
View from east showing concrete strip foundation and concrete floor.

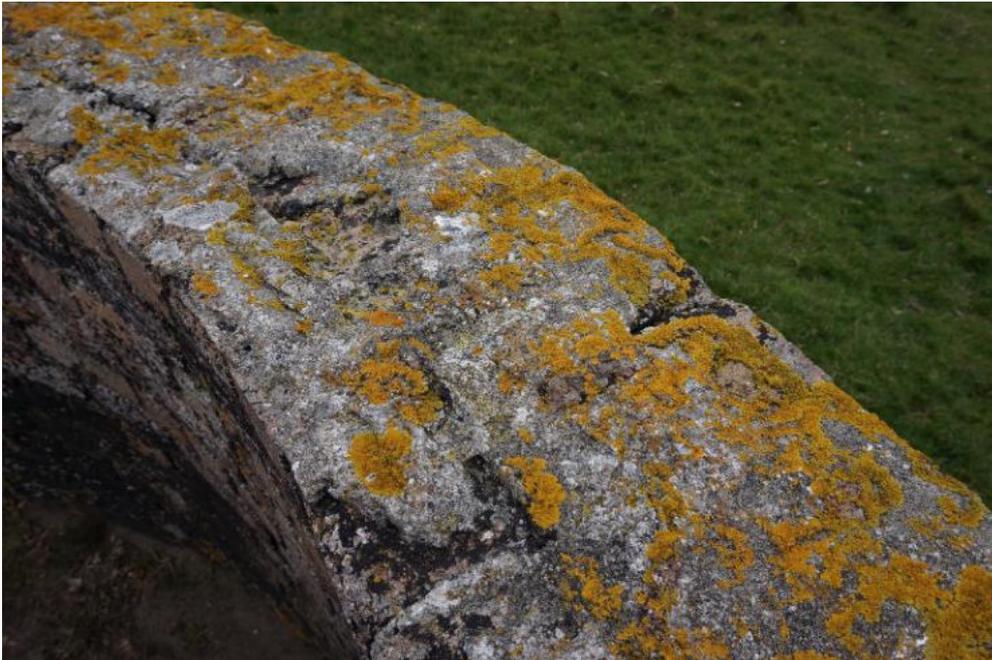
Localised failing skyward facing wallhead joints.

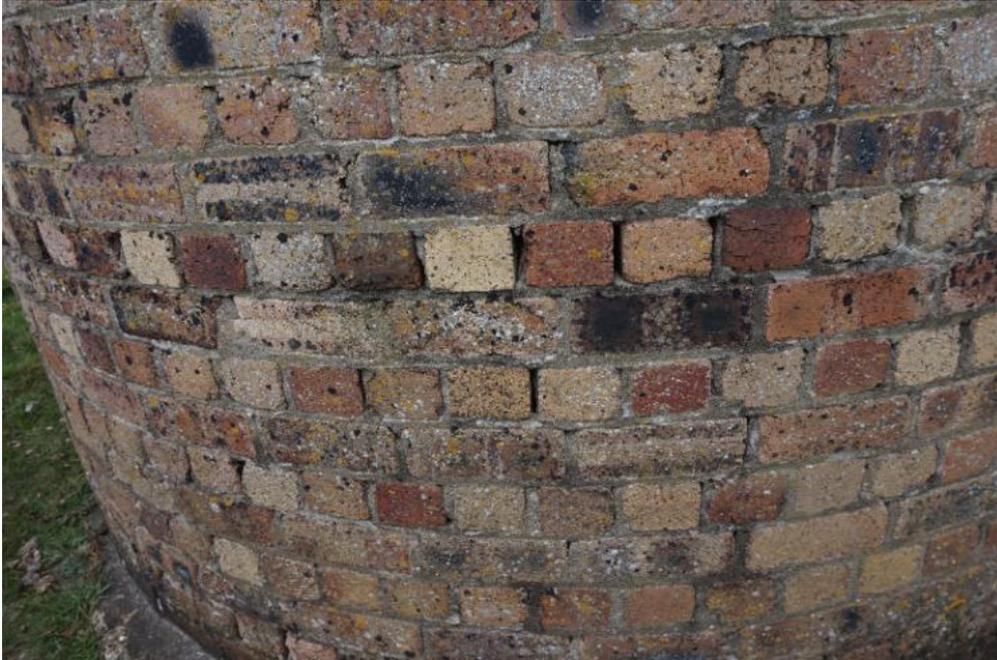
Localised failing wallface joints.

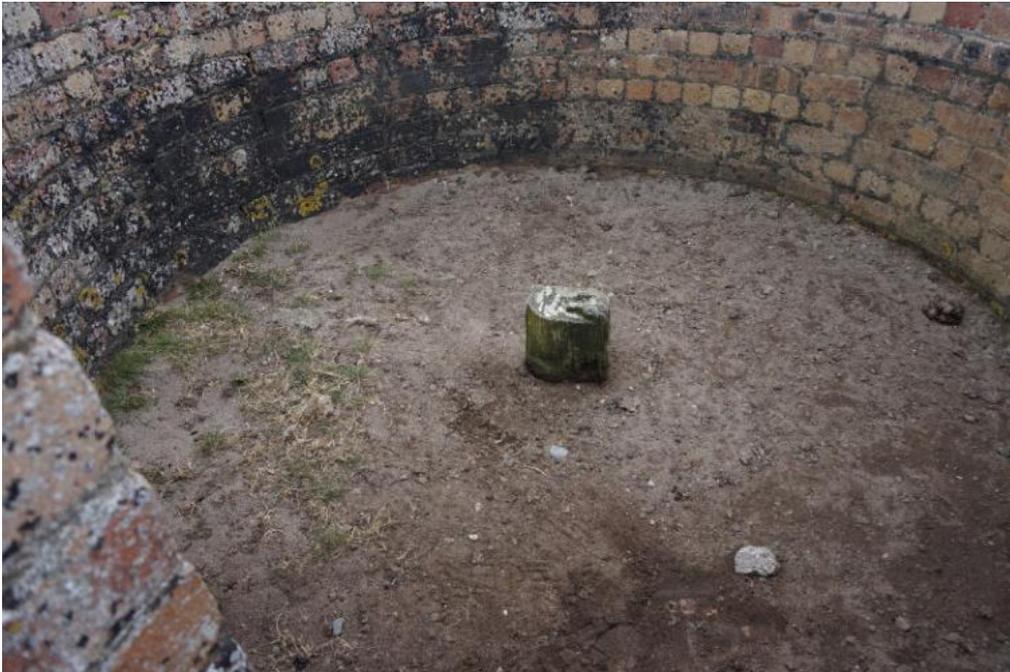
Partly obscured internal floor with central timber post.

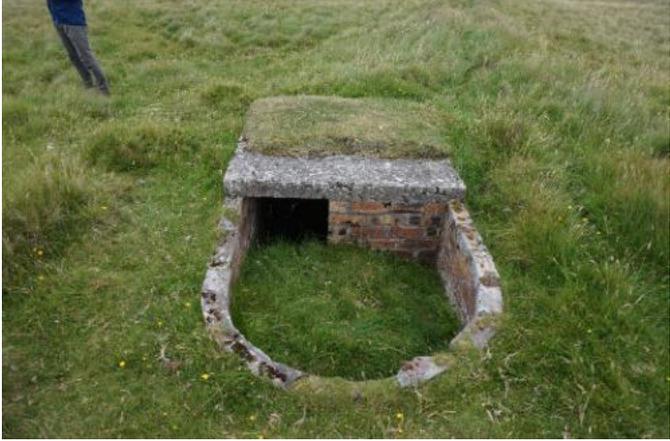
Condition:			
<p>Fair: Cracked brick joints at curved end and locally below roof slab. Localised damaged bricks at curved end. Minor disaggregation of exposed roof slab. Internal walls saturated below covered area.</p> <p>Covered part of the structure is flooded.</p>			
Recommendations:			Priority:

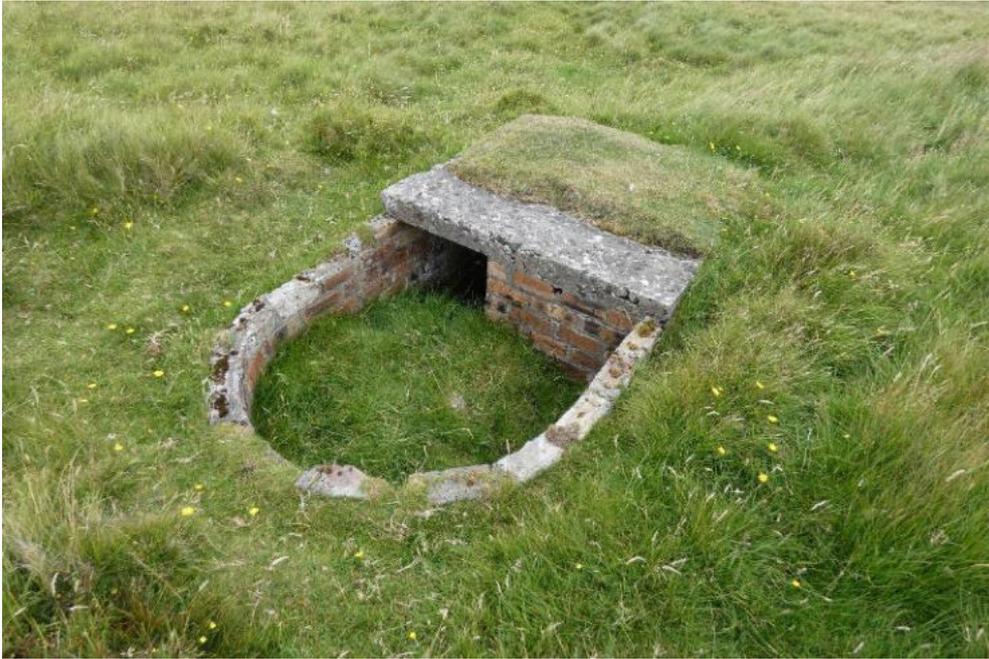
General view. Note damaged wallhead bricks.

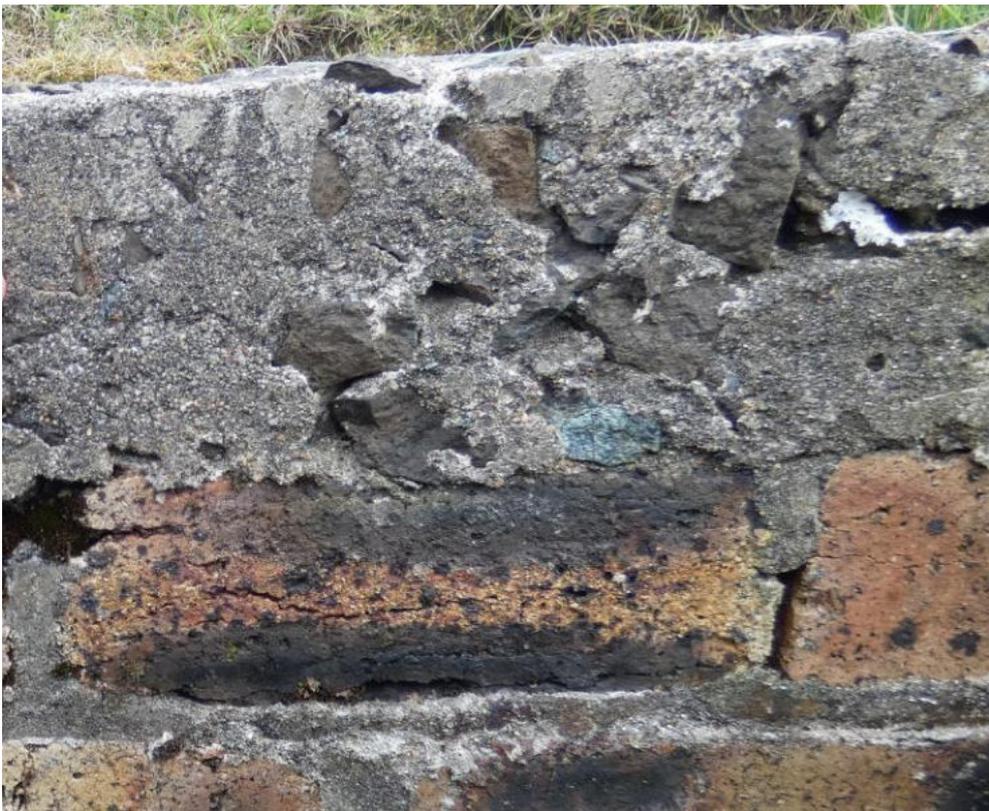
Defective brick joints and exposed aggregate to roof slab.

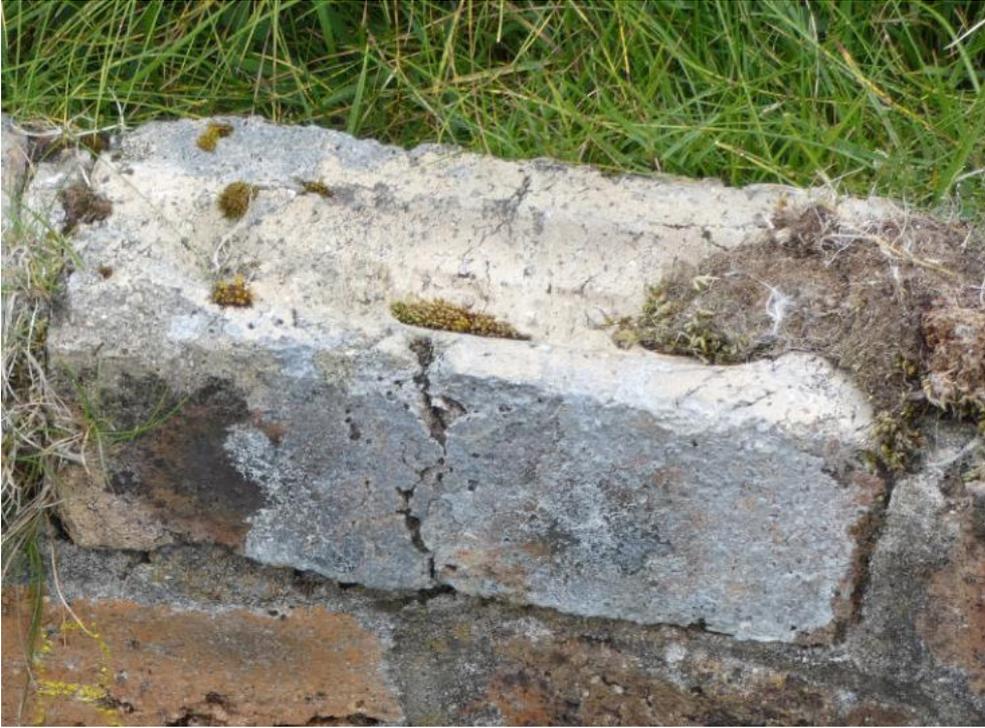
Localised failing joints at curved wallhead.

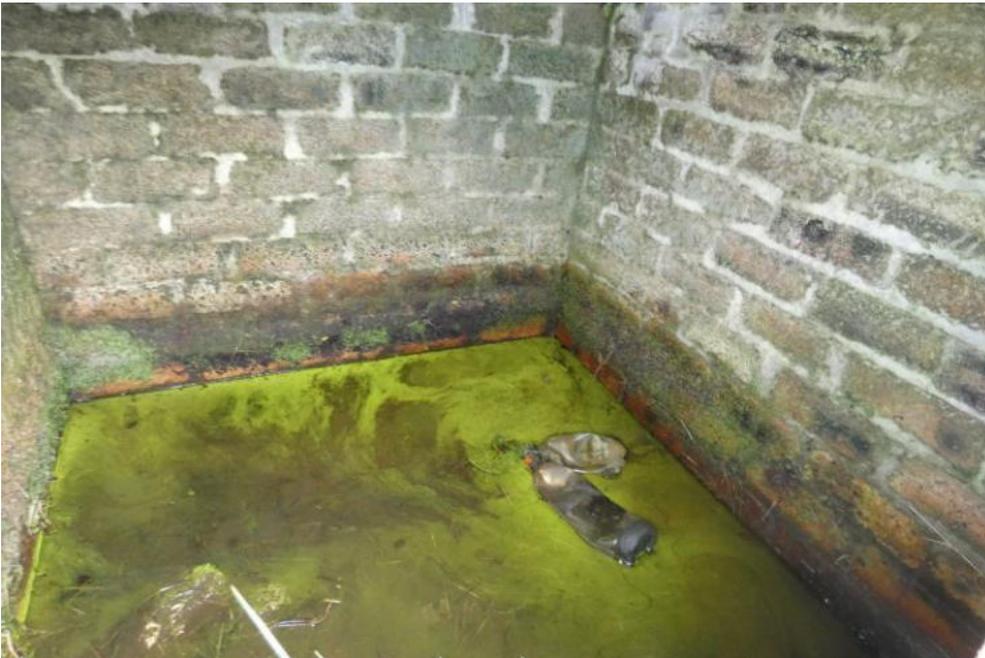
Flooded covered area saturating brickwork above.

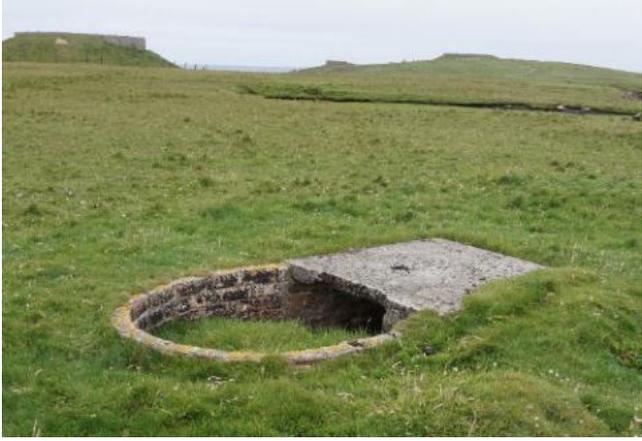
Condition:			
<p>Fair: Cracked joints at curved end. Spalled concrete and exposed corroded reinforcement over entrance to covered end. Internal walls saturated below covered area.</p> <p>Covered part of the structure is flooded.</p>			
Recommendations:			Priority:

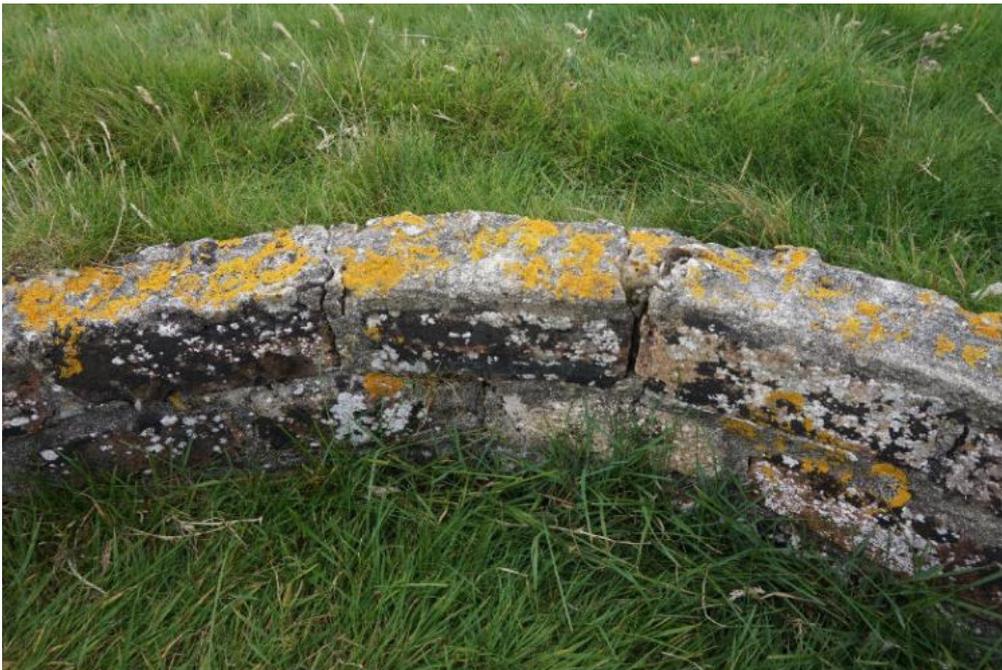
Localised failing joints to wallhead of curved west end.

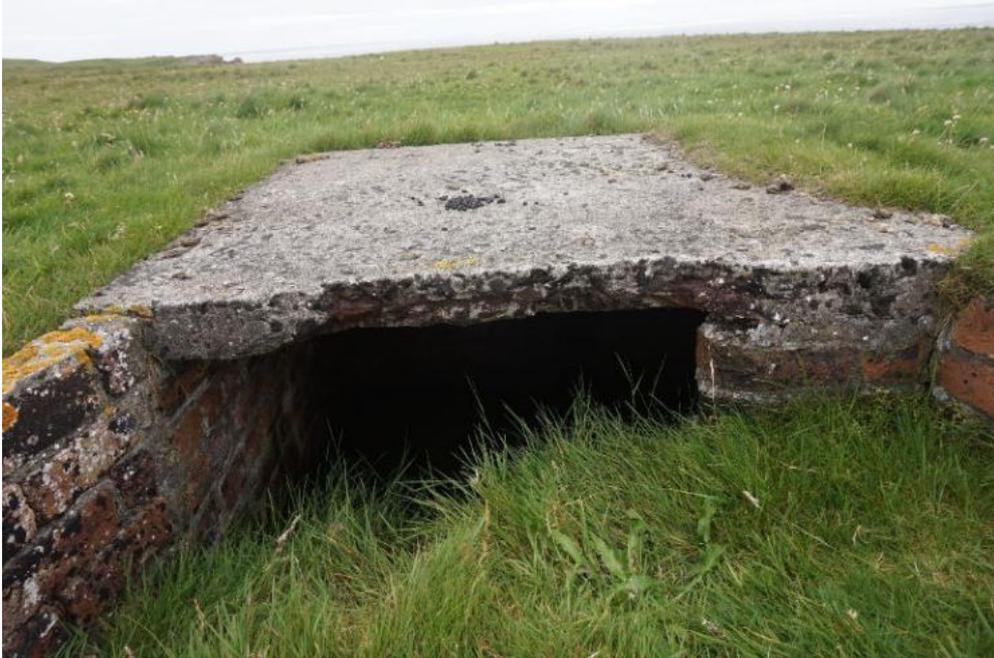
The concrete roof slab is currently stable, however, its condition should be monitored as part of future inspections.

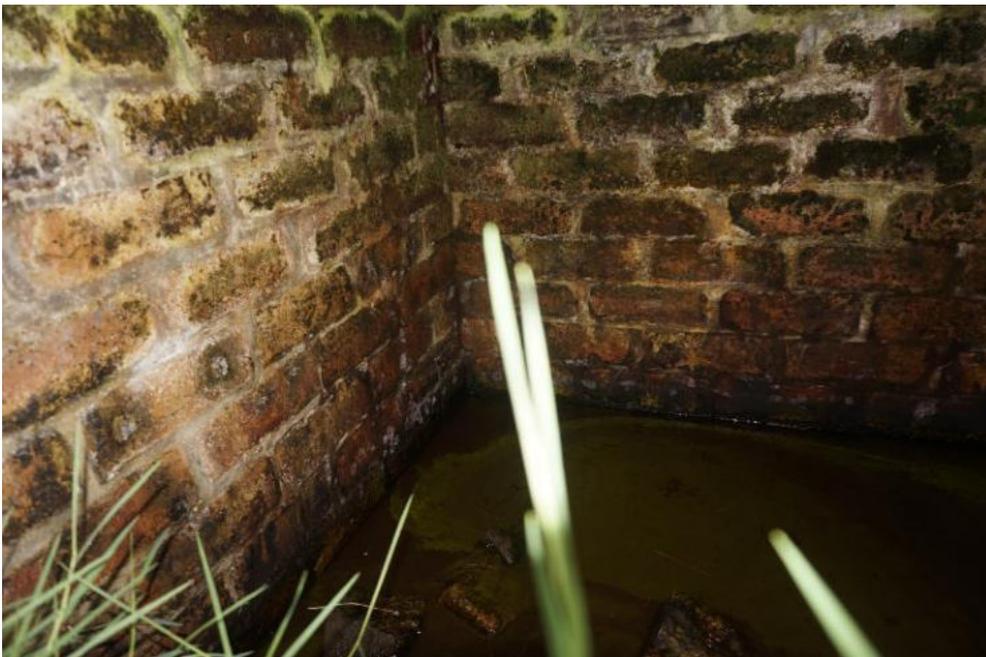
Flooded covered area, with displaced bricks.

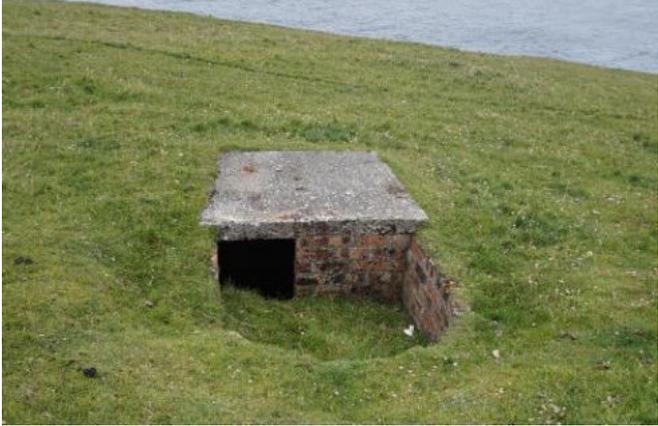
Condition:			
<p>Fair: Wallhead mostly covered with grass to curved north end but failing joints and missing brickwork visible. at curved end. Minor spalled concrete and rust staining to roof slab. Internal walls saturated below covered area.</p>			
Recommendations:			Priority:

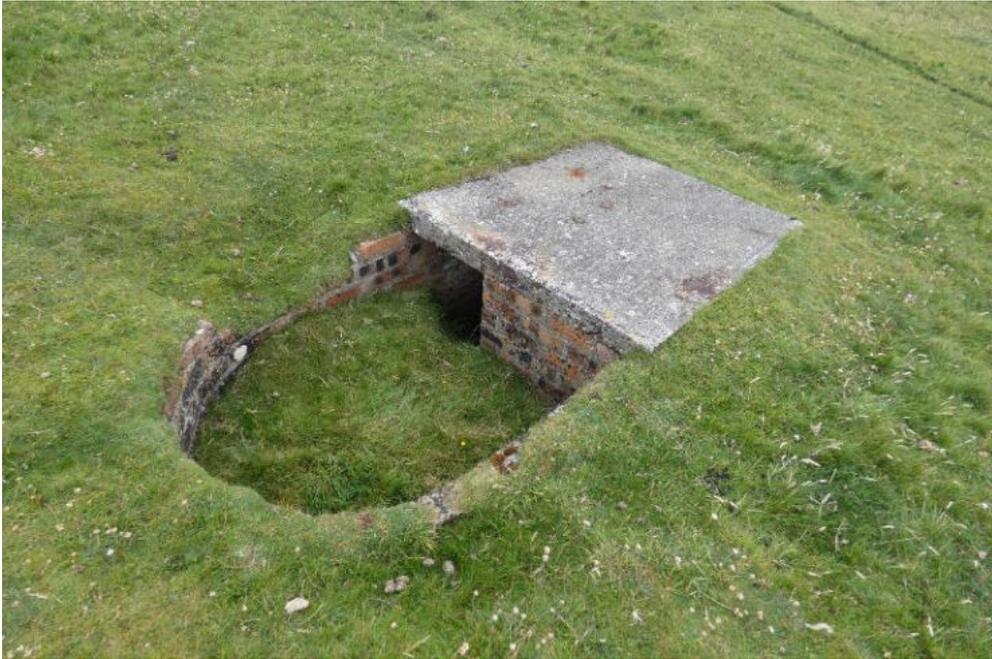
Missing wallhead brick work and defective mortar joints. Minor concrete spalling at slab edge.

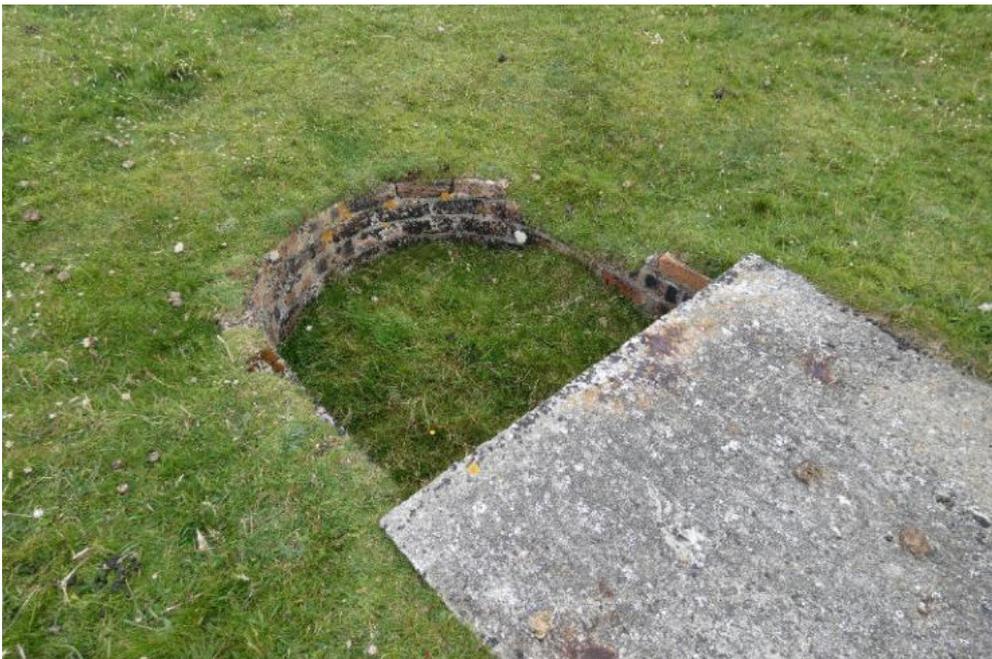
Missing wallhead brick work and defective mortar joints. Localised rust staining to concrete roof slab.

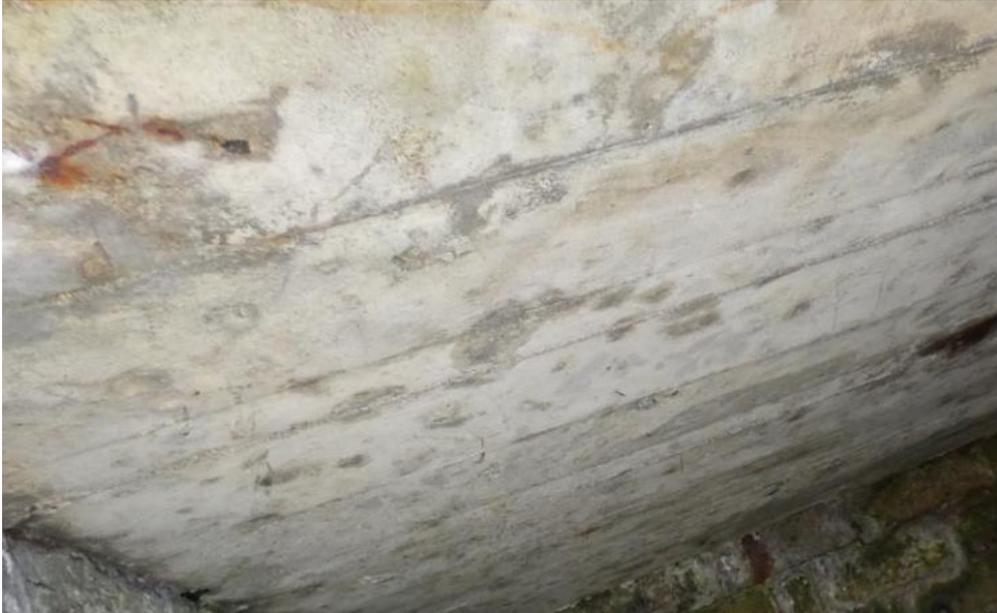
Minor spalling and exposed reinforcement.

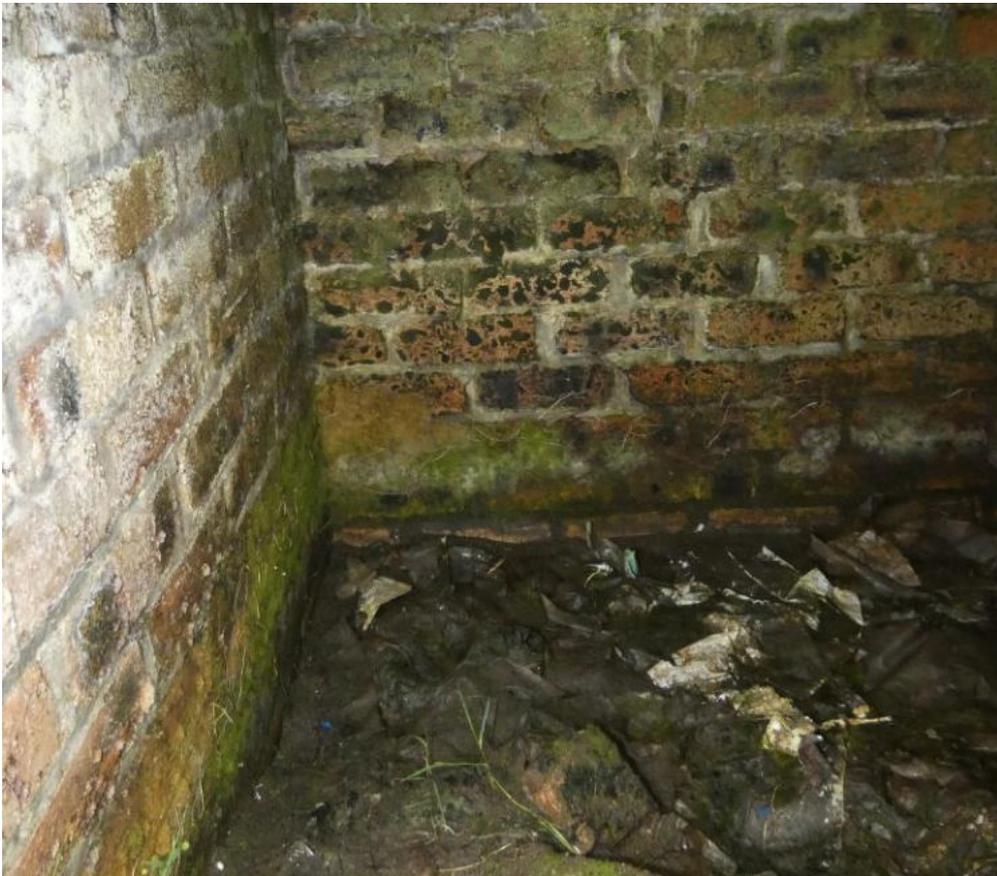
Saturated brickwork below covered area.

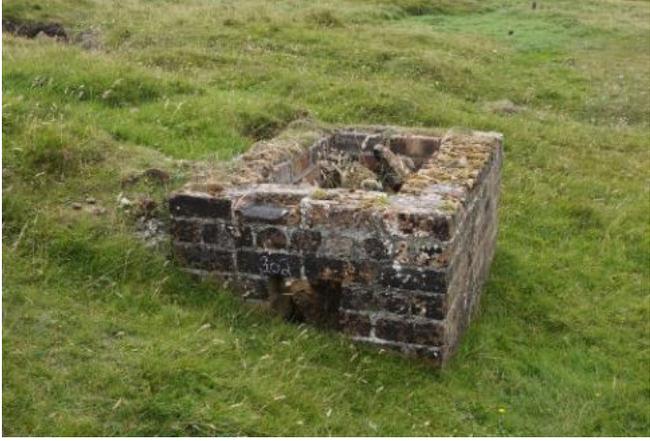
Condition:			
<p>Fair: Minor localised open, cracked and failing mortar joints, including to exposed wallhead which is supporting vegetation growth. Minor localised damaged bricks.</p>			
Recommendations:			Priority:
1.	Repoint open and defective joints, especially skyward facing joints. £50.00		Desirable

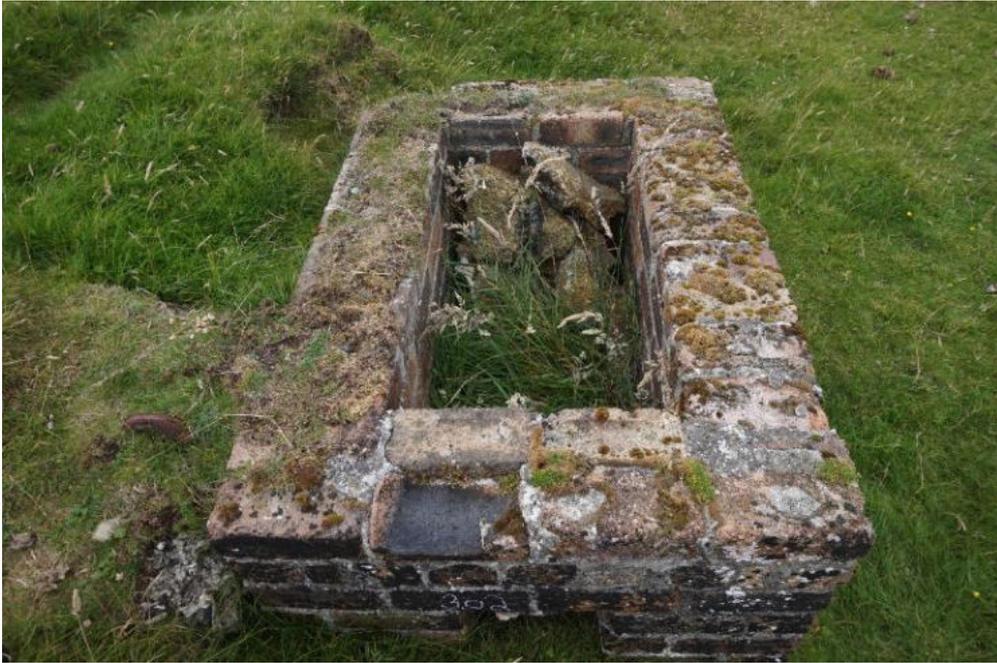
Failing joints to wallhead supporting vegetation growth. Localised damaged bricks.

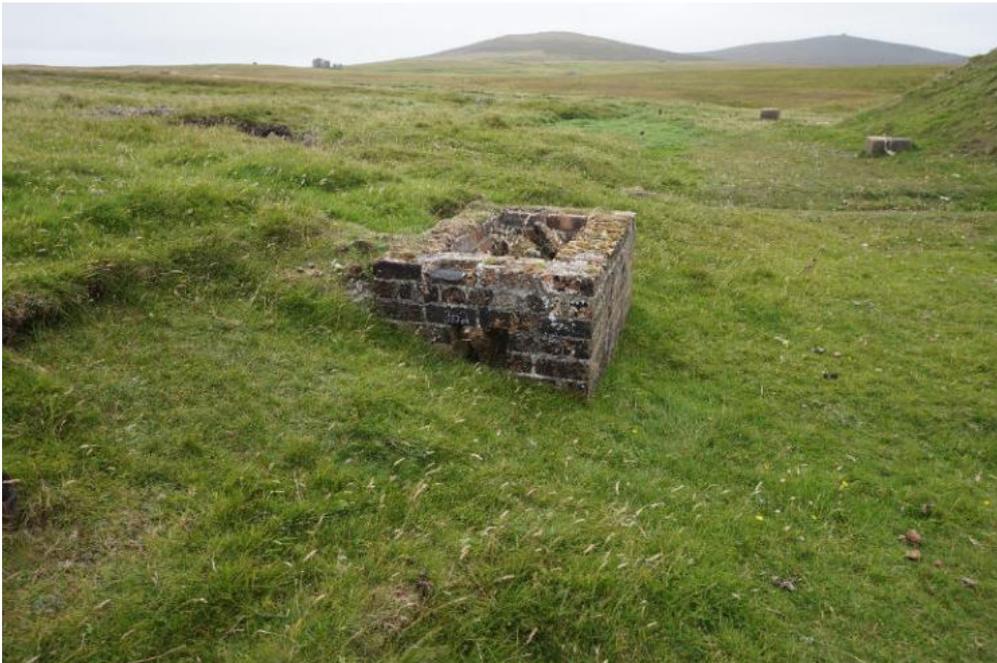
View from east showing small opening at ground level.

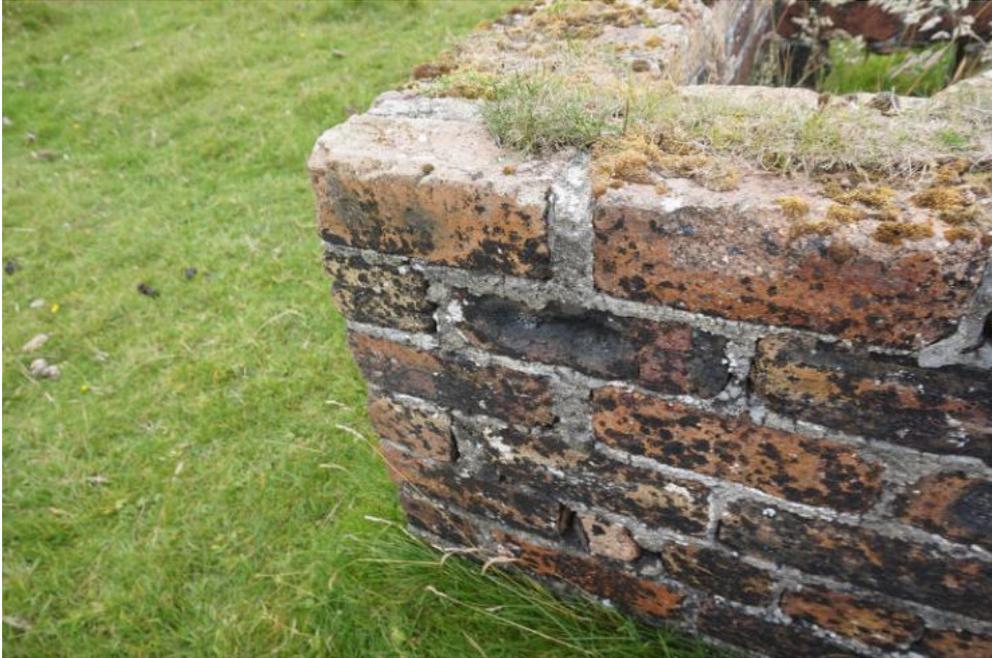
Failing joints to wallhead supporting vegetation growth. Localised damaged bricks and open joints to wall face.

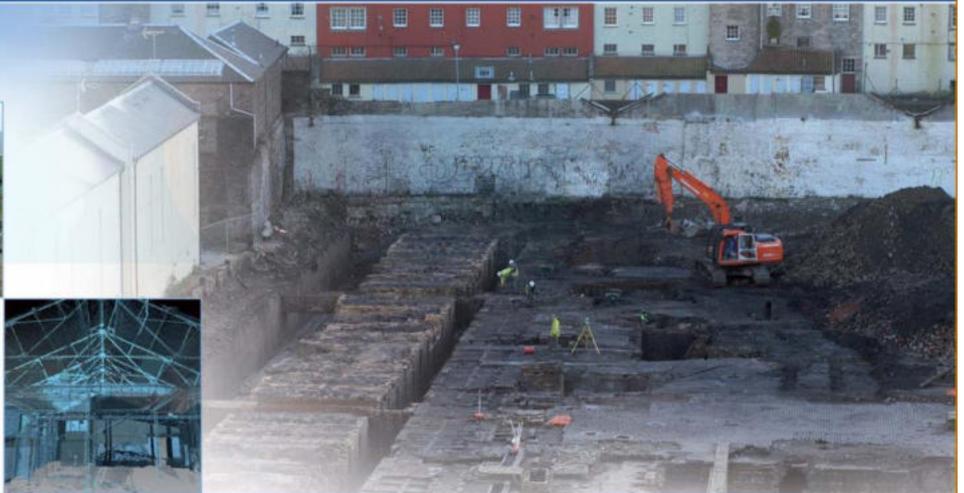
AOC Archaeology Group, Edgefield Industrial Estate, Edgefield Road, Loanhead EH20 9SY
