Civil Aviation Authority  
**EMERGENCY  
AIRWORTHINESS  
DIRECTIVE**

**Number: G-2024-0001-E**

Lindstrand Technologies Limited

**ATA - Hot Air Balloons - Envelopes with Polyester Filled Aramid (Kevlar) Load Tapes – Removal from Service**

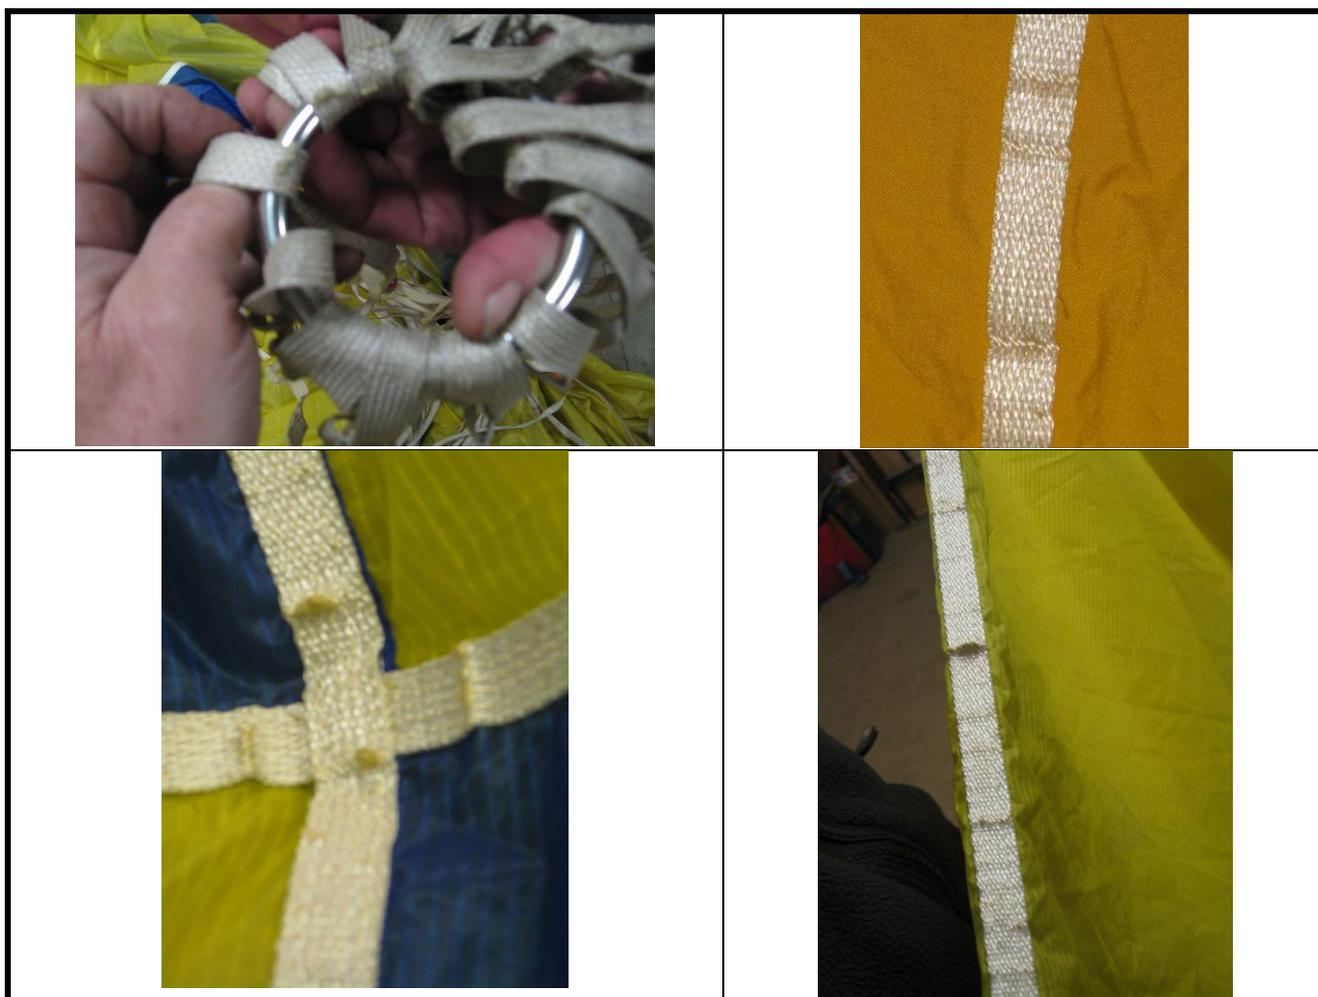
**Figure 1: Examples of load tape damage**

During a routine 100 hr/Annual inspection of an envelope, it's been discovered that the polyester filled aramid load tapes have degraded significantly (see Figure 1).

The damage has allowed the Kevlar core (coloured yellow) to become exposed which would degrade the strength of the tape due to ultraviolet exposure. Both horizontal and vertical tapes are affected and there is significant distortion to the horizontal types.

Additionally, in the area where the tape loops around the crown ring, the polyester has failed completely, and Kevlar is totally exposed. In other areas the load tapes have stretched and frayed.

The envelope that has been inspected has only completed 100 flying hours.

Although the maintenance manual states no damage to the load tapes is acceptable, an unsafe condition could exist as the rate of degradation is unknown and the residual strength of the tape, following exposure to UV, cannot be determined.

1. Before further flight from the effective date of this AD carry out a visual inspection to determine the date of manufacture (from the envelope data plate) and whether the envelope is fitted with Polyester Filled Aramid (Kevlar) load tapes.

2. If the date of manufacture is after March 2017 **and** the envelope has been found, by inspection, to be fitted with optional Polyester Filled Aramid (Kevlar) Load Tapes, the envelope must be considered as an **Affected Serial Number** for the purposes of this AD.
3. If the envelope is an **Affected Serial Number**, carry out a 100% visual inspection of the load tapes.
4. If damage is visible, no further flight is permitted until the damage has been rectified.
5. **If no damage is visible, amend the aircraft maintenance programme to include a 100% visual inspection of both the horizontal and vertical load tapes before each flight.**

Note: this visual inspection can be performed by the pilot/owner. In cases of doubt, the envelope should be inspected by a suitably qualified engineer.

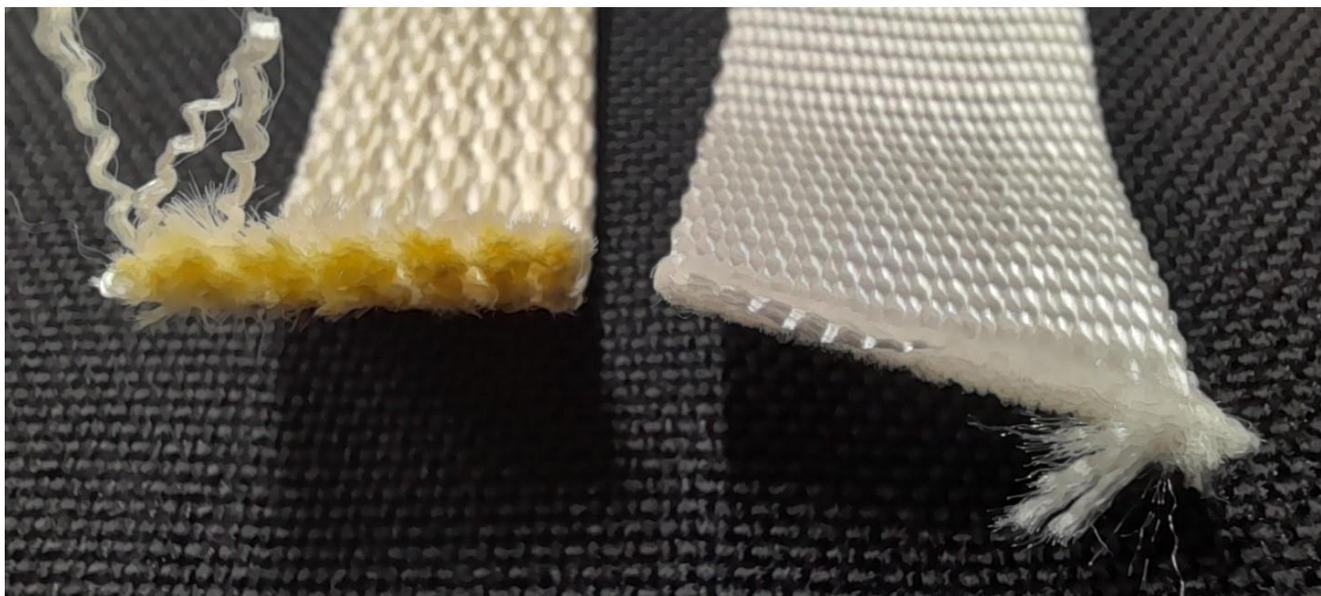
The Polyester Filled Aramid (Kevlar) load tapes (shown on left) have a distinctive yellow core which will become visible if damage has occurred.

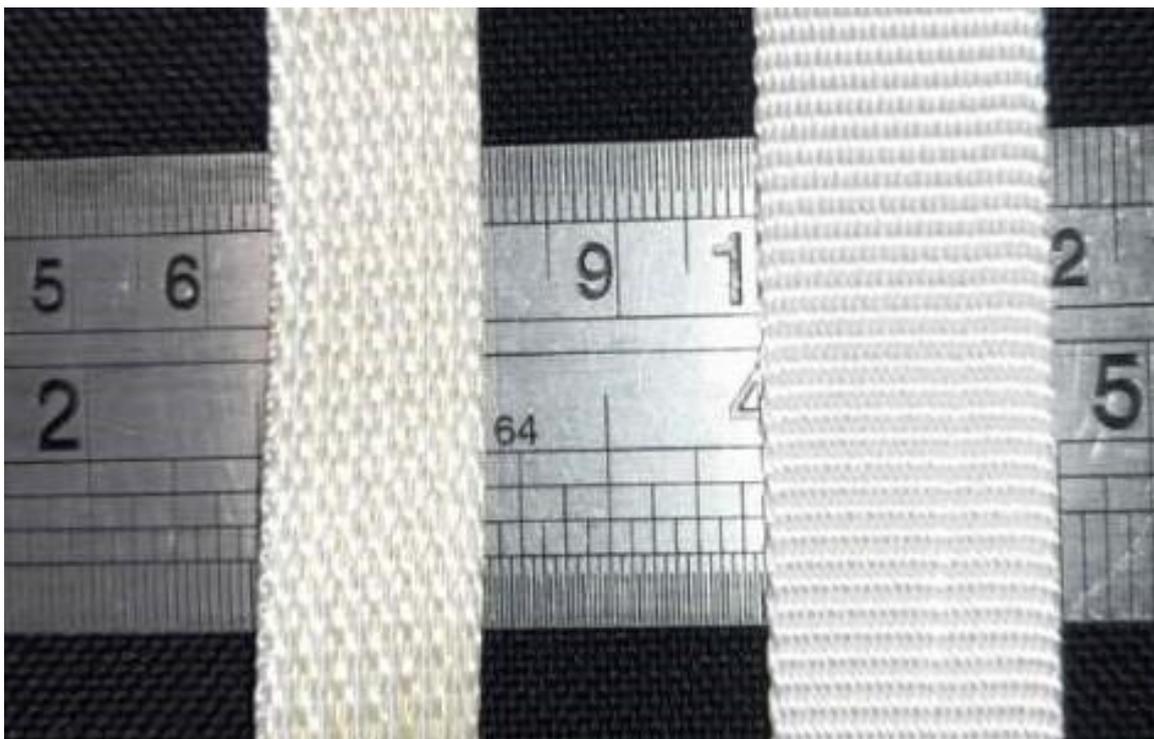
The Polyester Filled Aramid (Kevlar) load tapes (shown on left) is 15 mm wide; the standard polyester tape is 20 mm wide.
