Civil Aviation Authority
Safety Notice
Number: SN-2025/009

Issued: 9 June 2025

Maintenance of Historic Piston and Gas Turbine Airframe Fuel/Hydraulic System Switches and Components

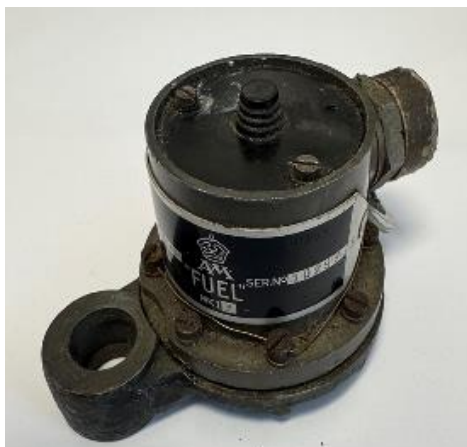
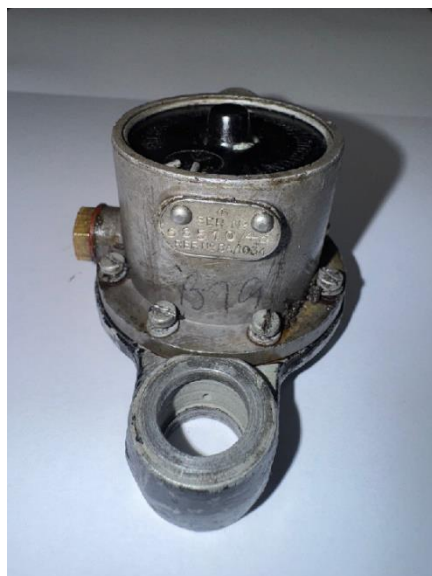
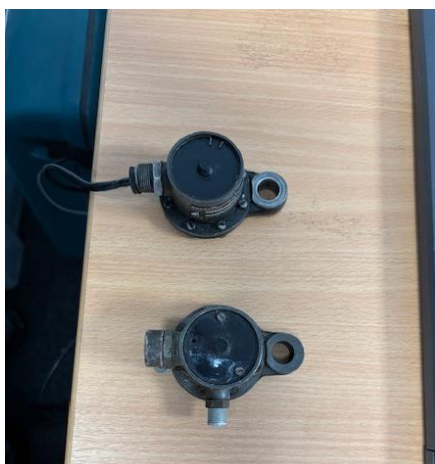
Appendix 1

- 1.2 Subsequent investigations by the maintenance organisation concluded that the engine malfunction had been caused by a significant fuel leak from an airframe mounted low pressure fuel warning switch for the main engine fuel feed system. The component developed an external leak at system pressure because of casement securing screws loosening off on the switch body, possibly caused by the aging effects of internal elastomeric diaphragm components shrinking and hardening with age, resulting in the screws no longer being at the correct clamping torque. The component was approximately 70 + years old with unknown last overhaul date. The external fuel leak resulted in a cockpit low-pressure warning light illuminating, along with an engine rich cut scenario from leaking unmetered fuel ingested directly into the engine air intake, which is situated below the fuel pressure switch.

The root cause is likely to be age-related failure of the component.

Examples of pressure warning switch devices found on historic aircraft:

- 2.1 This Safety Notice reminds individuals and organisations maintaining historic piston and gas turbine engine aircraft to ensure procedures are in place to:
 - 1) Review the aircraft systems to establish details of tertiary airframe / engine mounted fuel or hydraulic system switches and components that contain elastomeric or metallic components that may be affected by degradation due to age and or extended usage.
 - 2) Ensure the Aircraft Maintenance Programme (AMP) includes, for these tertiary components:
 - regular inspection for leakage and security of fasteners (where applicable),
 - periodic operational and functional checks,
 - calendar life limits where elastomers and other perishable components are present.
