# Civil Aviation Authority

Number: SN-2024/002

## Piper PA-28 and PA-32 Undercarriage Inspections

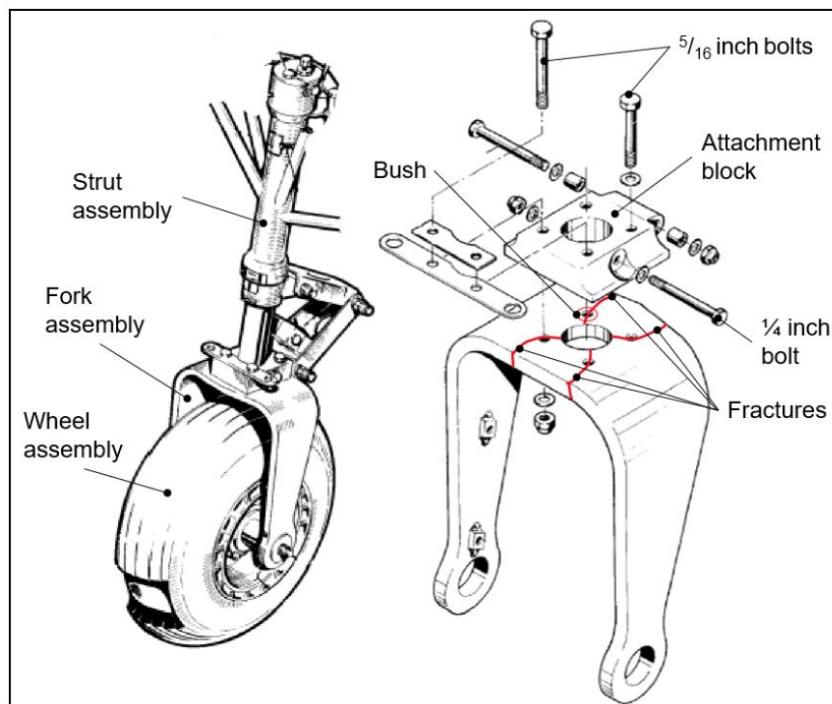
Figure 1 Nose Wheel Fork Assembly

- 1.2 The first incident involved the failure of both upper torque link attachment lugs on the main landing gear cylinder due to fatigue cracking (Figure 2). The second incident involved the nose wheel fork assembly fracturing because of fatigue cracks from corroded bolt holes in the fork assembly. Following both accidents, the undercarriage components were removed from the aircraft and were subject to an AAIB investigation (AAIB reports AAIB-29130 and AAIB-29086 refers). These types of failures can remain undetected until the aircraft touches the ground during landing, leading to the collapse of the landing gear, consequential airframe damage and loss of control. These events could carry the risk of injury.

- In accordance with the Aircraft Maintenance Manual (AMM) remove the nose wheel fork assembly fork attachment block (Appendix 1 Figure 1).
- Visually inspect the area for corrosion, signs of wear and cracking around the attachment block bolt holes. Consideration should also be given for inspecting the area by applying a liquid penetrant dye to detect any signs of cracking.

- If no defects are found, clean and re-protect the area as required in accordance with the AMM.
- If defects are found, rectification is to be carried out in accordance with the AMM. If cracking is found as noted in Appendix 1 Figure 1, the CAA should be notified using the following email address - [certification.gau@caa.co.uk](mailto:certification.gau@caa.co.uk).

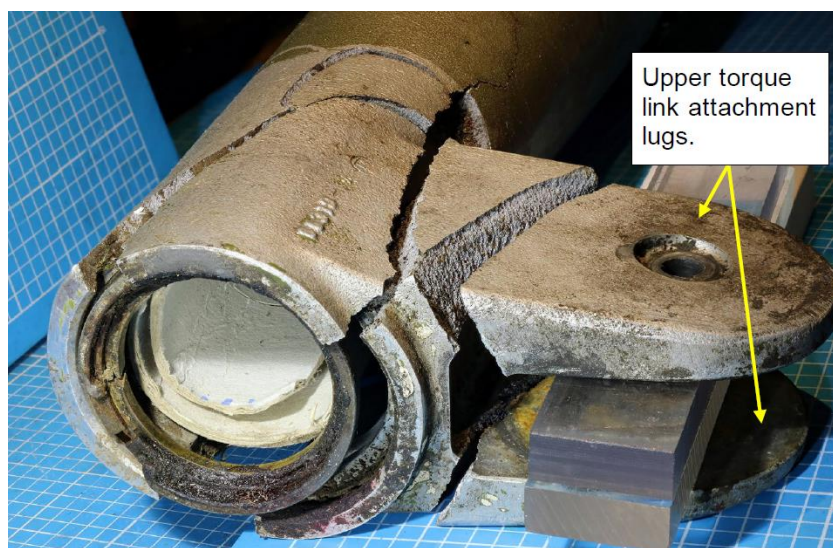
Figure 2 Lower Main Landing Gear Cylinder

- To verify compliance with Piper Service Bulletin SB1131A (if applicable) and to incorporate the SB into the aircraft maintenance programme.
- At the next routine maintenance inspection, to visually inspect the areas highlighted in Appendix 1 Figures 2 and 3 for corrosion, signs of general wear as well as cracking around the attachment upper and lower torque link attachment lugs in accordance with the AMM.

- It is also important to note that fatigue cracking of the torque link attachment lugs has been known to occur on the cast main landing gear cylinders fitted to PA-28 and PA-32 aircraft manufactured between 1961 and 1977. Aircraft manufactured since 1977 were fitted with a forged cylinder which can be used as a replacement for the cast cylinders.

- If defects are found, rectification is to be carried out in accordance with the AMM. If cracking is found as noted in Appendix 1 Figure 2, the CAA should be notified using the following email address - [certification.gau@caa.co.uk](mailto:certification.gau@caa.co.uk).
