(2) Auster 3, 4 and 5 Variants 'J' and 'D' Series and Taylorcraft Plus 'C' and 'D' Aircraft

UK National Airworthiness Directives previously published in CAP 476 – Mandatory Aircraft Modifications and Inspections Summary

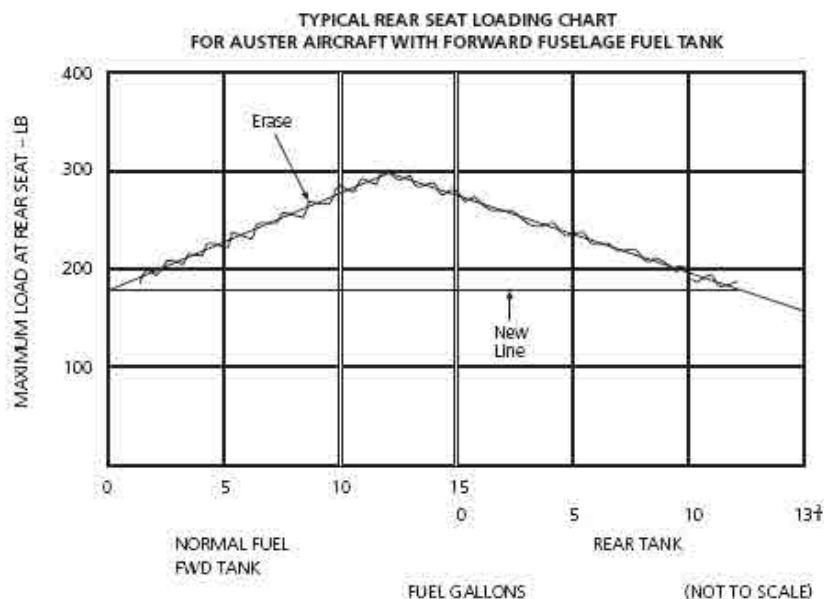
Description: Rear seat loading limitations amendment.

Applicable to Auster Models Mk4, Mk5, Mk5C, Mk5D, J1, J1B, J1N, J1S, J5, J5B, J5F, J5G, J5H, J5K, J5L, J5P, J5Q, J5R, J5V, D5 and D6 which are fitted with a forward fuselage fuel tank. Compliance is required prior to the next flight on which it is intended to carry passengers on the rear bench seat, but in any case not later than 30 September 1976. Amend the loading limitation chart which is displayed in a plastic holder on the rear cabin bulkhead, as follows:

(1) Draw a line, parallel to the base line of the chart, from the rear seat load at zero fuel, i.e. the intersection of the loading limitation line with the left-hand vertical axis of the chart, and continue this horizontal line to intersect with the right-hand slope of the loading limitation line.

(2) Erase all that part of the original loading limitation line, which lies above the new line (drawn in accordance with 1).

NOTE: The following sketch illustrates an amended loading chart. If the existing loading chart should differ significantly from this illustration, advice must be obtained from the CAA prior to amendment. This Directive hereby authorises the Operator to make an entry in the aircraft Log Book, quoting the AD number, and this entry must be made when the loading chart has been amended in accordance with these instructions.
