AGÊNCIA NACIONAL DE AVIAÇÃO CIVIL – BRAZIL

## BRAZILIAN EMERGENCY AIRWORTHINESS DIRECTIVE

**EAD No: 2026-04-02**

**EAD No. 2026-04-02 - EMBRAER / 39-1602.**

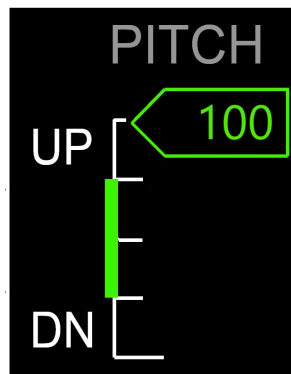
Figure 1 - Pitch trim indication.

**(ii)(1)** If the pitch trim indication stops before to reach the upper limit (full UP) (100) position or FLTCTRL HSTAB FAIL or FLTCTRL HSTAB FAULT message is displayed on Engine Indicating and Crew Alerting System (EICAS) of the airplane, it is prohibited to take-off the airplane. Report the failure to the applicable maintenance service and replace the PTA P/N 492600-1017 by another airworthy PTA with the same P/N, and perform a new OPC on the new PTA.

**(ii)(2)** If the full UP (100) position is reached and FLTCTRL HSTAB FAIL and FLTCTRL HSTAB FAULT messages are not displayed on airplane EICAS, accomplish with the requirements of paragraph **(a)(1)(i)** of this EAD within the next 50 FC or 75 FH after the pitch trim verification, whichever occurs first.

**(ii)(3)** Record the pitch trim verification procedure in the airplane logbook.
